WETLAND DELINEATION REPORT

600 & 700 Hoffmann Drive

Watertown, WI 53094

PROJECT #: 23-198

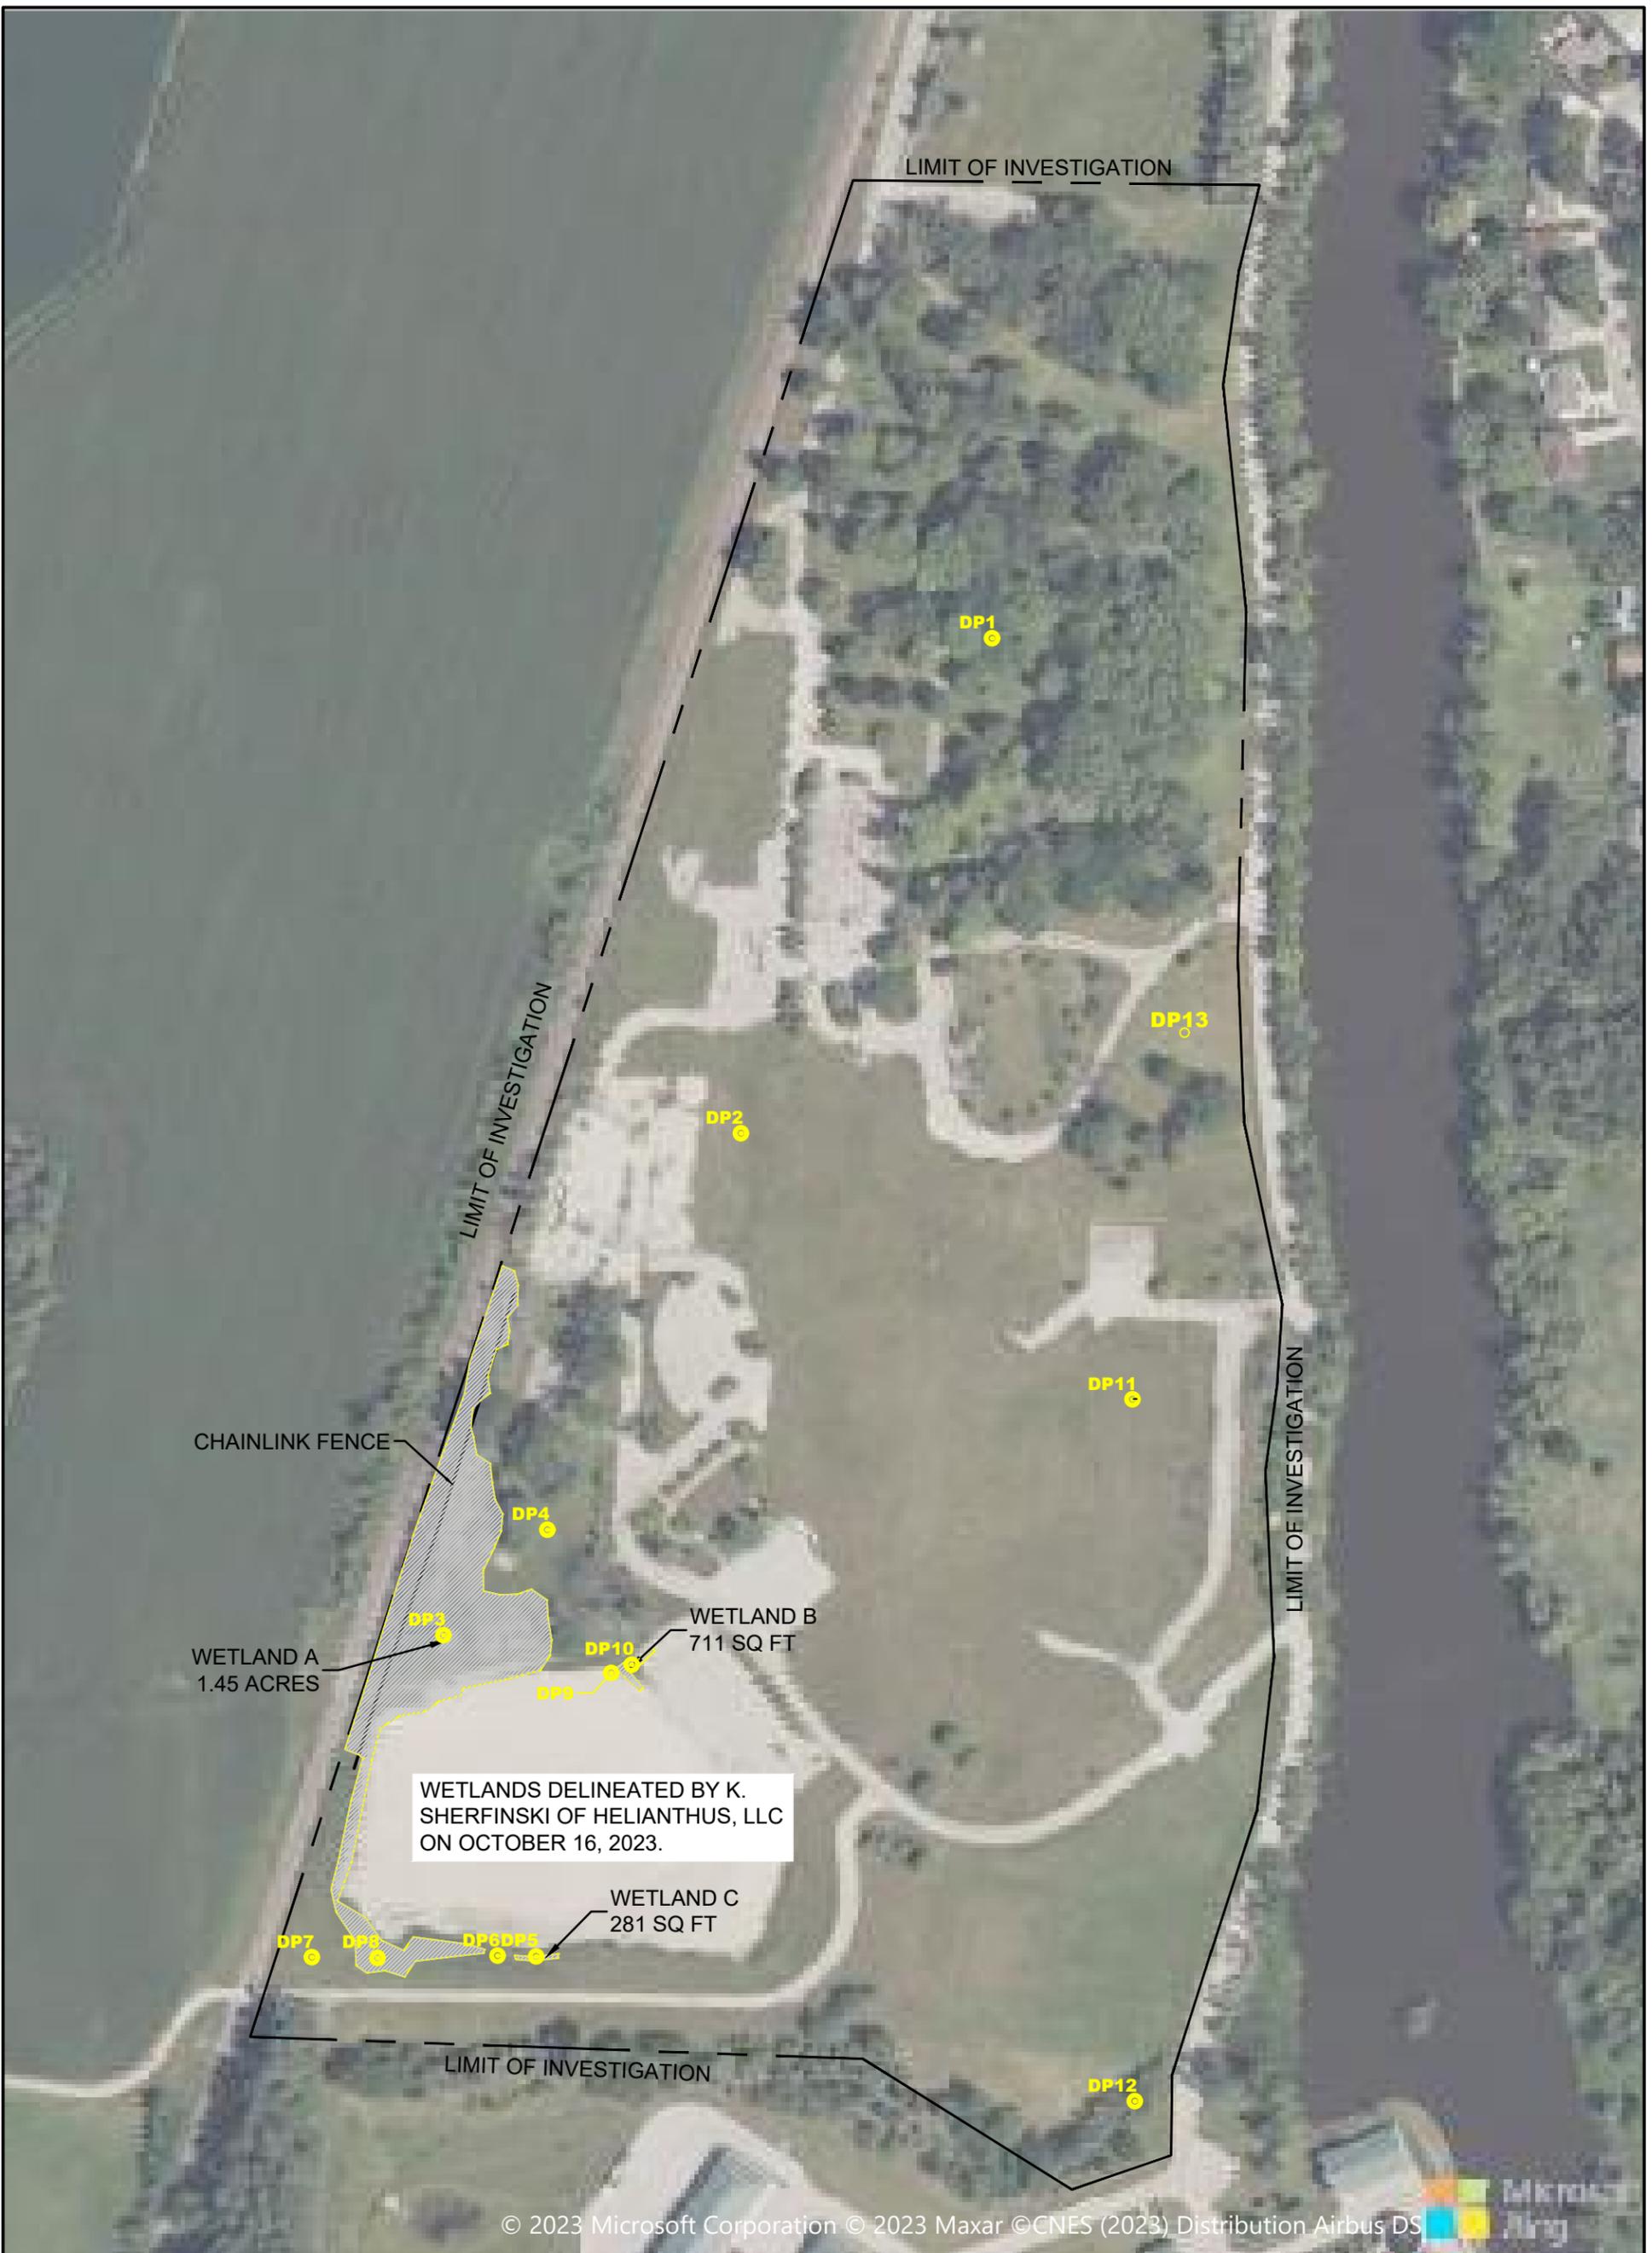
FIGURE 9. WETLAND BOUNDARY MAP

The predominant land cover for this property is a former campus with a collection of buildings that have been recently demolished. The lawn areas have been left unmowed and the parking lots were still present. The purpose of the wetland delineation was to identify the existing wetlands on the property and to create a map of their boundaries. A map of the surveyed wetland boundary is found in **FIGURE 9**.

A total of three wetlands were identified on the property during the field visit. Site photos of the different wetlands are included in **FIGURE 8**. The acreages and types of wetlands that were identified and flagged in the project are shown in **FIGURE 9**. Field data sheets are included in **FIGURE 10**. A description of the wetland areas follows.
