Riverside Middle School

Traffic & Pedestrian Safety Study

Prepared for
City of Watertown & Watertown Unified School District

August 2016

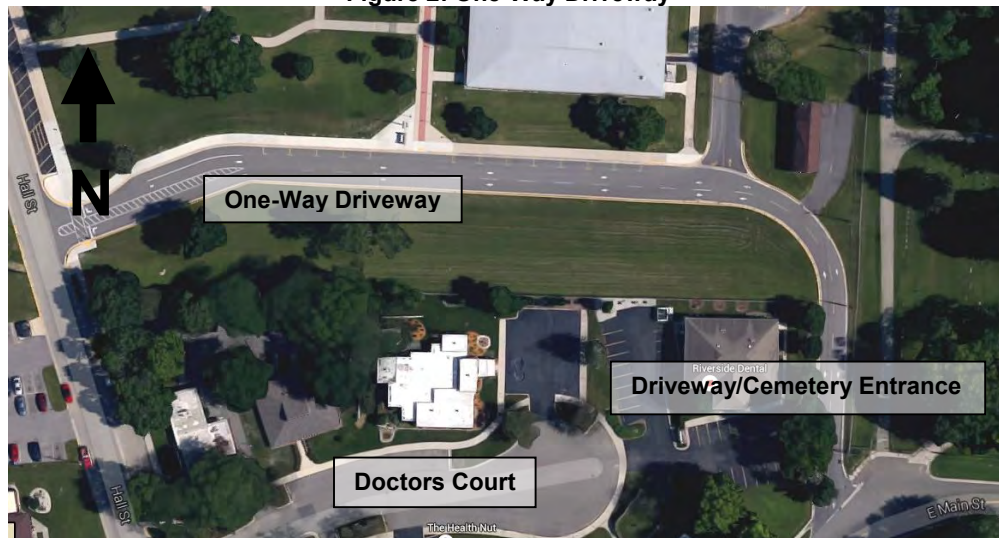
Figure 2: One-Way Driveway

Most motorists will use the right lane upon entering the driveway, and wait their turn to pull up to the sidewalk to drop off or pick up their child. Some drivers will use the left lane and stop in the travel lanes to drop off or pick up their child. This double parking results in drivers being required to weave in and out of the travel and parking lanes, and students weaving between cars to reach the school property. The parking spaces on the western end of the driveway are less utilized than those on the east end, as drivers do not have adequate space to weave across traffic to access the left-turn lane to Hall Street. During arrival and dismissal periods, traffic back-ups can build up at the driveway stop signs, as drivers wait for gaps in traffic to enter Hall Street.

1. Construct a sidewalk along the south side of the one-way school driveway from the main school entrance to its intersection with E Main Street.
2. Construct a raised pedestrian crosswalk on the one-way driveway to the new sidewalk identified in Improvement 1 above.
3. Convert the angle parking on Hall Street to 'back-in' only angle parking.

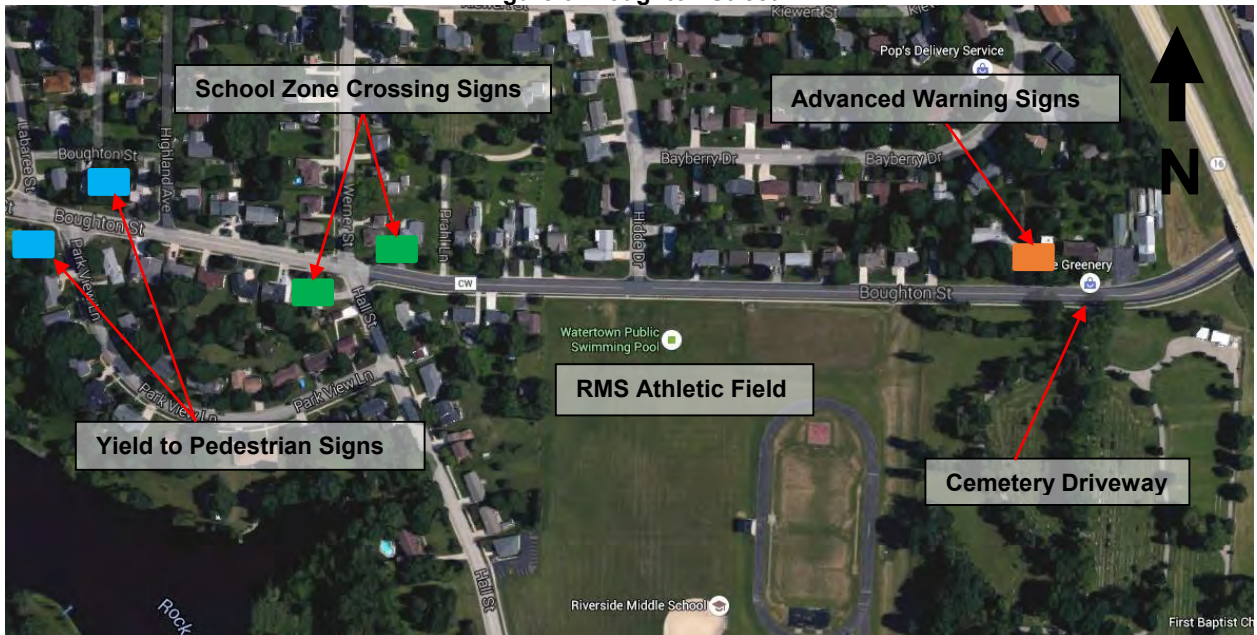
Figure 5: Boughton Street

Boughton Street is a two-lane street that runs east-west along the north side of Riverside Middle School. The primary intersection within the study area is at Hall Street. The other intersection is with Hidde Drive, which provides access to the neighborhood north of the school. Driveways to private residences are located along the north side of Boughton Street, and on the south side of the street near the intersection with Hall Street. A driveway to the Oak Hill Cemetery is also located at the east end of Boughton Street, on the south side.

During school arrival and dismissal periods, parents use Boughton Street to access Hall Street and HWY 16 to the east. Parents do not typically drop students off on Boughton Street. However, some students who walk and/or bike to school will use the field on the north side of the school to get to Boughton Street, crossing Boughton Street mid-block to access the adjacent residential neighborhood.

3. Consideration should be given to installing a mid-block crosswalk on Boughton Street near Hidde Street, as numerous students were observed to walk through the RMS athletic field to cross Boughton Street. This new crossing should be designed with a median pedestrian refuge island and rectangular rapid flashing beacons to create a safe crossing for students and increase driver awareness of the existing pedestrian activity. The 'Continental' Style crosswalk is estimated to cost approximately \$350. The median refuge island cost estimate is approximately \$5,000, and the rectangular rapid flashing beacon cost estimate is approximately \$7,750.

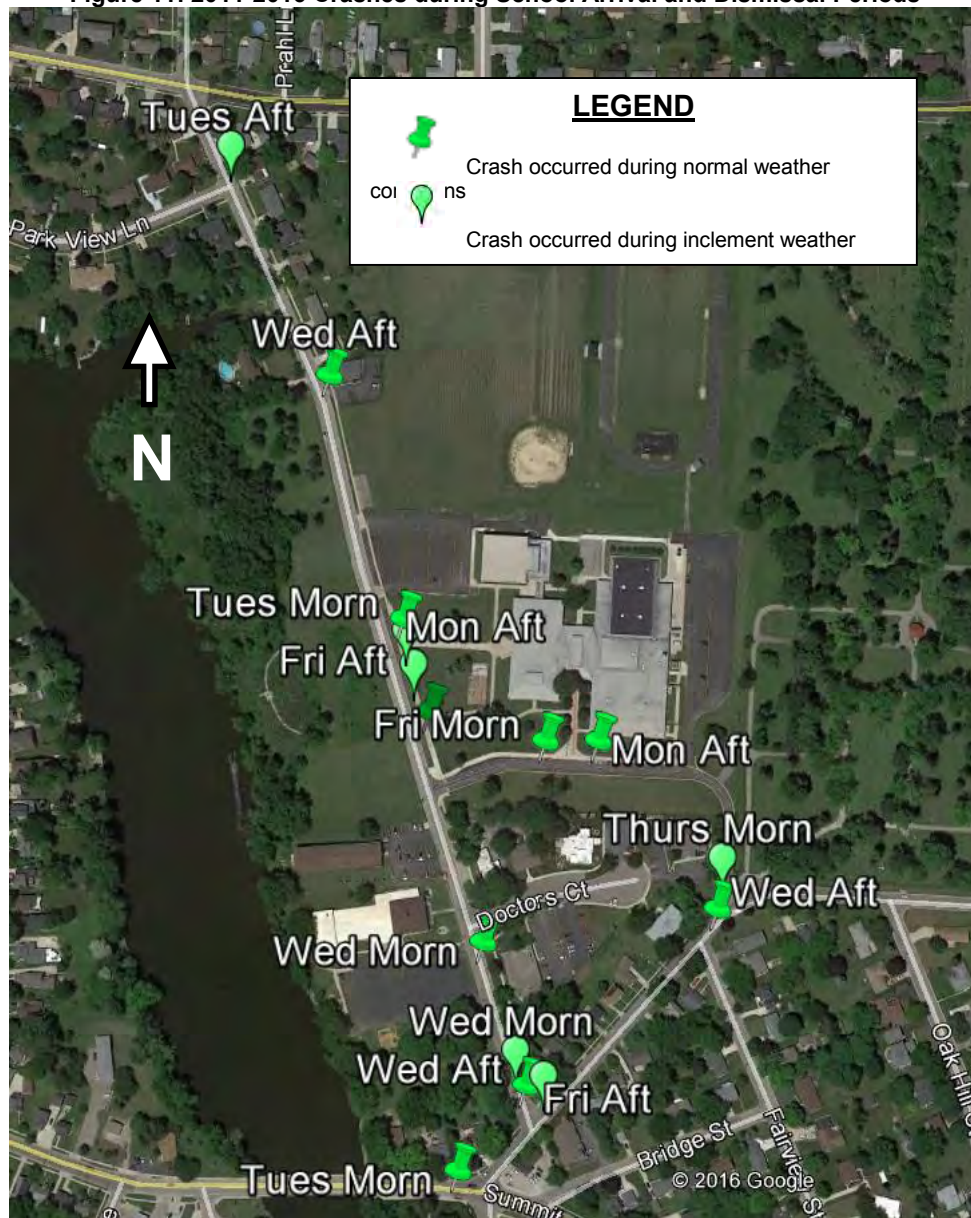
Figure 11: 2011-2016 Crashes during School Arrival and Dismissal Periods

Of the 26 crashes, 15 (58%) occurred during school arrival (7:00 AM – 8:00 AM) and dismissal (3:00 PM – 4:00 PM) periods, as shown in Figure 11. The remaining 11 crashes occurred during off-peak or weekend hours. Of the 15 crashes reported during school arrival and dismissal periods, 10 (67%) involved vehicles striking a fixed object or were sideswipe crashes. The fixed object crashes all involved vehicles colliding with a parked car in the parallel or angle parking on Hall Street, or a parked car on E Main Street. The sideswipe crashes occurred on the one-way driveway or Hall Street. There was also one crash involving a pedestrian. In this crash, a vehicle had stopped on E Main Street to allow a group of students to cross E Main Street at the one-way school driveway and cemetery entrances. The group of students had finished crossing, but one student turned around to walk back towards the school when the driver began moving forward, striking the student. This is the only reported injury crash in the entire study area. Table 1 and Table 2 summarize crash data for the study area.

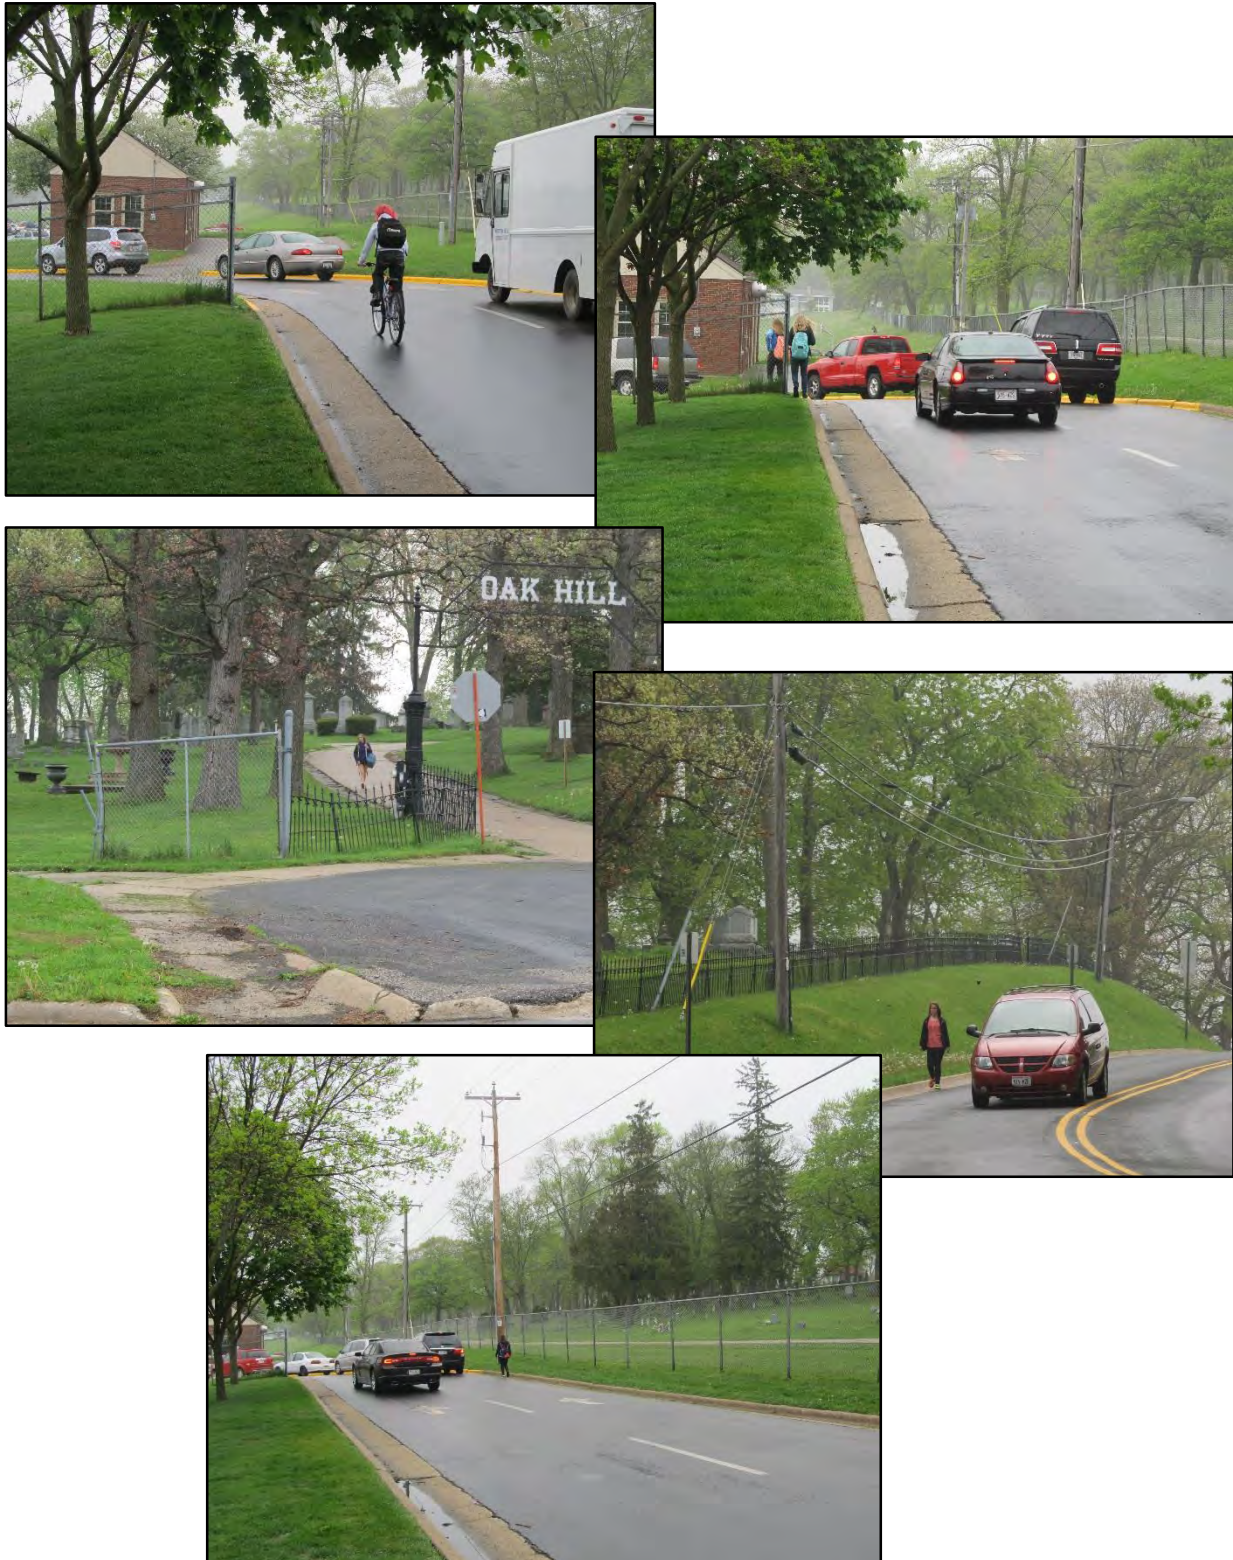
Figure 15: Students Walking/Biking on E Main St/One-Way Driveway during School Arrival Period

Students begin arriving at school around 7:00 AM. Only a side building entrance located on the one-way driveway is open for students to use before 7:30 AM. Students who walk to school access the school from all directions; some come from Boughton Avenue and Parkview Lane, walking down Hall Street, or cutting across the RMS Athletic field. Others come from the west end of E Main Street, accessing the school from Hall Street. Sidewalks are available for these routes. Other students come from the east on E Main Street or through the cemetery, accessing the school from the one-way driveway. No sidewalk is available for students coming from these directions. Students walk on the grass or in the street. There are no crosswalk markings across the driveway for students to get from one side to the other. Figure 15 shows various students as they walk or bike to school from E Main Street, Fairview Street, and the

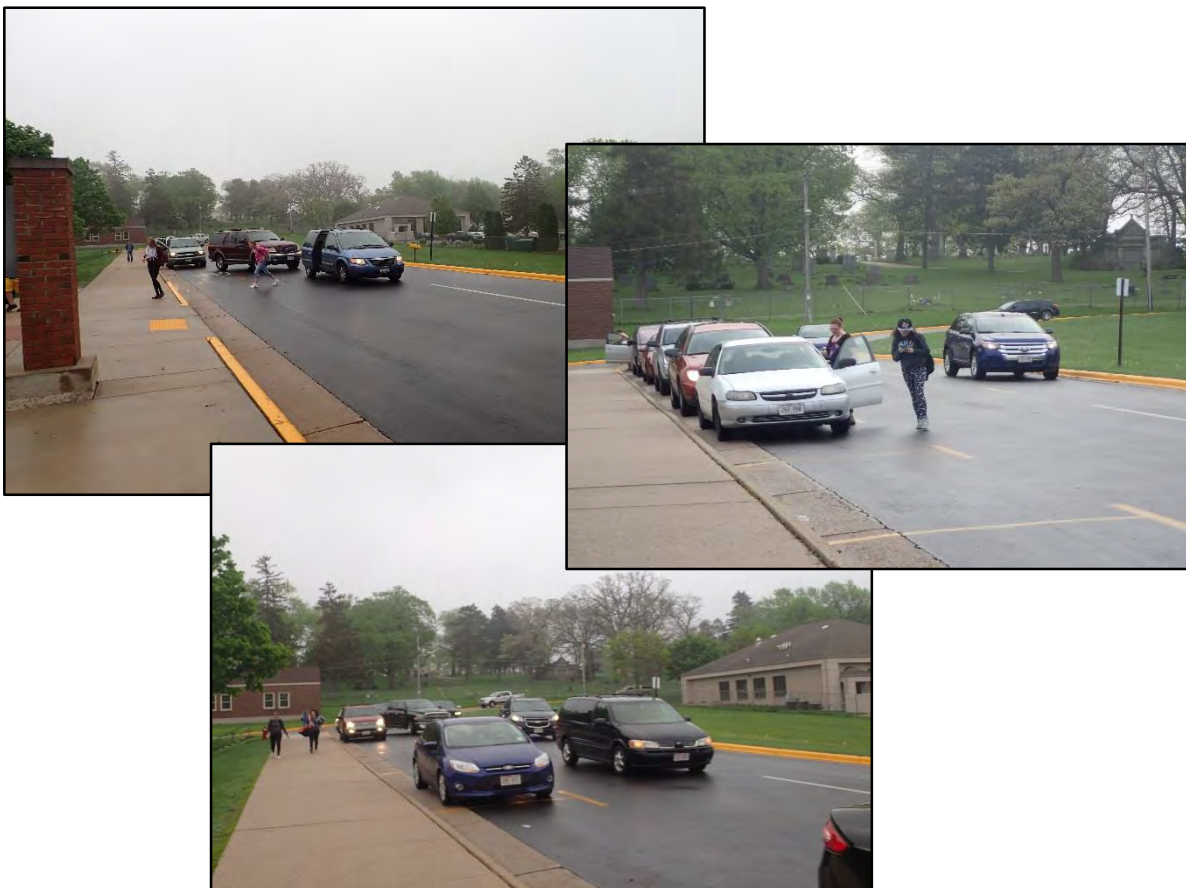
Figure 16: Vehicles and Students Navigating One-Way Driveway during School Arrival Period

Similarly, parents dropping their children off do so primarily on the one-way driveway in front of school or on Hall Street near the angle parking. When dropping off in the one-way driveway, parents queue up in the right lane waiting their turn to pull up to the sidewalk in front of the main school building entrance. The queue can extend back to the driveway entrance intersection with E Main Street. Some drivers will use the travel lanes to pull into the spots on the west end of the driveway and other drivers will stop in the travel lanes to drop off their children. Additionally, some students exit their vehicles on the left side, directly into the travel lanes, rather than on the right, onto the sidewalk. The combination of all of these practices creates safety conflicts, congestion, and driver/pedestrian confusion, as vehicles have to navigate around each other, as well as students, to exit the driveway. Additionally, drivers will sometimes park and talk to their children or allow their children to sit in the car during cold weather conditions before entering the school building. This adds to driver delay and vehicle queueing.

Drivers also drop students off on Hall Street in the angle parking area. Pulling into and backing up out of the angle parking spaces can create queuing and safety problems. In general, Hall Street can become quite chaotic as it serves several purposes: some drivers use it as a drop off and turn around location, while others use it as a street to arrive at and leave the school grounds. This operation is exacerbated during inclement weather, such as cold temperatures, snow, or rain. Fewer students walk to school under these conditions, and the number of vehicles navigating the roadways increases. Additionally, if snow banks are located along the curbs, buses and vehicles have less room to maneuver around parked vehicles. Figure 16 shows parents dropping students off from the driveway center lane, students exiting vehicles

into traffic while focused on cell phones, and multiple vehicles navigating the one-way driveway to avoid other vehicles and students.

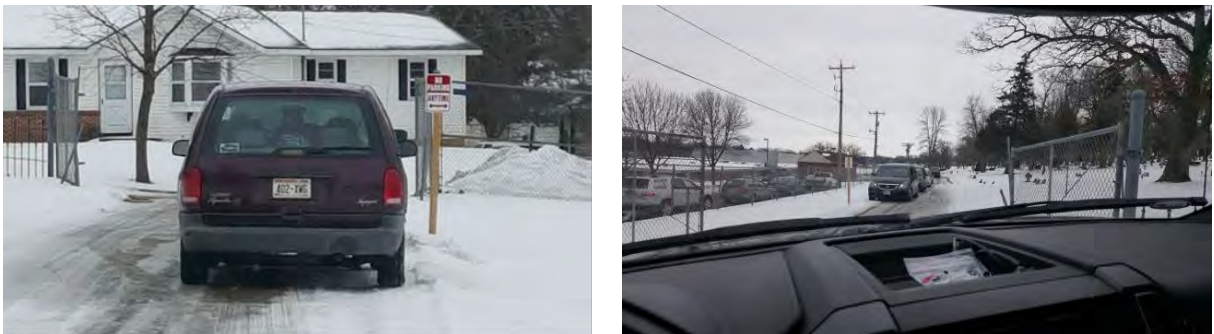
Figure 19: Queues on Cemetery Drive Adjacent to School and “No Parking” Sign

The cemetery would like to continue cooperating with the school, providing parents and students with access to the cemetery, but they hope to find a solution that allows the cemetery staff to work safely and also maintains the respect and dignity of those buried in the cemetery.

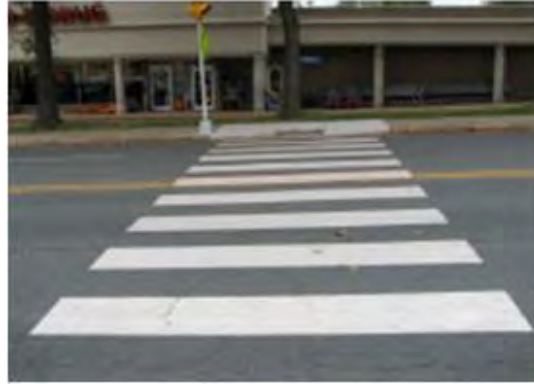
Figure 22: 'Continental-Style' Crosswalk Pavement Marking

2. Crosswalks should be marked with 'Continental' style pavement markings, as shown on Figure 22. Studies have shown that 'Continental' style crosswalk markings are the most visible to motorists and sight-impaired pedestrians. All existing school area crosswalks should be updated with the 'Continental' pavement marking design. In addition, the following intersection approaches are recommended for new crosswalks:

The total cost estimate to update and add all of the recommended 'Continental' style crosswalks is approximately \$3,500.
