From: Dan Schultz
Sent: Tuesday, January 30, 2024 12:56 PM
To: Pete Hartz
Cc: Timothy Hayden
Subject: FW: 409 & 411 Baxter Street
Attachments: Baxter St 1.jpg; Baxter St 2.jpg; Baxter St 4.jpg; Baxter St 5.jpg; Baxter St 6.jpg; Baxter St 7.jpg; Baxter St 8.jpg; Baxter St 9.jpg; Baxter St 10.jpg; Baxter St 11.jpg; 04B-003 plugged 15in line.jpeg; 409 Baxter 2.jpeg; 409 Baxter 1.jpeg; 411 Baxter.jpeg

#546 West St, Rail & Transload/Specialty Ingredients

History & Timeline for past issues with discharge from said address:

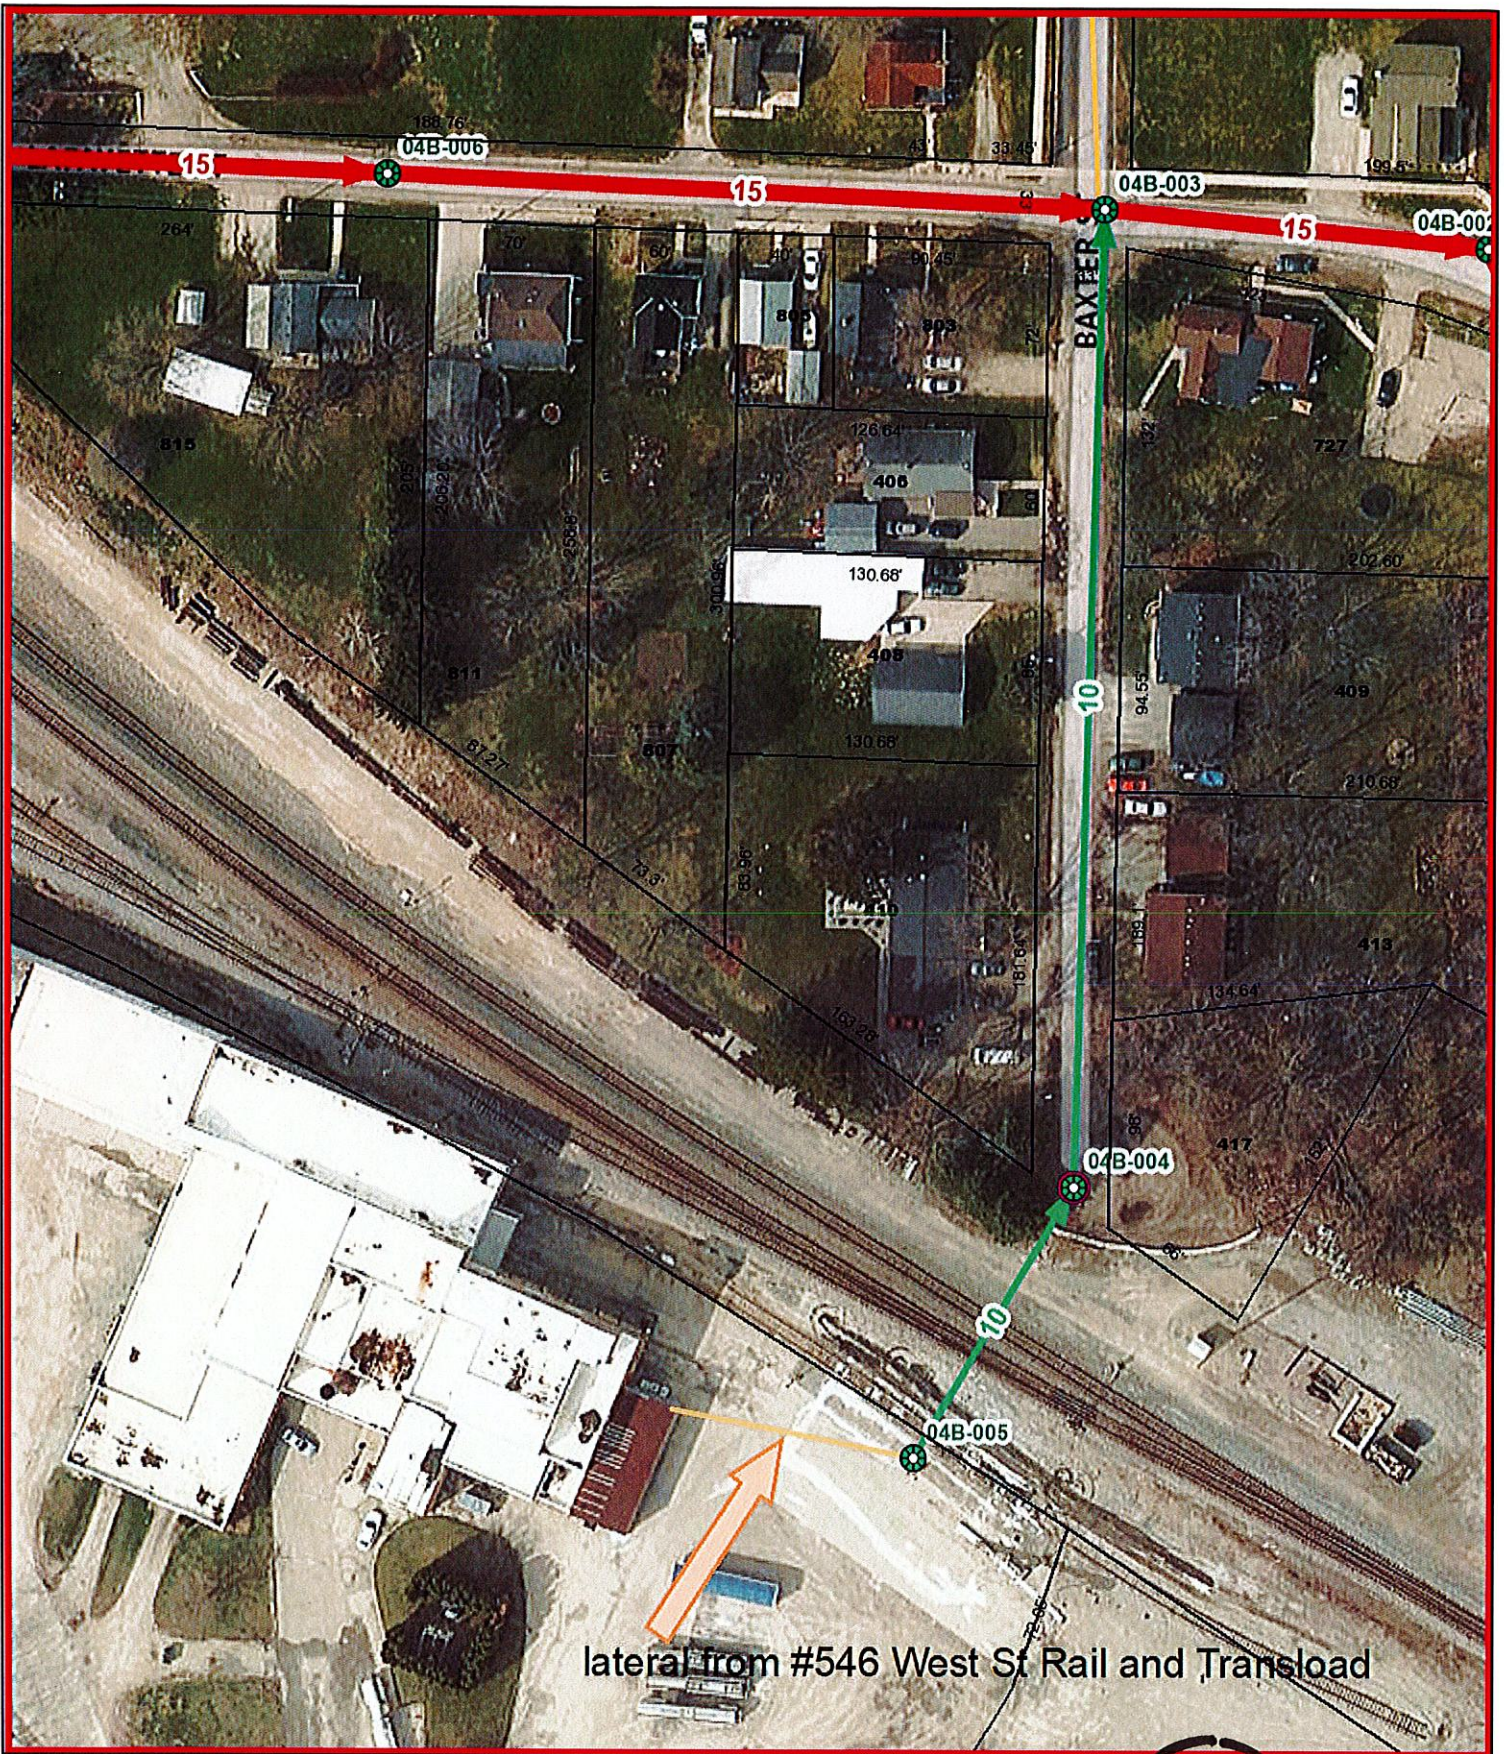
#3

1)The lateral for said address dumps into the sanitary sewer from 1 spot only, that is into the sanitary manhole #04B-005, S of the RxR tracks on there property, it then flows N under the RxR tracks onto Baxter St through a 10” pipe then it’s an inside drop into the 15” W Interceptor at Lafayette St.

lateral from #546 West St Rail and Transload

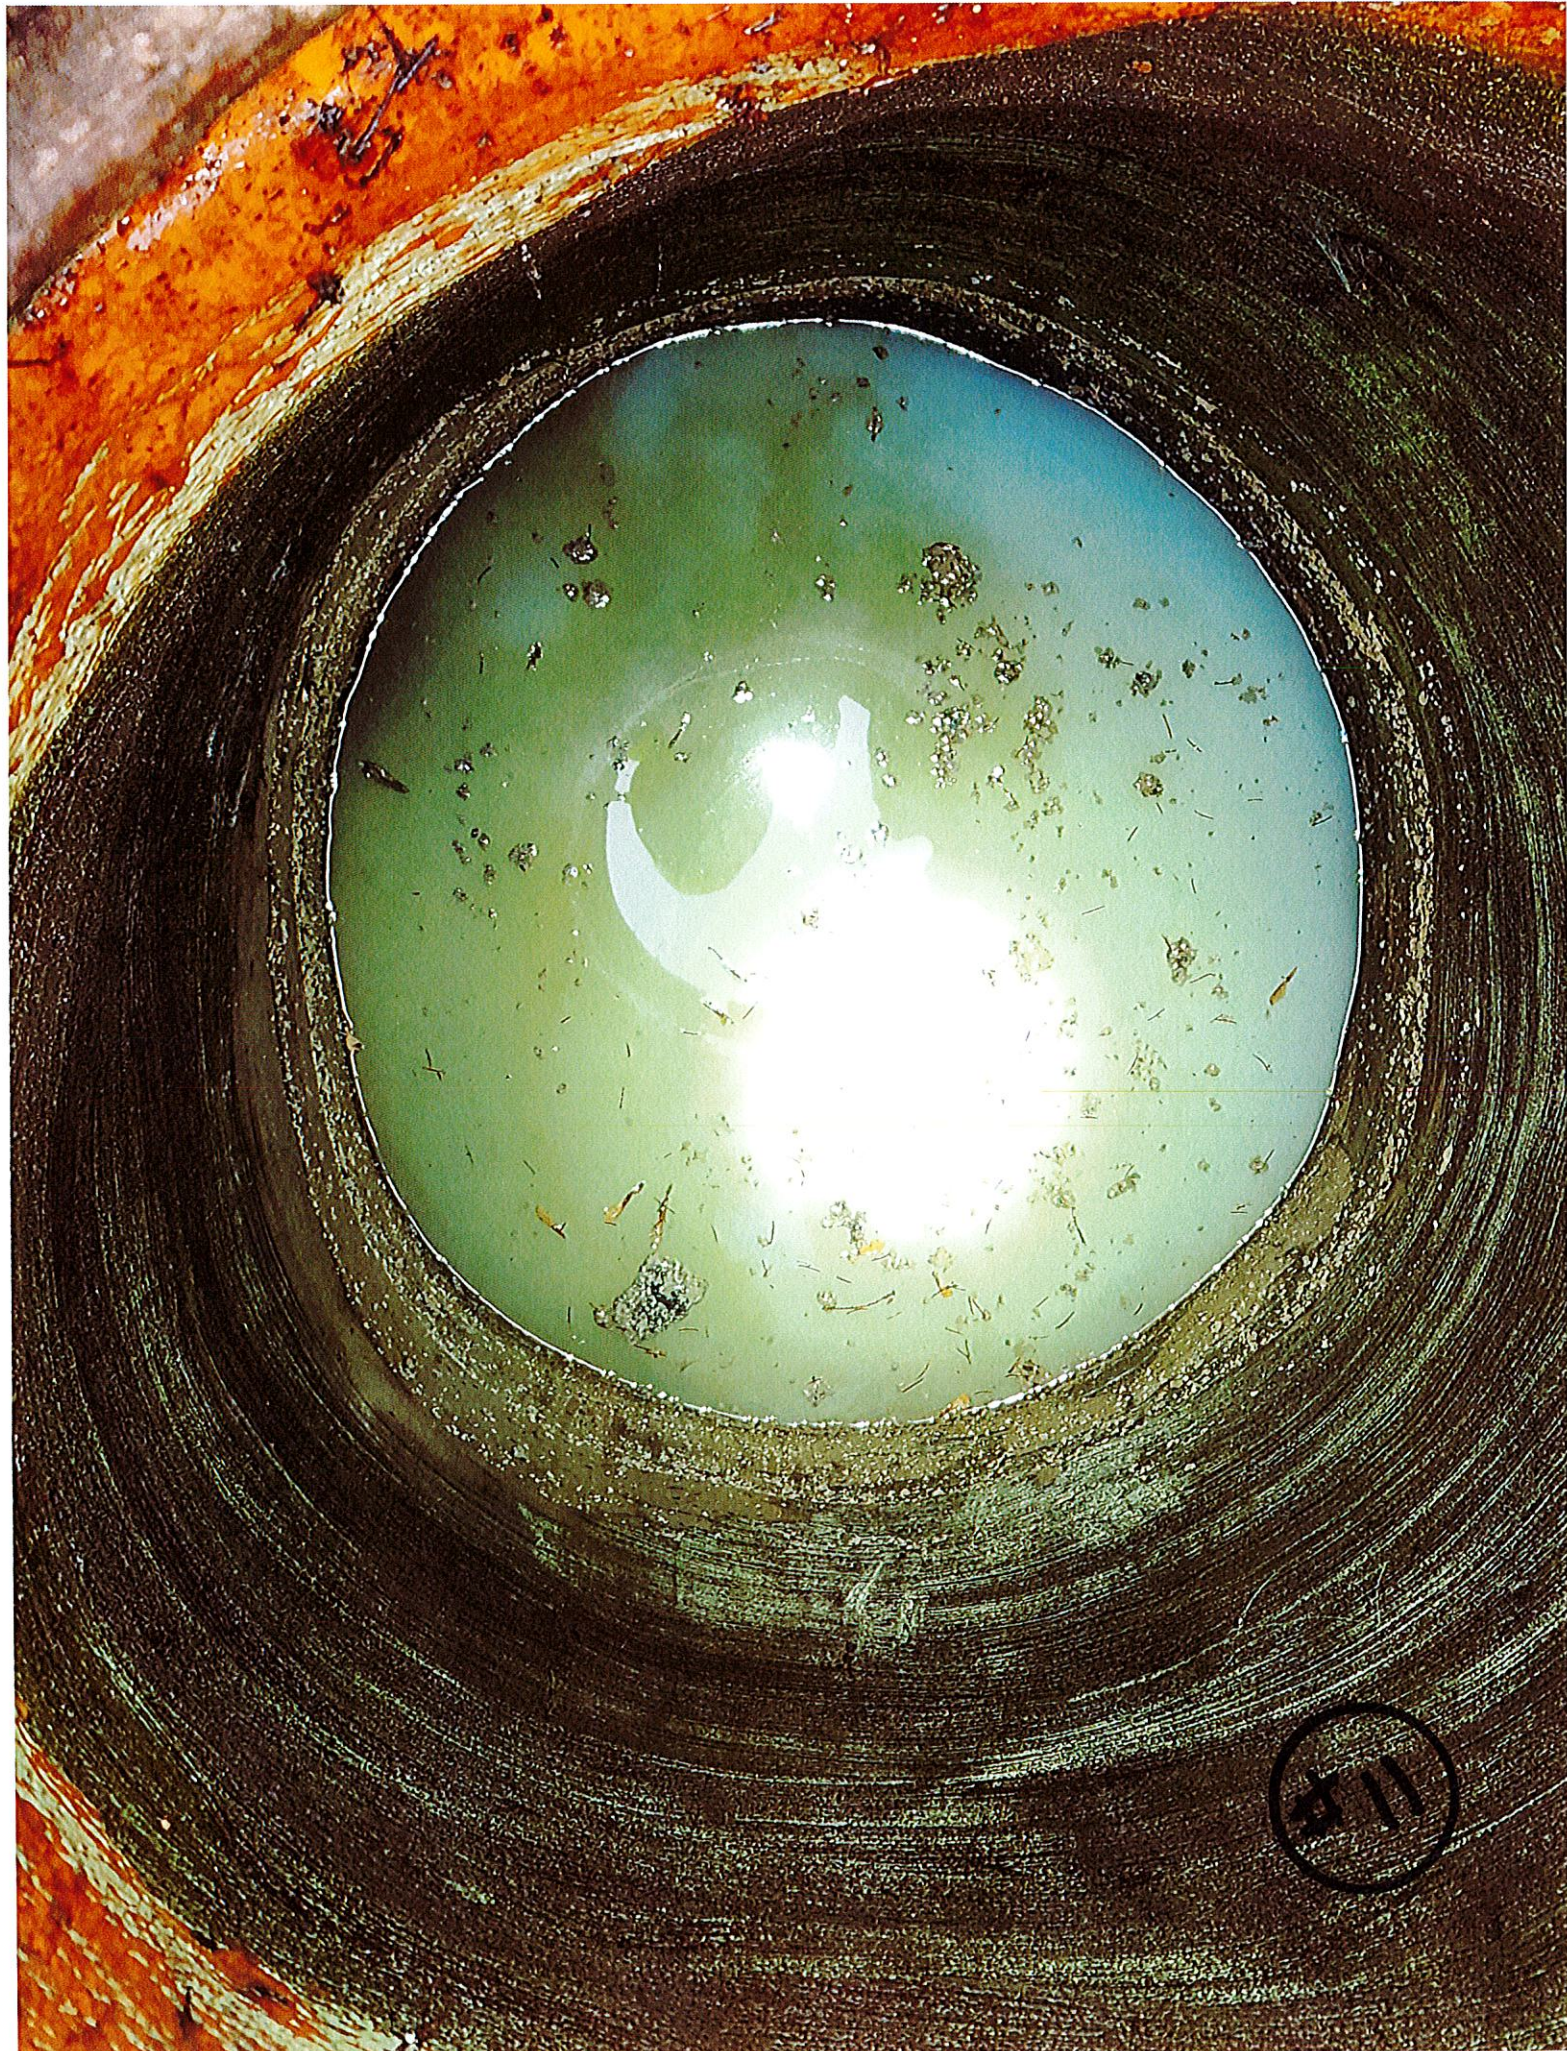
212

7) We were detained on another jobsite and was not able to get to Baxter St until 9:10am +/- . Upon arrival we found the upstream manhole #04B-004 surcharged (meaning it was full over the pipe & not taking water)

15" surcharged
w/ grease like
substance
yards....
of
material

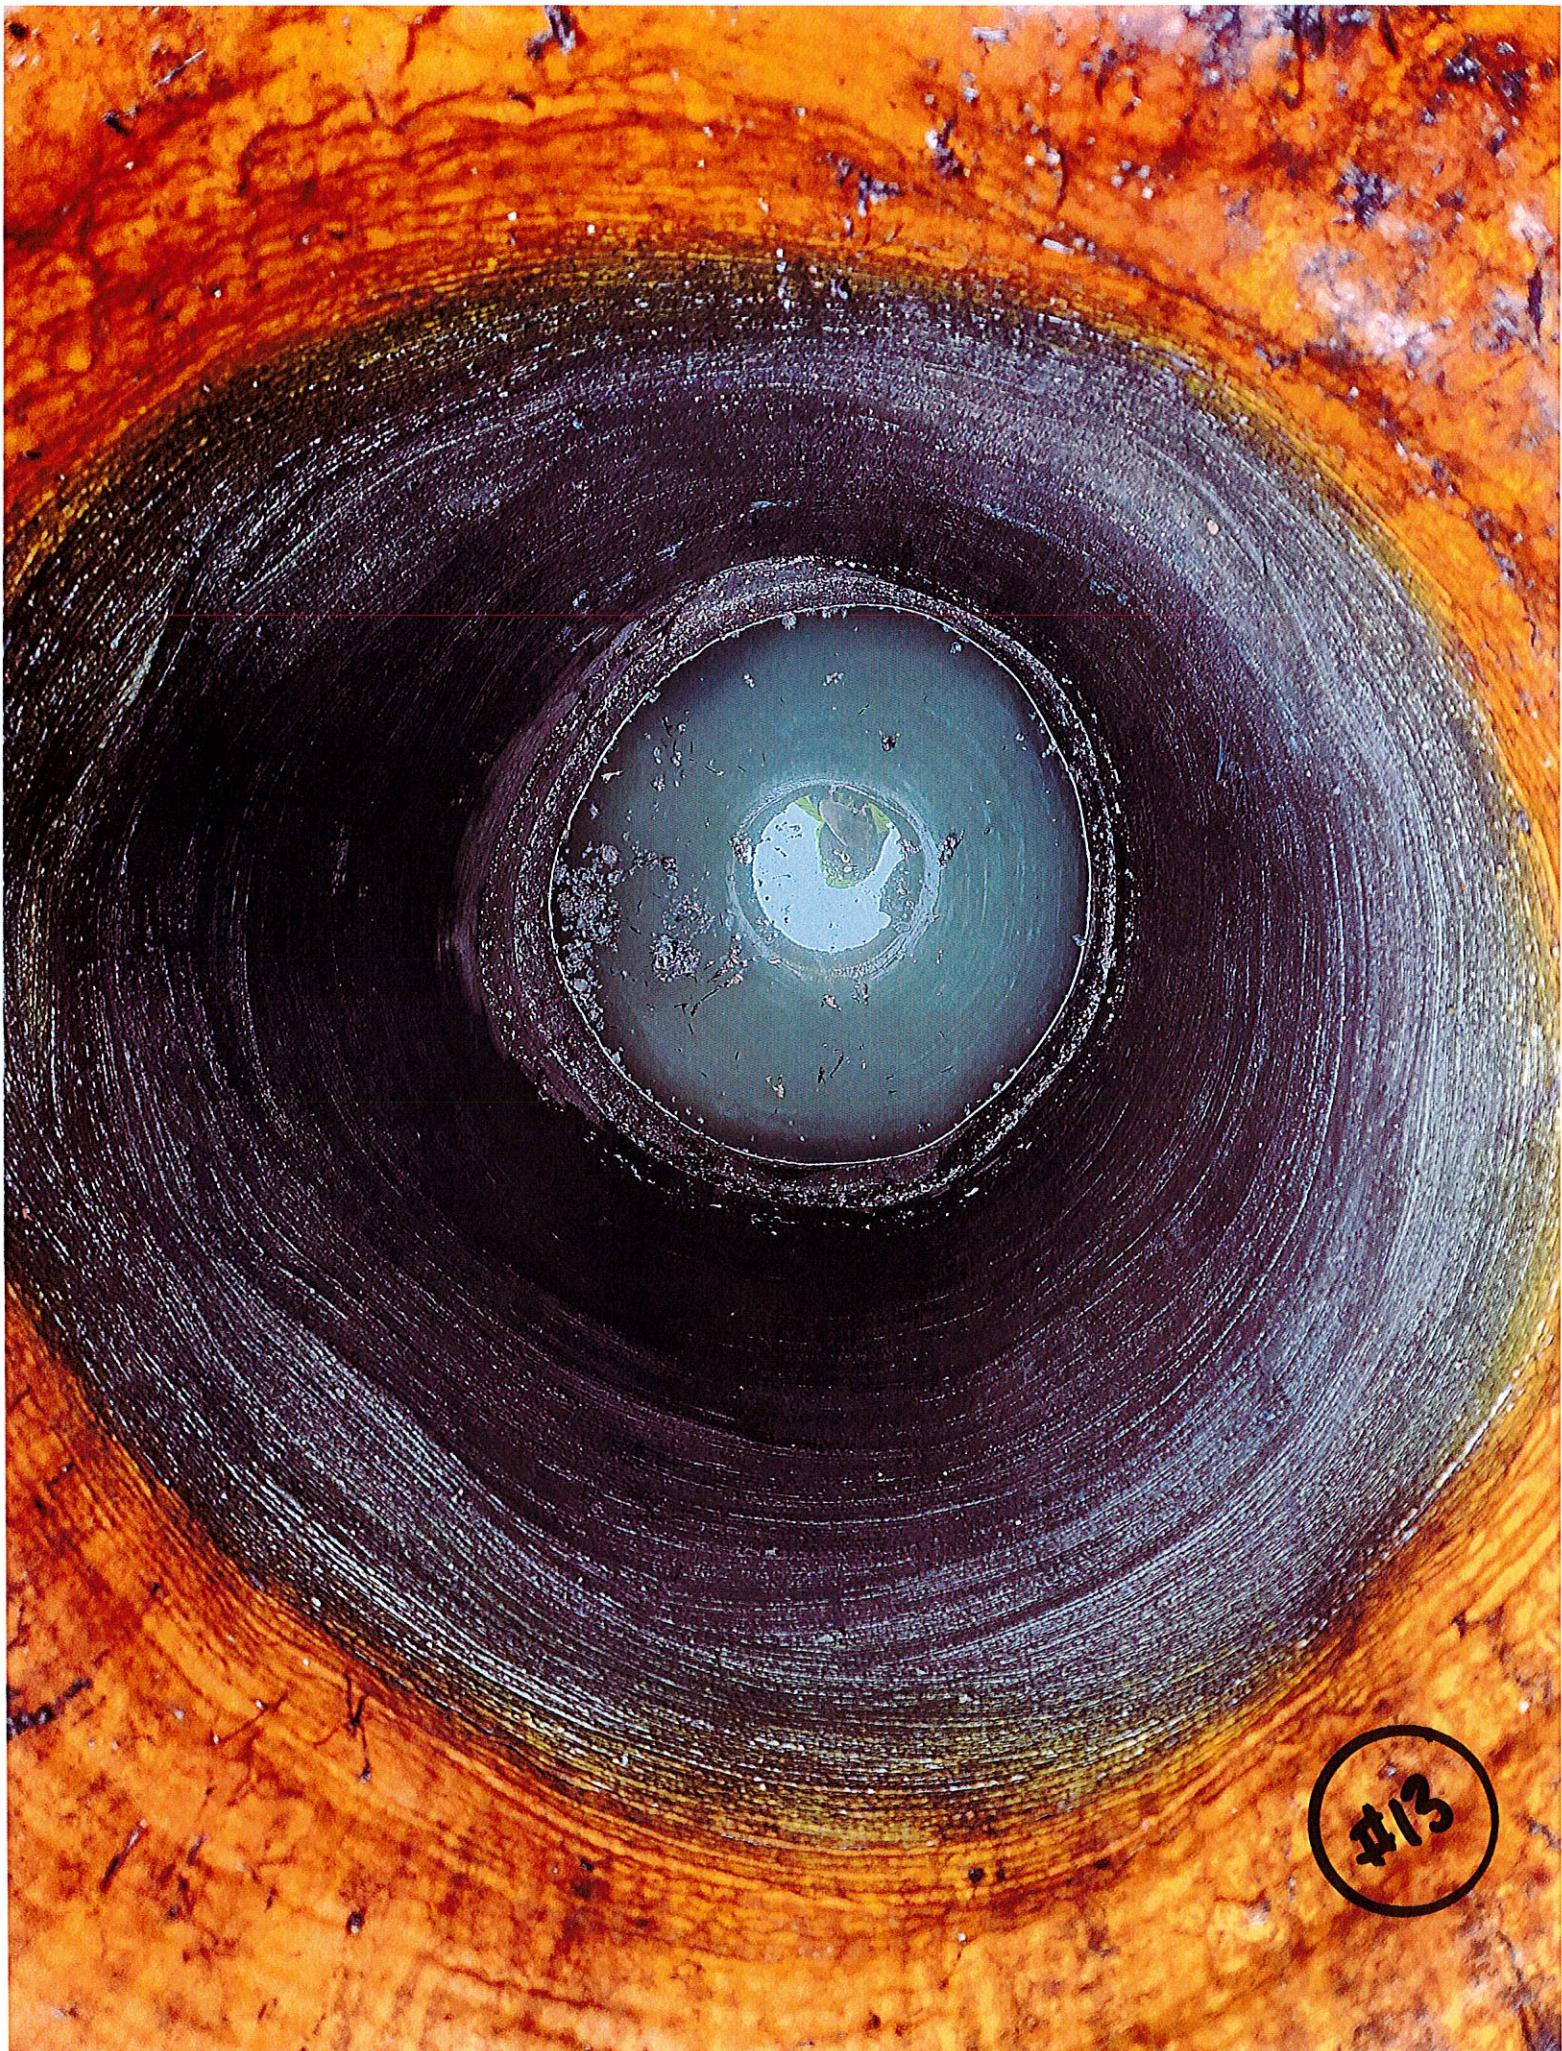
13

9) Photos of the upstream manhole #04B-004 on Baxter St show the manhole surcharged, the debris field/ grease layer left behind, the bluish colored water & finally the water flowing only after the blockage was removed.... (see sheets #13, 14, 15, 16 & 17)

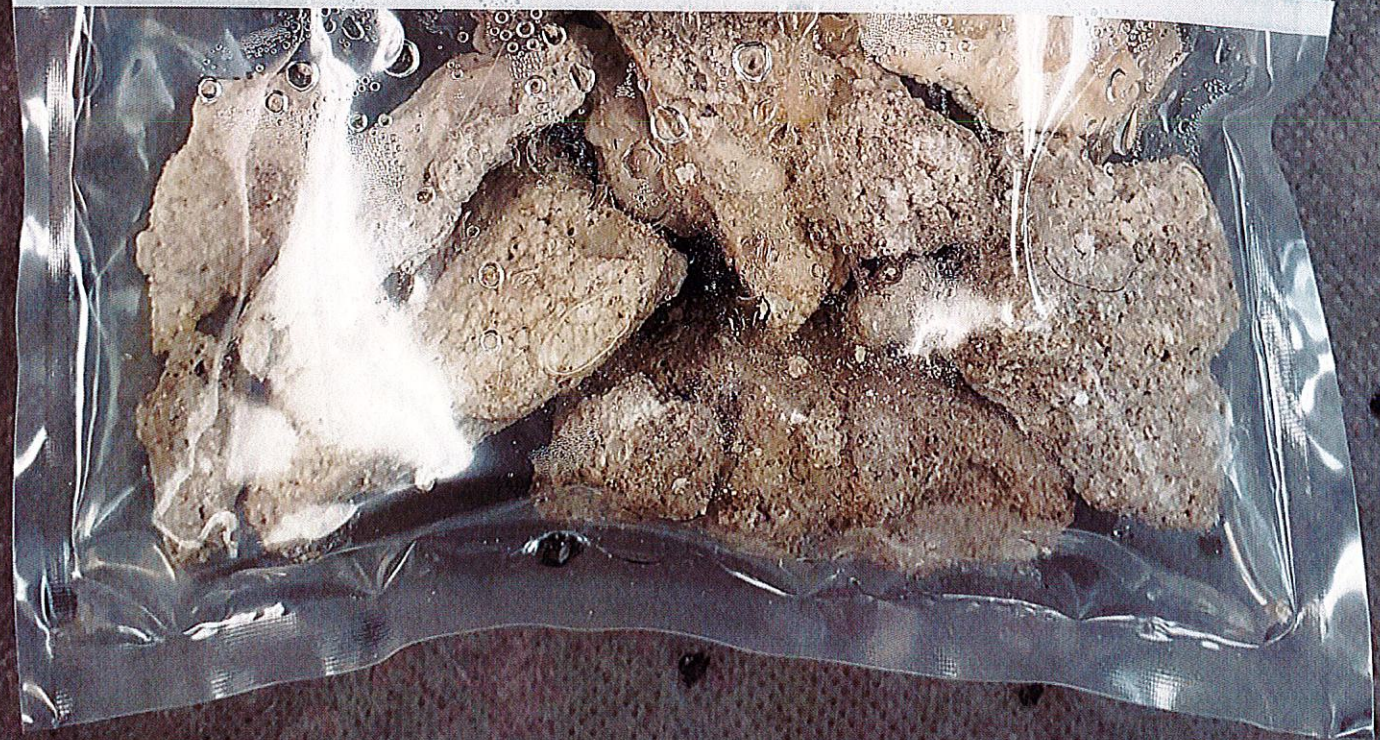
#19

10) As soon as the line was open and the blockage was removed, I contacted manager/Pete Hartz, who gave me the authorization to contact Rail & Transload. Once I made contact, I was put on hold until they could find the yard manager, Brady Hansen answered the line & soon after walked over as we were pulling samples of what plugged our line. At the back of the TV truck sitting on Baxter St. Brady grabbed a handful, smooshed it in his hand then smelt of it and said, "this is from us washing out the tankers for Clausen

Pete, this is the sample we collected on 1/30/2024 at approximately 10:00am +/-, the sample of what we collected is what plugged a 10in x 406ft sewer line, I would assume it happened over a short period of time as we had just been here & cleaned the line early May of 2023. We placed the red basket at the backend of the TV truck and showed the sample to Brady Hansen from Rail & Transload, he grabbed a handful, smooshed it in his hand & said it was from washing out tankers from C.Q.C., he said that they had plugged their own lateral & had Brisc Plumbing out to clean the line.

. Line 10' x 406'
. plugged, filled
2-duplexes - 2" +/-

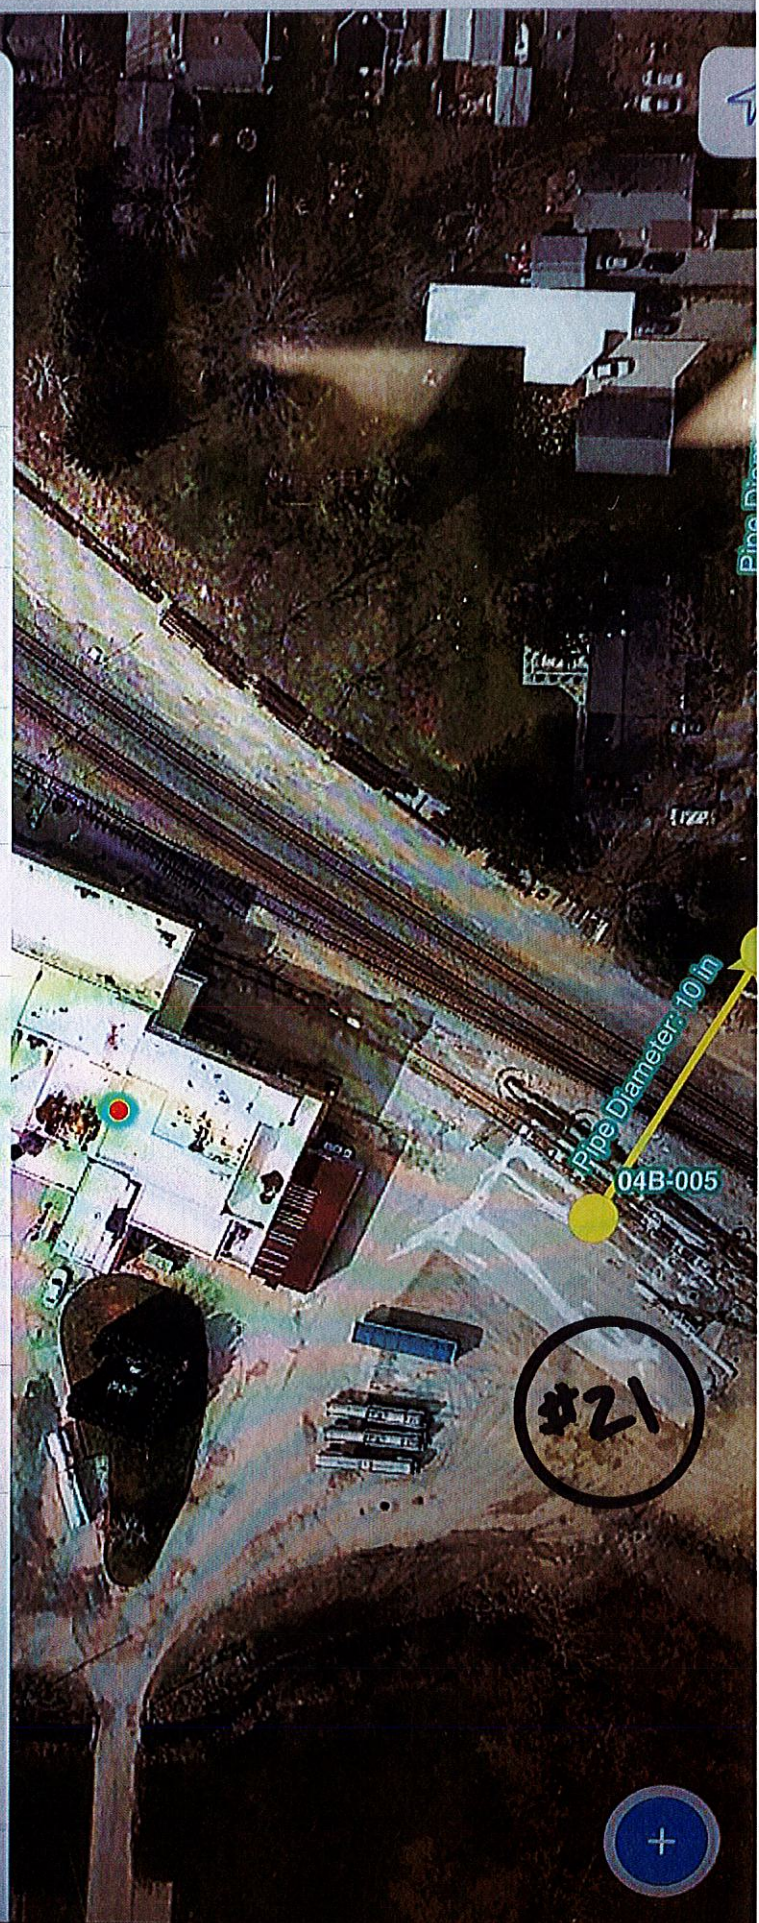
NOTE: we are aware of past issues as we were called upon on 4/3/2023 and made up a plugged sewer report. (see sheet #20 & 21)

Brisco plumbing was rodding from the basement toward manhole 04B-005 and got stuck around 120' out. By the looks of it, the pipe is possibly built up with minerals. Darwin from expeditors will be coming out to jet the line and suck the minerals out.

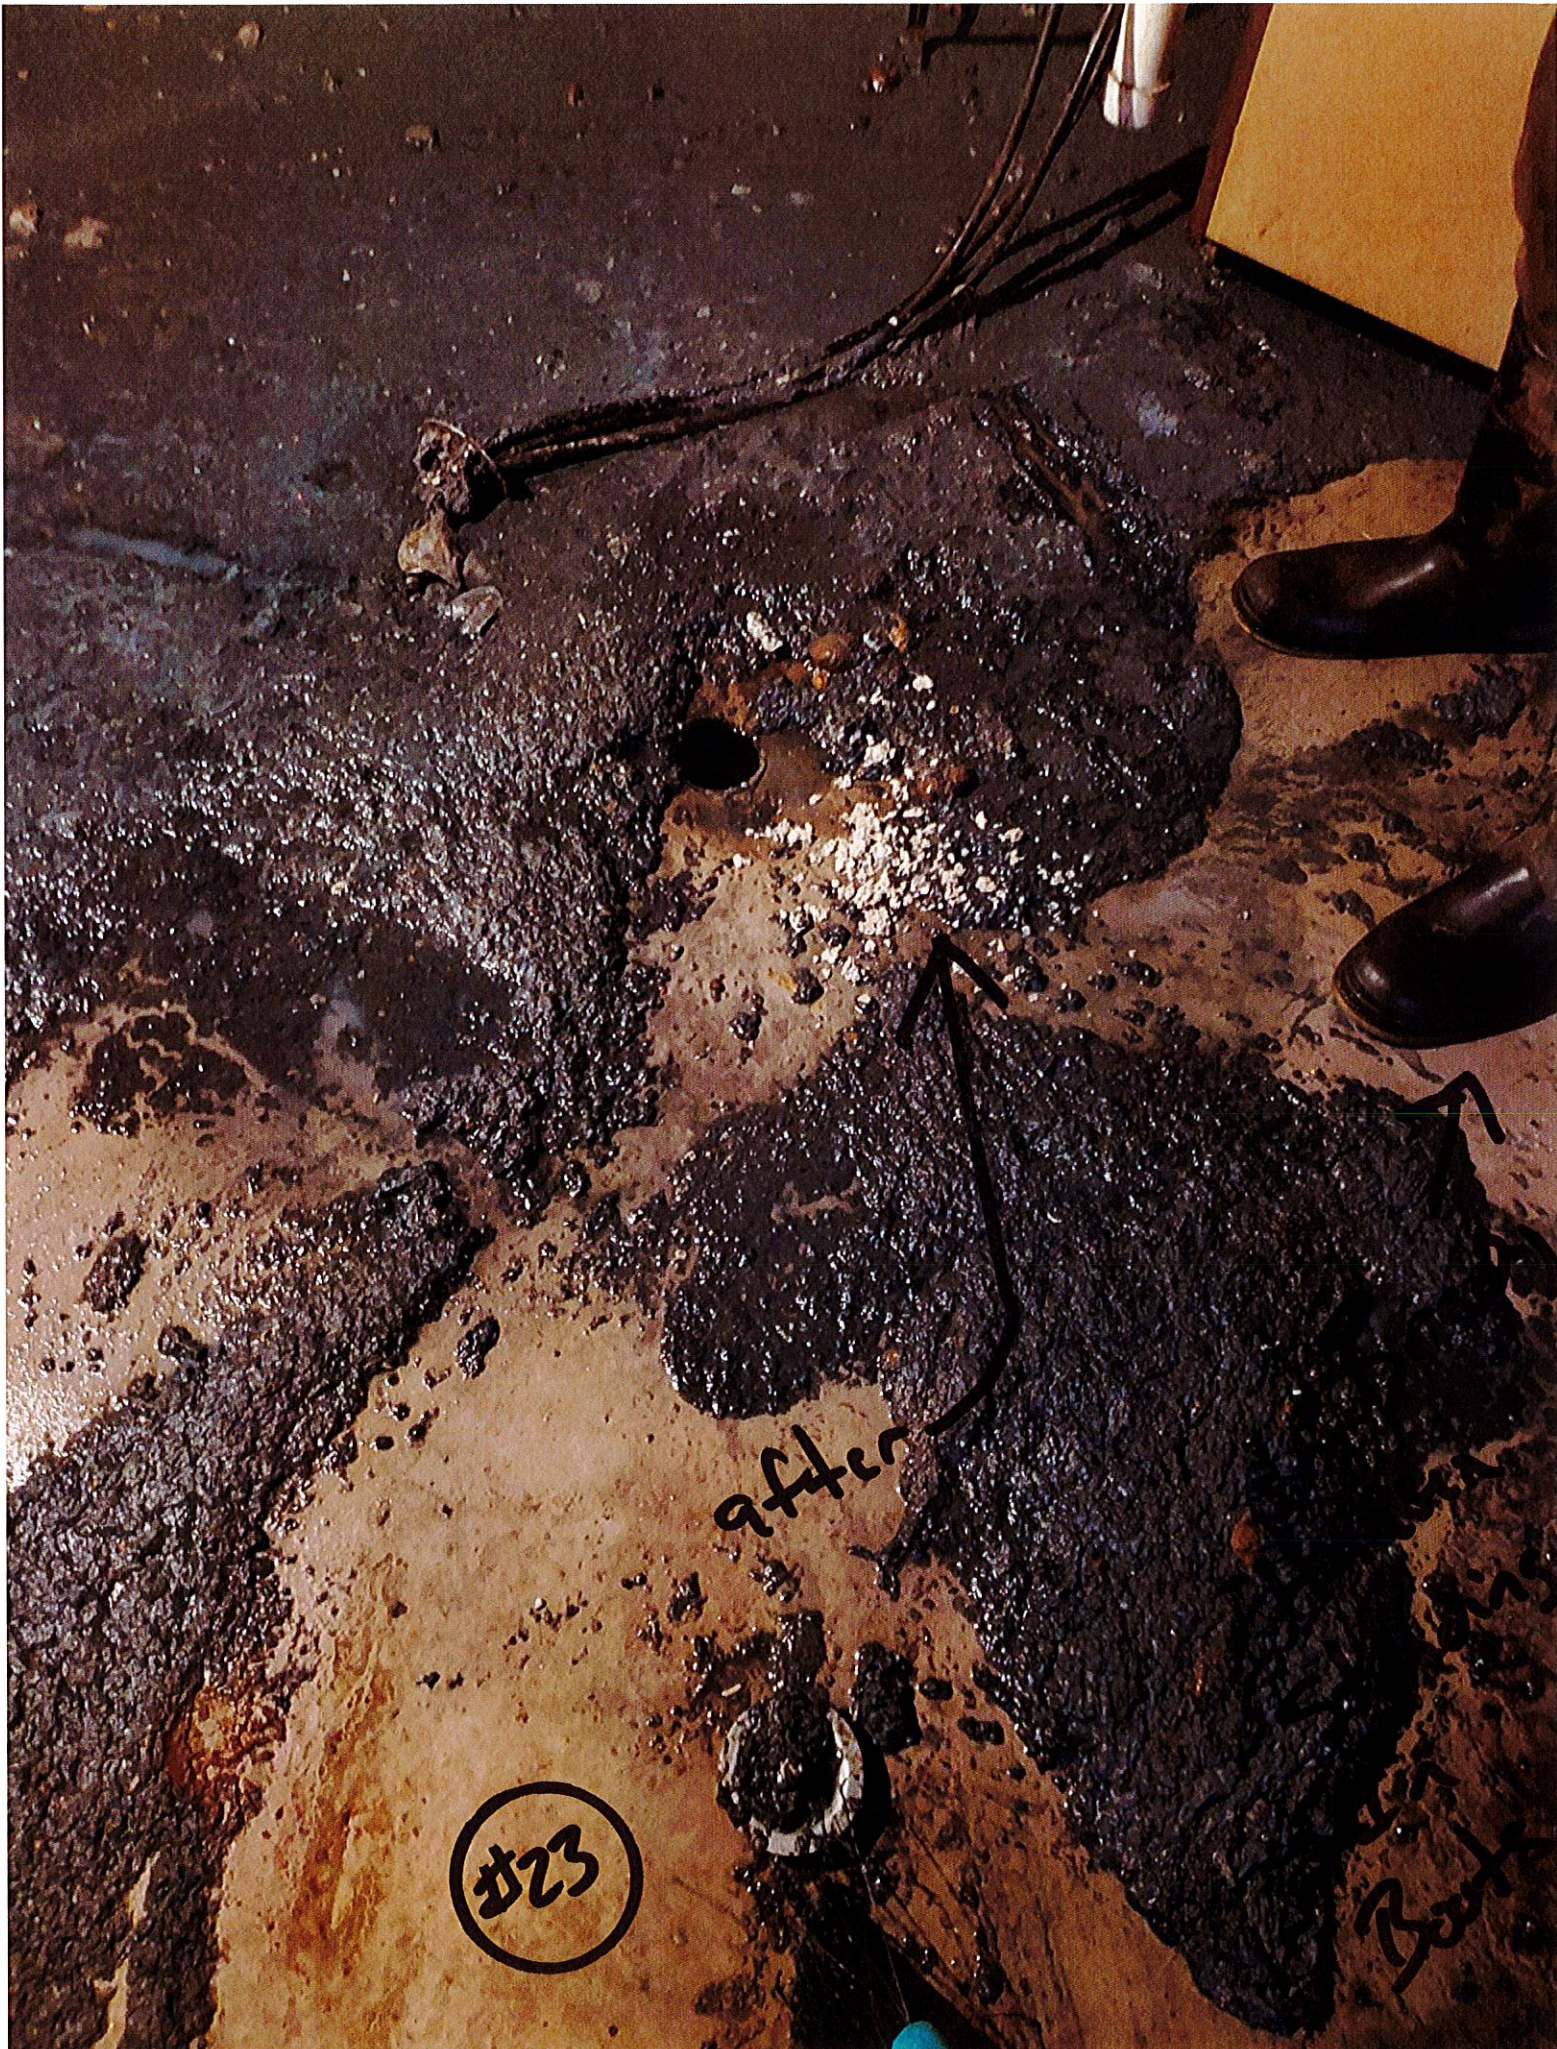
23

11) Brady Hansen from Rail & Transload then followed along with Jake & (myself /Dan) into the first basement of #409 Baxter St where Jinna Jung showed us the backup around the washer, dryer, furnace...(see sheet #22) Brady then reached down with his hands & grabbed the chunk of grease/solid, smooshed it in his hand and smelt of it and again said yep that from C.Q.C. then he took the crumbled up pcs and tossed them back onto the floor next to the floor drain where he stood in his rubber boots (see sheet #23)

← Rug's floor drain

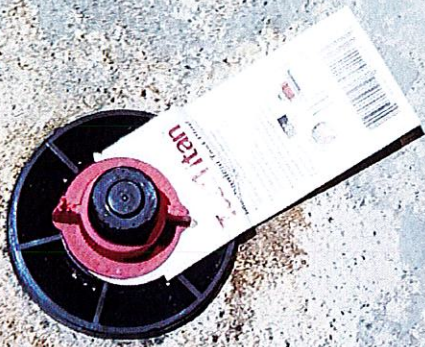
#24

We then entered the other side of the duplex#411Baxter St, but were surprised to see the tenants had cleaned it all up & plugged the drain to protect them selves from another backup. (see sheet #24)

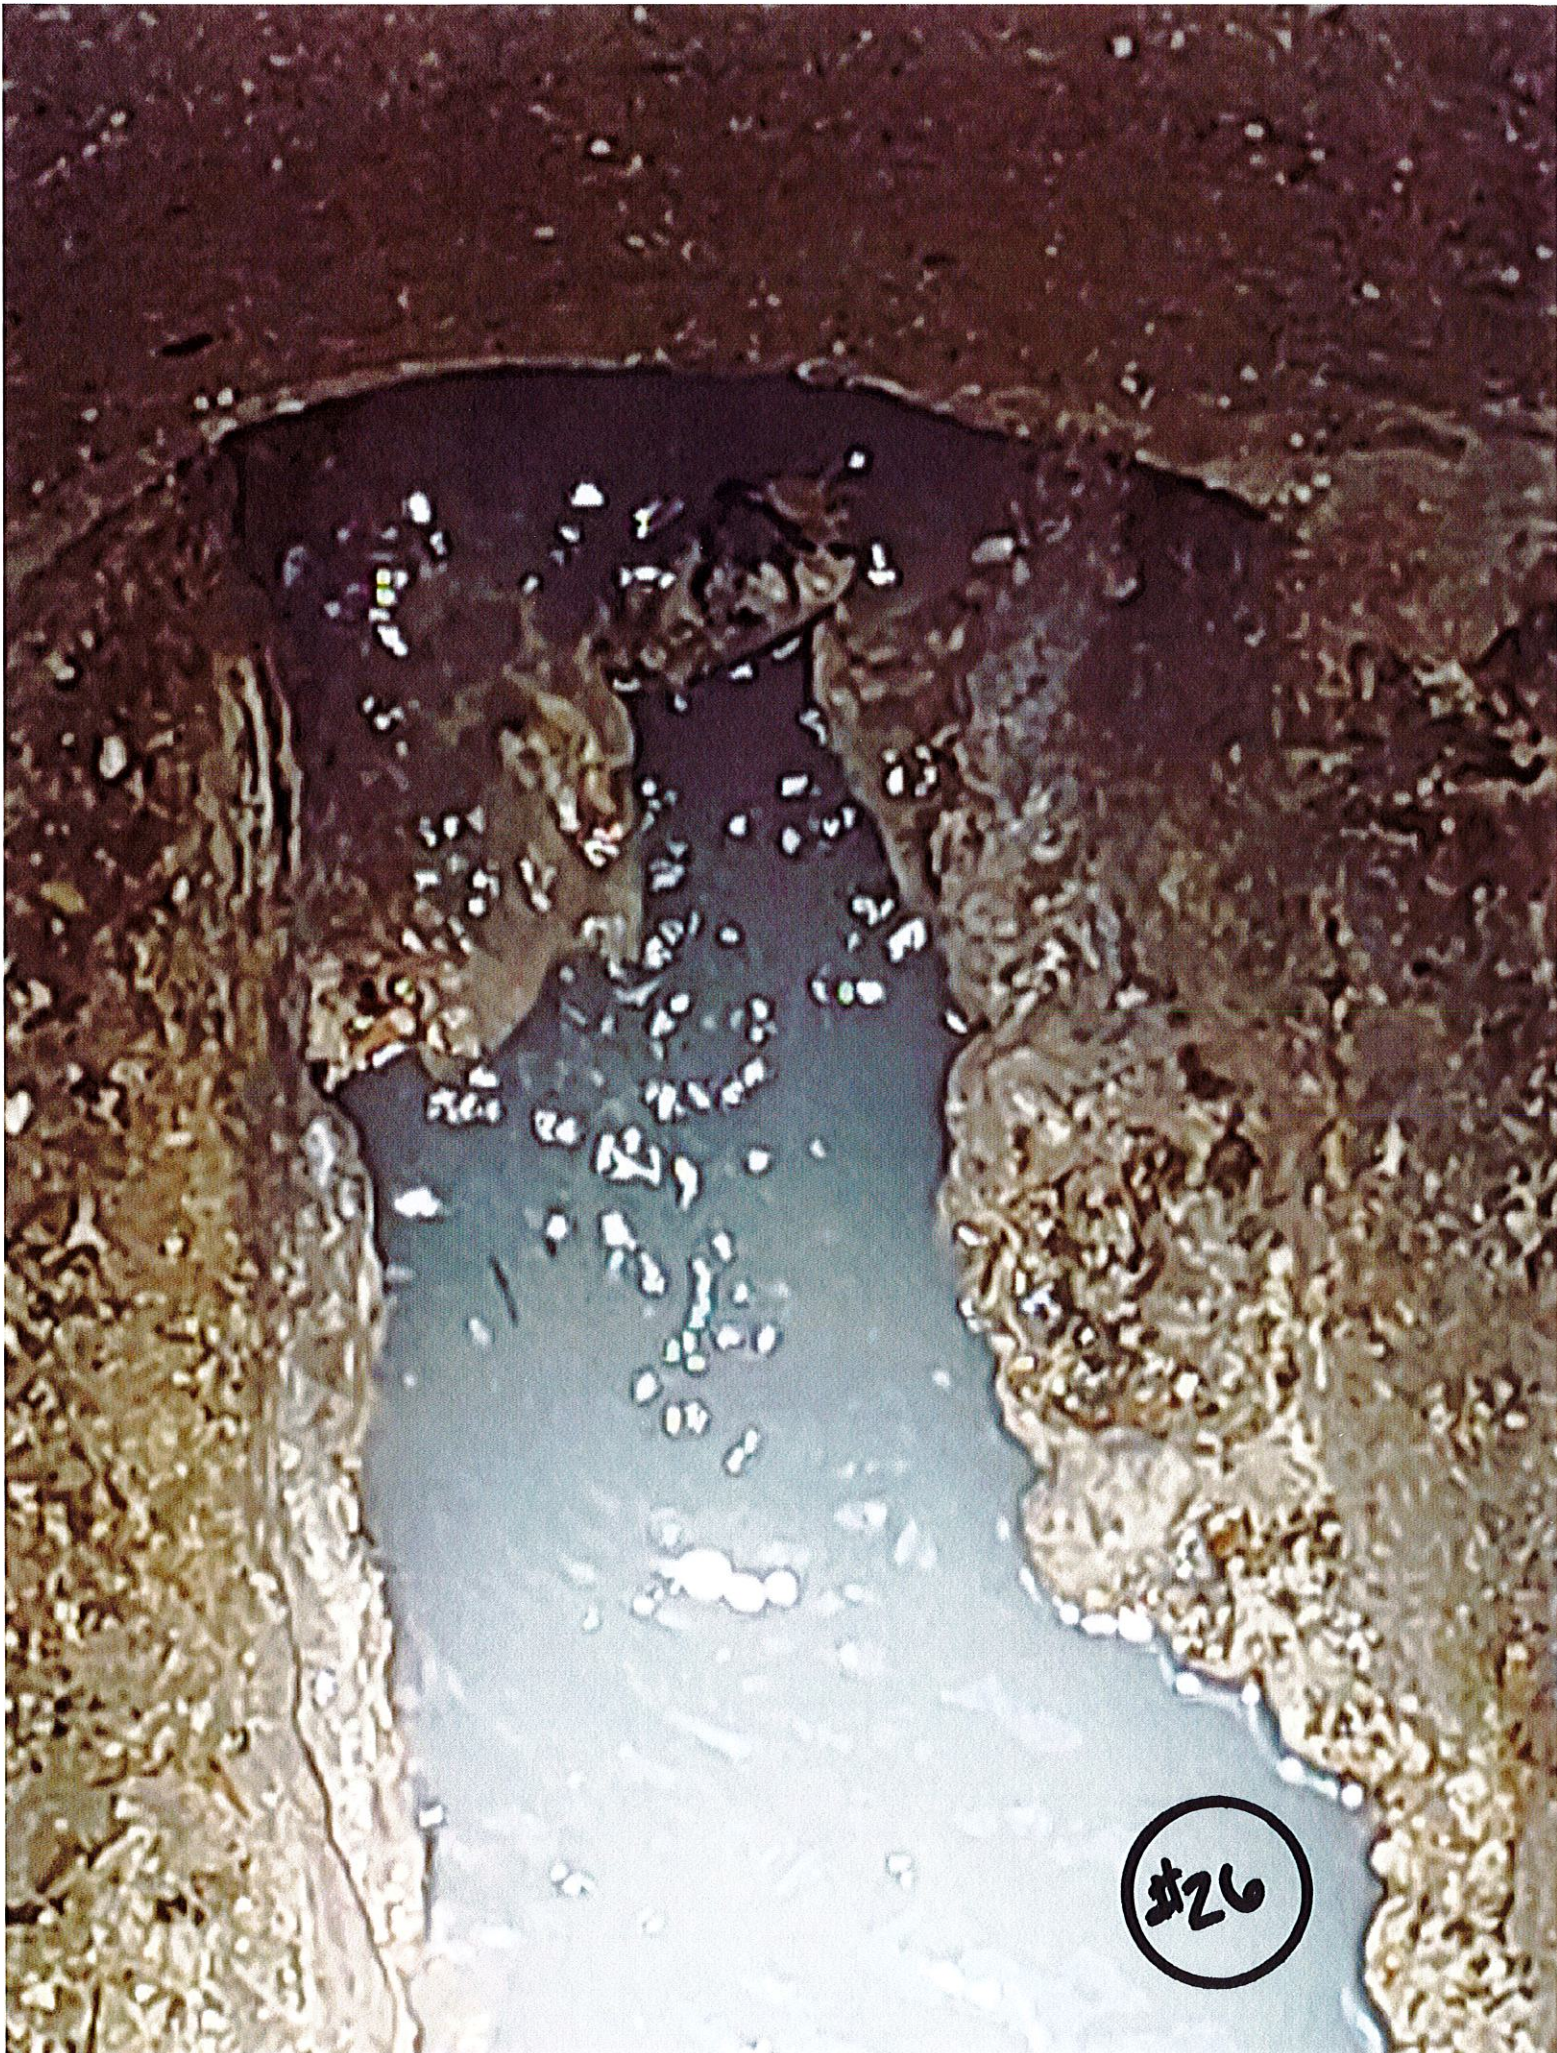
26

12) February 12 2024, we were in the area doing inspection on a repaired manhole on Depot St and so we decided to stop & inspect the Baxter St line, we found evidence of continued buildup of the material again in the line along with the bluish colored water coming from Rail & Transload and so we documented it again. (see sheet #25, 26,27)

Pete, while doing inspections this morning in the area of Depot St, we swung by Baxter St, there was no evidence of grease or buildup in the upstream manhole #04B-004, but there was a blueish liquid being discharged from Rail & Transload, see attached photo.

Also see the stains of last backup from 2 weeks ago, where there was 30in of surcharge in that same manhole....

All ok for now, will continue to monitor and after the 30day notice has passed we will make contact with Rail & Transload and clean that line with them on site n present.
