**SUBJECT: WATER SLIDE STRUCTURAL EVALUATION**

**PROJECT: WHITEWATER AQUATIC AND FITNESS CENTER  
WHITEWATER, WISCONSIN  
RAMAKER AND ASSOCIATES PROJECT #64588**

A waterslide structural evaluation of the indoor body slide was performed by Austin Nolden, P.E. of Ramaker & Associates, Inc. for the Whitewater Aquatic and Fitness Center on April 14, 2026. The slide flume, support columns, associated tower, platform and handrails were evaluated for structural stability and integrity as required by the Wisconsin Administrative Code for Health Services. The DHS Code under Chapter 172.37, Section 2, Part C, requires this evaluation to be performed on all water slides every five years.

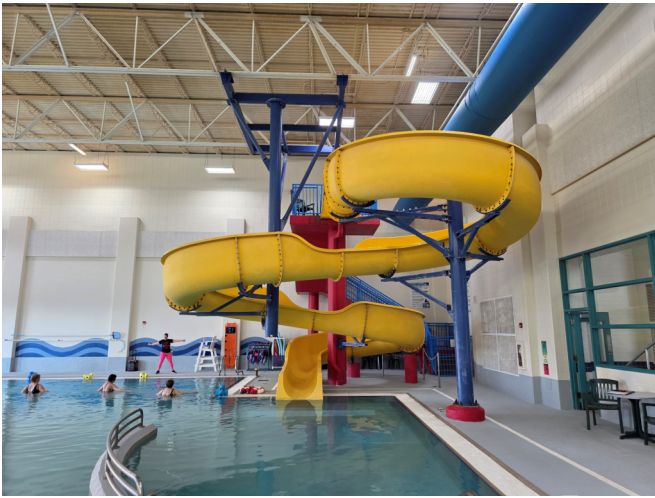
The following items were noted. See photo 1 for an overall view of the slide and tower.

1. OVERALL VIEW OF THE SLIDE

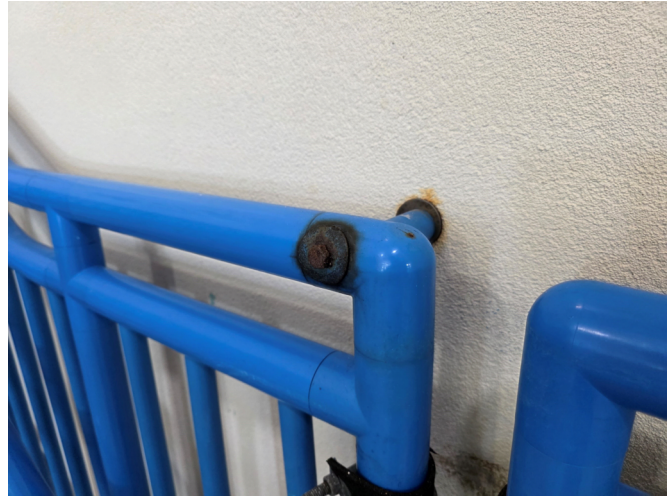
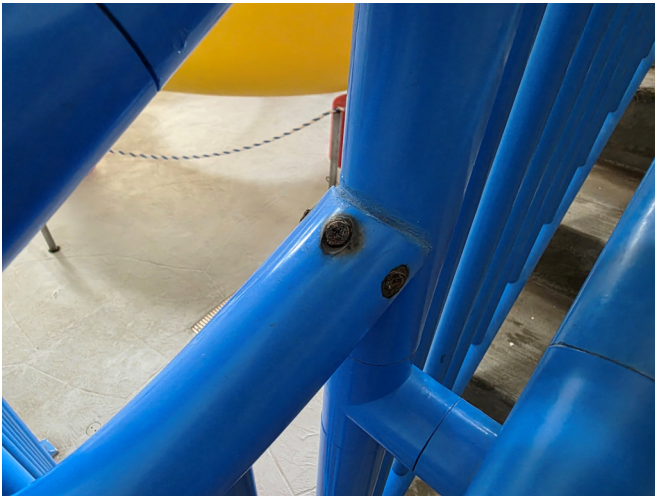
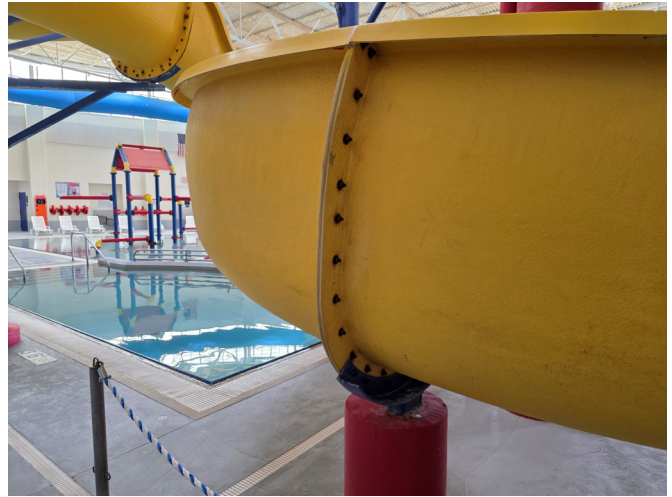
1. There is minor corrosion on the fasteners and hardware throughout the structure. Remove rust with a wire brush and refinish impacted areas. Items that cannot be repaired should be replaced. See photos 2, 3 and 4.

2. CORROSION ON FASTENERS

3. CORROSION ON FASTENERS

4. CORROSION ON FASTENERS

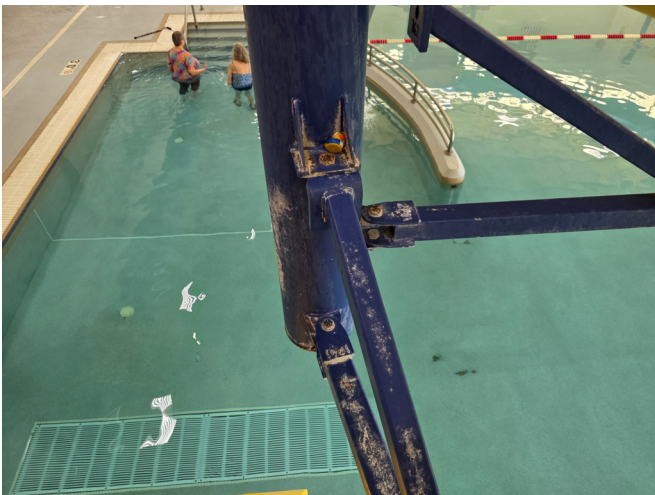
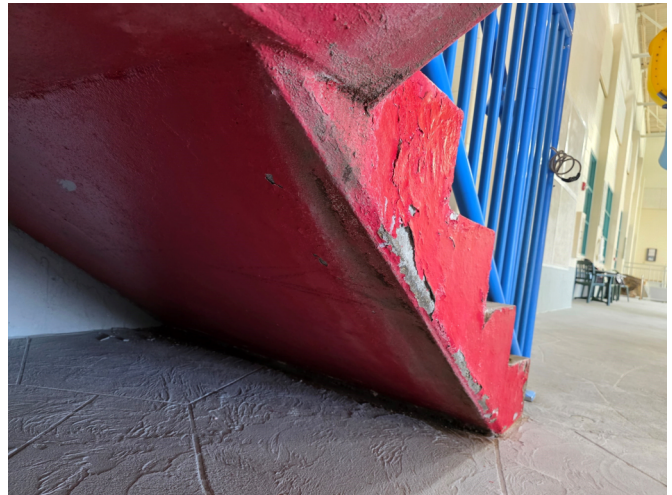
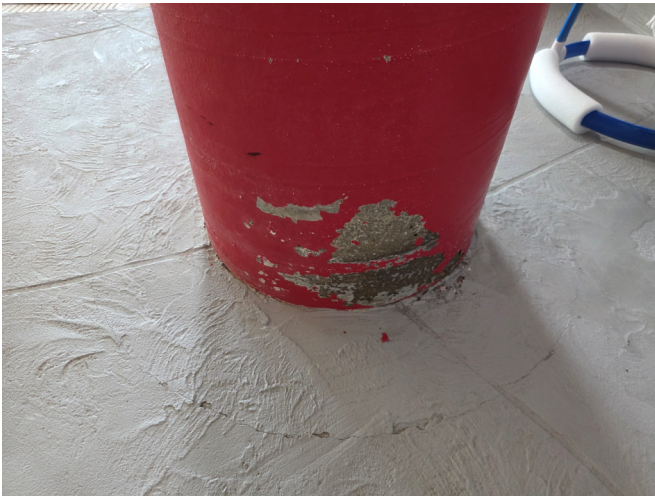
2. The paint is chipping and wearing off in multiple locations around the slide structure. The flaking paint should be removed and the impacted areas refinished to match existing to prevent further corrosion. See photos 5, 6, and 7.

5. FLAKING/WORE PAINT AND FINISH

6. FLAKING/WORE PAINT AND FINISH

7. FLAKING/WORE PAINT AND FINISH

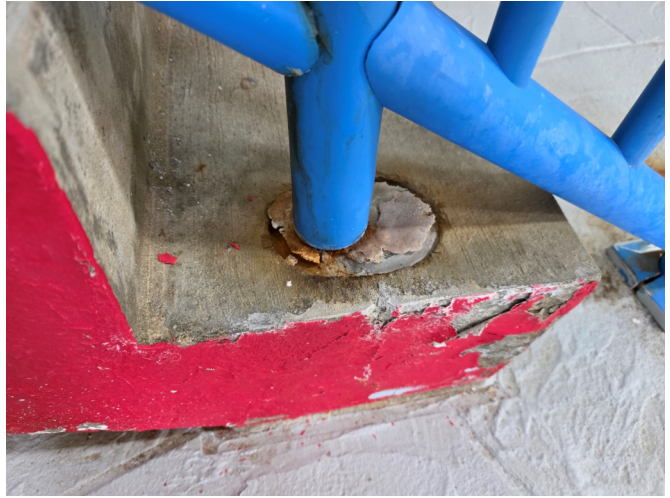
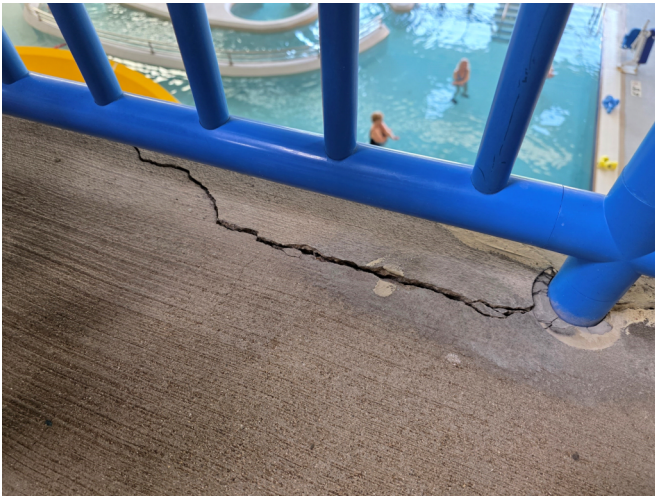
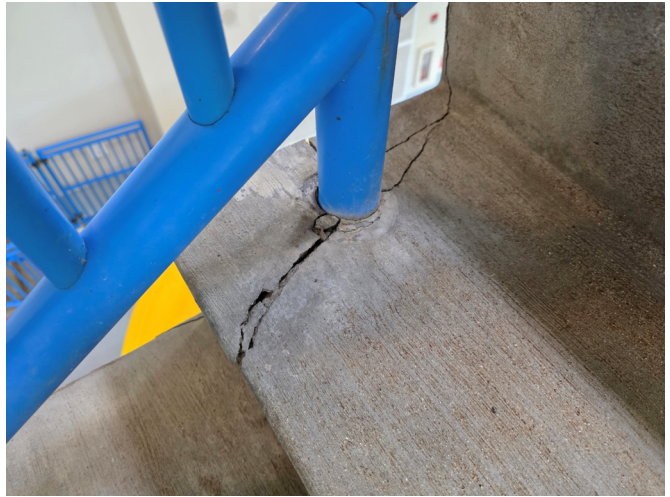
3. There is cracked/deteriorating concrete in multiple locations and around some of the handrail anchors. See photos 8, 9, and 10. Ramaker recommends contacting the original slide/tower manufacturer for recommendations on how to repair these areas of concern.

8. CRACKED/DETERIORATING CONCRETE

9. CRACKED/DETERIORATING CONCRETE

10. CRACKED/DETERIORATING CONCRETE

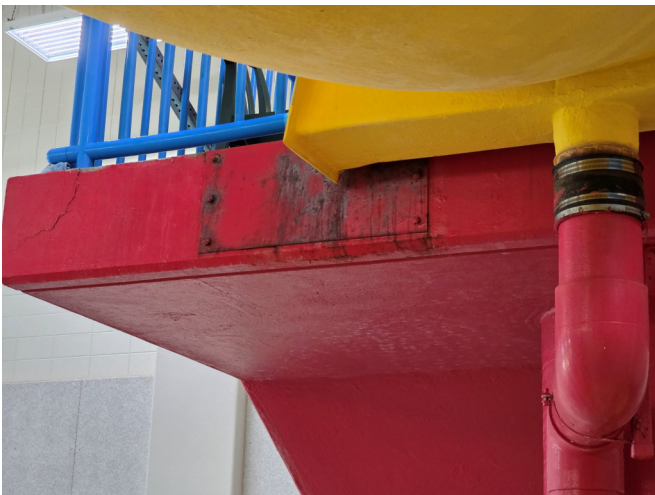
4. Metal plates and a piece of strut have been installed in previous areas of concern where the concrete was deteriorating and to help strengthen the railings. The plate under the entry tub shows signs of corrosion and wear and should be replaced to prevent further deterioration. See photos 11 and 12.

11. CORROSION ON METAL PLATE UNDER STARTING TUB

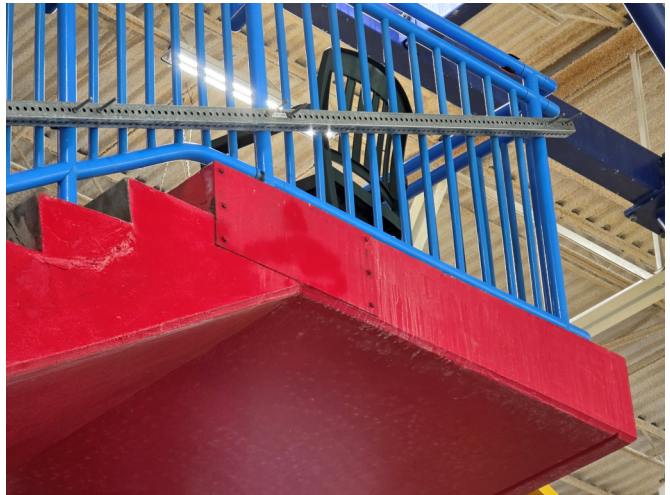
12. STRUT INSTALLED TO SUPPORT RAILINGS

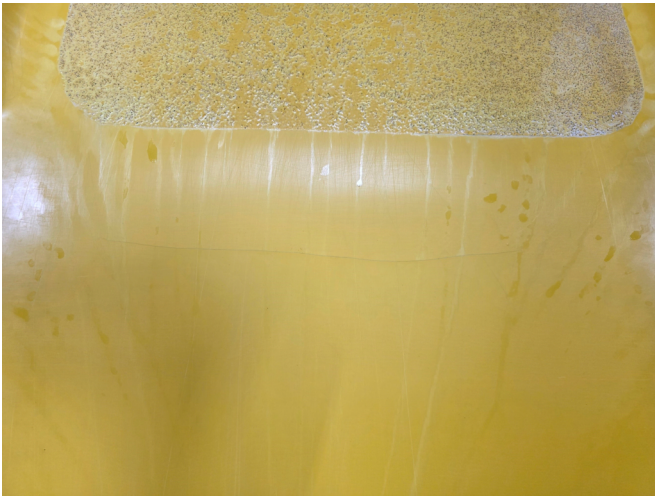
5. There is a minor scratch in the flume entry tub section of the slide. This should be repaired with a fiberglass patch per manufacturer's recommendations. See photo 13.

13. SCRATCH IN THE FLUME ENTRY TUB

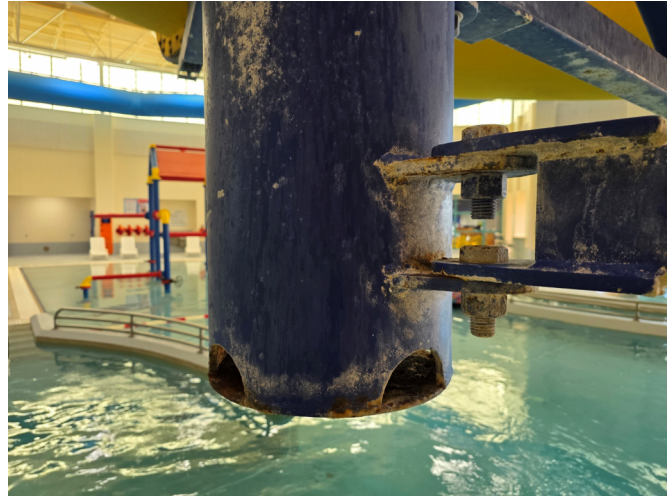
6. Corrosion and paint wear was observed on the slide support trees. The paint and corrosion should be removed in these areas and then refinished to match the surrounding areas and prevent further corrosion. See photo 14.

14. CORROSION AND PAINT WEAR ON SLIDE SUPPORT TREE

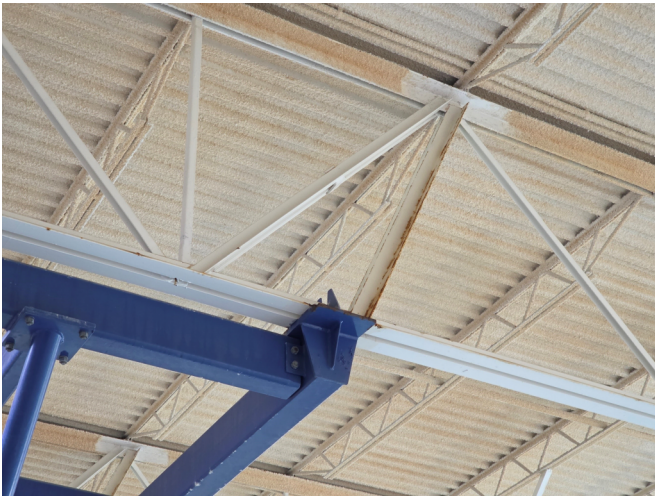
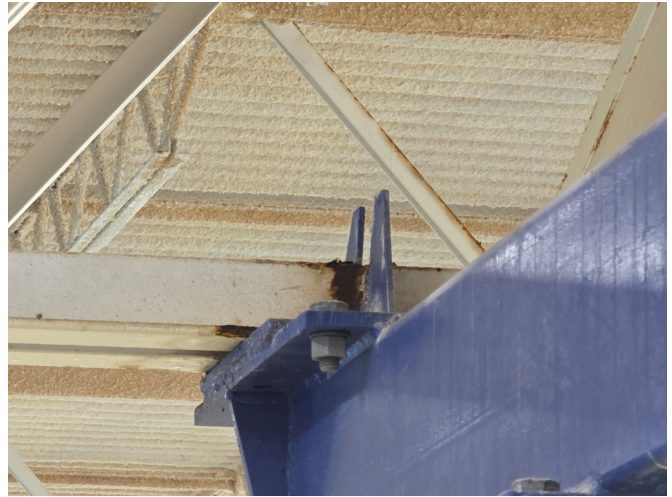
7. The building roof/ceiling structural system provides support for one of the slide columns and subsequent support arms. The roof/ceiling structural system is showing surficial corrosion and should be inspected by a certified consultant to ensure the building system is still structurally sound. See photos 15 and 16.

15. CORROSION ON ROOF/CEILING SYSTEM

16. CORROSION ON ROOF/CEILING SYSTEM

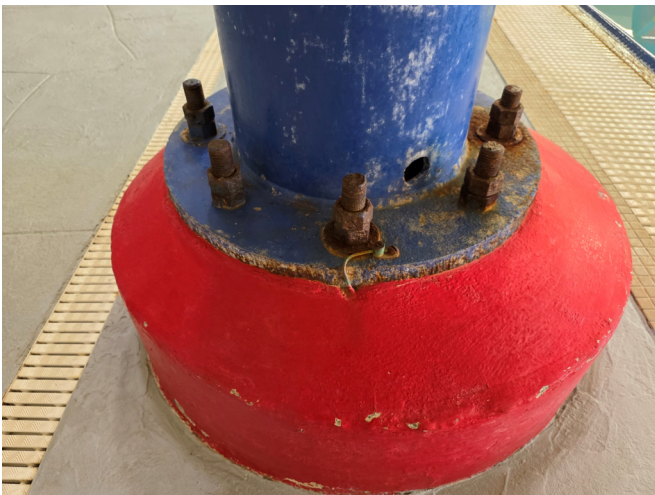
8. There is corrosion present on the flume support tree flanges and fasteners. See photo 17. Remove rust with a wire brush and refinish impacted areas. Items that cannot be repaired should be replaced.

17. CORROSION ON SUPPORT TREE FLANGE AND FASTENERS

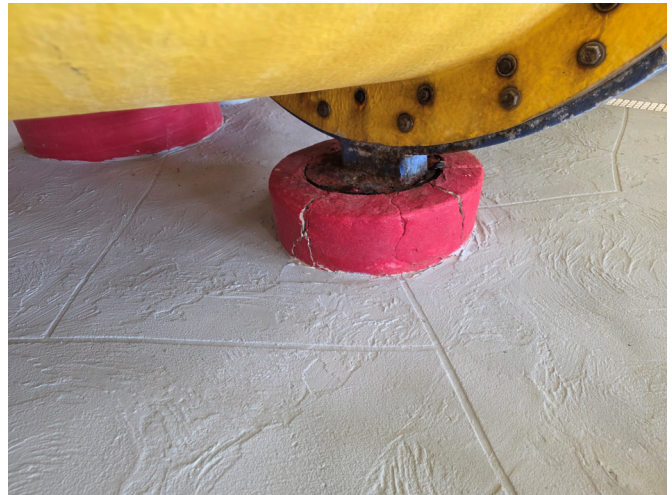
9. The concrete pedestal under the exit flume section of the slide is cracked and the support plate is showing signs of significant corrosion. The support pedestal and plate should be replaced. See photo 18.

18. CRACKED PEDESTAL AND CORRODED SUPPORT PLATE

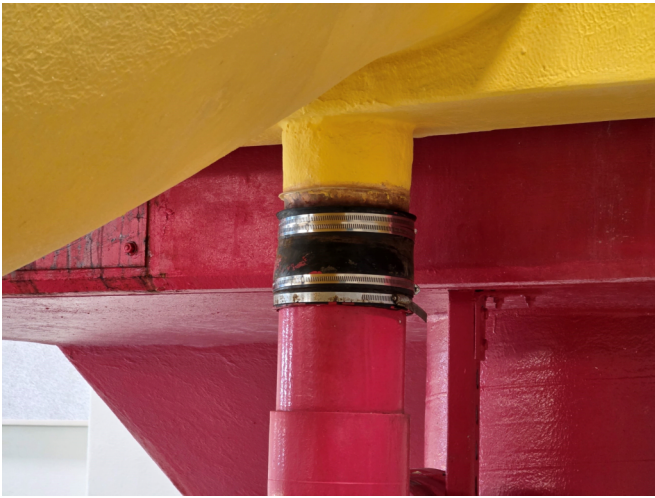
10. There is minor corrosion on the slide supply coupling. Remove the rust and corrosion with a wire brush and refinish impacted area. Items that cannot be repaired should be replaced. See photo 19.

19. MINOR CORROSION ON SLIDE SUPPLY COUPLING

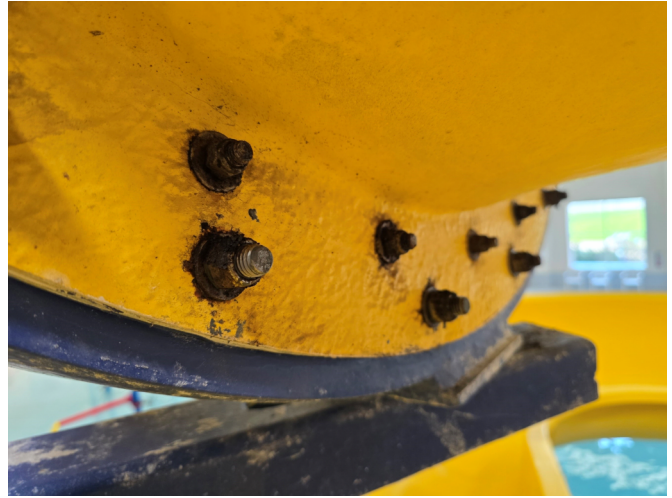
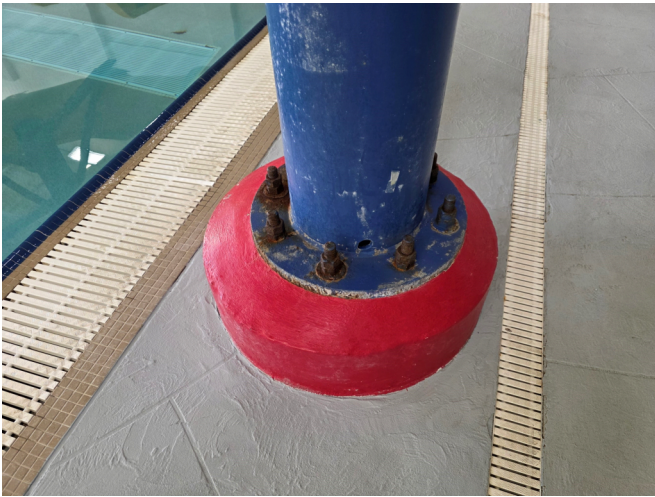
- There are fasteners within reach of patrons that are missing thread caps. Thread caps should be installed on all exposed threads within reach of patrons to avoid cuts. See photos 20 and 21.

20. MISSING THREAD CAPS

21. MISSING THREAD CAPS
