AQUATIC PLANT MANAGEMENT PLAN FOR
CRAVATH AND TRIPPE LAKES, WALWORTH COUNTY, WISCONSIN

SEWRPC Staff Memorandum Report Number 275

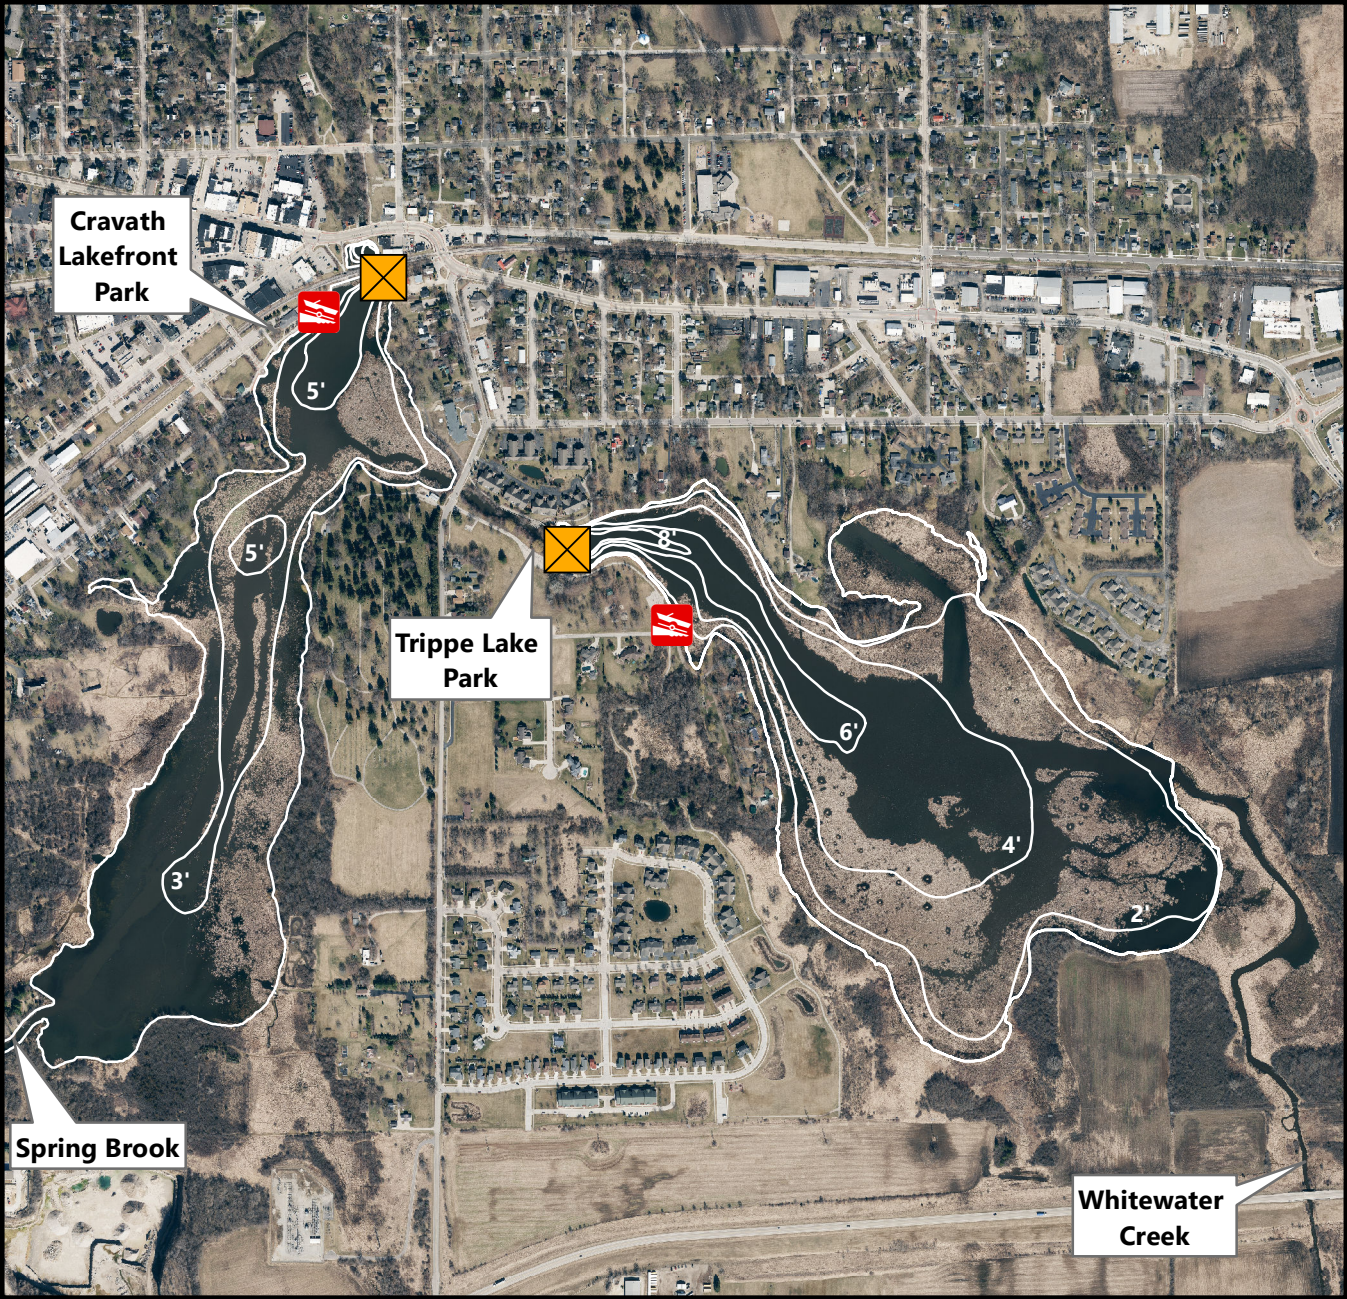
Map 1.1
Location, Public Access, and Bathymetry of Cravath and Trippe Lakes

NOTE: Aerial imagery from 2024; Bathymetry depths are from WDNR, Trippe Lake's contours are from 1961 and Cravath Lake's contours are from 1966 and thus may not reflect the current depth of the lakes.

Trippe Lake is a 212-acre lake drainage also located in the City of Whitewater. It is fed by Whitewater Creek, and outflows into Cravath Lake (see [Map 1.1](#)). It has a maximum depth of 8 feet and was previously surveyed by Lake and Pond Solutions in 2017. A total of 16 species were reported, with similar beneficial native species (*Stuckenia pectinata*) as well as non-native invasives (*Potamogeton crispus* and *Myriophyllum spicatum*). Cravath and Trippe lakes underwent a drawdown from 2019 to 2021, followed by dredging and controlled

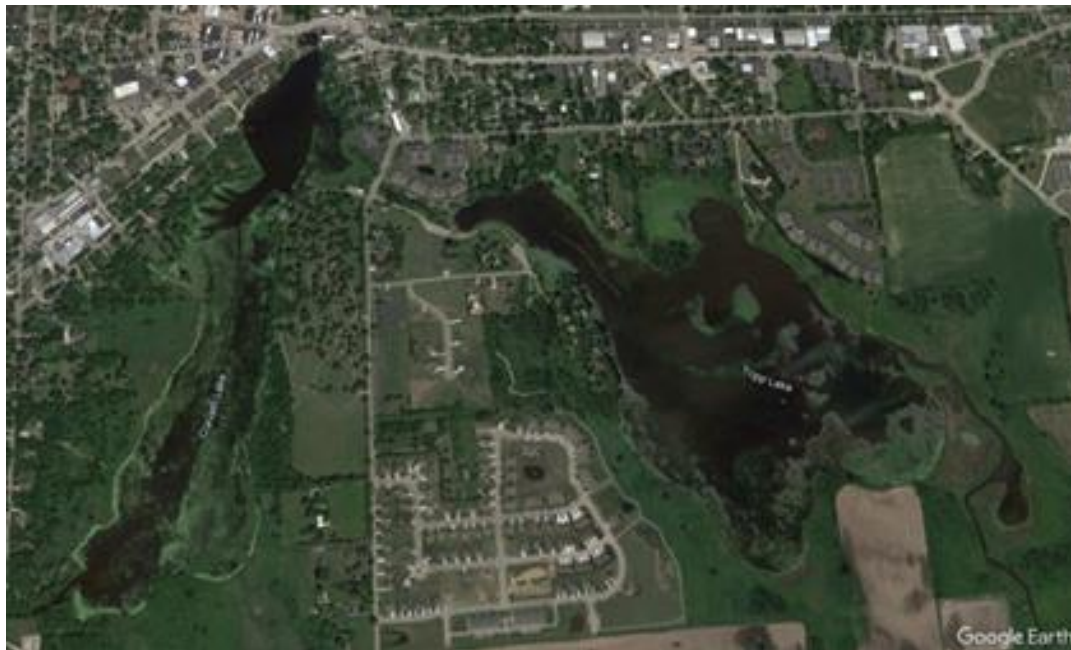
Figure 2.13
Hybrid Cattail Extent in Cravath and Trippe Lakes

June 2015 Cattails

May 2023 Cattails

estimate the increase of cattail growth in the Lakes from pre draw-down conditions in 2015 as well as recent cattail conditions in 2023 (see **Figure 2.13**)²⁵. The cattail coverage on Trippe Lake in June 2015 was estimated to be 27 acres, or 22%. Comparatively, the cattail coverage in May 2023 was estimated to be 50 acres, or 41% of the lake acreage. Cravath Lake's cattail coverage in June 2015 was estimated to be 3 acres, or 5%. Comparatively, the cattail coverage in May 2023 was estimated to be 33 acres, or 47%.
