## **REPORT OF GEOTECHNICAL ENGINEERING SERVICES**

Delta Logistics Day Road Annex  
SW Day Road  
Wilsonville, Oregon

For  
Delta Logistics, Inc.  
June 30, 2021

Project: DeltaLog-1-01

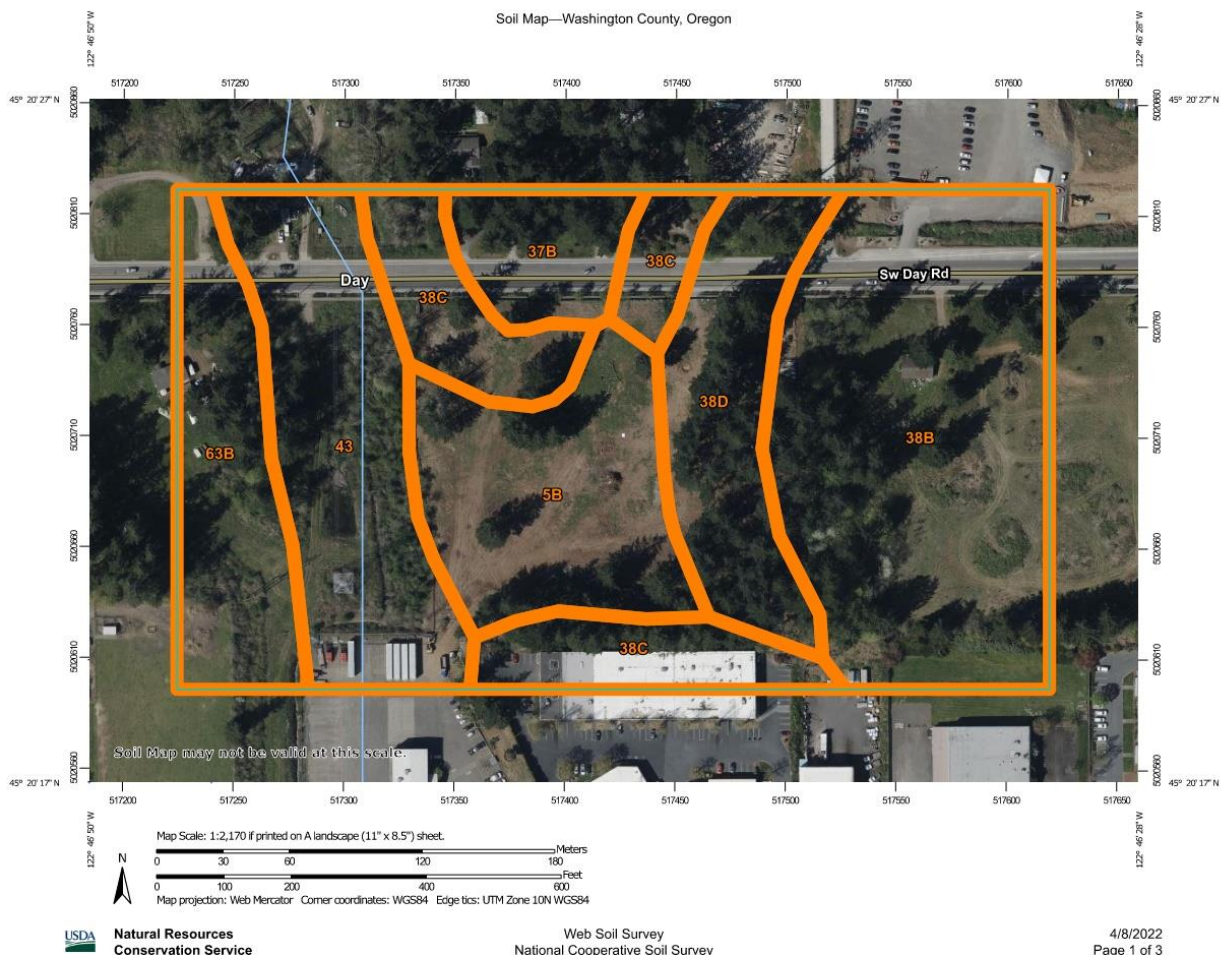
**Figure 3: Web Soil Survey Map**

Per the USDA Web Soil Survey, the existing soil is primarily a variety of silty and loamy soils. See Figure 3 for their locations across the site. The site has soils identified as Hydrologic Soil Groups B, C, and D for the purposes of relating to the Discharge Management Area (DMA) Soil Group in the BMP Sizing Tool.
