**NATURAL RESOURCE ASSESSMENT REPORT
FOR**

9710 SW Day Road

T3S, R1W, Section 2B, Tax Lot 600 & 601
Wilsonville, Washington County, Oregon

Project #: 2739

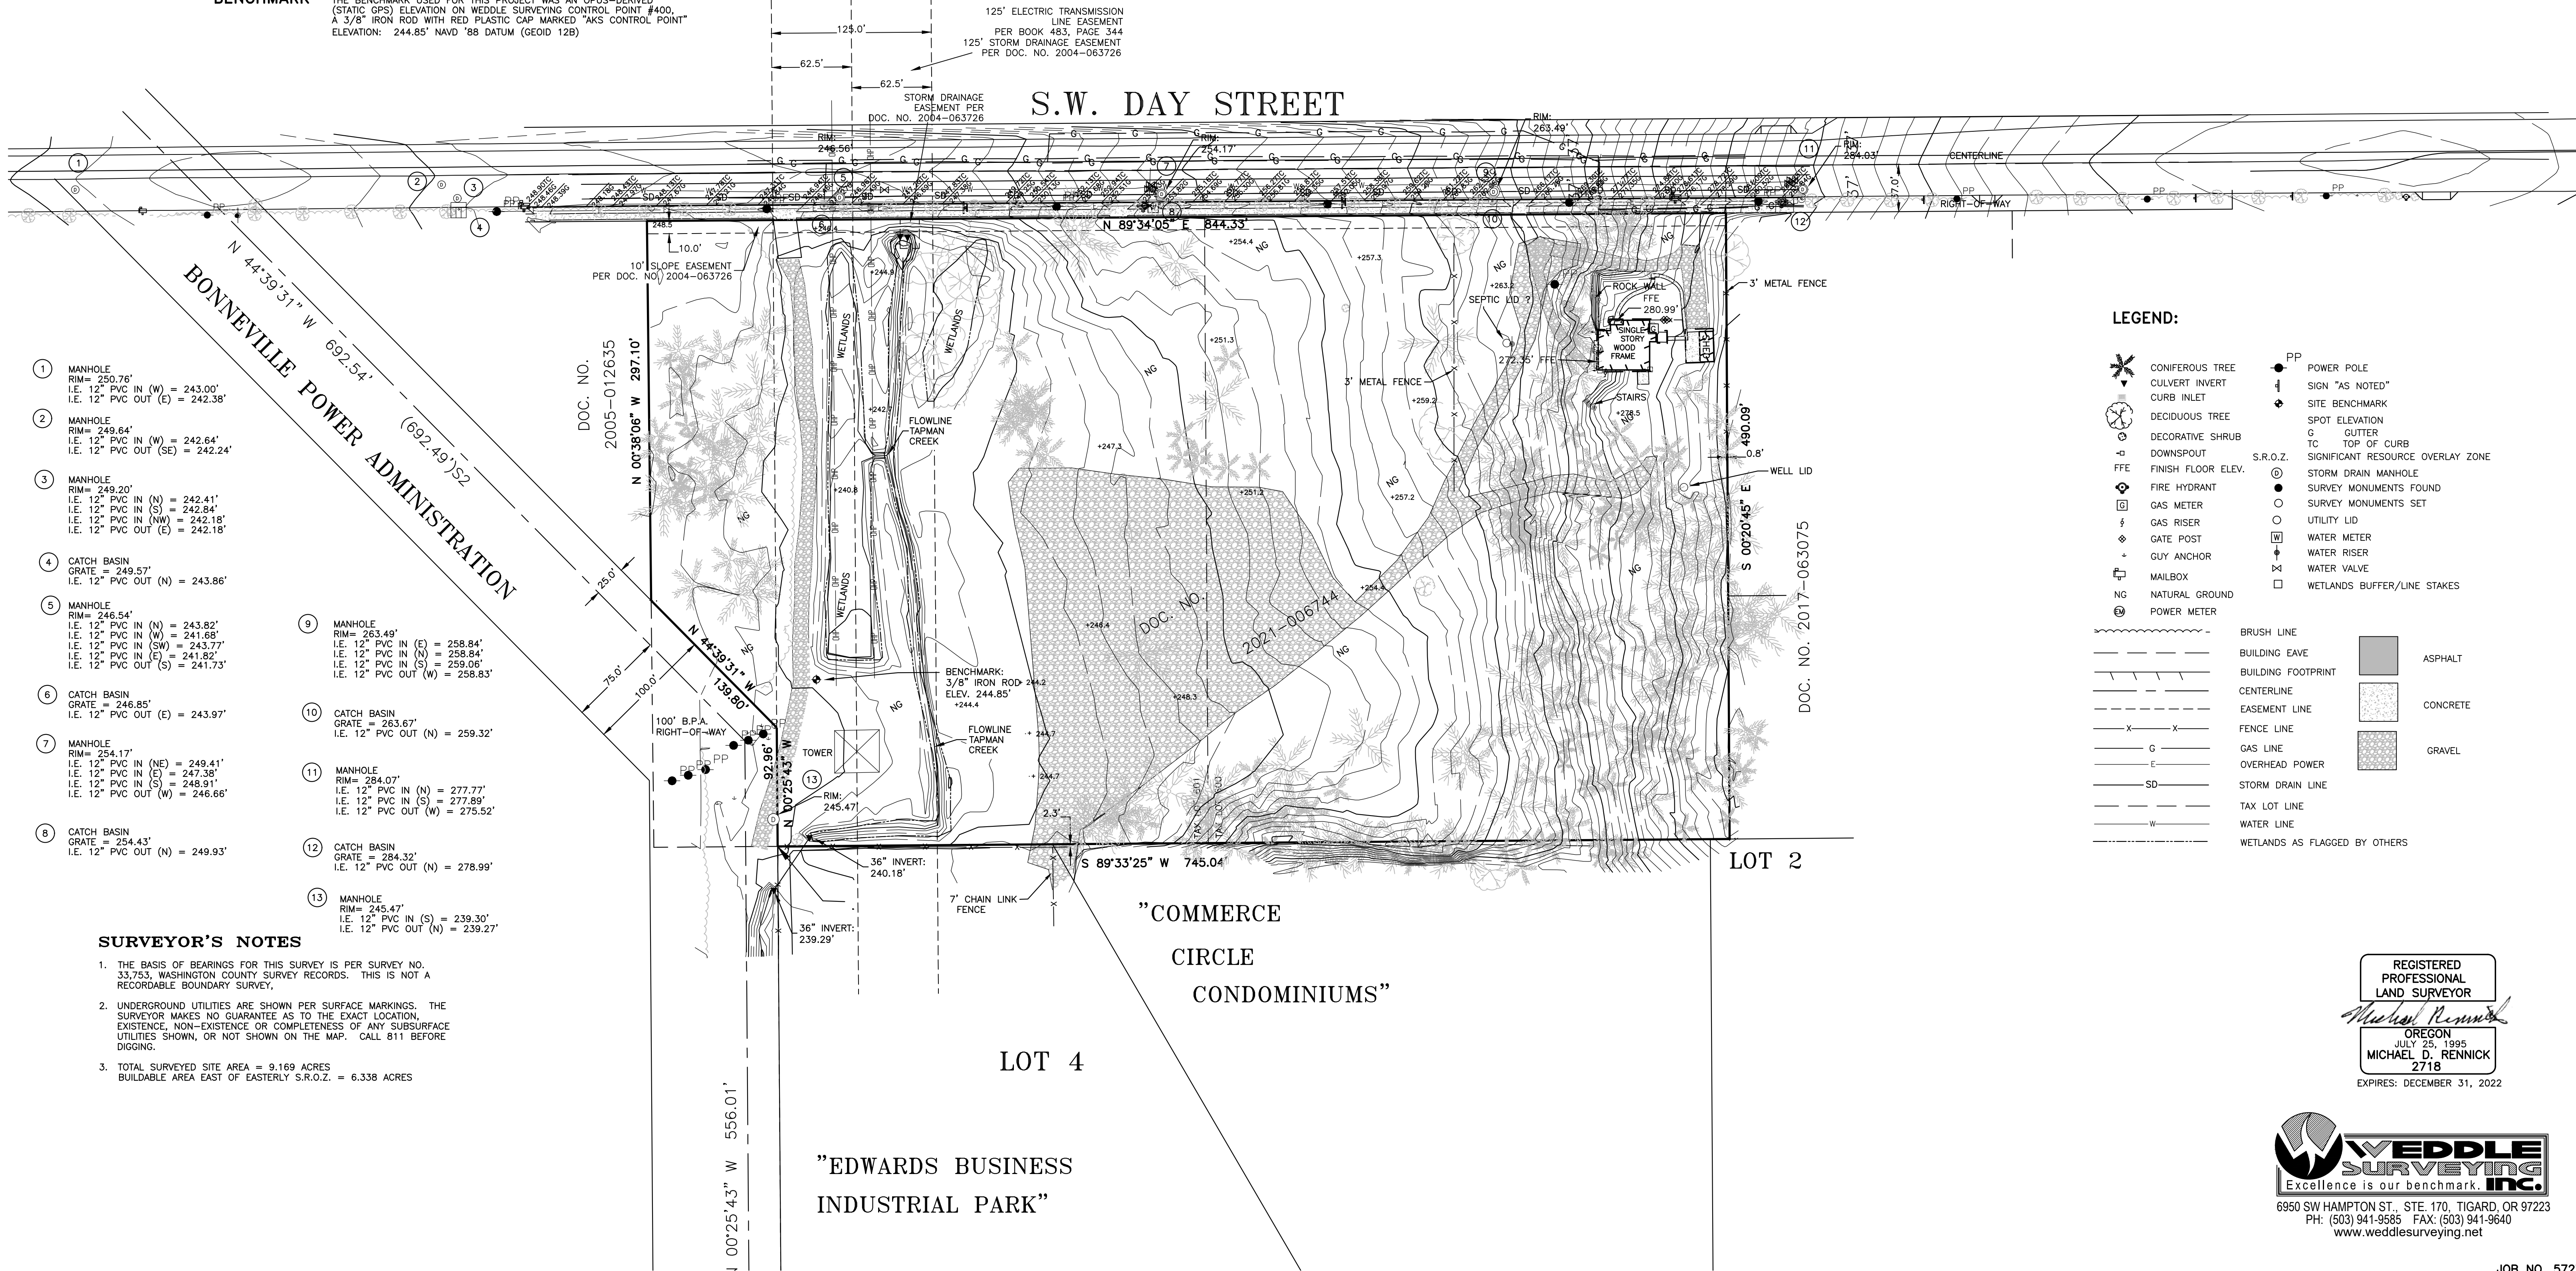
TOPOGRAPHIC SURVEY

- 1 MANHOLE
RIM = 250.76'
I.E. 12" PVC IN (W) = 243.00'
I.E. 12" PVC OUT (E) = 242.38'
- 2 MANHOLE
RIM = 249.64'
I.E. 12" PVC IN (W) = 242.64'
I.E. 12" PVC OUT (SE) = 242.24'

- 3 MANHOLE
RIM = 249.20'
I.E. 12" PVC IN (N) = 242.41'
I.E. 12" PVC IN (S) = 242.84'
I.E. 12" PVC IN (NW) = 242.18'
I.E. 12" PVC OUT (E) = 242.18'
- 4 CATCH BASIN
GRATE = 249.57'
I.E. 12" PVC OUT (N) = 243.86'

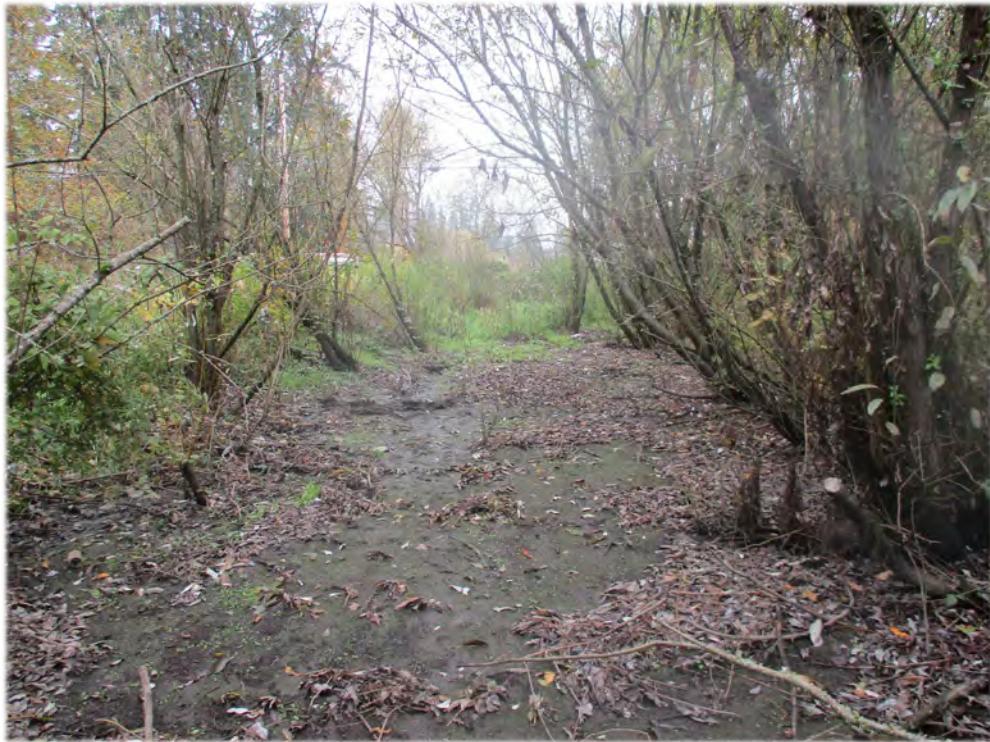
Photo Point 3. From the northern portion of Wetland 1 (CWM site) facing north toward wetland area (photo date: 10/23/2019).

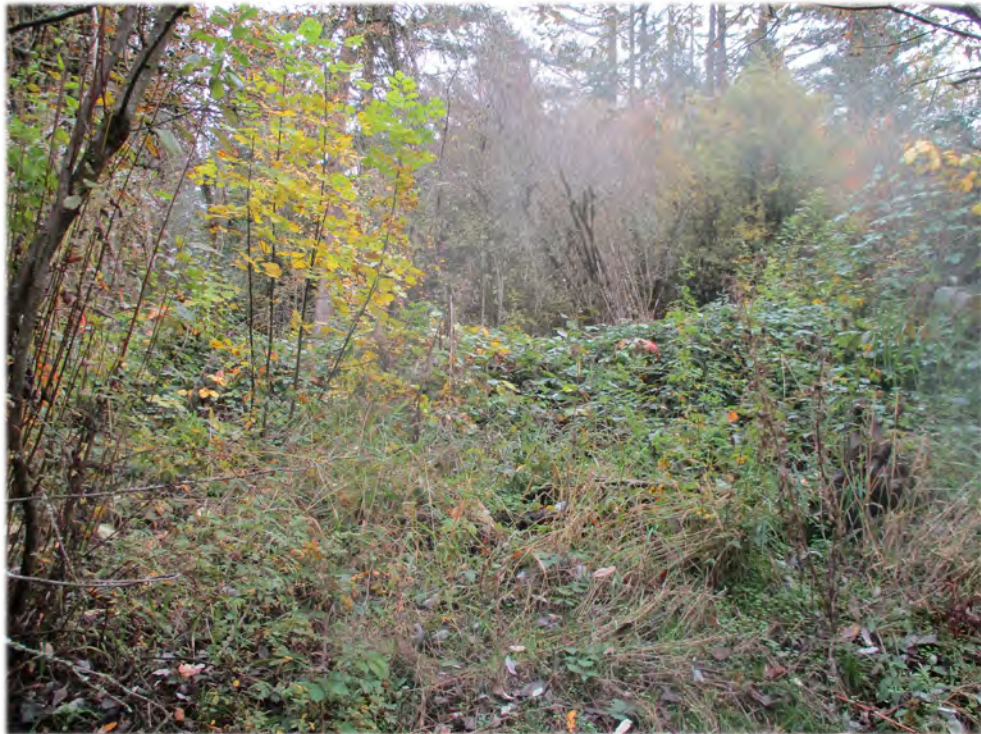
Photo Point 3. From the northern portion of Wetland 1 (CWM site) facing east toward wetland boundary (photo date: 10/23/2019).

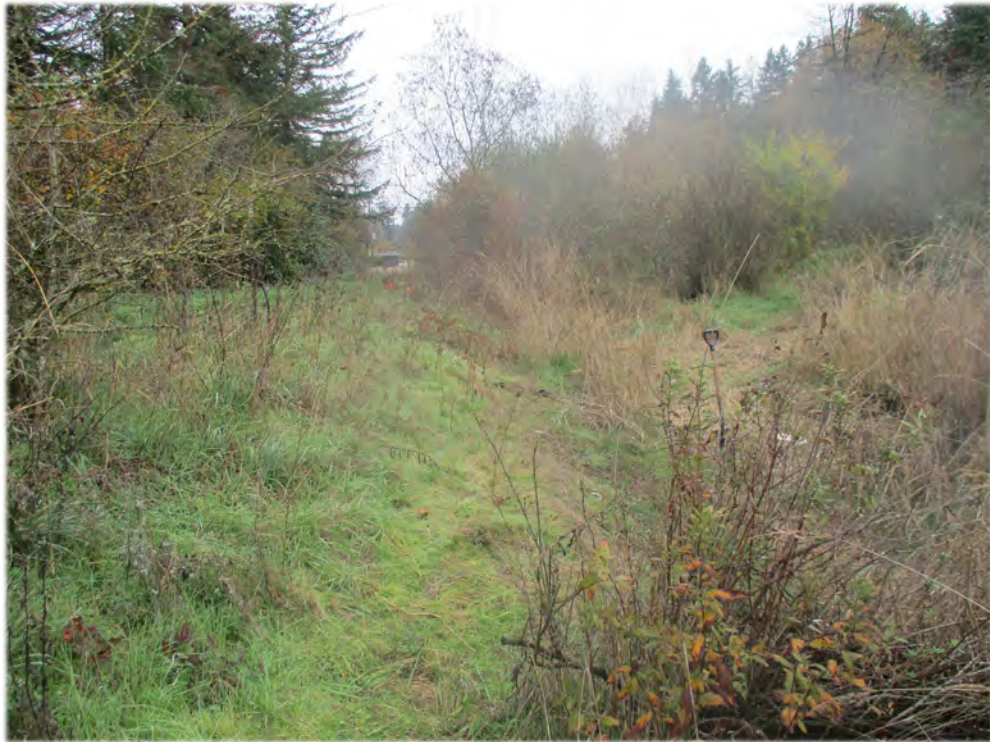
Photo Point 4. From the southern portion of Wetland 1 (CWM site) facing north along wetland boundary at toe of slope (photo date: 10/23/2019).

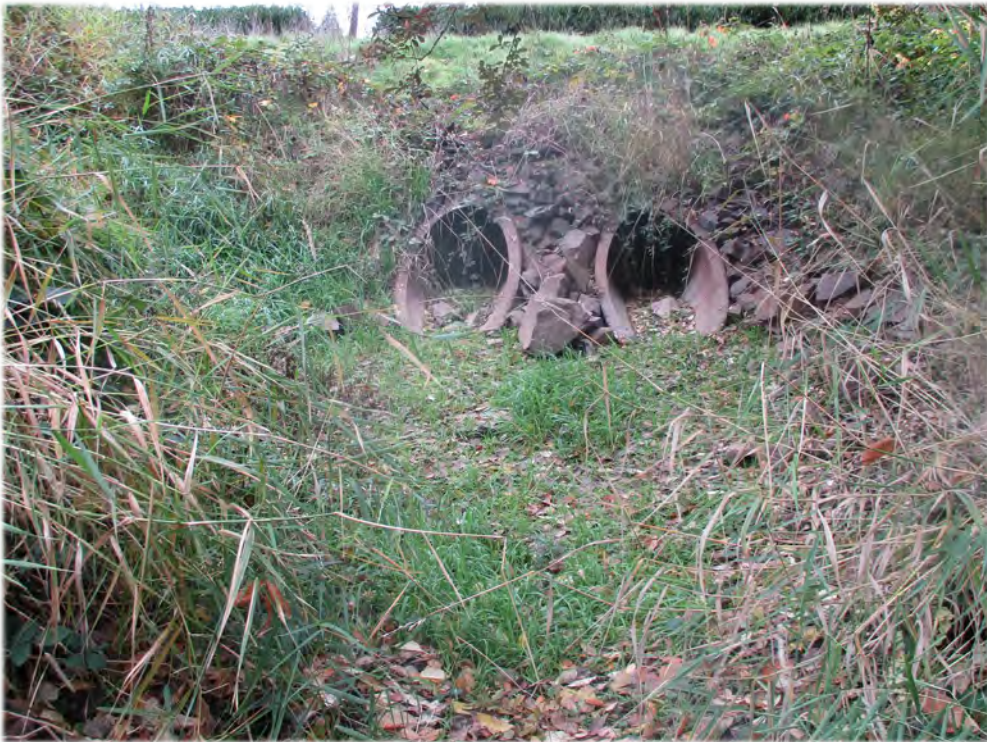
Photo Point 5. From the northern portion of Tapman Creek (wetland drainage) facing north toward double culverts (photo date: 10/23/2019).

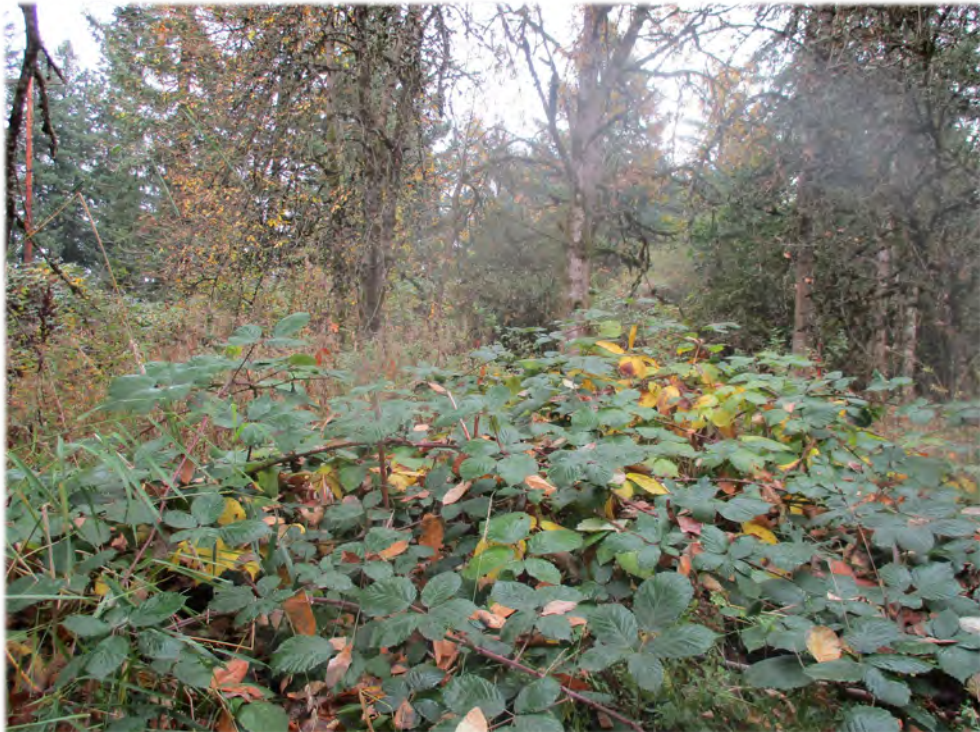
Photo Point 5. From the northern portion of Tapman Creek (wetland drainage) facing east toward drainage bank (photo date: 10/23/2019).

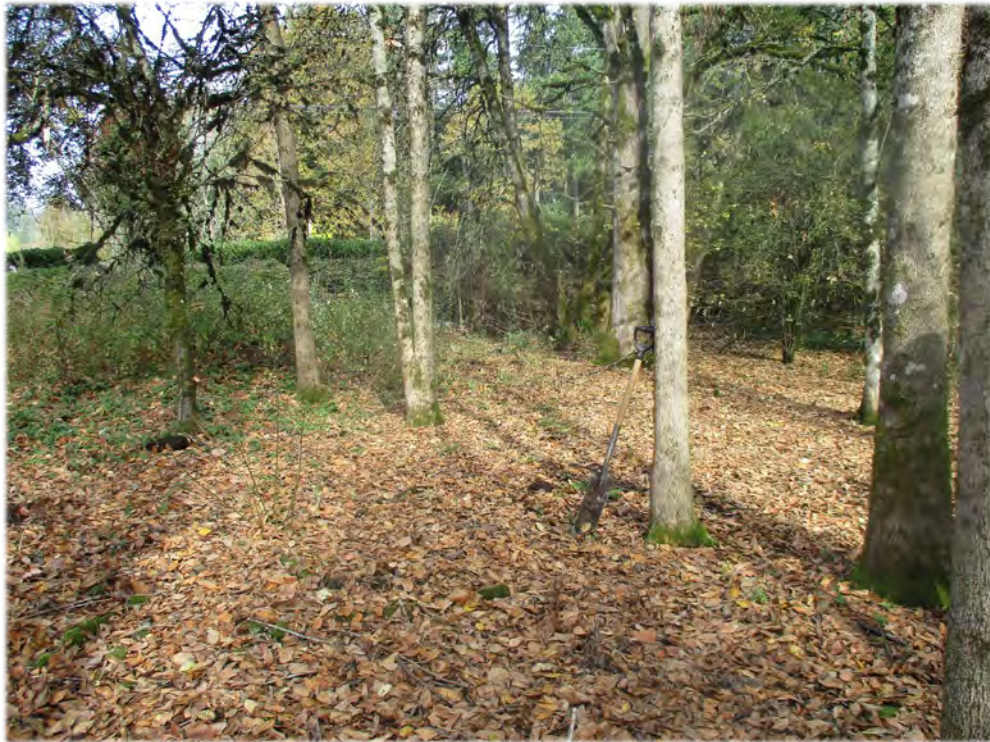
Photo Point 6. From Wetland 2 facing north toward wetland area (photo date: 10/23/2019).

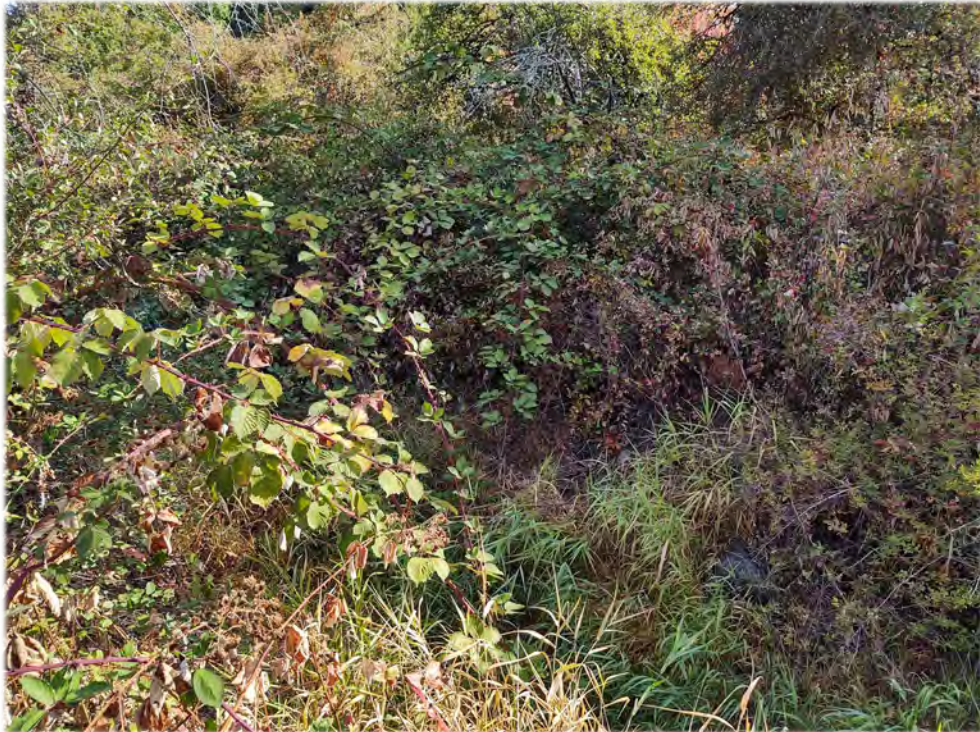
Photo Point 8. From the top of bank of Tapman Creek (wetland drainage) in the central portion facing north, upslope (photo date: 9/1/2021).

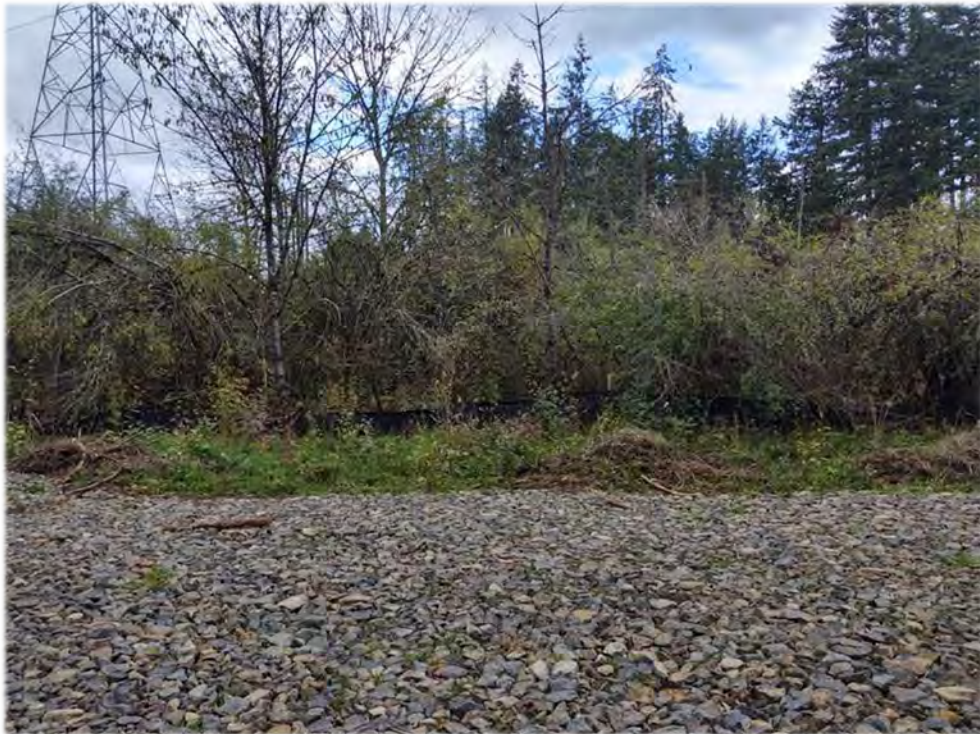
Photo Point 9. From the recently graveled area facing west (photo date: 9/1/2021).

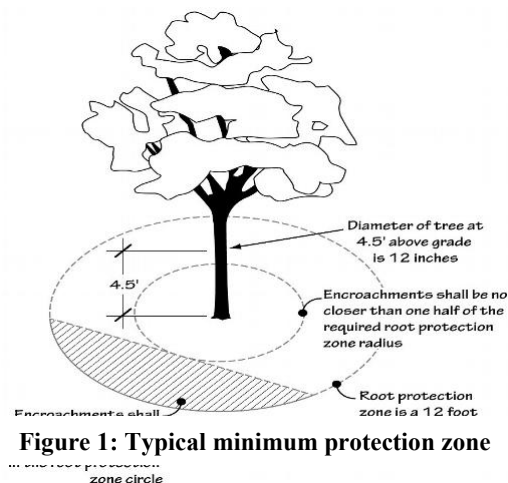
Figure 1: Typical minimum protection zone
