DEVELOPMENT REVIEW BOARD MEETING

3. **Resolution No. 421. 6753 SW Montgomery Way SRIR and SROZ.** The applicant is requesting approval of an Abbreviated Significant Resource Impact Report (SRIR) and Significant Resource Overlay Zone (SROZ) large lot exception for construction of a residence at 6753 SW Montgomery Way.

**DEVELOPMENT REVIEW BOARD
RESOLUTION NO. 421**

A RESOLUTION ADOPTING FINDINGS AND CONDITIONS OF APPROVAL, APPROVING AN ABBREVIATED SIGNIFICANT RESOURCE IMPACT REPORT (SRIR) AND SIGNIFICANT RESOURCE OVERLAY ZONE (SROZ) LARGE LOT EXCEPTION FOR CONSTRUCTION OF A RESIDENCE AT 6753 SW MONTGOMERY WAY.

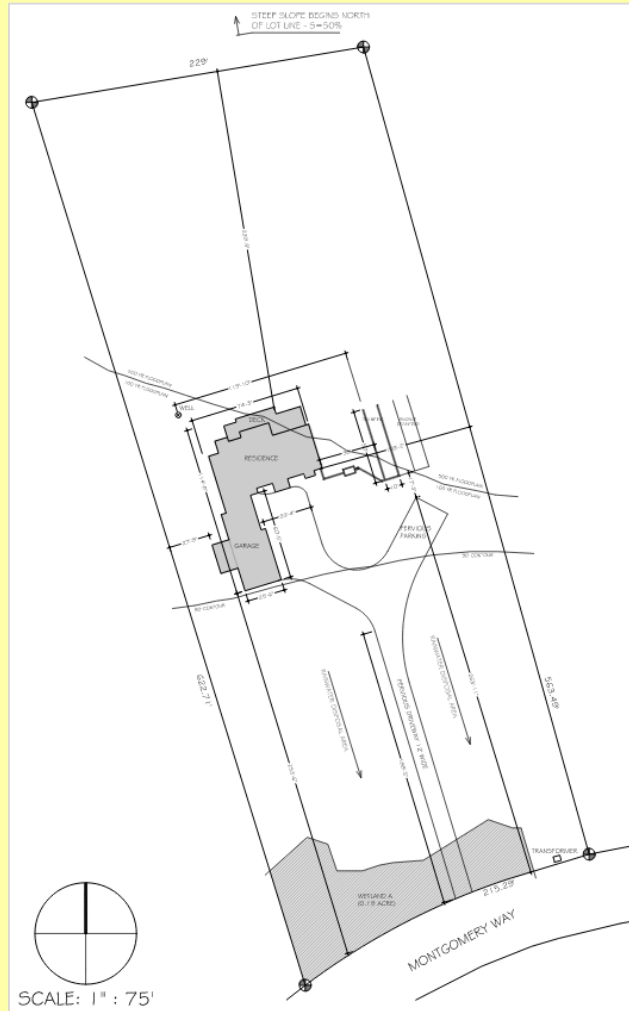
Generalized Site Plan

As shown in the generalized site plan below, the applicant proposes to build a residence roughly in the center of the subject property. Although most of the development area is within the 100-year floodplain, the location for the residence was chosen by the applicant in consultation with the City to minimize impacts on the SROZ and minimize tree removal. Extension of City utilities to the site is not required and the residence will use a domestic well and septic system. Access to the residence will be provided by a driveway from SW Montgomery Way.

The subject property is 2.98 acres (129,808 square feet). Approximate area of disturbance within the SROZ that would be needed to build the residence and other site improvements, as shown in the table below, is 12,636 square feet (9.73% of the property).

Building or Improvement	Approximate Area/Size (square feet)
House, including Garage	4,949 sf
Driveway (pervious pavement)	7,493 sf
Alternative Septic System	194 sf
Total	12,636 sf

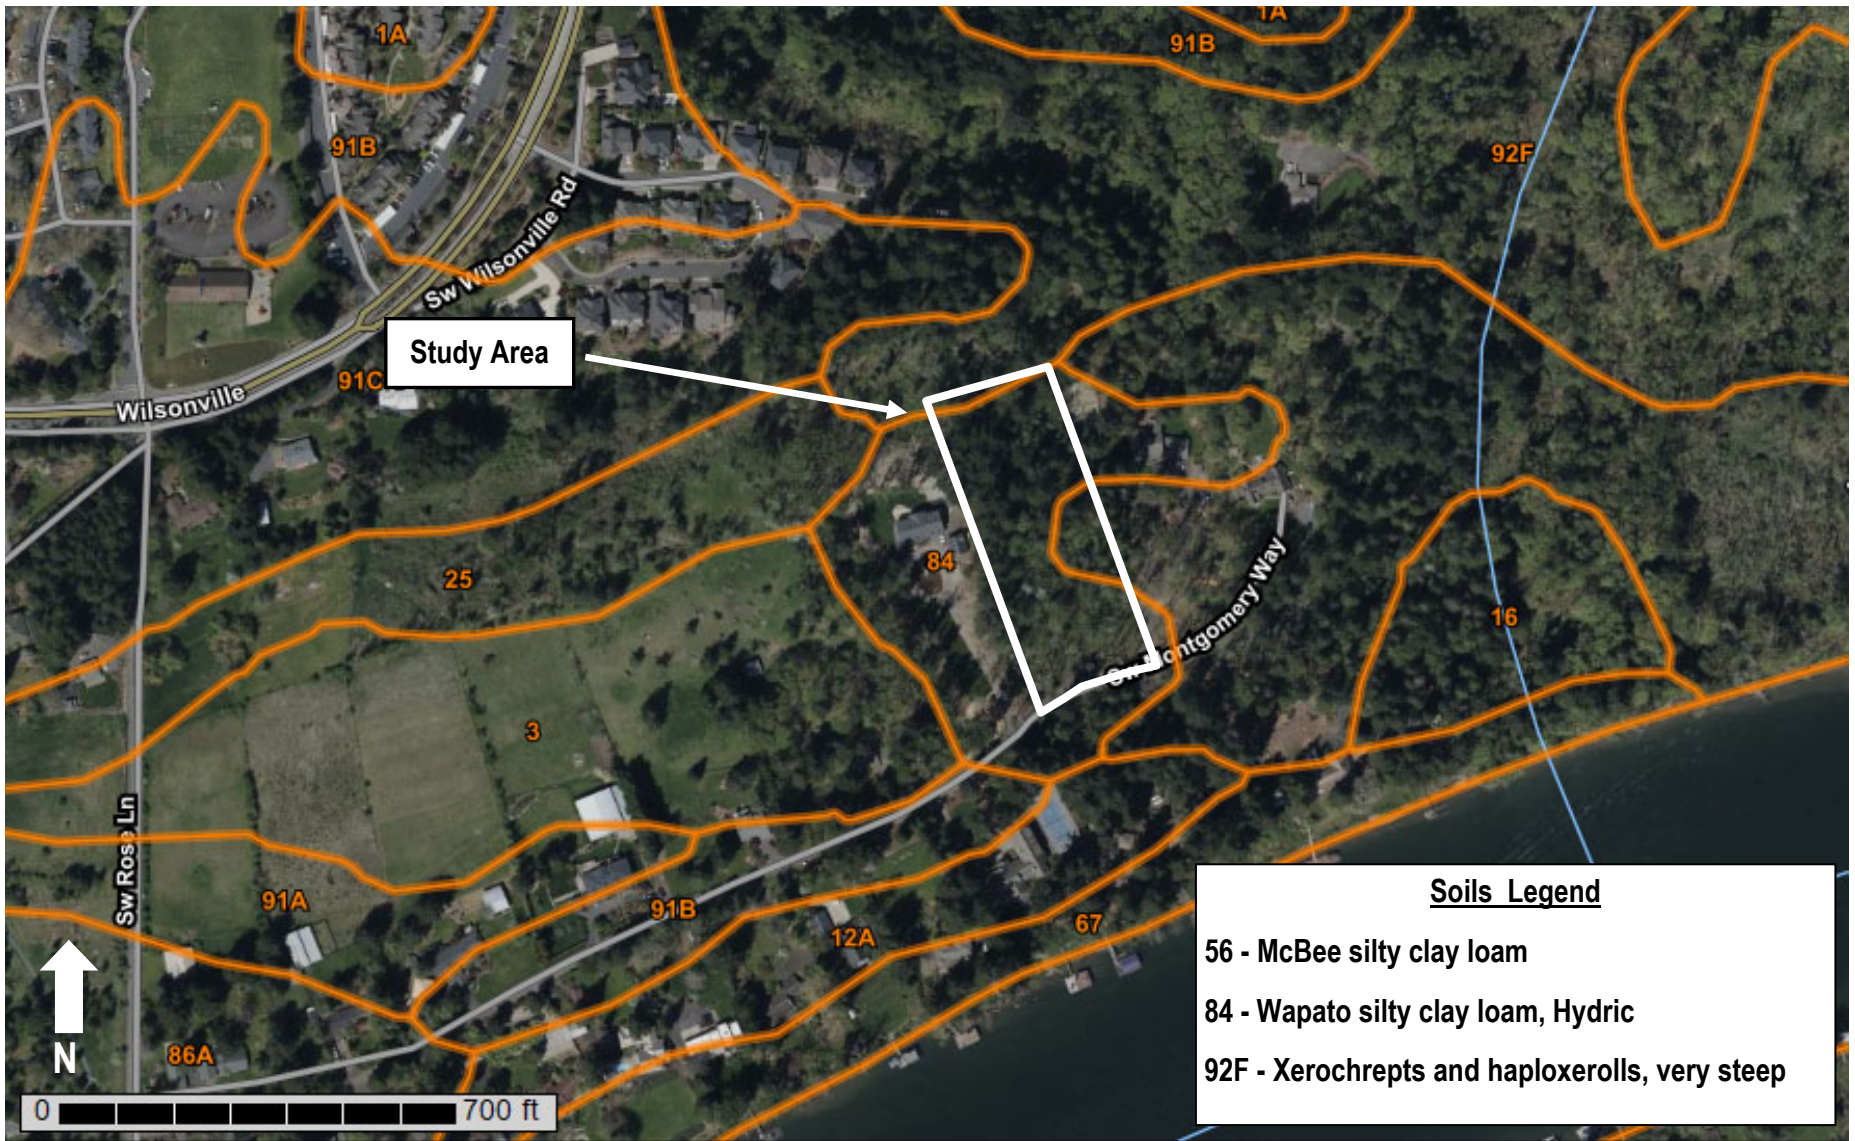
FIGURE
3

Local Wetlands Inventory
6753 SW Montgomery Way - Wilsonville, Oregon
Fishman Environmental Services, Inc., 1999

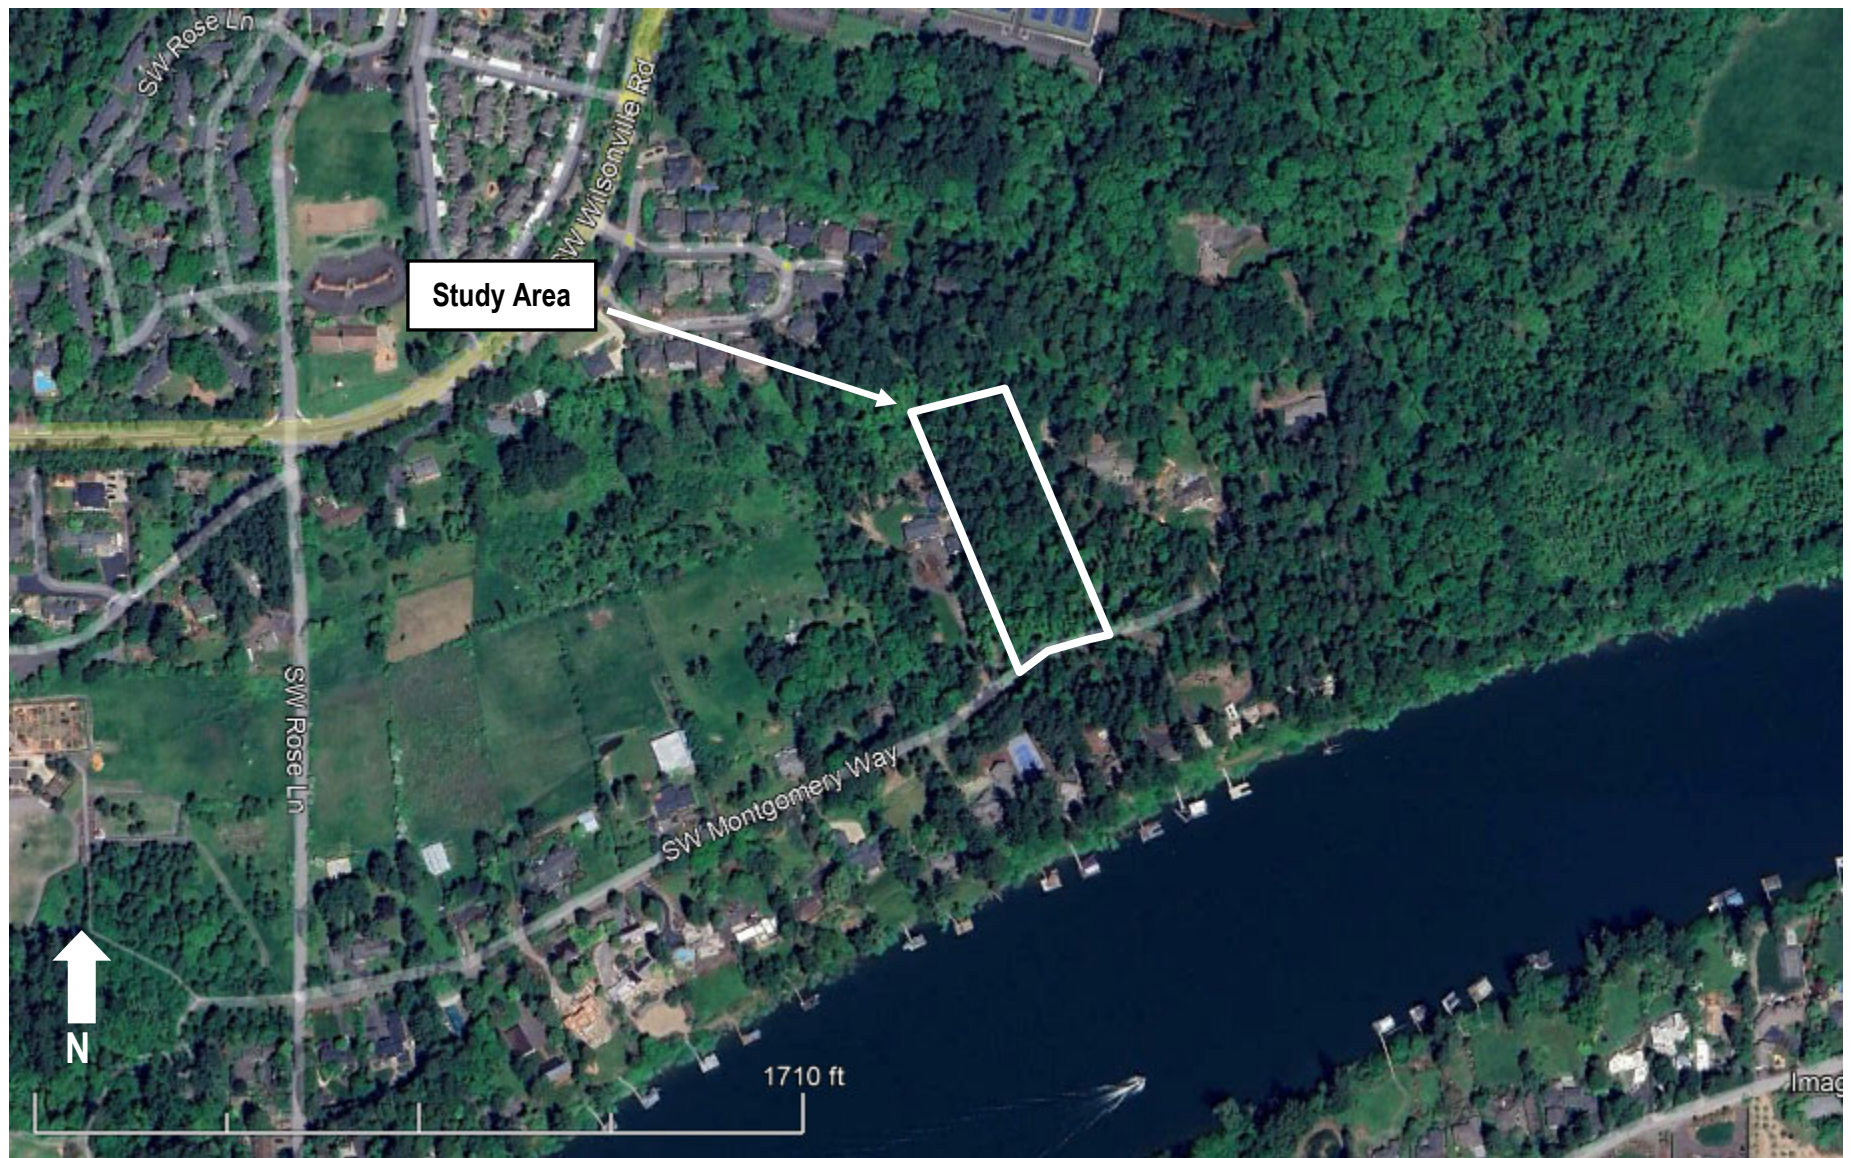
FIGURE
4

- 56 - McBee silty clay loam
- 84 - Wapato silty clay loam, Hydric
- 92F - Xerochrepts and haploxerolls, very steep

Soils
6753 SW Montgomery Way - Wilsonville, Oregon
Natural Resources Conservation Services, Web Soil Survey, 2019
(websoilsurvey.sc.egov.usda.gov)

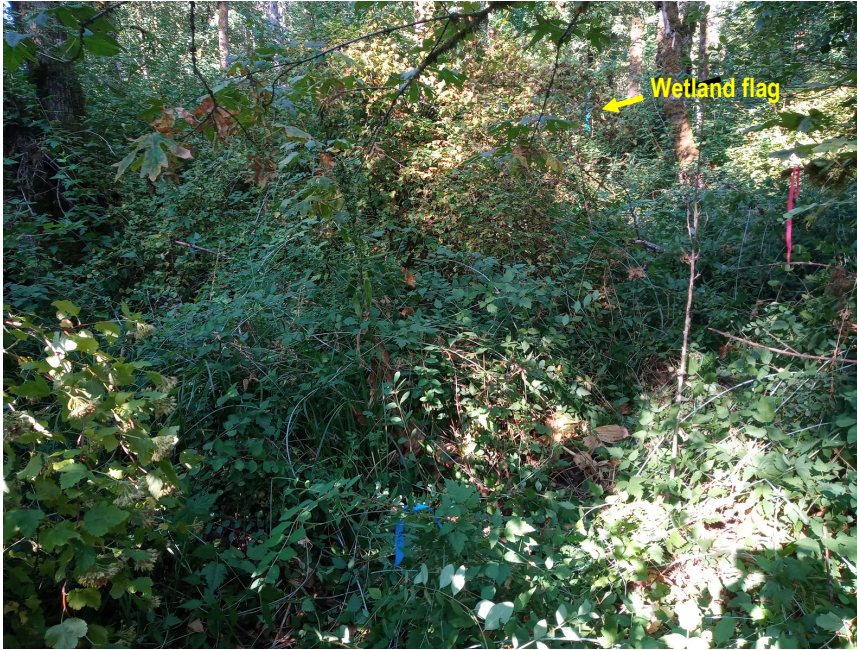
Photo A:

Looking west along the northern wetland boundary. The pink flag is upland sample point SP-4.

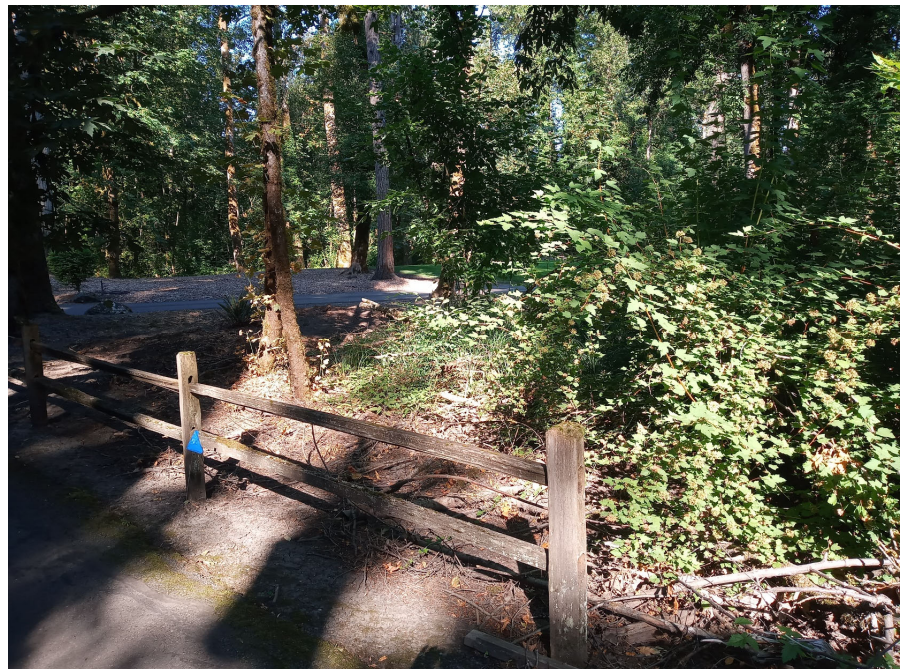
Photo B:

Looking northwest across the west end of the wetland. The driveway in the background is just beyond the study area.

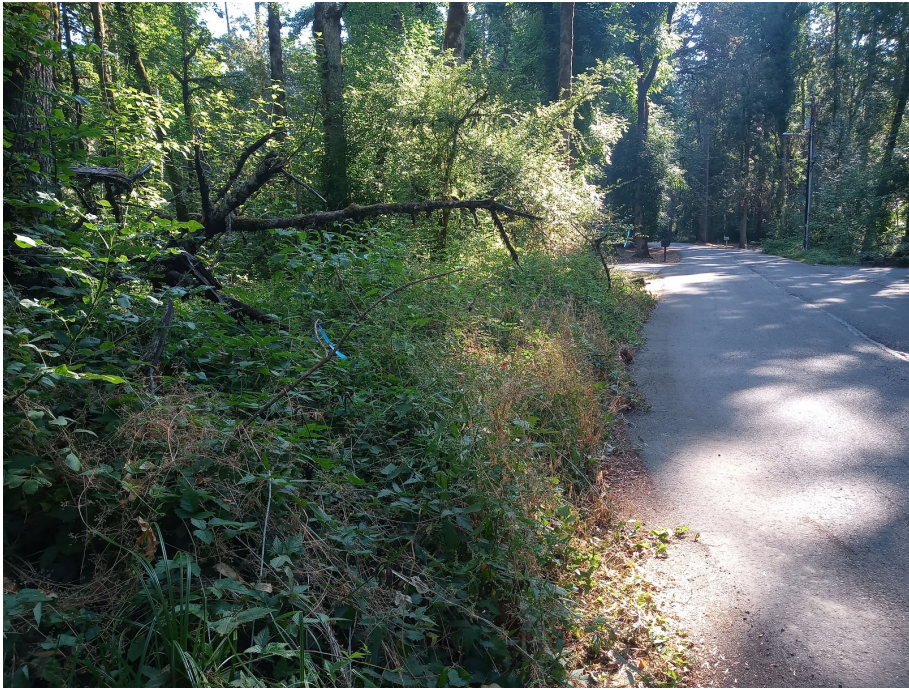
Photo C:

Looking east near the east end of the study area. The wetland begins just north of the street surface.

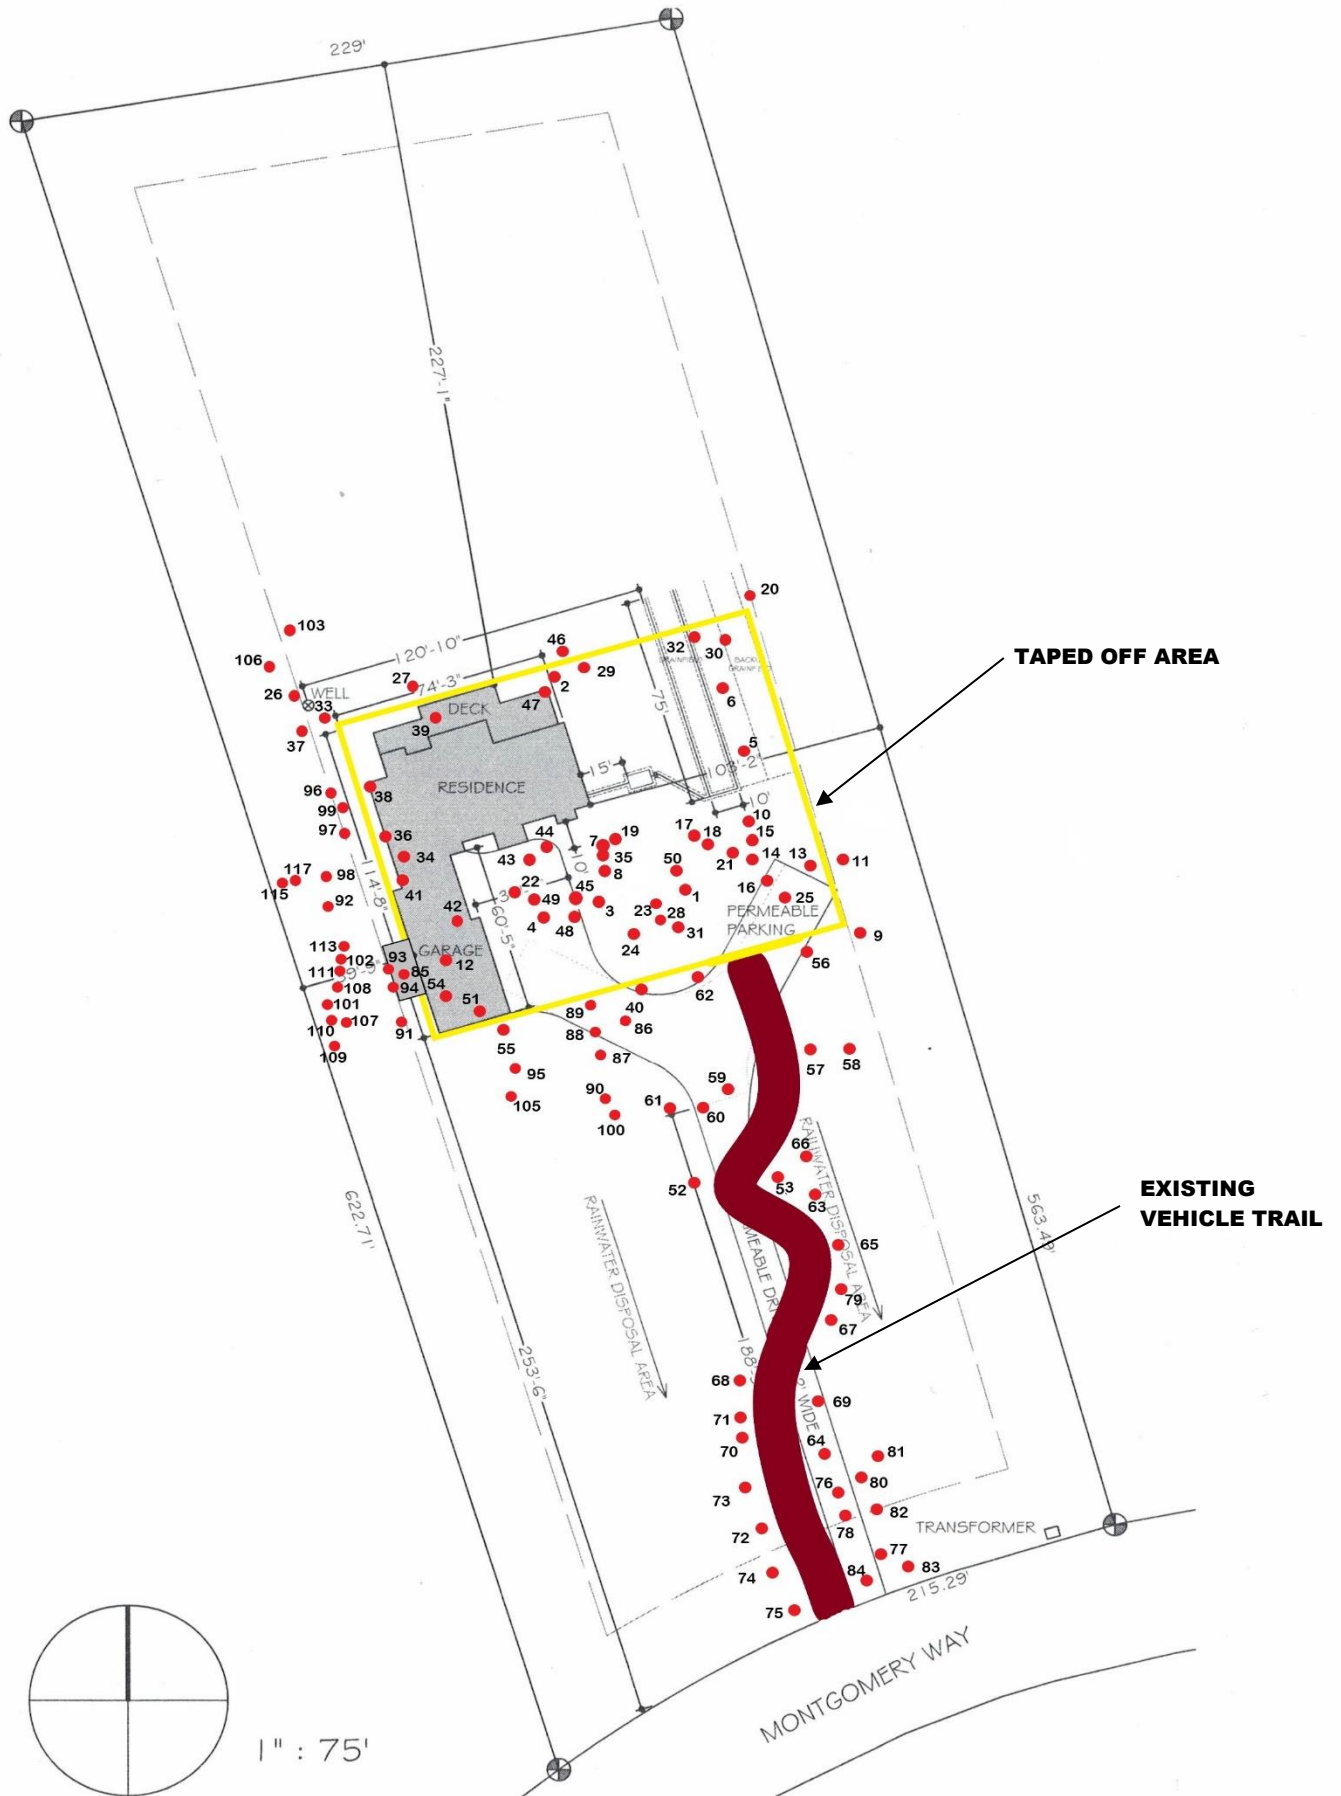
Figure 1. Tree Locations (all trees 6-inches DBH and over – see Table 1 for location info)

Given the locational data provided in Figure 1 and Table 1 the following 59 trees may require removal either because of their location, condition, future life expectancy or their unsuitability for preservation within proximity of a residence:

Table 1. Tree Survey of March 31 & April 24, 2023, all trees 6-inches DBH and over within area shown in Fig 1.

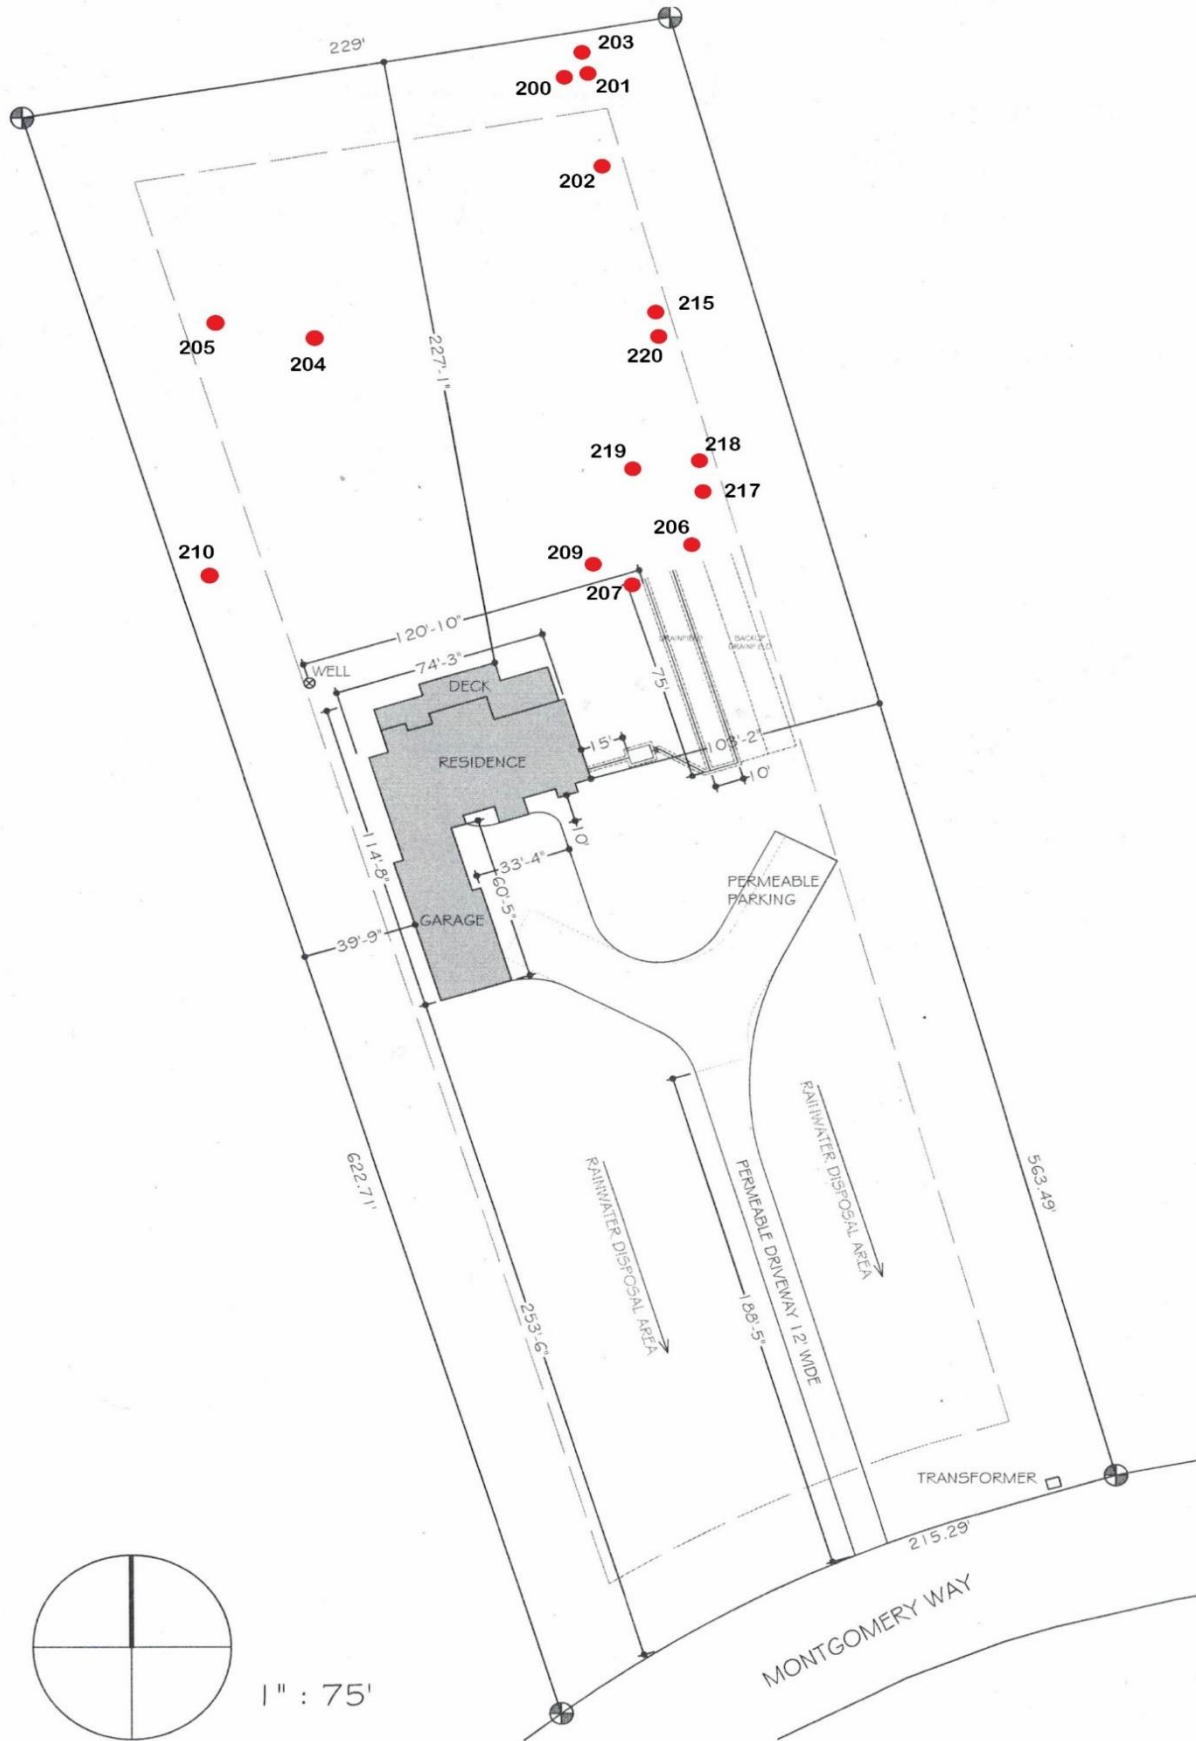
Figure 2. Tree Locations (Dead Dying and Dangerous Trees – see Table 2 for location info)

There are 15 trees recommended for removal solely due to their condition. These trees were classified as Dead, Dying or Dangerous by the consultant. Details and explanations for these classifications are given within Table 2 below. The approximate locations of the trees within the property are shown in Figure 2. The trees have been tagged with aluminum tree tags numbered per Table 1 below.

During the April 24th inventory the property owners asked the consultant to provide information and approximate locations of all trees not adjacent to the proposed development that were either dead, dying or dangerous and that were able to be recommended for removal. These trees were tagged in the field and are detailed in Table 2 and Figure 2 of this report.
