From The Director's Office:

Facilities

Utilities

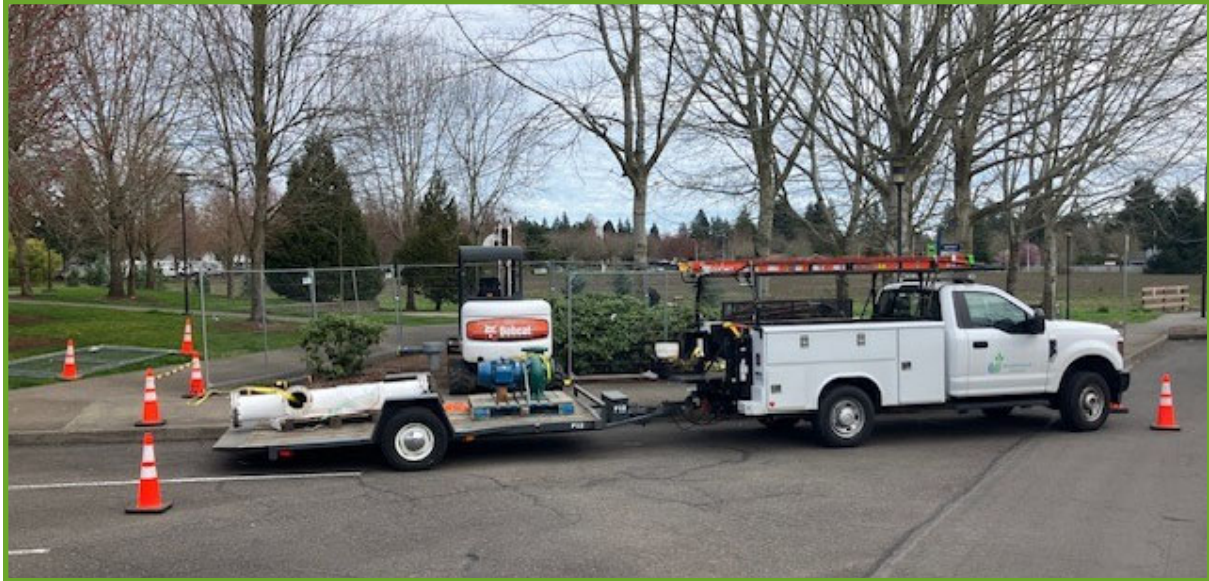
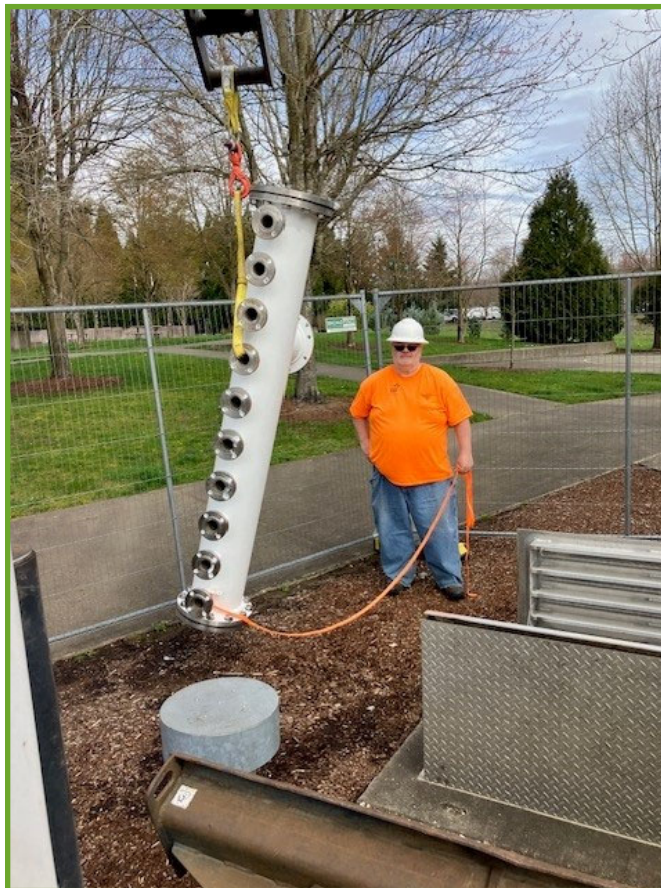
With water feature season quickly closing in, the Facilities team assisted with moving the Town Center Water Feature project to completion. The team previously removed the 20+ years old equipment from the vault and stripped the vault down to bare concrete floor and walls. Next a contractor coated all the walls and floor with a durable white epoxy. This month the Facilities Team assisted the contractor with lowering the manifold pipe and pump/motor into the vault to begin the reconstruction process. Once this project is complete, the Facilities team will turn maintenance and operation responsibilities of the park water features, back to the Parks Department.

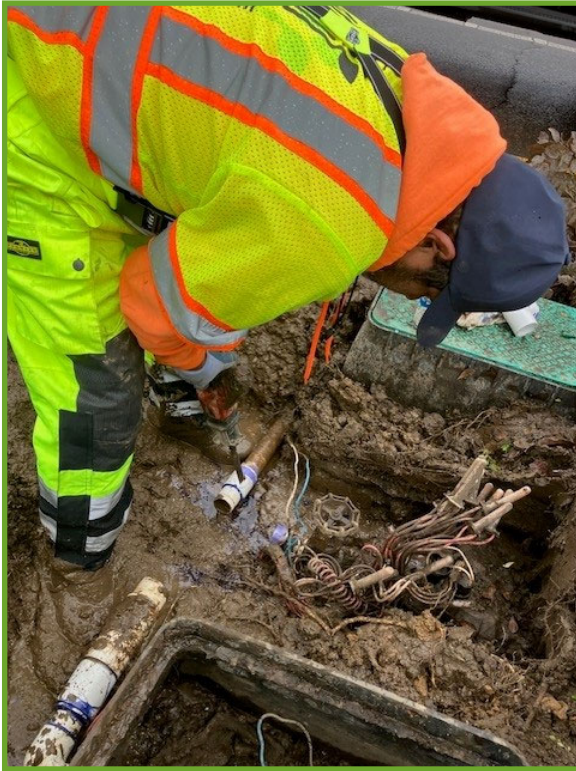
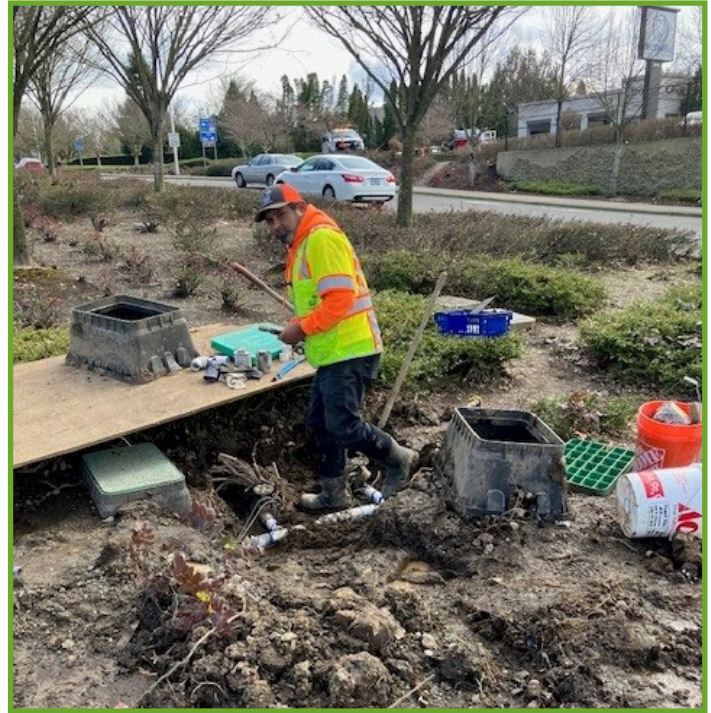
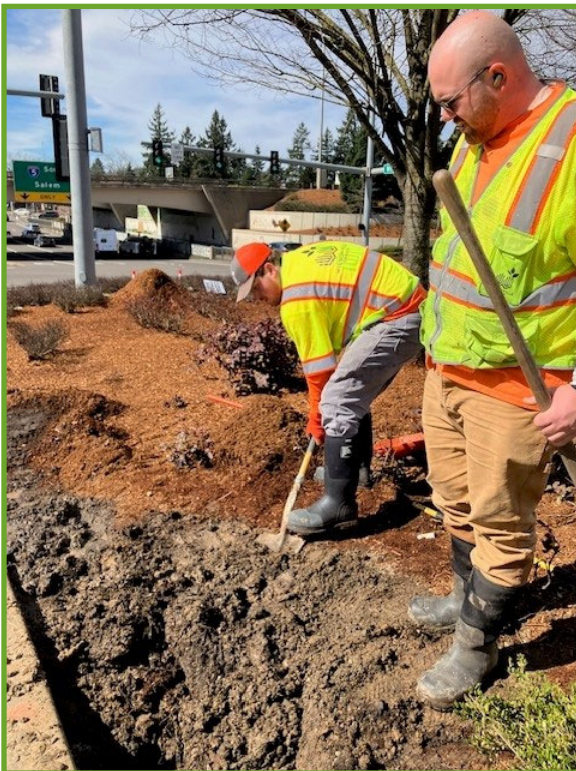
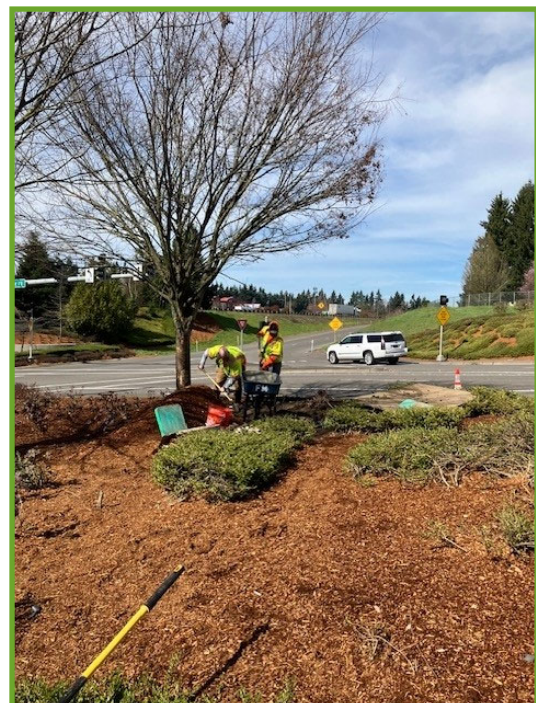
Every March the Roads team turns on irrigation systems in right-of-way median landscapes to ensure things are in good working order before summer. This early activation allows time for any needed repairs while the rain is still keeping the vegetation alive without assistance from irrigation. As you can see, there was a large repair needed on Wilsonville Road; luckily testing was done before the arrival of new bark dust and repairs were finished prior to the Spring refresh of the landscaping!

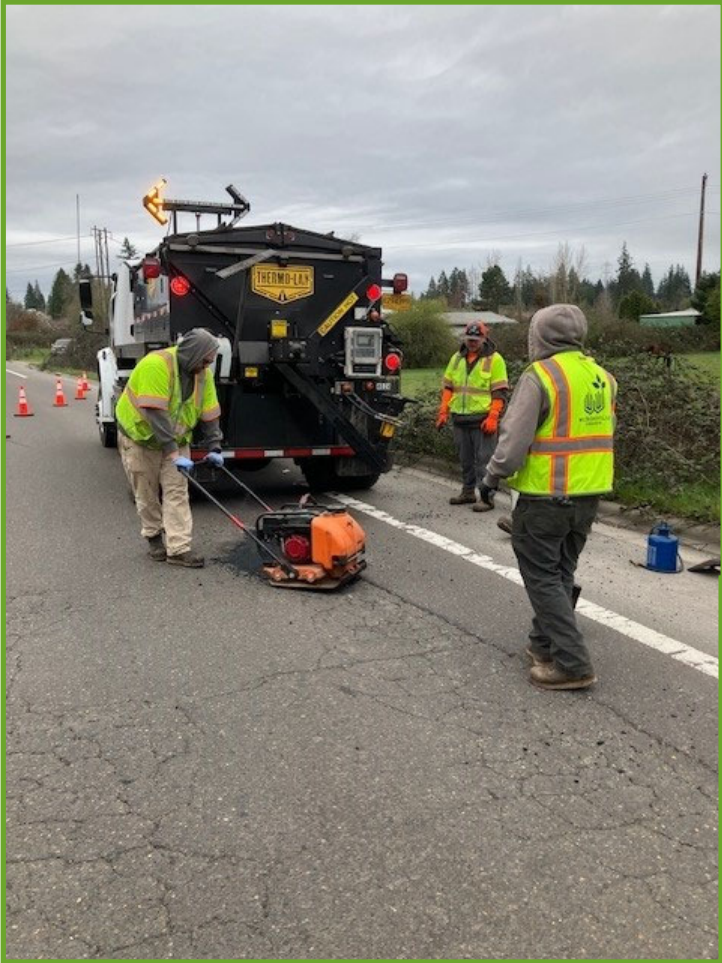
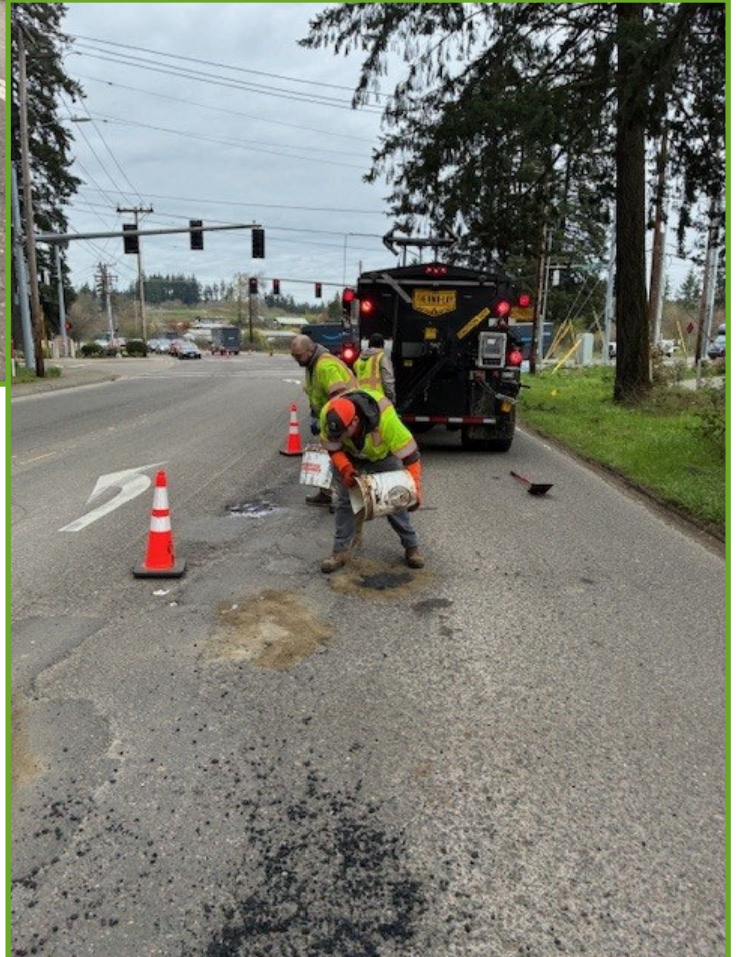
The Roads team can always count on winter rains and frequent temperature fluctuations creating potholes that need repair. March offered many dry days that allowed the crew to address these potholes, especially the extremely heavily traveled Day Road and Grahams Ferry Road areas of the City. Potholes are always on the agenda, and frequent repairs mean that equipment is often used, inspected, and maintained.

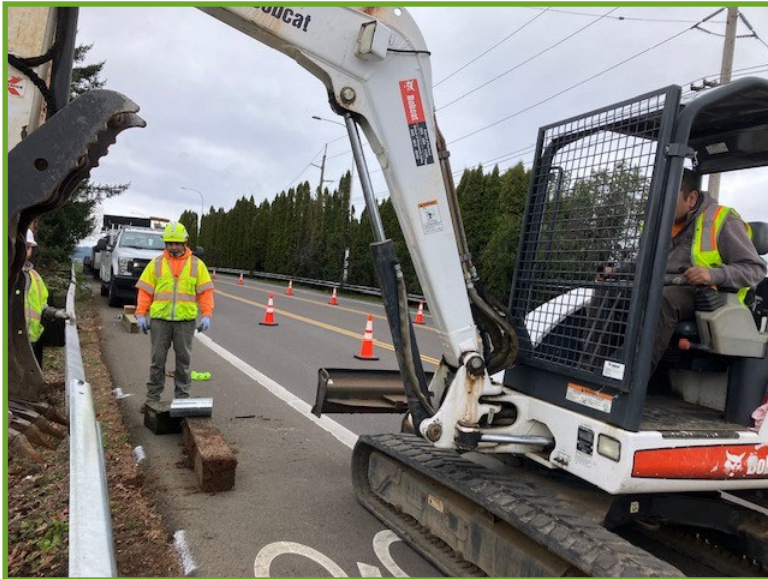
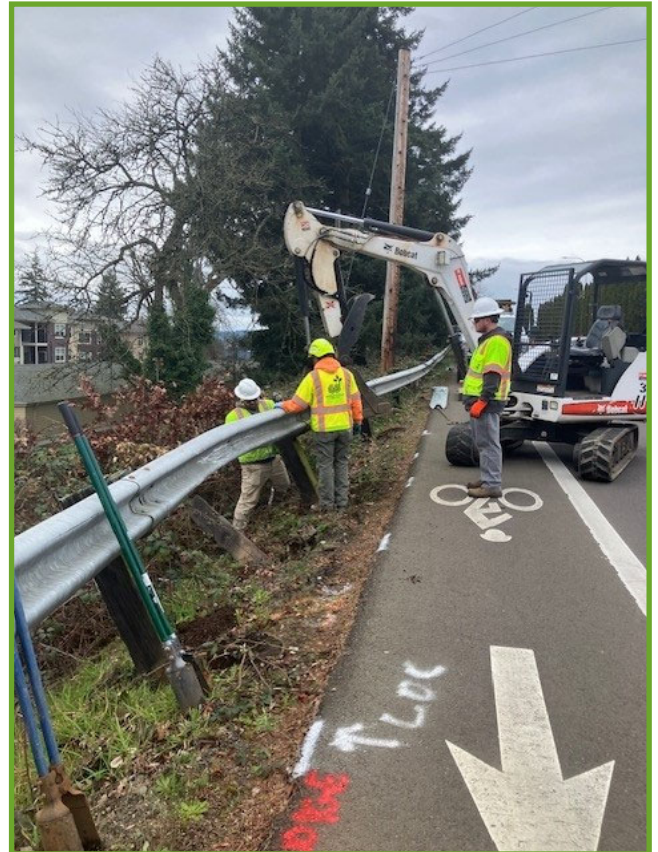
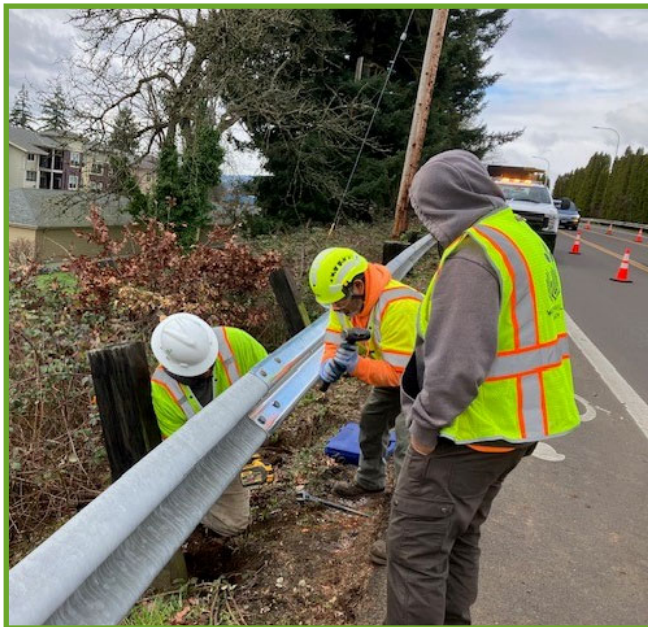
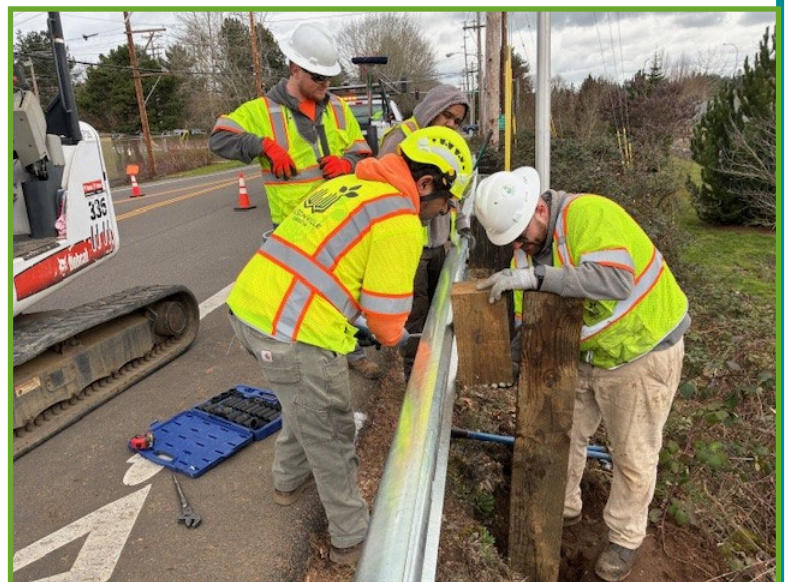
A car accident left a section of guardrail on Boeckman Road damaged. These important safety barriers are repaired as soon as possible after an incident, to keep drivers and adjacent properties safe. In this instance, a support beam and damaged guard rail were removed, a new support beam and new section of guardrail were installed and secured, returning the guardrail to the appropriate function and impact resistance.

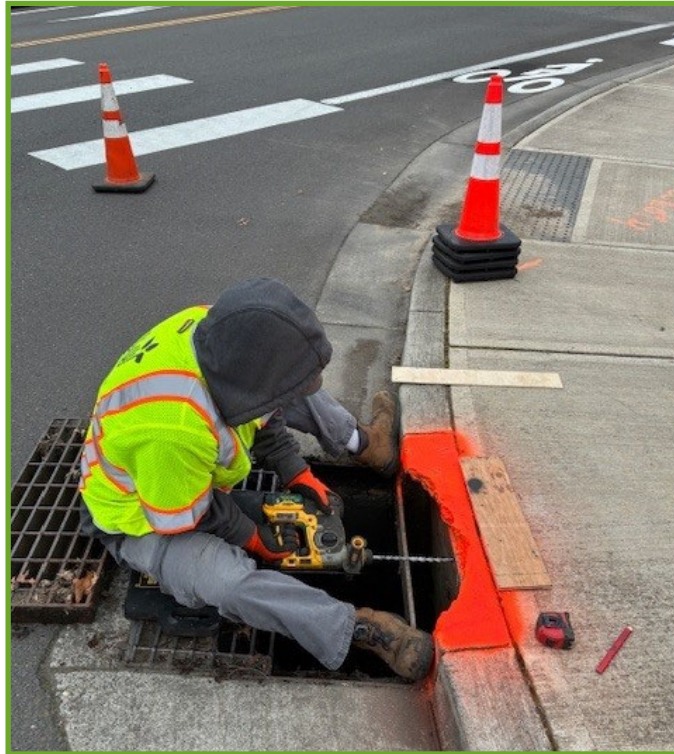
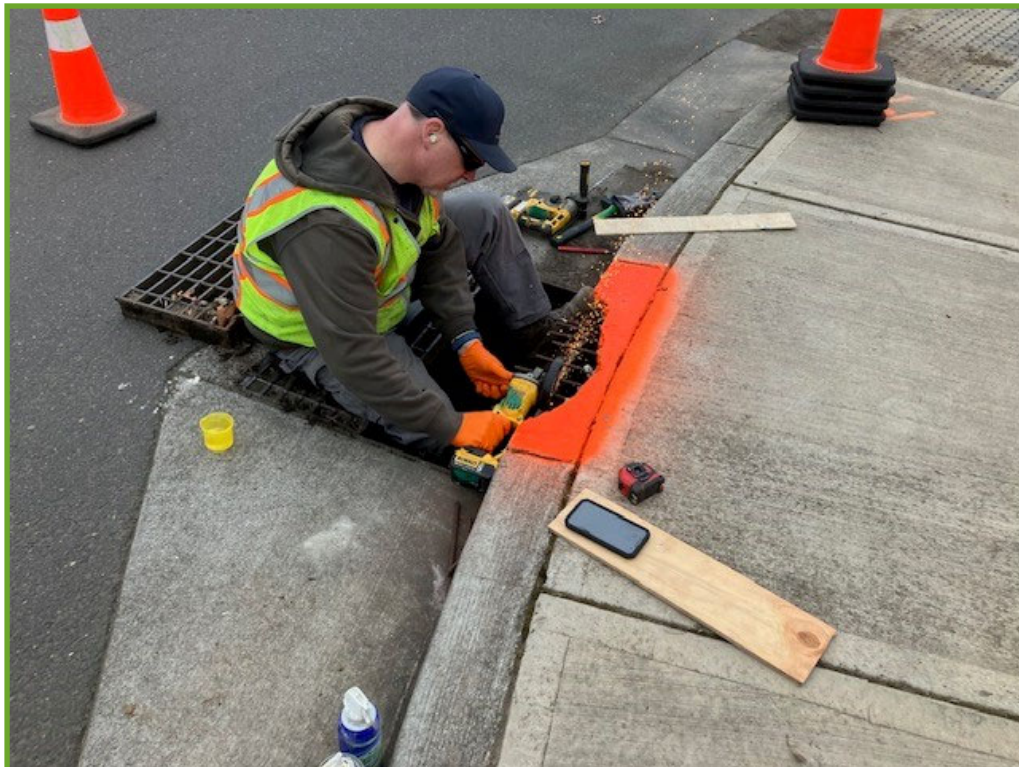
Occasionally commercial vehicles cause damage to infrastructure while navigating through the City. Here is a catch basin that was damaged when a heavy vehicle drove over the curb. The repair involved replacing rebar to reinforce the structural integrity of the curb, then new concrete was poured and the catch basin lid was repositioned after repairs were completed.

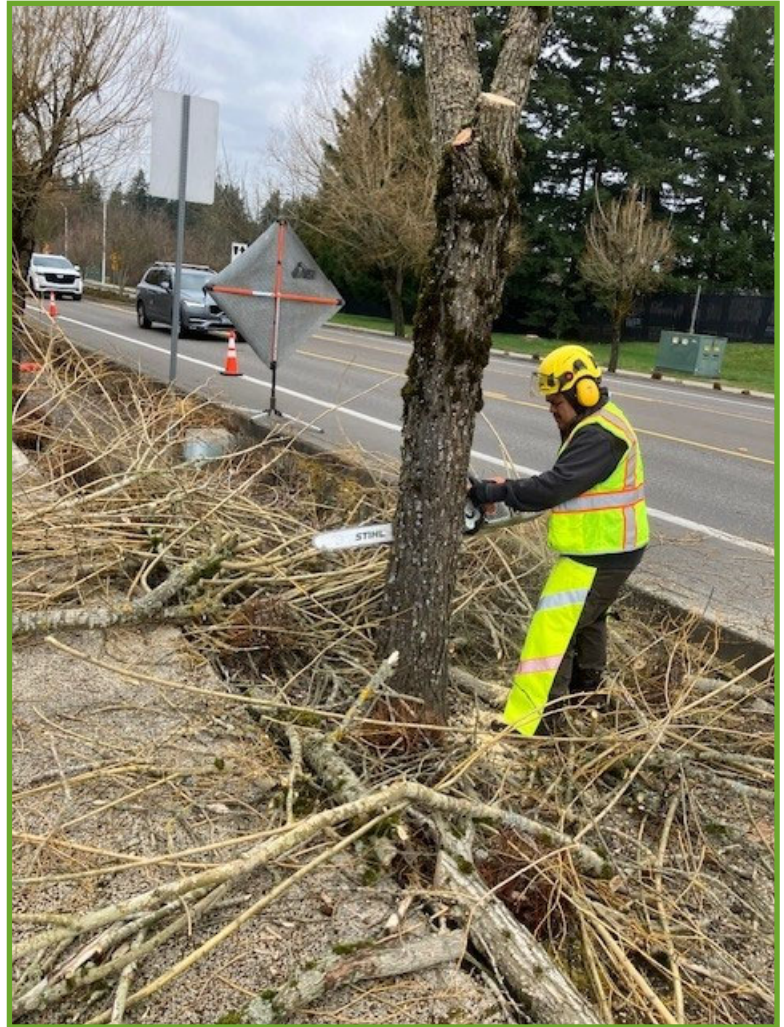
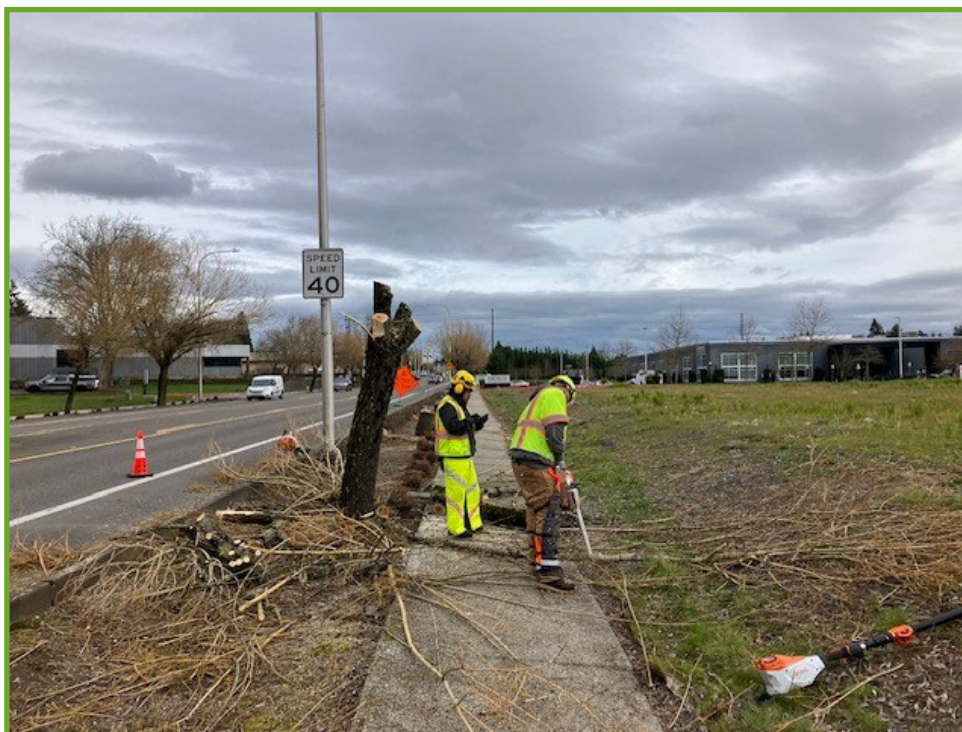
East of Kinsman Road on Boeckman Road, phase one of a project repairing stormwater swales and pervious sidewalks kicked off in March. This pilot project addressed one of the most urgent areas of pervious walkway needing repair. Step one is to remove the white willow trees that have impacted the existing the pervious sidewalk in this area. Once the sidewalk has been replaced, new trees will be planted where the willows were removed.

There are approximately 1.75 miles of pervious sidewalk along Boeckman that will need be systematically replaced over the next few years.

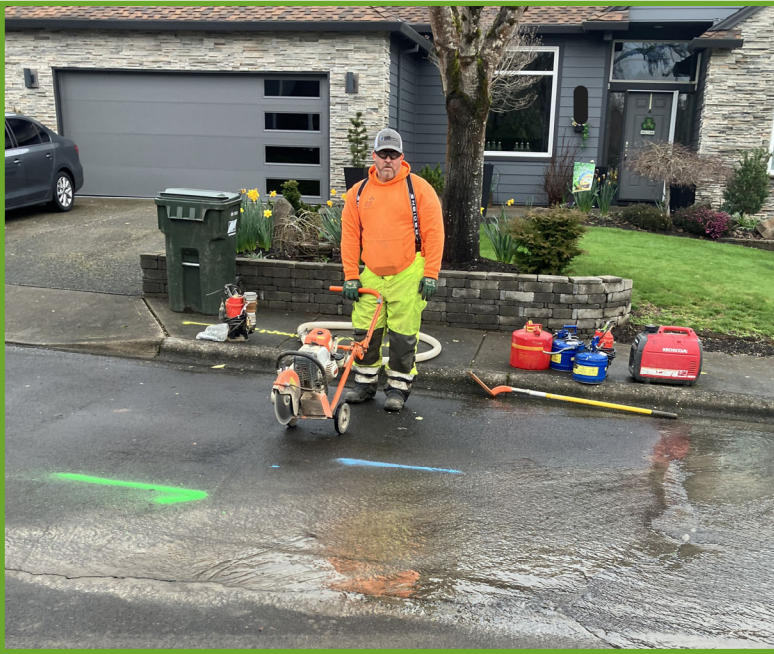
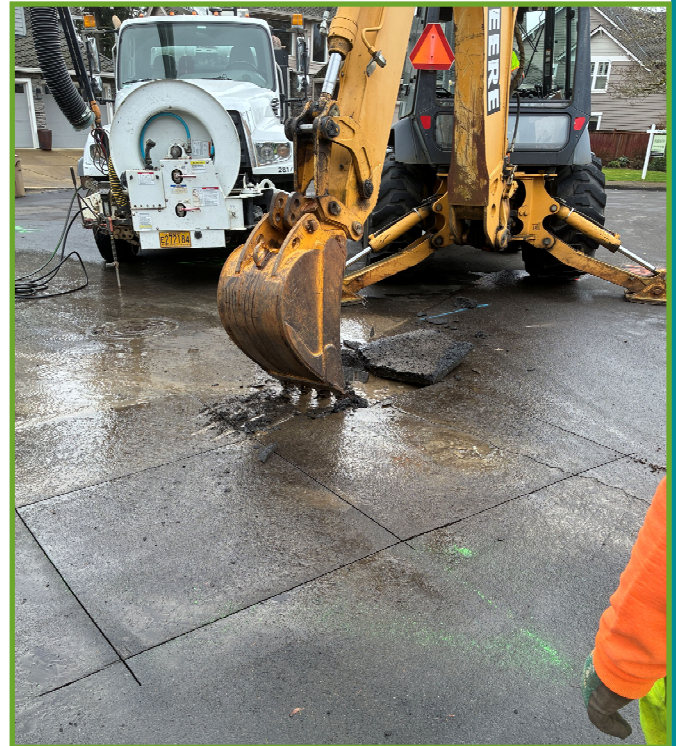
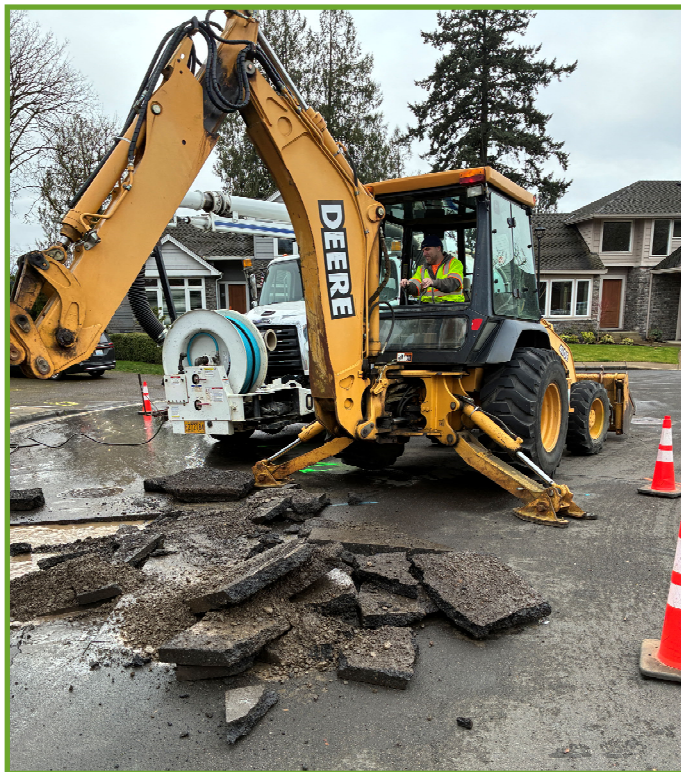
A community member report of water in the roadway on Willamette Way East led to an eventful evening on Friday the 13th. A second call from a homeowner reporting extremely low water pressure confirmed the concern. When Utilities team members arrived onsite, they determined that an emergency repair was necessary. The crew went right to work ordering locates before beginning the work of removing a section of roadway to pinpoint the location of the needed repair. Next was the arrival of the large equipment on the scene, and the work begins...

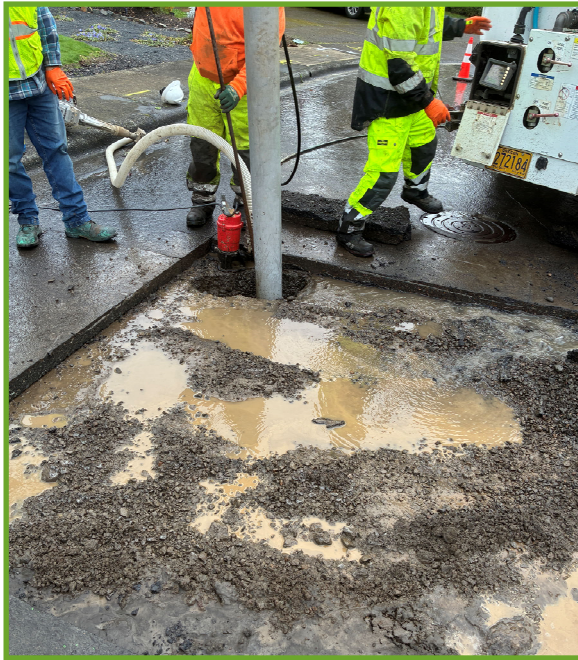
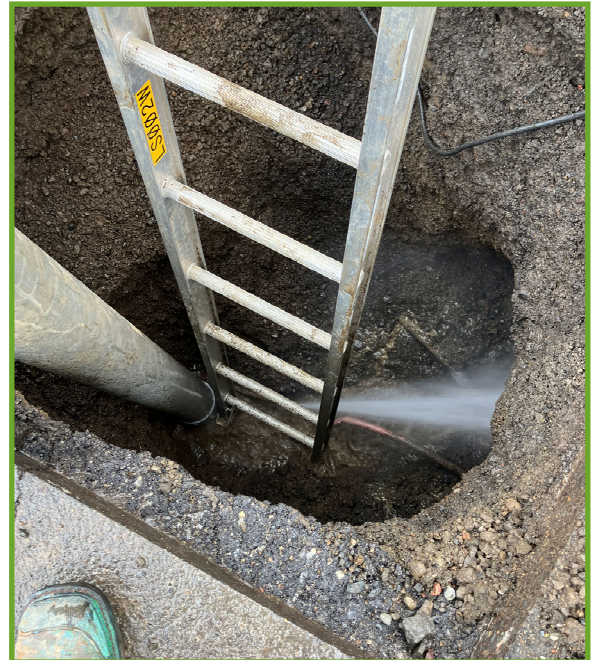
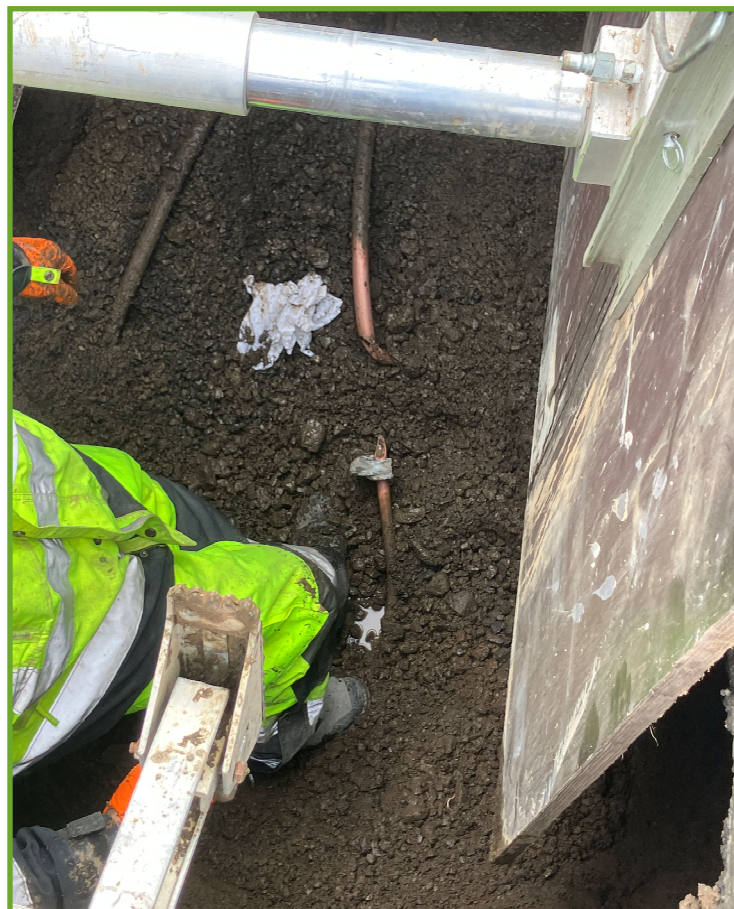
After removing the asphalt on Willamette Way East, public works teams began using the hydro-excavator to quickly and safely remove gravel and dirt around the service line, which was located quite deep underground. To keep the worksite safe, shoring was used to eliminate the danger of saturated ground giving way while the repair was performed. The third photo shows the damaged pipe causing the problems.

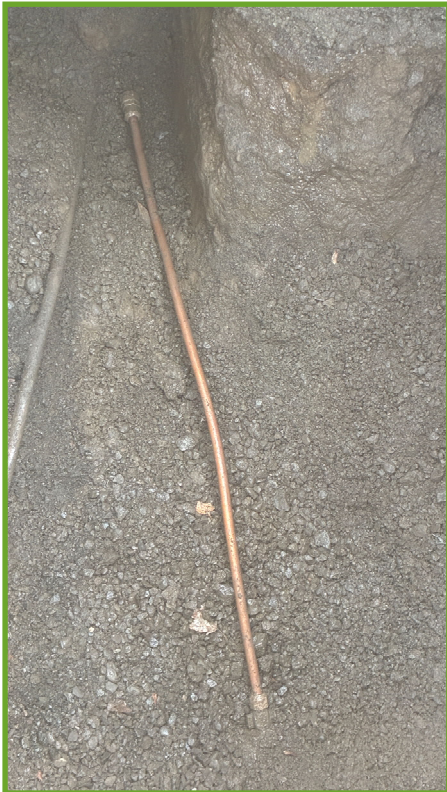
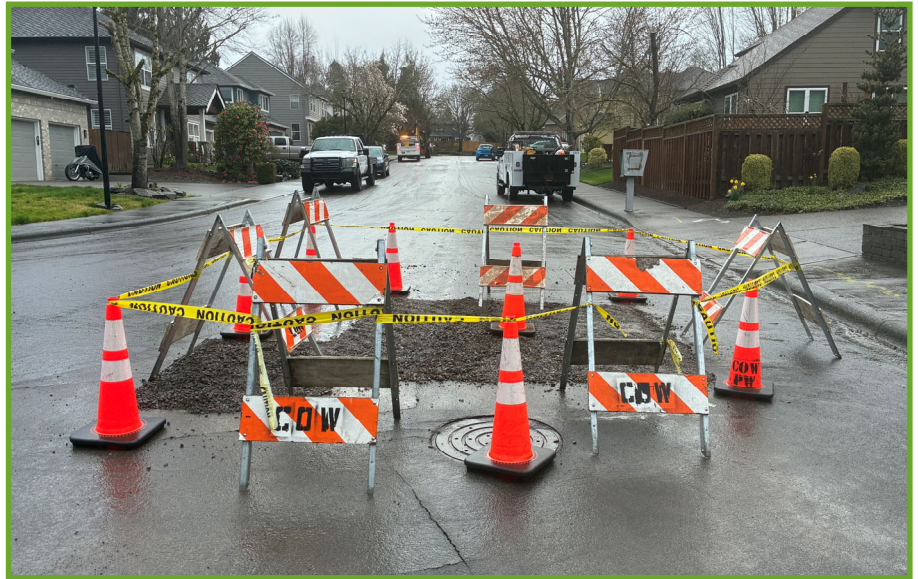
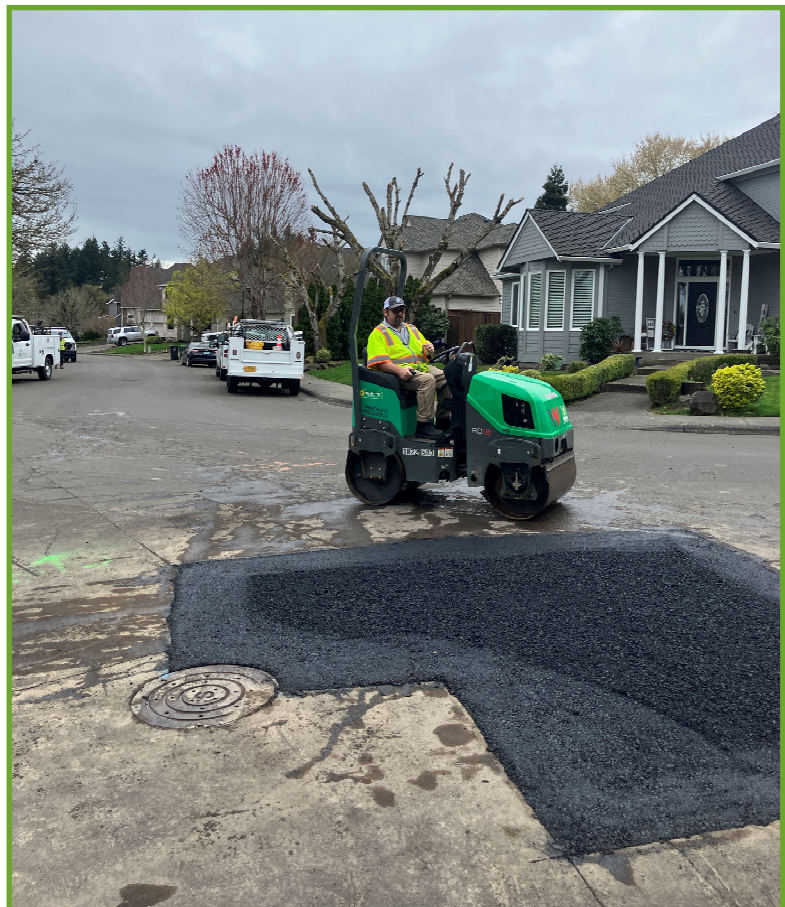
After uncovering the broken service line, Utilities Water Technicians removed the affected section of pipe. Upon inspection it was discovered that two rocks had become lodged in the pipe, causing an extreme build up of pressure. The pressure became so great that the pipe exploded underground. The affected section was replaced with a new pipe, the worksite filled in with dirt and area barricaded before the crew left at 7pm.

The following day members of the Roads and Stormwater crew lent their expertise and equipment for the final step in the repair—repaving the affected site.
