JANUARY 2026 Monthly Report

From The Director's Office:

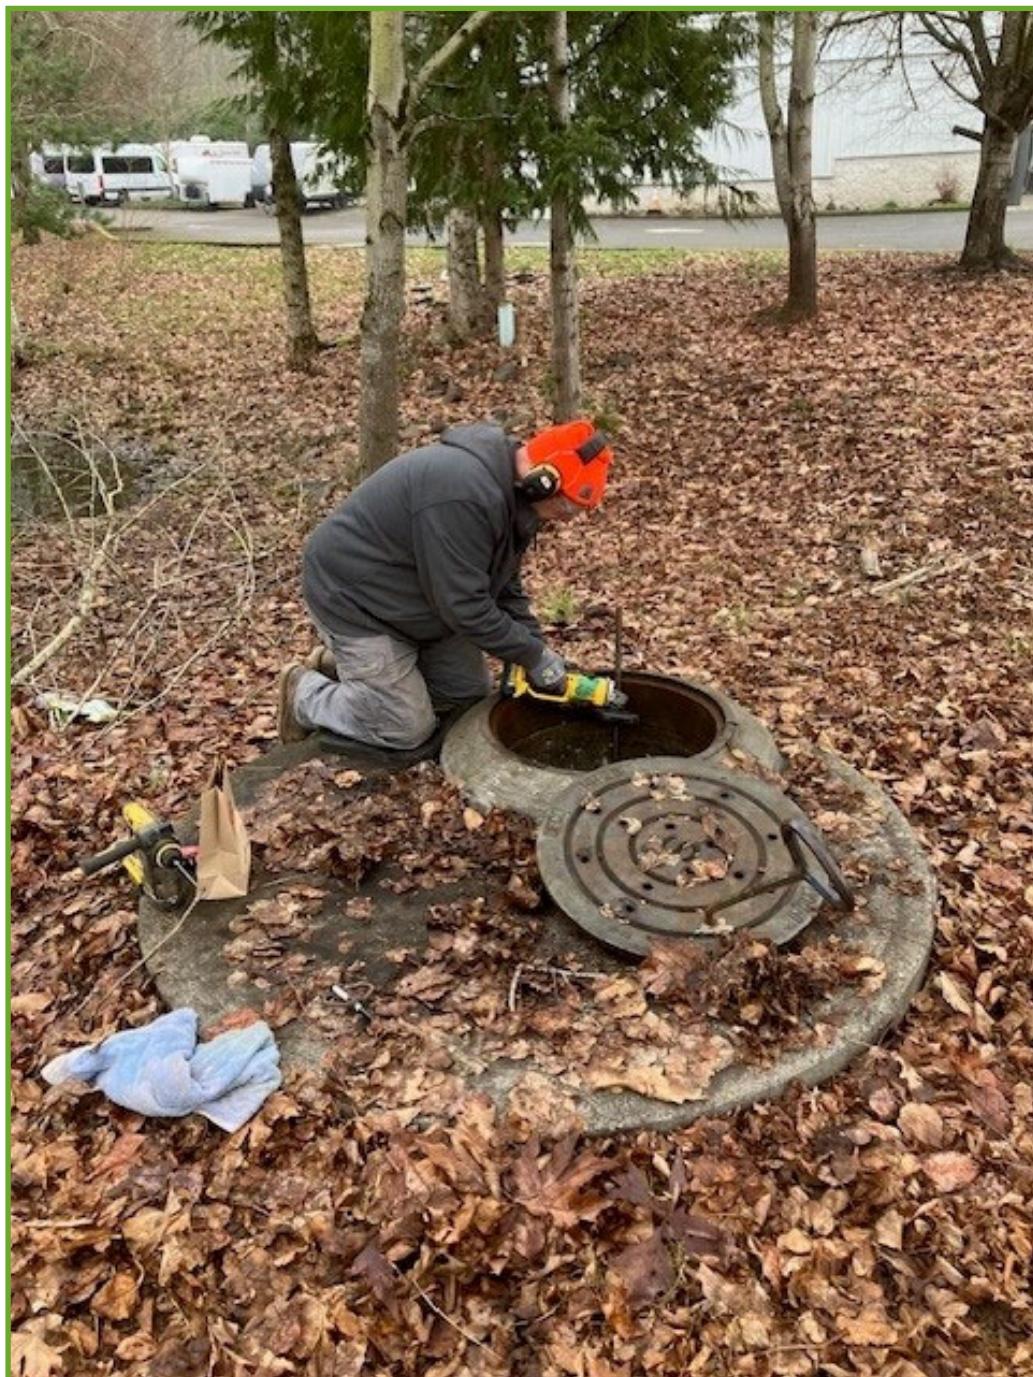
The extreme wet conditions we encountered in December brought our attention to a failed flow control feature at one of the stormwater treatment ponds on SW Parkway at St Helens Dr. These flow control access points have a sliding metal gate that controls the flow of stormwater leaving a treatment area, in this case a pond. This device helps prevent downstream flooding by controlling the rate of release of the water in the pond. Overtime this flow control feature had locked shut, causing the pond to overflow. Shown here is Stormwater Maintenance Specialist Jay Herber repairing this feature to prevent future downstream flooding during major rain events.

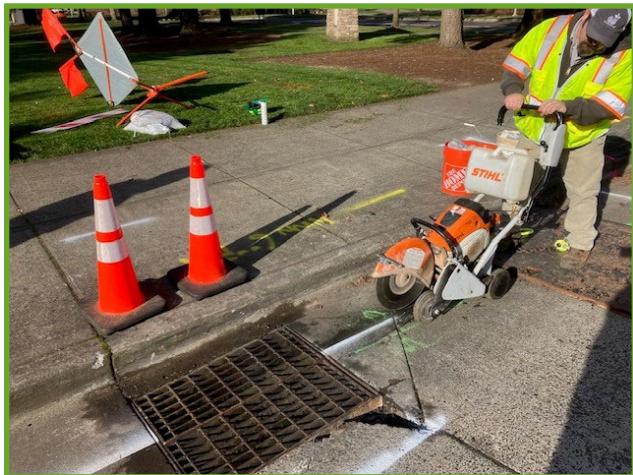
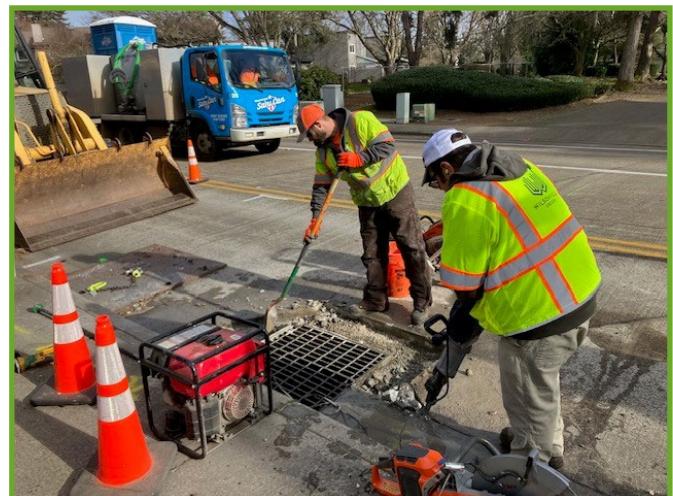
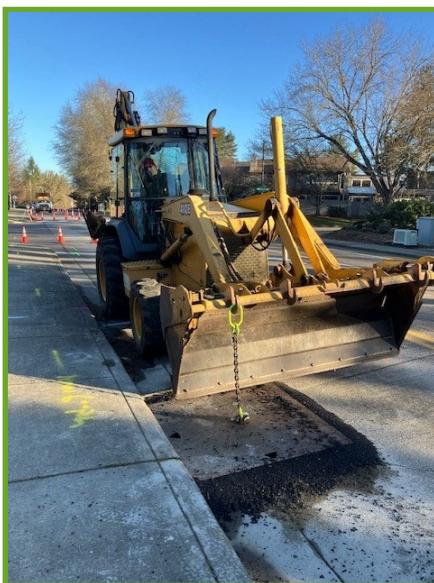
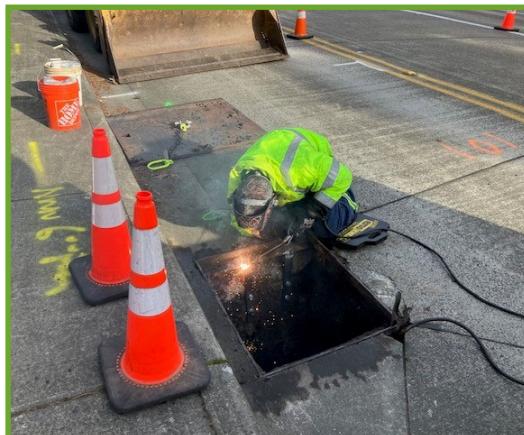
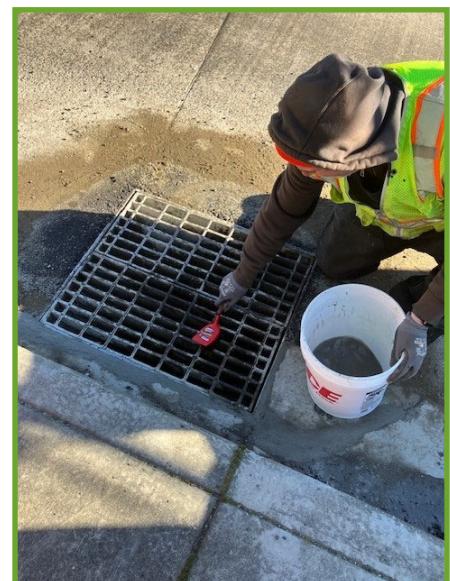
During the third week of January all hands were on deck to assist in repairing a collapsed catch basin in the travel lane on SW Parkway at Ash Meadows Loop. This structure was improperly installed many years ago, and had collapsed under vehicle traffic. Due to the nature of the failure and the location, this work required a high degree of coordination for both traffic control and repair. Our Stormwater and Roads crews were able to work together directing the flagging and traffic diversion and repair of the basin to prevent future issues on this heavily traveled roadway.

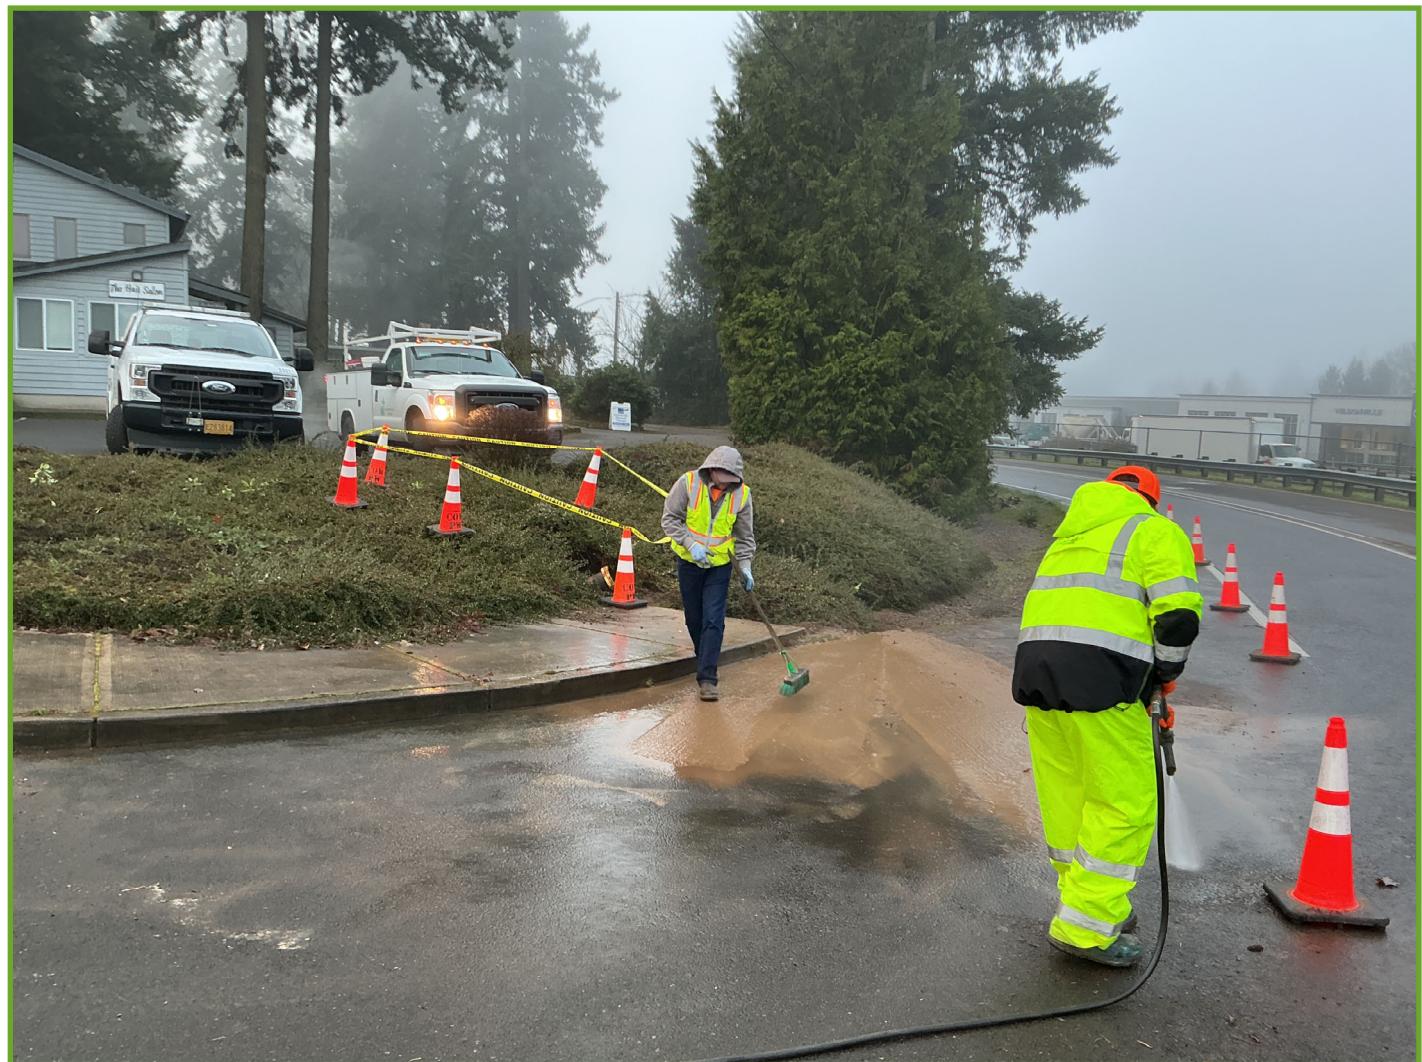
The Utilities team had an exciting repair with an after hours call reporting that a fire hydrant at the corner of SW Holly Street and Parkway had been severely damaged after being struck by a car. The hydrant was completely severed from the main water line that supplies the hydrant. Despite the quick response from an after-hours technician, the estimated amount of water lost due to this accident was approximately 1 million gallons. After shutting down water to the hydrant and securing the scene with caution tape and cones, the Utilities Technician took another very important step. When a hydrant is rendered non-functional, it is crucial that local first responders be made aware, to prevent any delays in emergency response. Public Works Utilities technicians work directly with the local emergency response agencies to 'deactivate' the hydrant in any maps and GPS systems until repairs are complete and the hydrant is suitable for a full return to service. This step saves vital time when emergency responders are looking for a hydrant to connect to. Upon completion of the needed repairs, the hydrant will be re-activated so that it appears as available for emergency use as needed.

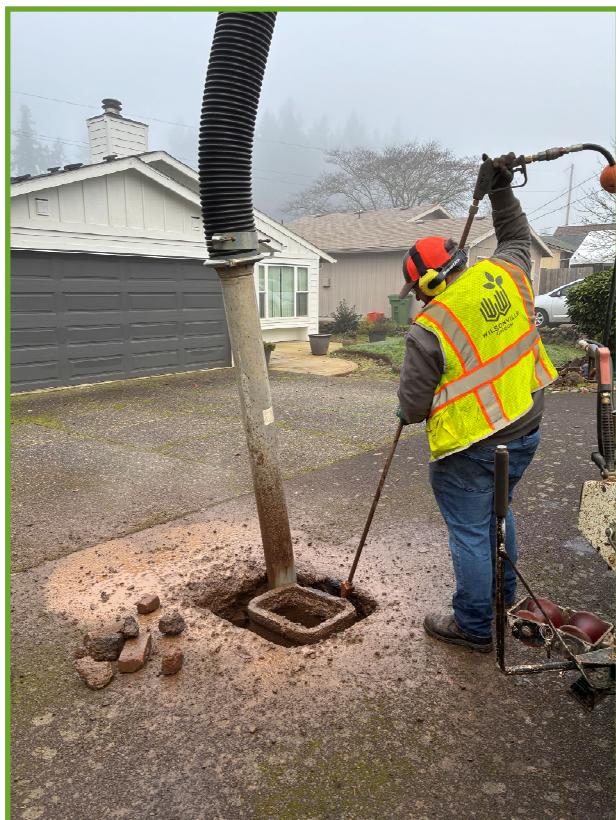
Some meters have been in the ground for as long as twenty years, and may be suffering from normal wear and tear. Replacing the older meters helps reduce the chances of equipment failure.

Hydro excavation is being used to assist in the meter replacement shown in photo to the left.

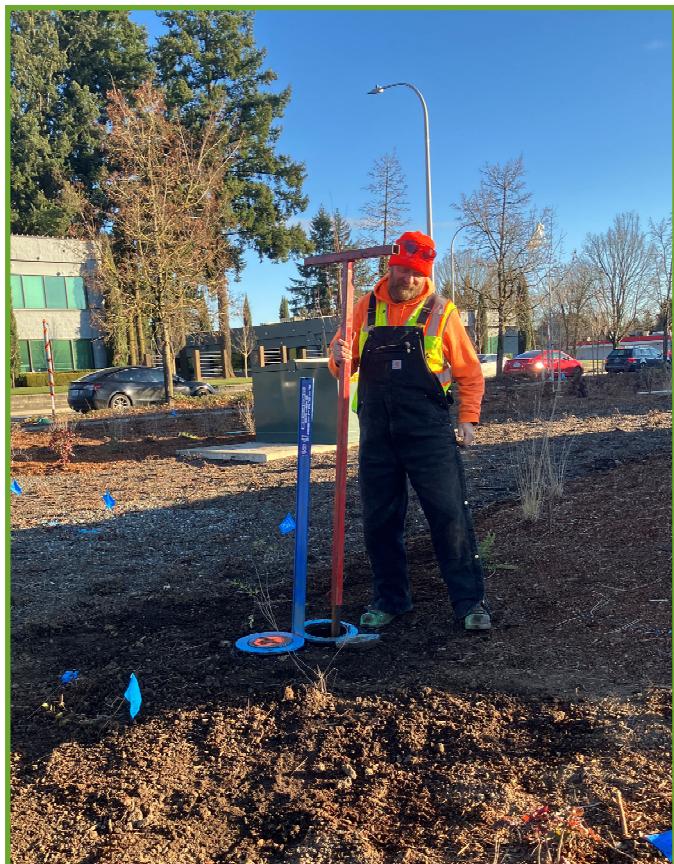
Water valves are installed in various areas around the City and are typically used for isolation of water flow. When a repair or upgrade is needed nearby, these valves isolate specific pipes so that water flow can be stopped, and repairs can be made more quickly, easily and safely.

Shown below, valve exercising is the systematic, routine maintenance process of fully closing and reopening water distribution valves to ensure they are operational, prevent corrosion and sediment buildup, and ensure the assets are in good working order if a shut down is required.

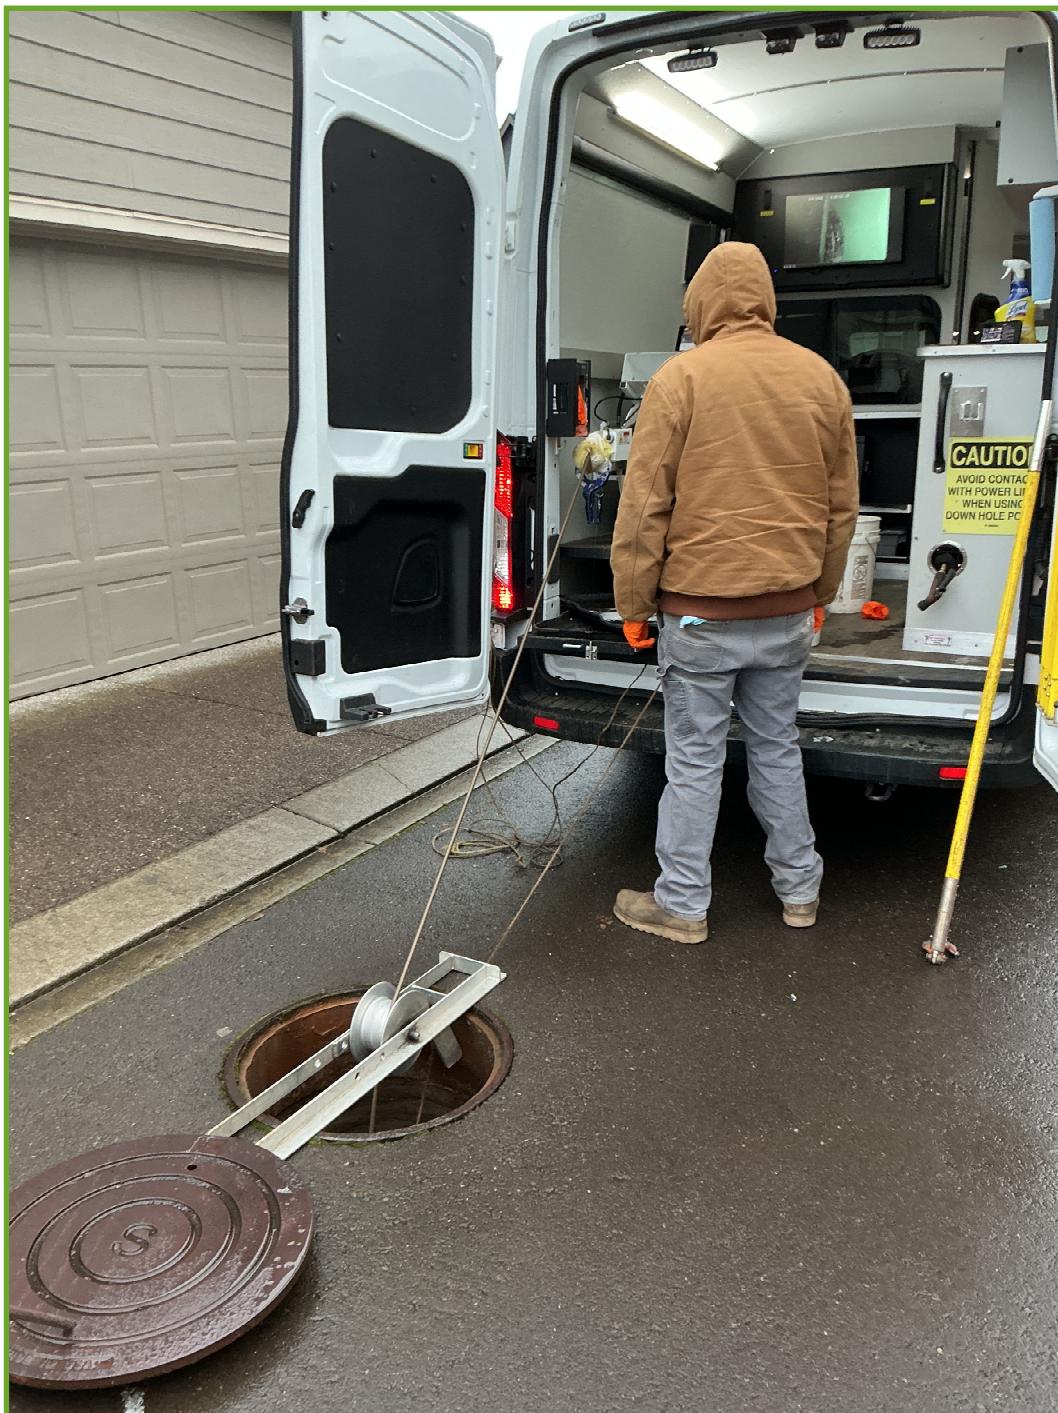
Our sanitary sewer department is continuing their efforts to clean and video inspect as many lines as possible to keep wastewater flowing as it should. Jetting or hydro jetting sanitary sewer lines is a high-pressure, non-invasive cleaning method that uses specialized equipment to shoot water up to 4,000 PSI through pipes to remove stubborn blockages, grease, sludge, and tree roots. This method cleans the entire diameter of the pipe, maximizing flow and preventing future backups. It is easy to forget that when wastewater leaves our premises, it has only completed a portion of the journey to the Wastewater Treatment Plant. This routine maintenance helps ensure its uninterrupted arrival at the treatment facility.

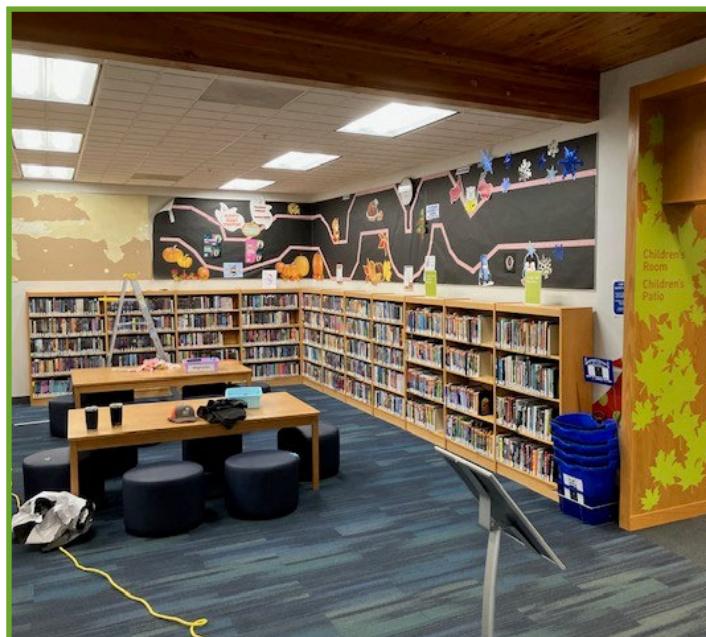
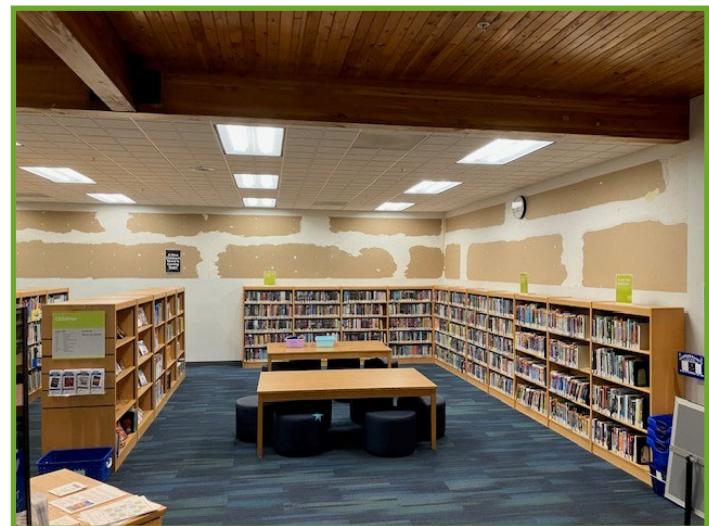
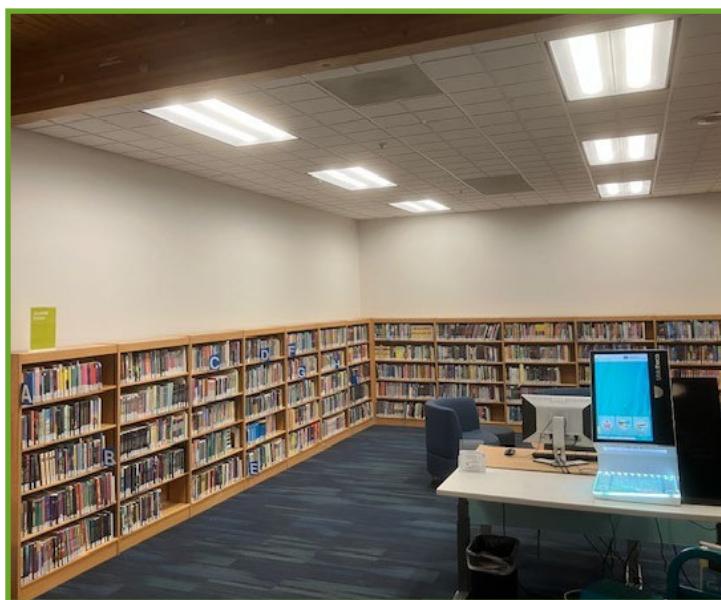
The Library has received a grant that will fund an artist painted mural above the bookshelves in the Children's area. The Facilities team was asked to remove the existing pin boards installed above the bookshelves to prepare for the new mural. The boards were four feet high and approximately 100' long, and to everyone's surprise, the boards were glued on to the wall. This resulted in a more labor intensive and time-consuming project than originally expected.

Maintenance Technicians Konnen Bell and Trevor Denfeld spent several early mornings carefully removing the boards to limit the damage to the sheet rock and lessen the amount of wall repair needed for the mural preparation. Once the boards had been removed, a contracted painter applied a skim coat of wall compound and finished up with a fresh coat of paint.

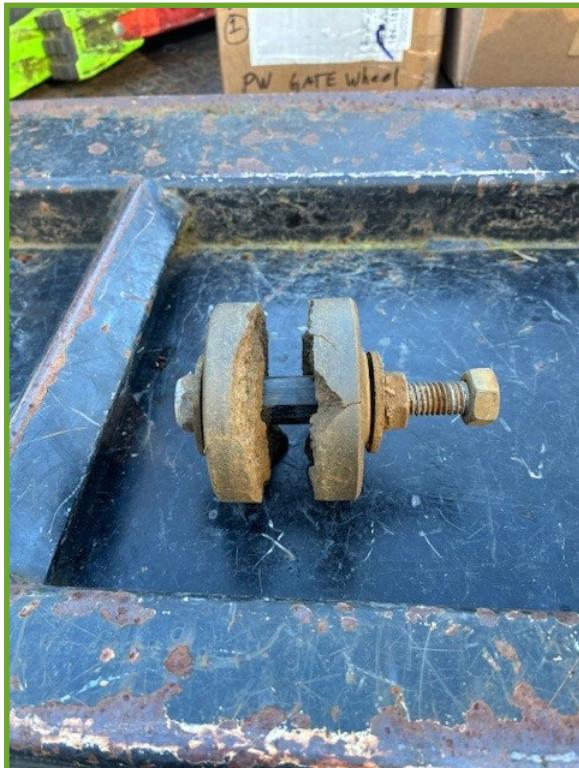
The wheels on the gates go around and around, so many times per day! Facilities Maintenance Technician Trevor Denfeld and Specialist Robert Todd worked as a team to perform maintenance on several City facility gates in January. The tasks included tightening drive chains, lubricating moving parts, adjusting closure limits and replacing worm rollers and trolleys. This routine inspection and maintenance of the gates keeps secured areas reliably safe and sound, protecting the City's valuable assets.

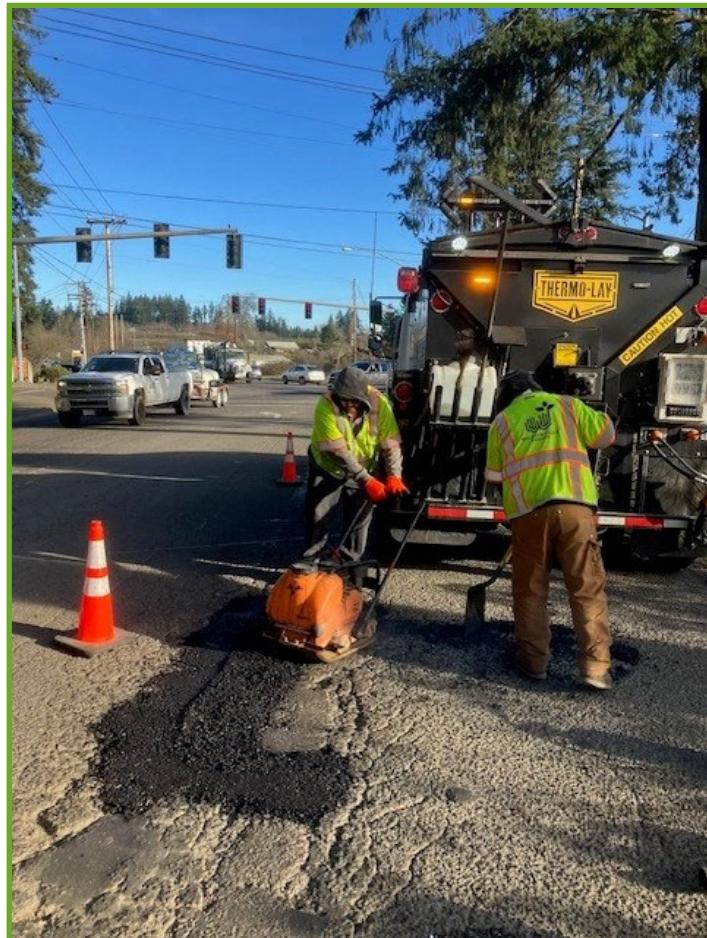
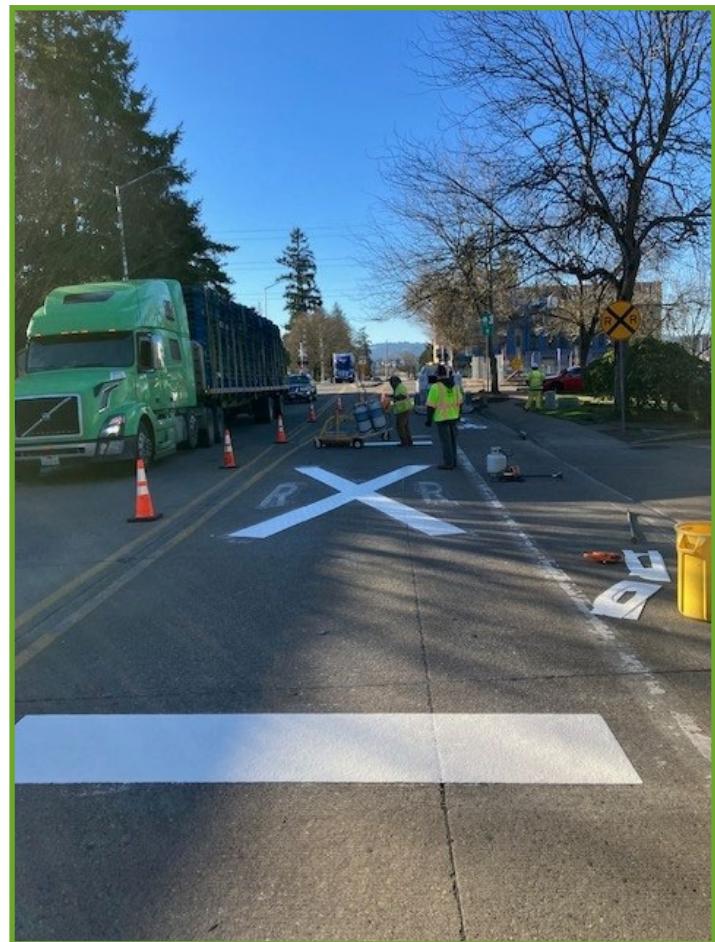
As a result of the extremely wet December weather, several potholes appeared around the City. A dry January made it possible for the Roads team to address these potholes quickly. These repairs kept the crew busy for several days, and used over four tons of traffic-rated hot asphalt in the repair process. Dry weather also allowed for new railroad crossing symbols to be applied on SW Barber Street.

This work required advance planning with the railroad to ensure the safety of everyone traveling in the area when the marking were temporarily removed as part of the process of replacing them with new, durable, heat-applied decals.
