W5

96XX SW Boeckman Road, Wilsonville, OR 97070

Architectural Review Narrative:

Section 6: Reports & Documents (Cover Sheet & Index)

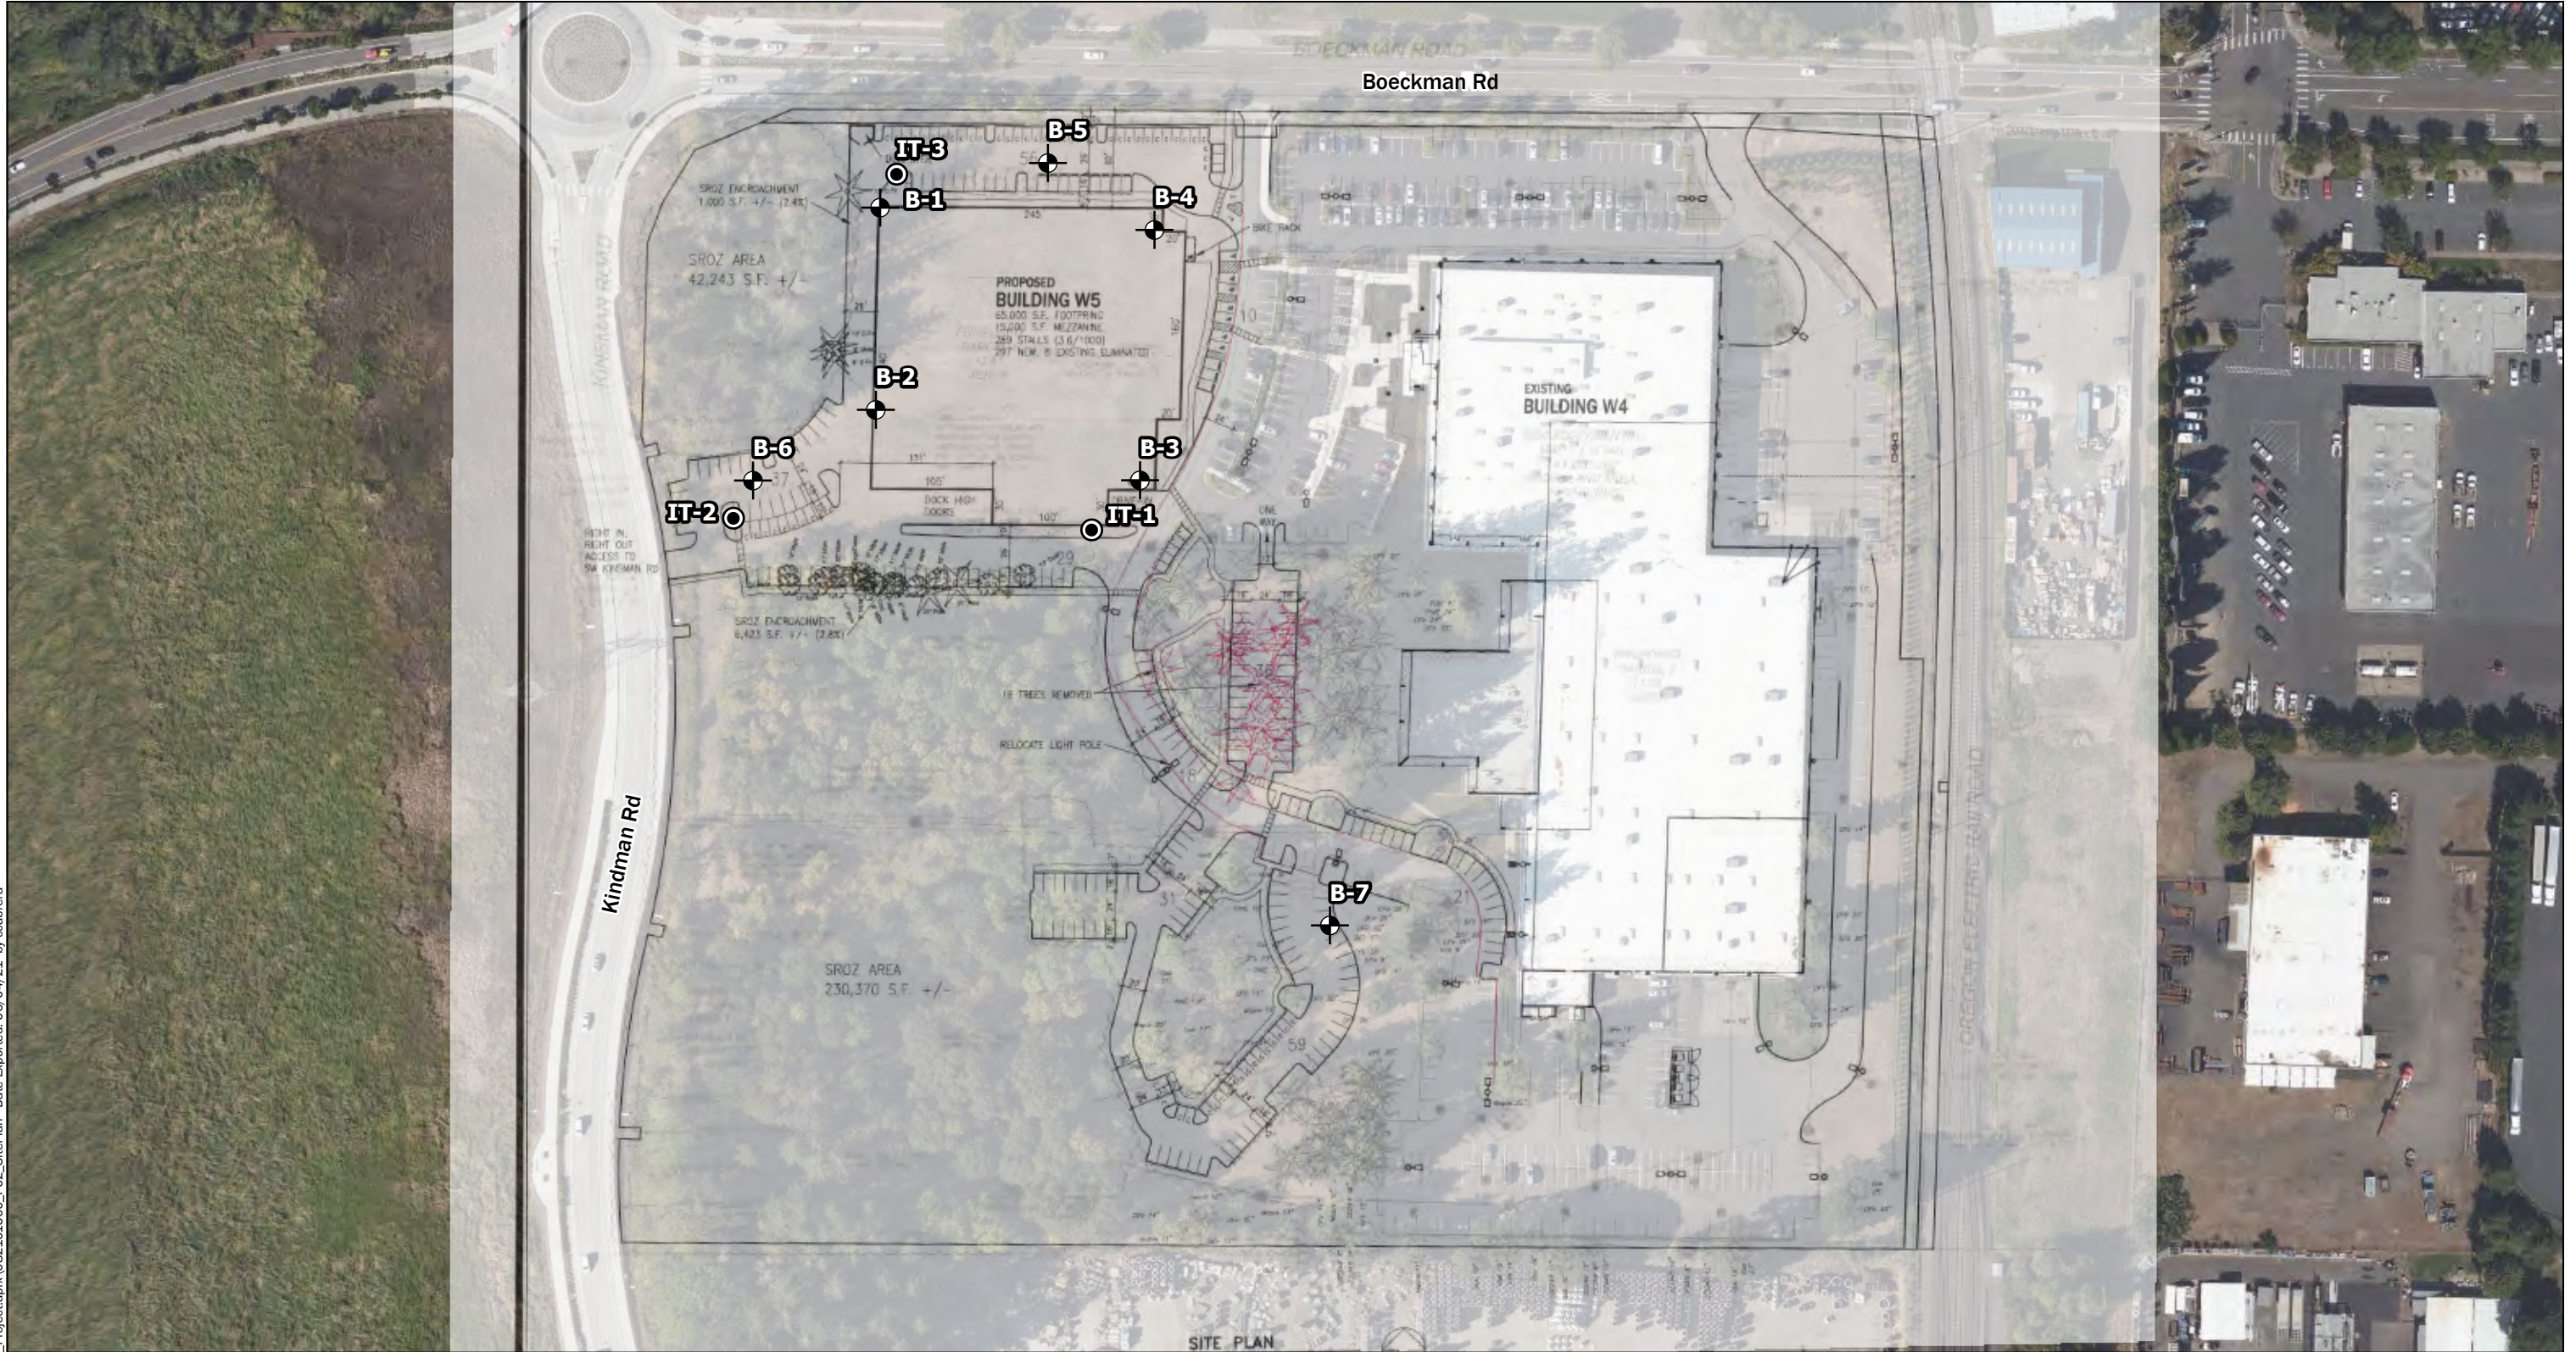
Site Plan	
Martin Development – Building W5 Wilsonville, Oregon	
 	Figure 2

Infiltration Test Number and Approximate Location

We explored subsurface soil and groundwater conditions at the site on May 26 and 27, 2021 by drilling four borings (B-1 through B-4) within the proposed building footprint to depths of 29 to 41½ feet below ground surface (bgs), three borings (B-5 through B-7) within proposed parking areas to a depth of 6½ feet bgs, and three borings (IT-1 through IT-3) for infiltration testing to a depth of 5 feet bgs at the approximate locations shown in the Site Plan, Figure 2.

We conducted a total of three infiltration tests at the three requested exploration locations (IT-1, IT-2 and IT-3), at a depth of approximately 5 feet bgs as shown in Figure 2. Testing was conducted using the encased falling head method in general accordance with the procedures outlined in Appendix B of Section 3 Public Works Standards, in the City of Wilsonville 2015 Stormwater & Surface Water Design & Construction Standards (SSWDCS). Test procedure is based on a modified procedure of the U.S. Environmental Protection Agency (EPA) Falling Head Percolation Test (Onsite Wastewater Treatment and Disposal Systems Design Manual, EPA/625/1-80-012, 1980). Our general procedure included drilling to the specified depth with a 6-inch hollow-stem auger, placing a 2-inch-thick layer of washed bagged gravel in the bottom of the hollow-stem auger prior to adding water to reduce disturbance from flowing water at the base of the auger.

Infiltration Test No.	Location	Depth (feet)	USCS Material Type	Field Measured Infiltration Rate ¹ (inches/hour)
IT-1	NW corner of Building (See Site Plan)	5	CL	0.05-0.1
IT-2	Parking Area SW of Building (See Site Plan)	5	CL	0.1
IT-3	SE corner of Building (See Site Plan)	5	CL	0.1

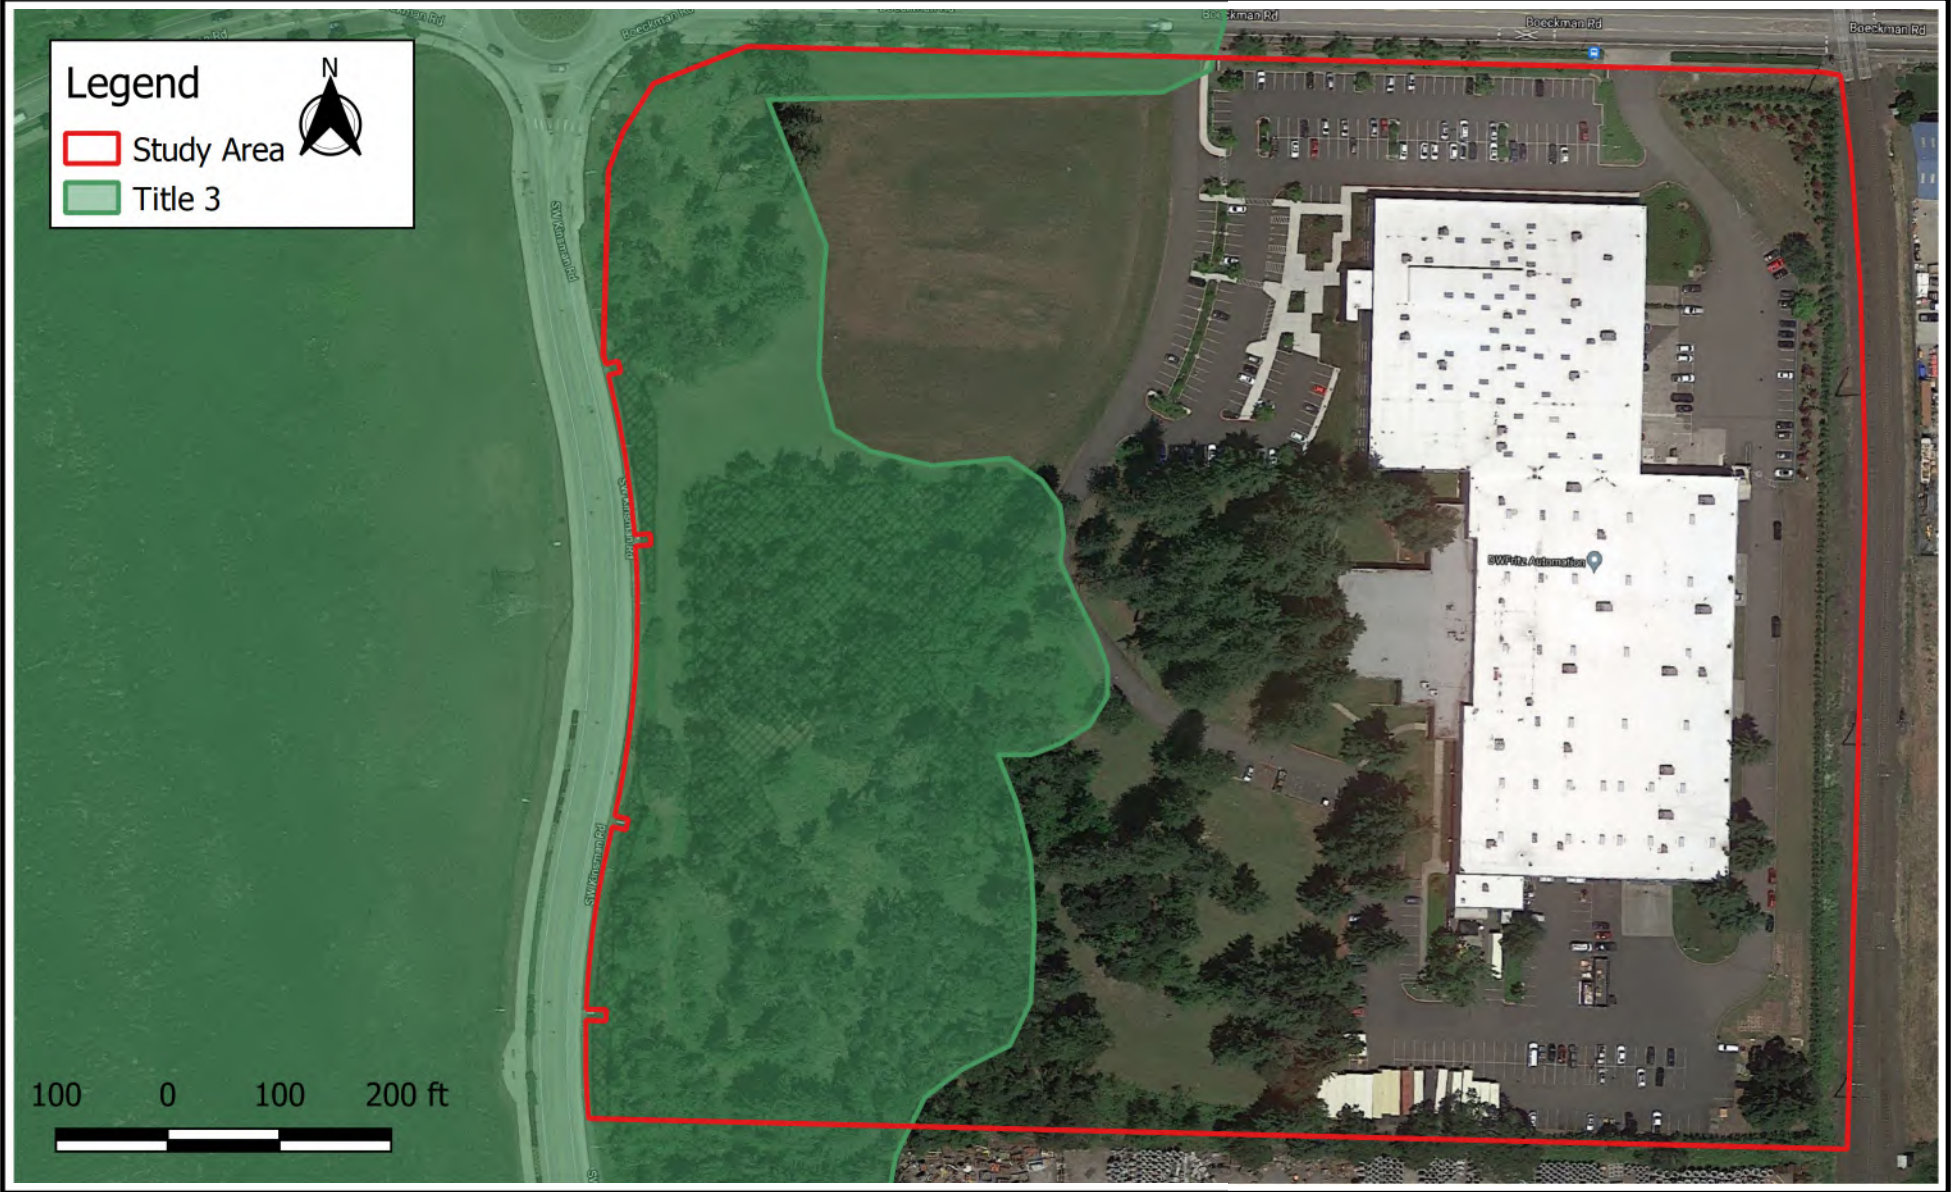
FIGURE
6

As described previously, for impacts of 340 square feet / 0.01 acres to the ALCU and the removal of 58 native trees, the applicant proposes to restore 33,000 square feet (0.75 acres) of degraded habitat within the remaining ALCU (Figure 6). The applicant will remove invasive and non-native species including Himalayan and cut-leaf blackberry, English ivy and holly, and plant 328 native trees and 840 native shrubs, which per the SROZ ordinance will more than offset the loss of riparian function associated with the proposed impacts to the existing habitat. A mitigation plan showing the location of the proposed mitigation and a proposed plant list is included in Figure 6.

6). The applicant will remove invasive and non-native species including Himalayan and cut-leaf blackberry, English ivy and holly, and plant 328 native trees and 840 native shrubs, which per the SROZ ordinance will more than offset the loss of riparian function associated with the proposed impacts to the existing habitat. A mitigation plan showing the location of the proposed mitigation and a proposed plant list is included in Figure 6.

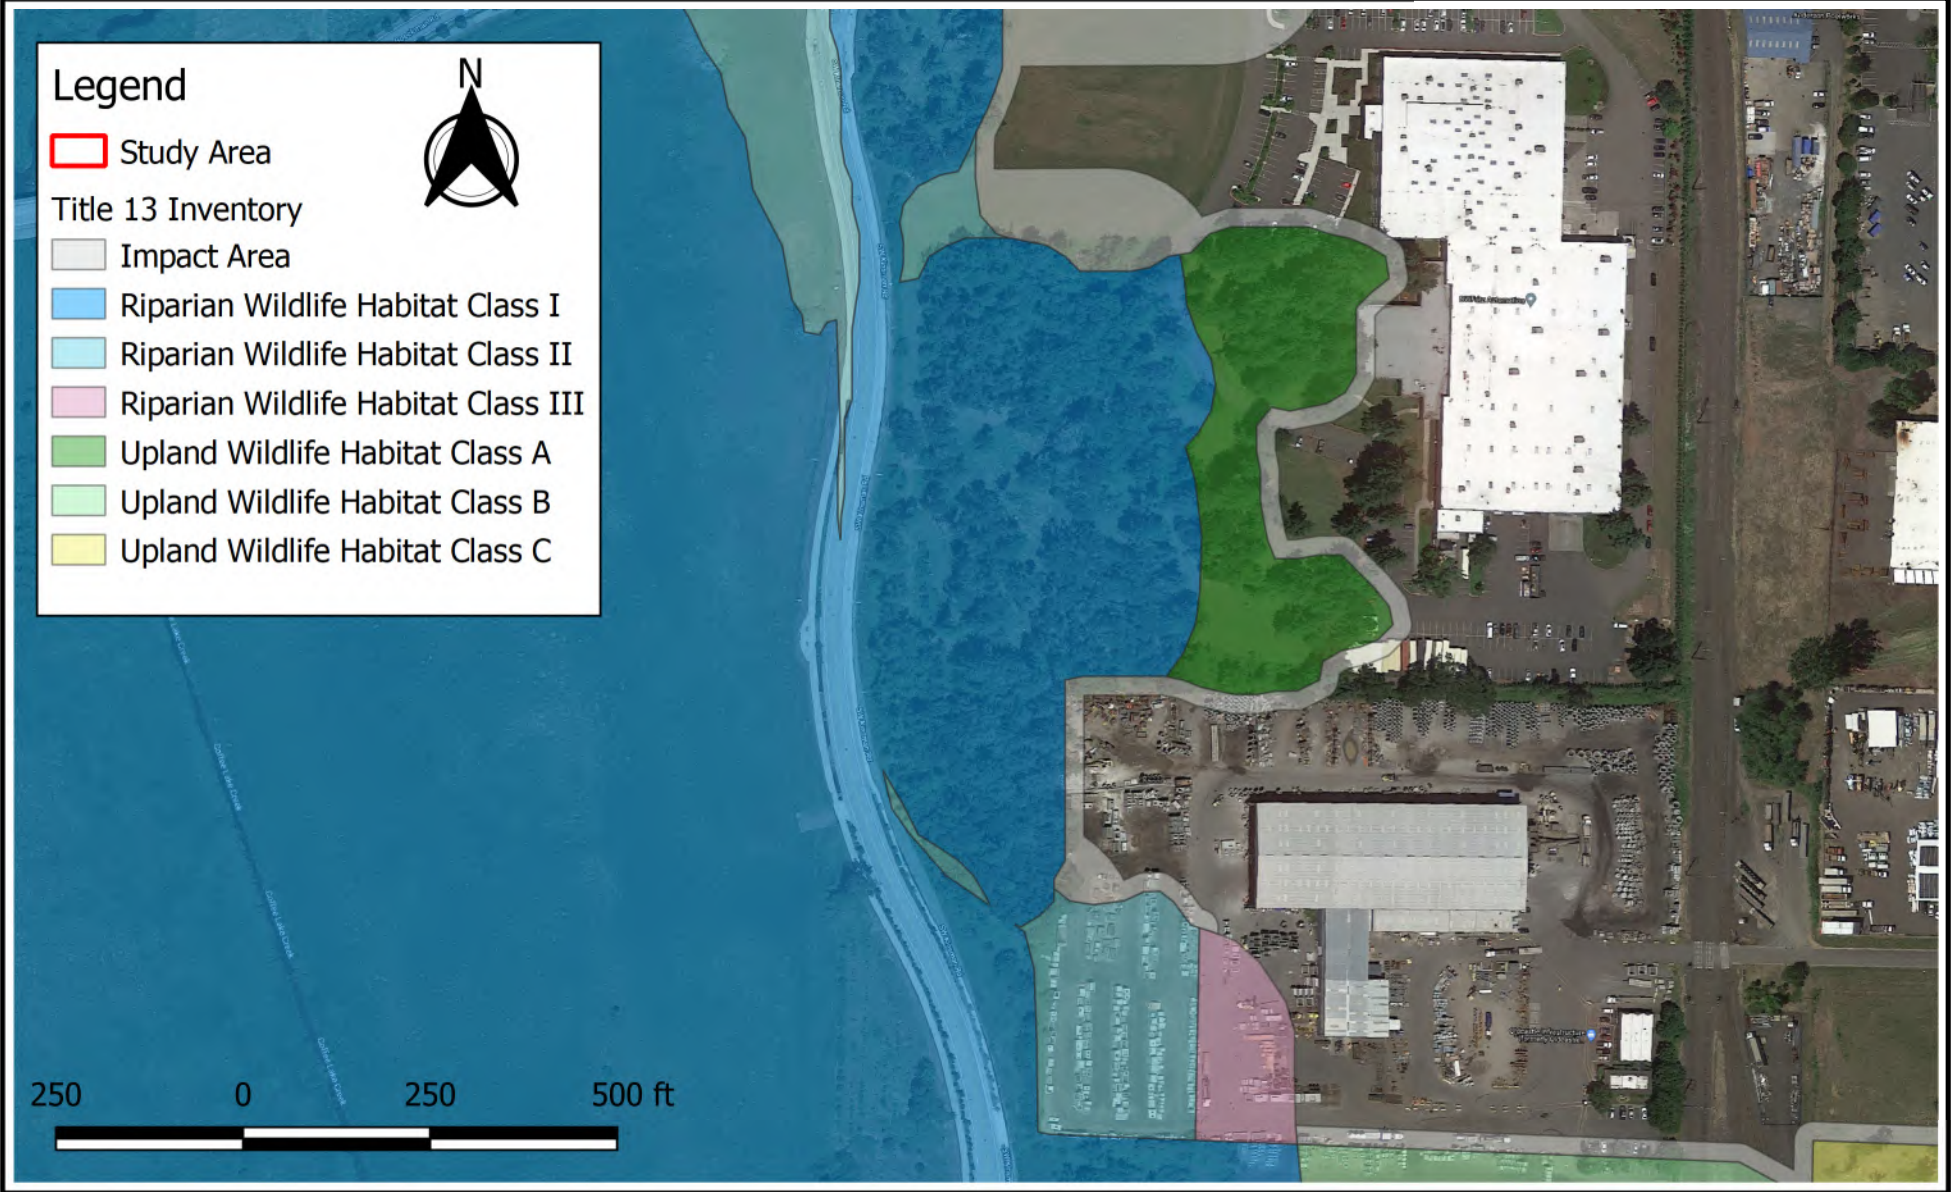
FIGURE
 9

Figure 4 shows the delineated boundaries and coverage of wetland resources within the project area as well as the SROZ boundary, slope measurements calculations adjacent to Wetland A, and the SR Impact Area. Figure 9 shows Metro's map of Regionally Significant Habitat (under Title 13), the site includes the following habitat classifications:

Title 13 Land in the Portland Metro Region
 9900 SW Boeckman Road Property - Wilsonville, Oregon
www.oregonmetro.gov/rliis, 2012

conifer and broad-leaf forests within the riparian communities mapped in Figure 9 as well as two managed grass/lawn areas east of the Riparian Corridors / Wildlife Habitat Class I area. The larger of these is in the northern part of the site and the other is near the site's southern boundary. The eastern portion of the site is developed.

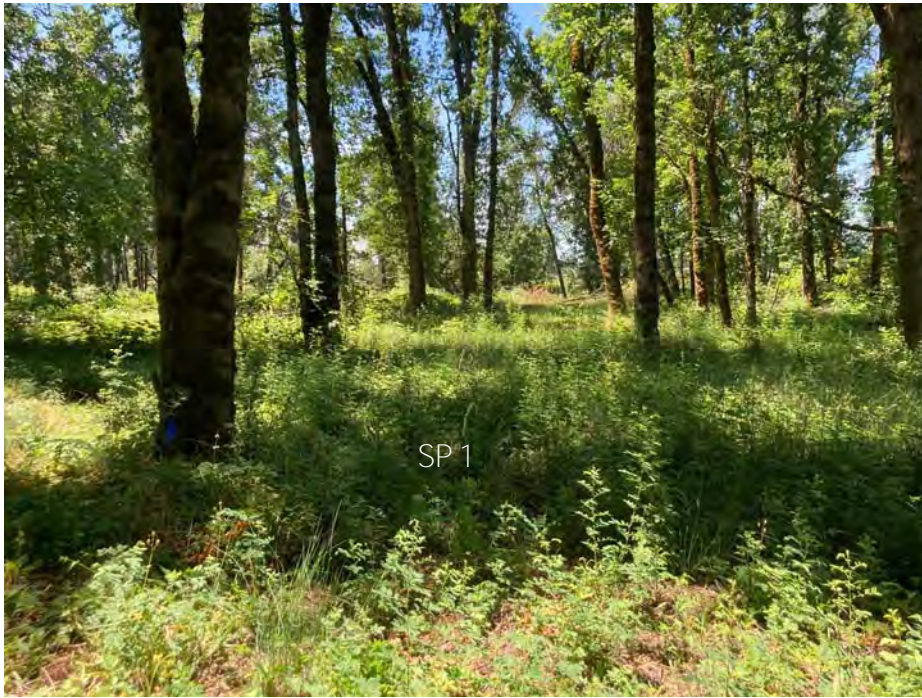
Photo A:

Looking southwest at upland Sample Point 1, east of Wetland A.

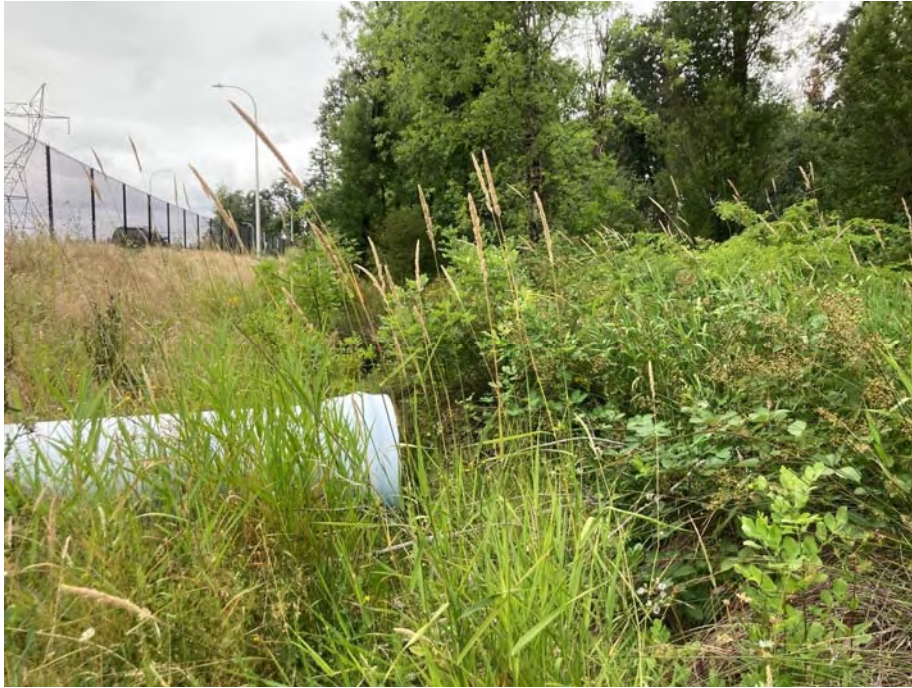
Photo C:

Looking north at Wetland B, which is confined to a ditch at the west end of the site.

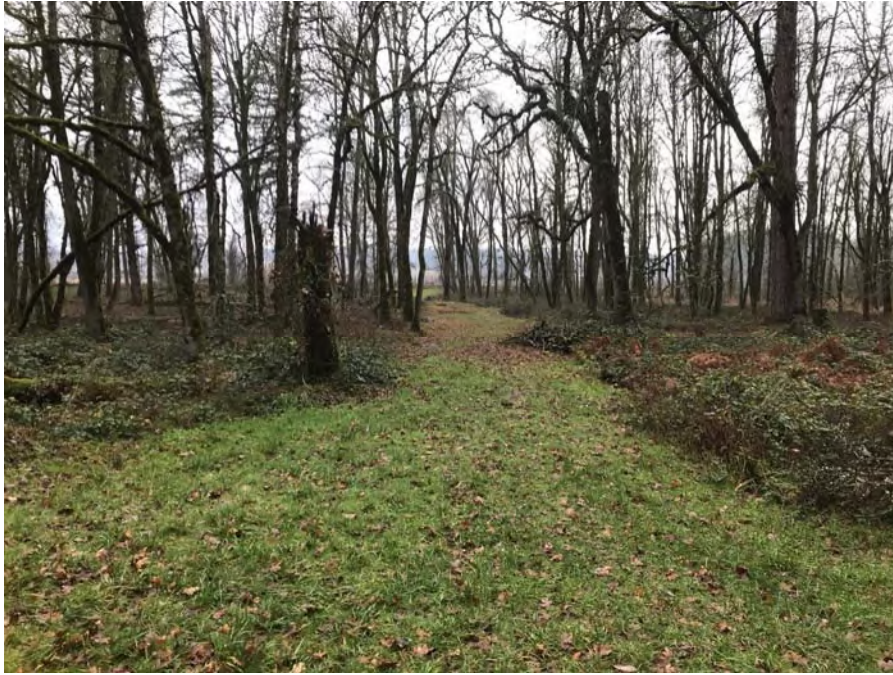
Photo E:

Looking west at an access road through Wetland A.

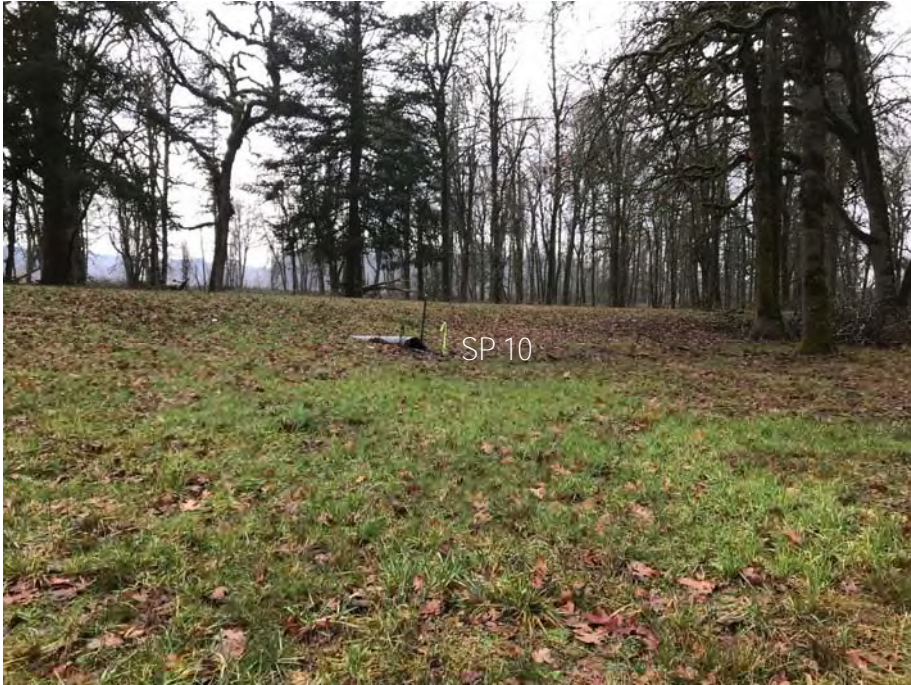
Photo G:

Looking northwest at Sample Point 10, located adjacent to a pipe that carries runoff below a constructed berm to the basin in the western portion of the study area.

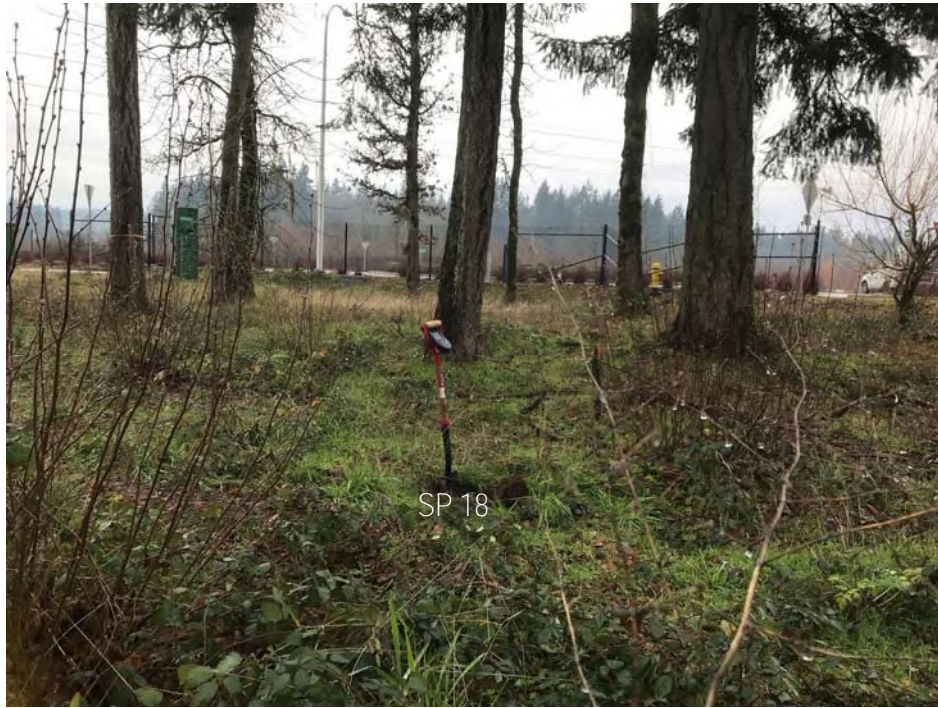
Photo I:
Looking west at Sample Point 18.
Photo taken on January 11, 2022

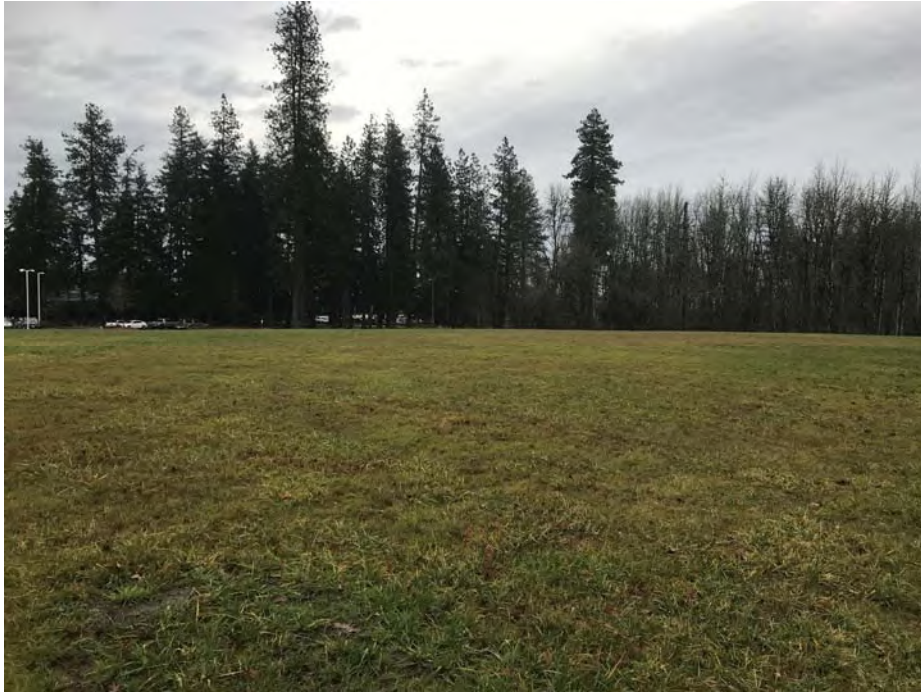
Photo K:

Looking southeast at the lawn area in the northwestern portion of the study area. This area is raised above the natural grade and likely consists of imported soil.

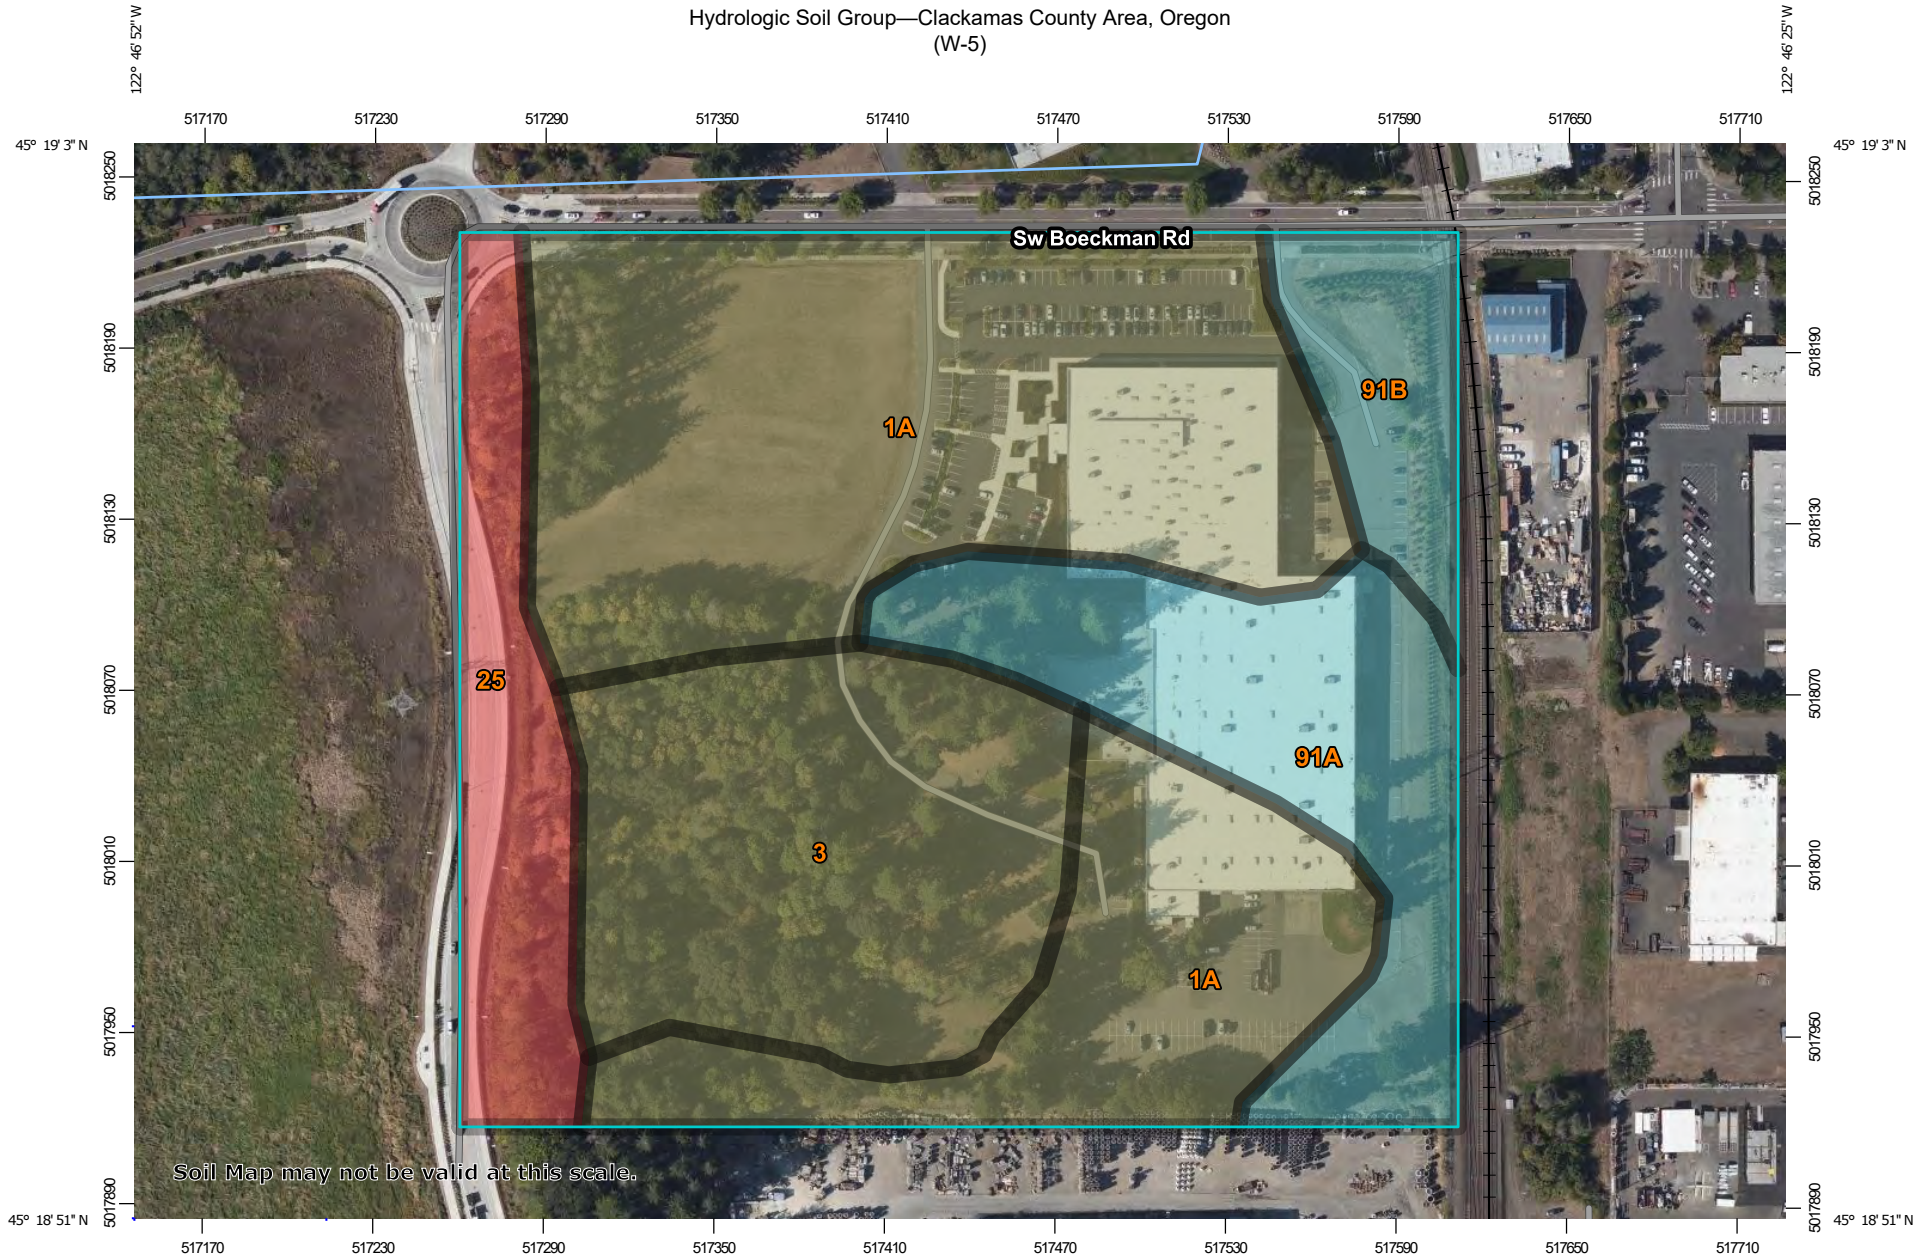
Hydrologic Soil Group—Clackamas County Area, Oregon
(W-5)

Soil Map may not be valid at this scale.

Map Scale: 1:2,660 if printed on A landscape (11" x 8.5") sheet.

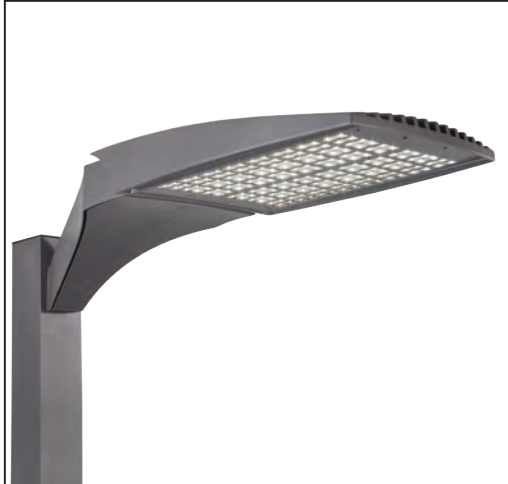
VLX LED Specifications

- The VLX series provides excellent thermal management by mounting the LEDs to the substantial heat sink of the housing. This enables the Luminaire to withstand higher ambient temperatures and driver currents without degrading LED life.
- The L70 test determines the point in an LEDs life when it reaches 70 percent of its initial output. The VLX series LEDs have been determined to last 90,000+ hours in 25° C environments when driven at 350 mA.

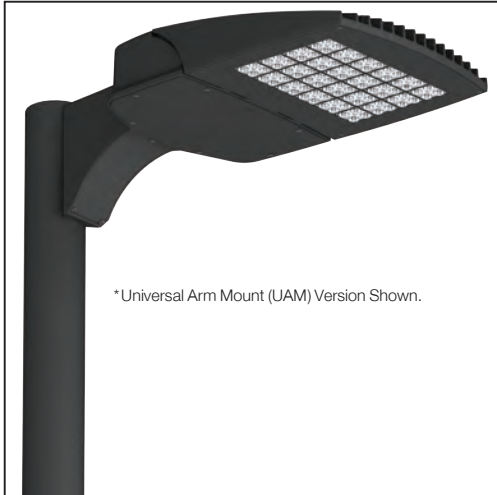
VMX-II LED Specifications

Durable two-piece die cast aluminum driver compartment utilizes stainless steel hardware and sealed with a one-piece silicone gasket.

- The VMX-II series provides excellent thermal management by mounting the LEDs to the substantial heat sink of the housing. This enables the Luminaire to withstand higher ambient temperatures and driver currents without degrading LED life.
- The L70 test determines the point in an LEDs life when it reaches 70 percent of its initial output. The VMX-II series LEDs have been determined to last 100,000+ hours in 25° C environments when driven at 350 mA.

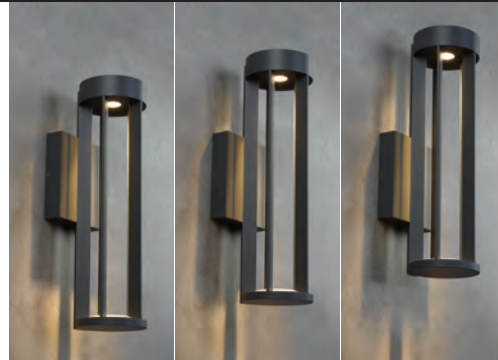
TURBO WALL SCENCE

Integrated height adjustment system allows you to customize your fixture position. Low, Mid or High.

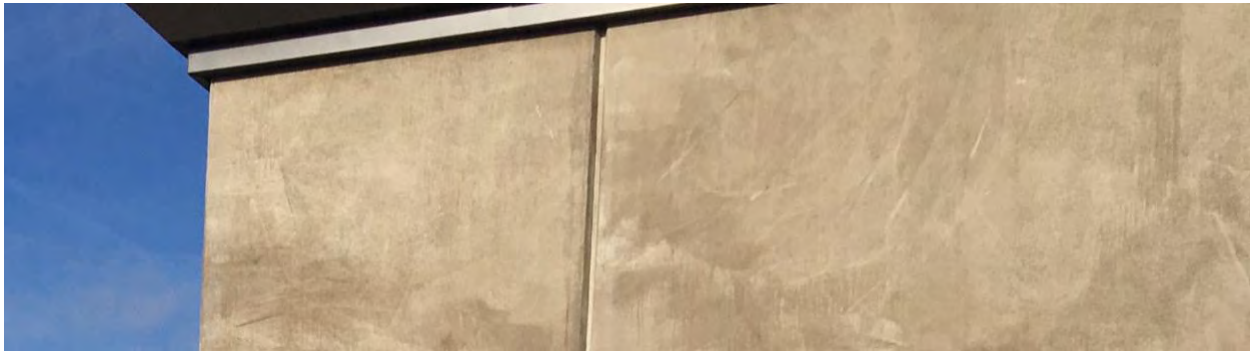
Precast Concrete Walls & Sills: The dominant exterior surface is walls, which receive two layers of clear sealer with semi-transparent stain. These images show the range of the warm vs. cool neutral colors from past projects in the area by ownership. W5 will be a neutral color between these two examples. Final selection is by owner from field samples. (Top is Lam Research in Tualatin. Bottom is W1 in Wilsonville. Appearance varies pending underlying concrete color variations, time of day, sunny or cloudy, etc. Color lightens over decades from sun exposure, and we think the patina softens and improves with age.)

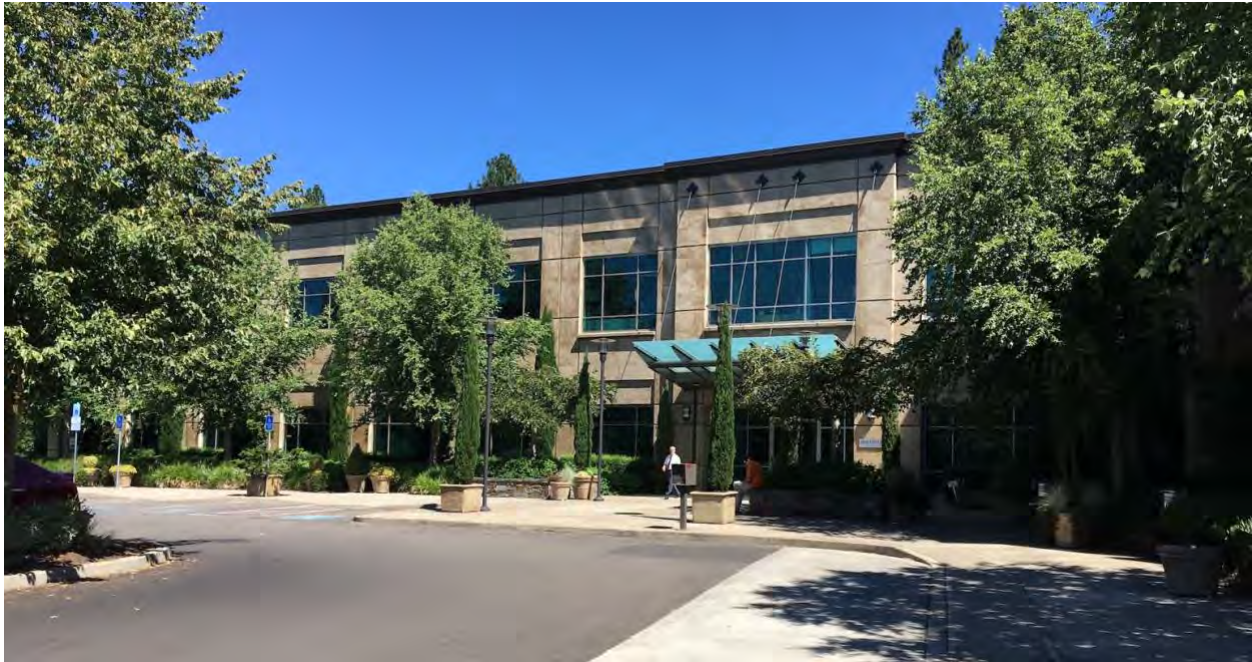
W1 in Wilsonville from 2009 at the front entry showing the simple palette of stained precast concrete walls, deep facade rustication with deeply set windows and extensive ornamental landscaping in addition to the preserved natural areas. This stain is in the warm range. Originally occupied by DWFRITZ Precision Automation until their expansion. Shell architecture by Lance Mueller & Associates (LMA).

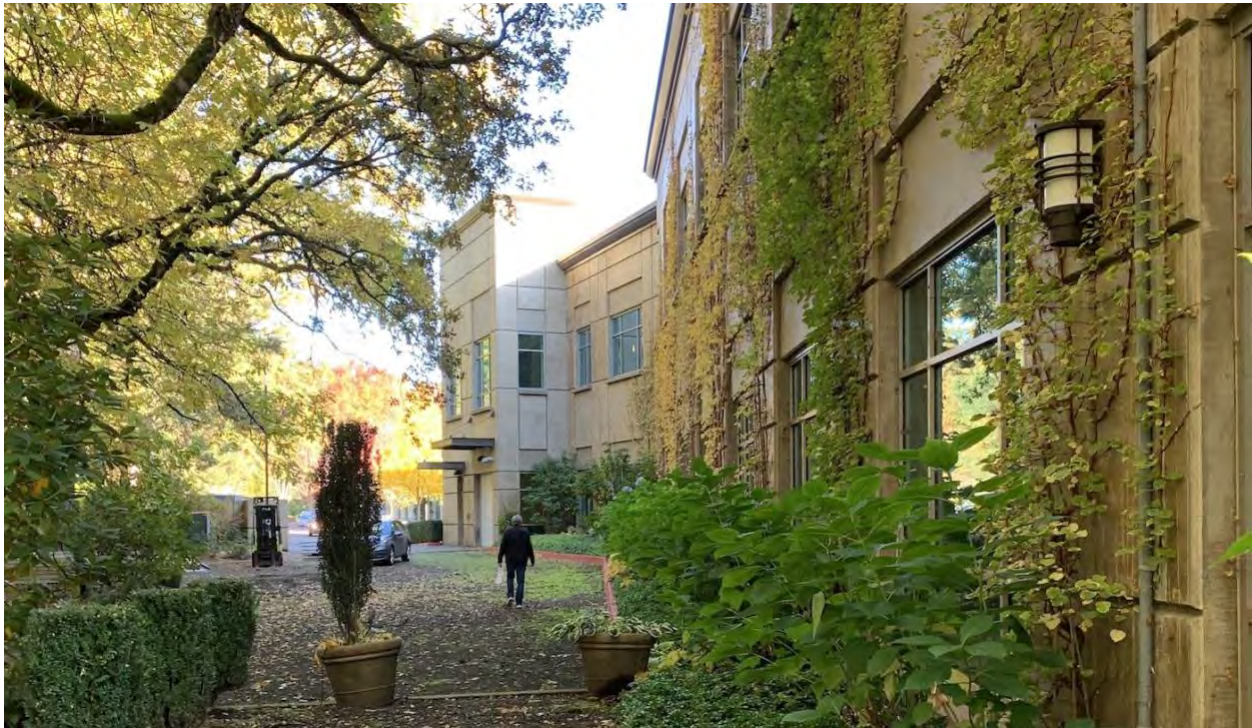
W1 in Wilsonville shown where it abuts an on-site SROZ natural area. This back-of-building view proves the high-quality materials and architecture extend all around the building. Vines on stained precast concrete walls are part of the architecture that include facade rustication and deeply set windows for visual interest. The big trees on left are part of the SROZ. Scale of this facade is similar to W5. Shell architecture by Lance Mueller & Associates. Address: 27200 SW Parkway Ave, Wilsonville, OR 97070

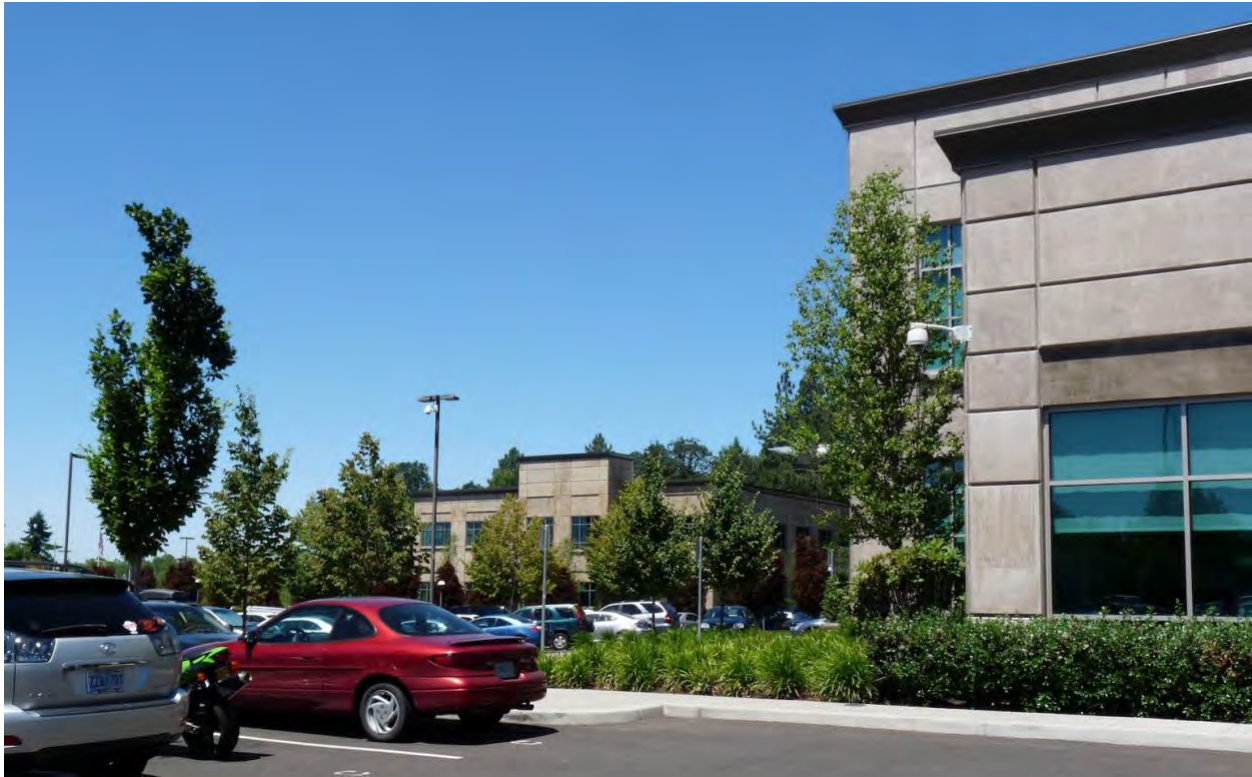
W2 in Wilsonville from 2006 in foreground with W1 beyond on left. W2 wall stain is slightly cooler than W1. Extensive large ornamental landscaping adds to the significant preserved SROZ natural areas, same as proposed in W5. Shell architecture by LMA. Address: 27300 SW Parkway Ave, Wilsonville, OR 97070

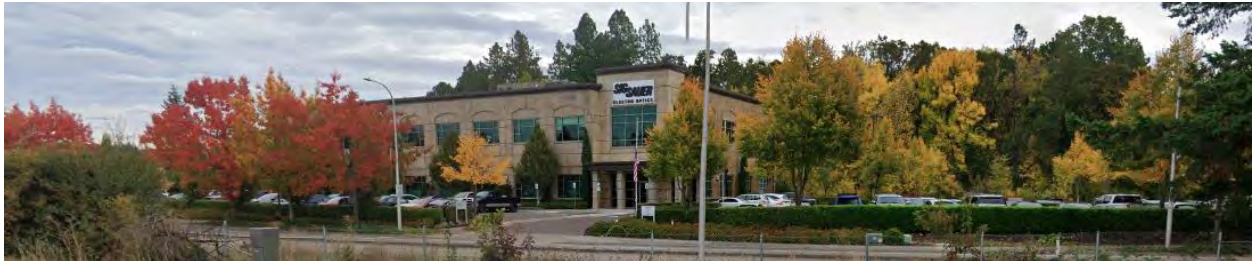
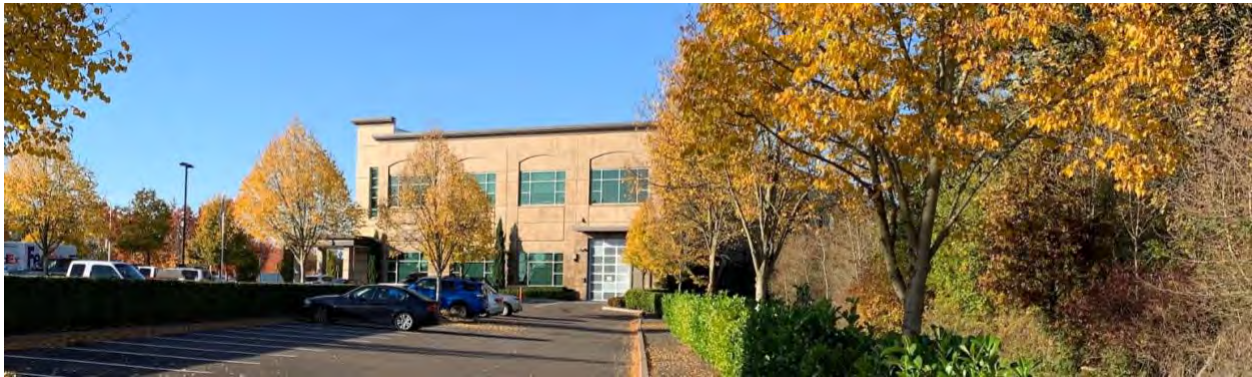
Two views of W3 in Wilsonville from 2012, the last part of the complex that includes W1 and W2 and borders the SROZ. Originally expansion space for DWFRITZ, it is now occupied by Sig Sauer, Electro-Optics. This wall stain is another warm example, and the warm afternoon sunlight is an influence. Shell architect is LMA. Address: 27100 SW Parkway Ave, Wilsonville, OR 97070

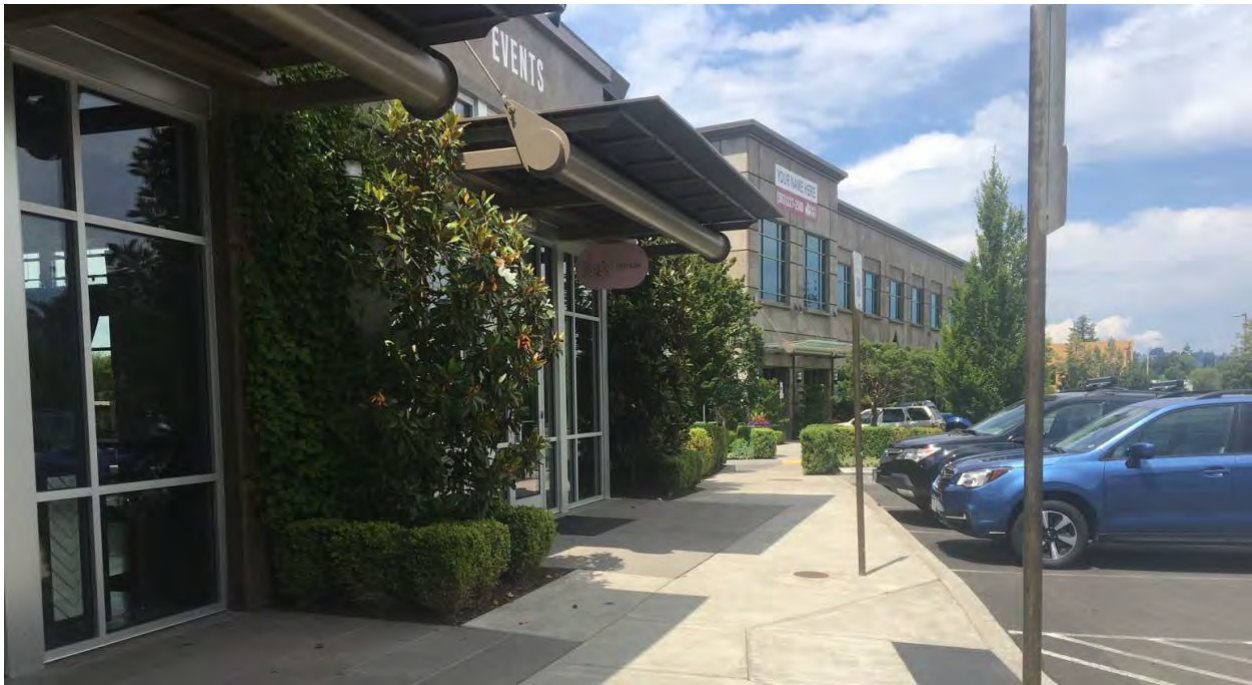
Another development by the owners in nearby Tualatin from 2014 that has a similar limited material palette as proposed in W5. In the foreground is Industry Restaurant and the background a 2-story hi-tech industrial building. Both show a strong architectural presence with facades in stained precast concrete, like W5. The restaurant includes vines on the facade and the project preserves protected natural areas (Hedges Creek), also same as W5. This stain is a slightly darker value and grayer hue. Shell architect is LMA. Address: 20185 SW 112th Ave, Tualatin, OR 97062
