W5

96XX SW Boeckman Road, Wilsonville, OR 97070

Architectural Review Narrative:

Section 6: Reports & Documents (Cover Sheet & Index)

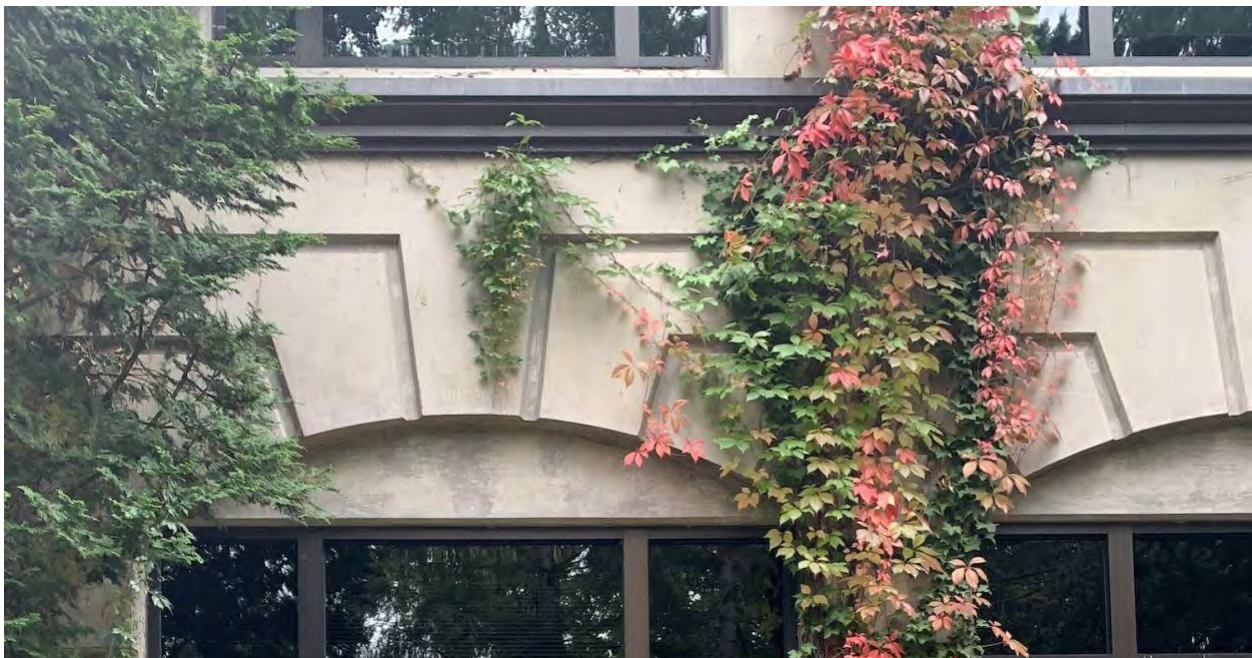
An office development with stained walls by the owners in Bellevue, WA from 1998 (permitted as I-90 1997). I include this close-up view from 2021 to show the nicely patinaed stained pre-cast concrete after weathering for 34 years. The vines have been cut back a few times to control them and the stain holds up very well. This was the first successful stained project by the owners after previous attempts ended being painted. I check every few years to verify if the sealer is still functioning, and irrigation spray still beads up on the walls! Shell architect is LMA. Address: 15405 SE 37th Street, Bellevue, WA 98006
