2025 Sidewalk Program Summary

Objectives & Results

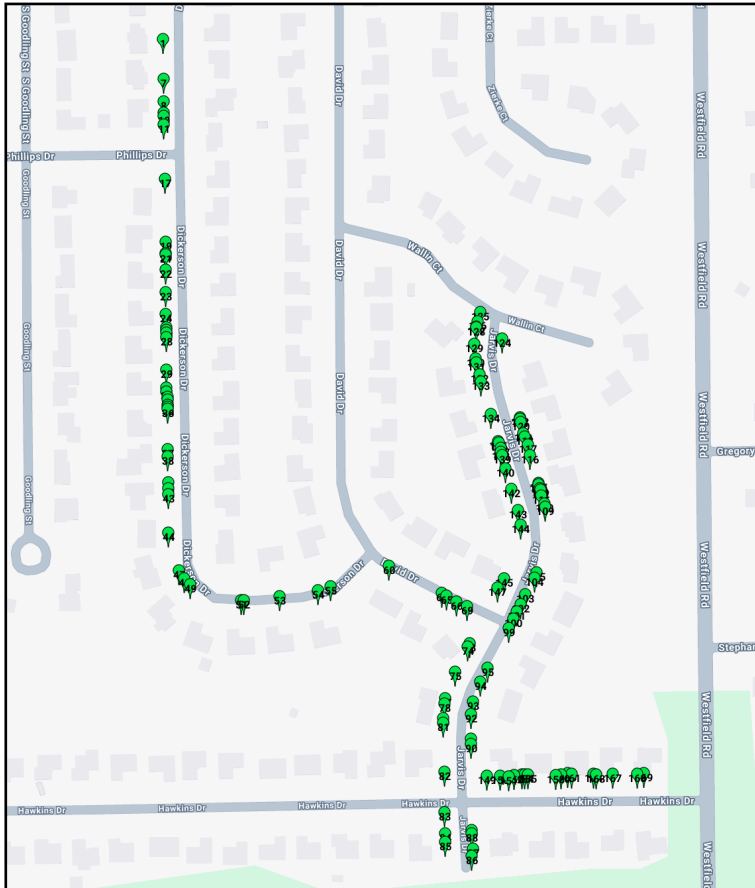
Saw-Cutting Repair Locations

33% OF ALL SAW-CUTS WERE CROSS-CUTS, LEVELING BOTH PANELS AT THE JOINT

Due to the limitations of GPS mobile app technology, the locations shown above should be relied upon as approximate to their actual locations. Map Data: Google

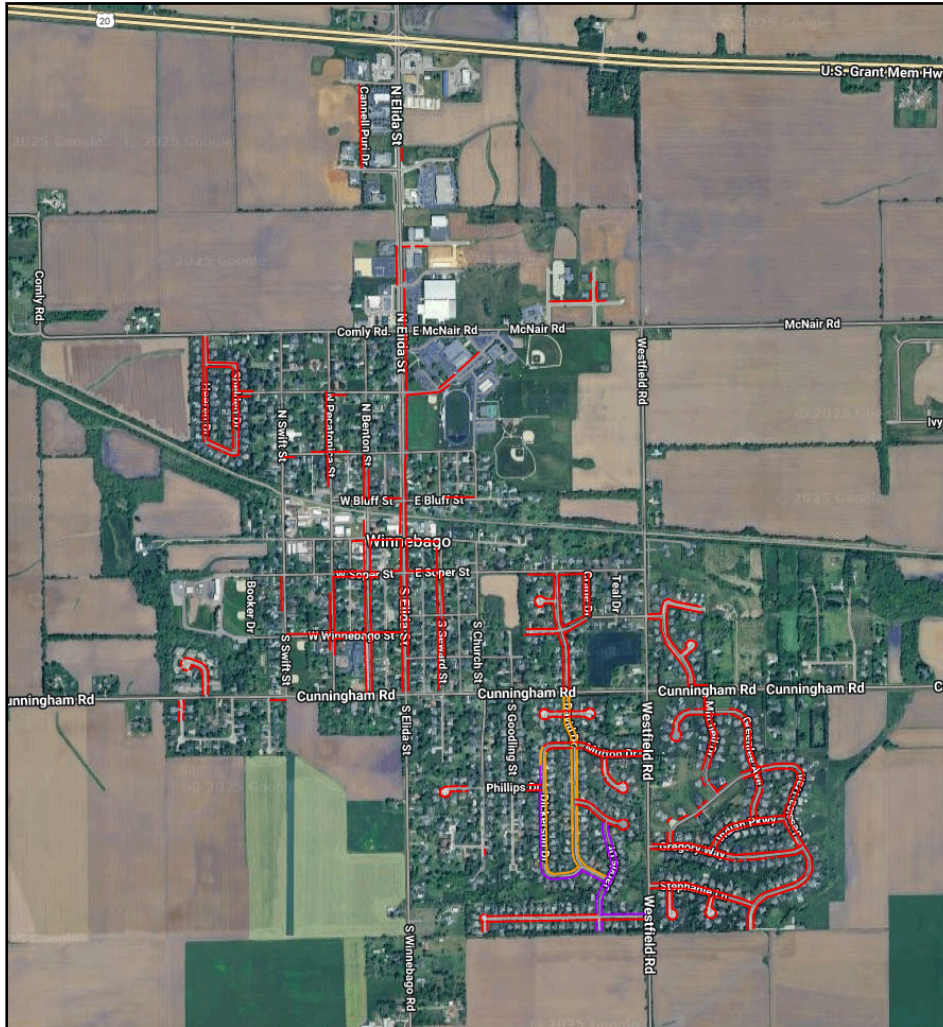
Sidewalk Repair Program Progress

█	2025	0.74 Miles
█	2024	1.04 Miles
█	Remaining	12.29 Miles
Total Miles		14.07

The map above shows the sidewalk areas that have been completed from 2024 onward.

Red highlighting indicates areas not yet evaluated or repaired. Various colored highlighting indicates the sidewalks that have been evaluated and repaired.

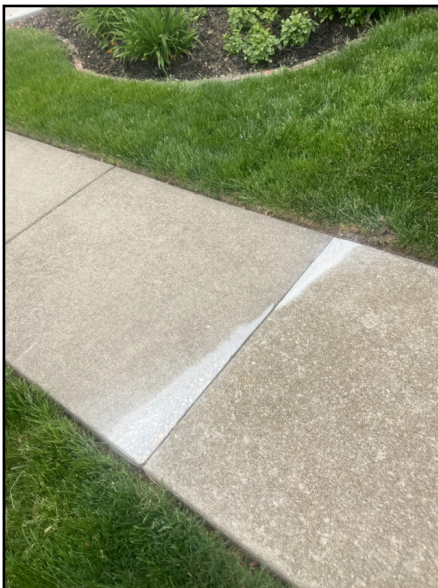
Sample Repair Photo: Defect 7 repaired on 05/19/25 at 507 Dickerson Dr. at 11:16 AM

Completed repair photos and timestamps help ensure repair quality
