# DRAINAGE STUDY REPORT

VILLAGE OF STILLMAN VALLEY

STUDY OF DRAINAGE CHANNEL  
LOCATED BETWEEN WALNUT STREET  
AND PINE STREET

**WILLETT HOFMANN**  
& ASSOCIATES INC

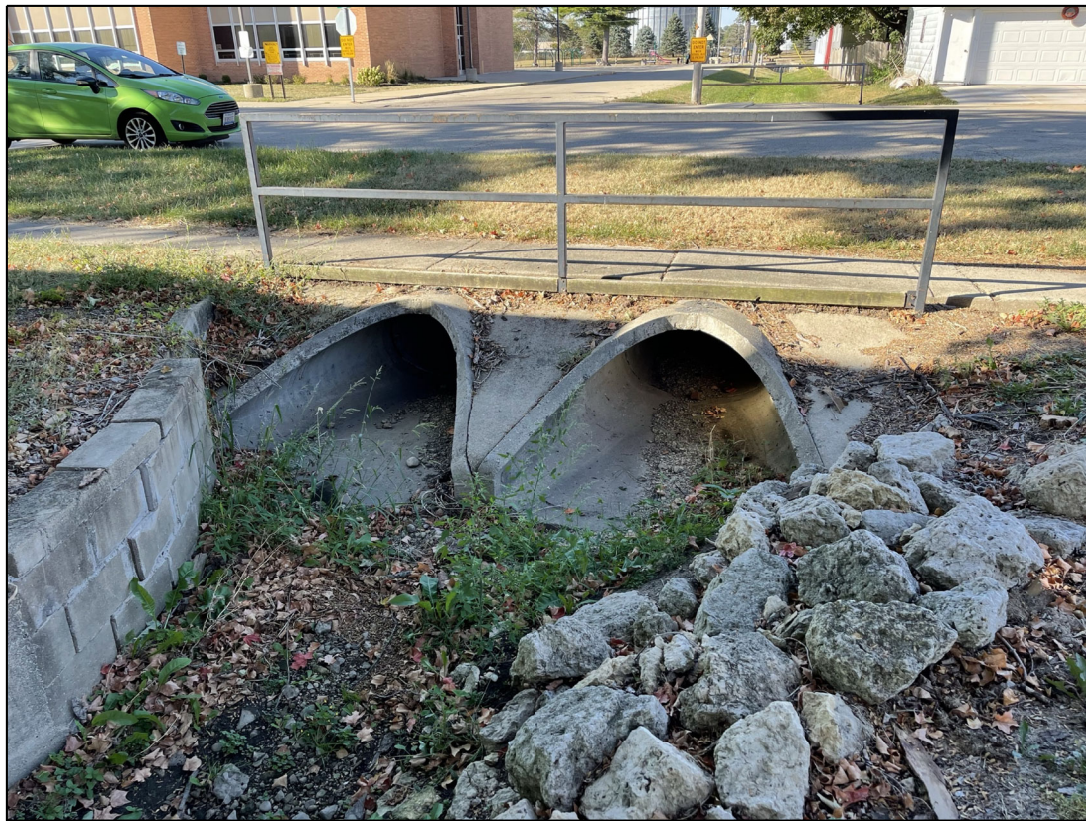
RIGHT PHOTO:

SEGMENT 1  
MAIN STREET CULVERT

The channel in Segment 1 is rectangular in shape with a dirt and stone bottom and vertical walls consisting of concrete blocks on the east side and a homemade gabion basket-type system comprising the west wall. The channel bottom, while only constructed in dirt and rock, appears to be stable and does not show significant signs of erosion. The homemade gabion basket-type system comprising the west wall also appears to be stable showing only a few places of erosion along the base. The concrete block wall on the west side of the channel is leaning significantly, and pieces of the top of the wall have started to fall off into the channel. While not imminent, the failure of the west wall is only a matter of time. The capacity of this section of the drainage channel will be discussed later in this report.

The results of this analysis indicate that the existing culvert sizes at each location are insufficient to convey the runoff generated by any of the modeled storm recurrence events without causing overtopping of the roadway to allow excess flow to continue to discharge downstream.

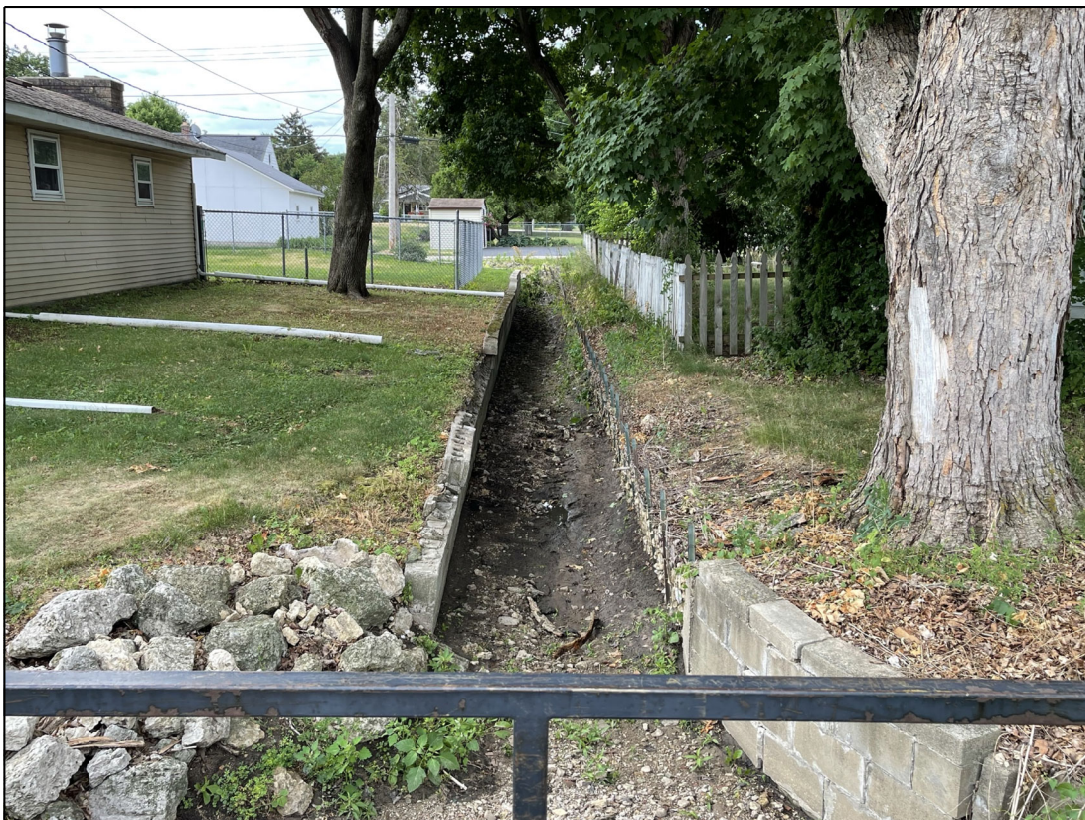
LEFT PHOTO:

SEGMENT 1  
LOOKING SOUTH FROM  
MAIN STREET CULVERT

To address this issue with Segment 1, Alternative No. 2 appears to be an ideal solution due to multiple factors. Alternative No. 2 is the most cost-effective solution based on the estimates of probable costs prepared. The use of gabion baskets are a cost-effective replacement for the masonry block wall that is failing while keeping the shape of the overall channel consistent with the existing. Finally, the new channel will be sized such that the existing private fences on either side of the existing channel can be returned to their current positions without reducing the current side yards of the existing adjacent properties. This fact could prove to be a significant selling point to the property owners when attempting to acquire property and or easement for the construction and maintenance of the channel going forward.

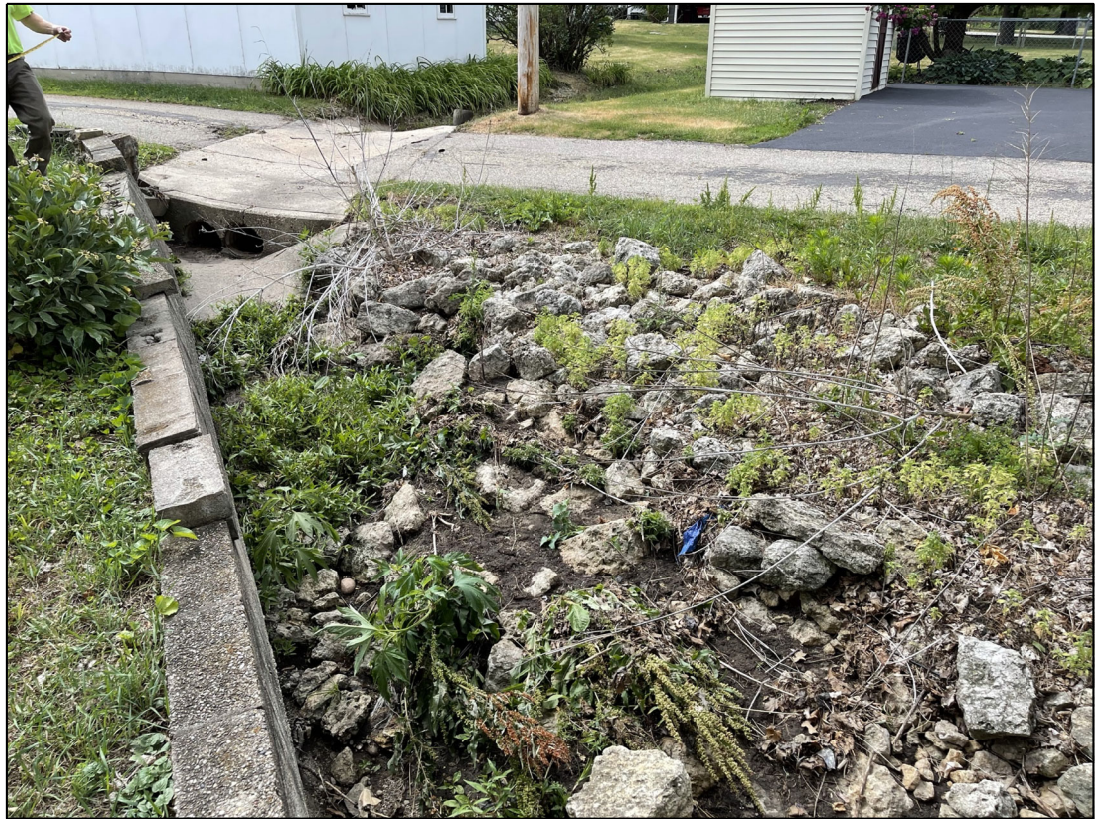
RIGHT PHOTO:  
SEGMENT 2  
ALLEY CULVERT

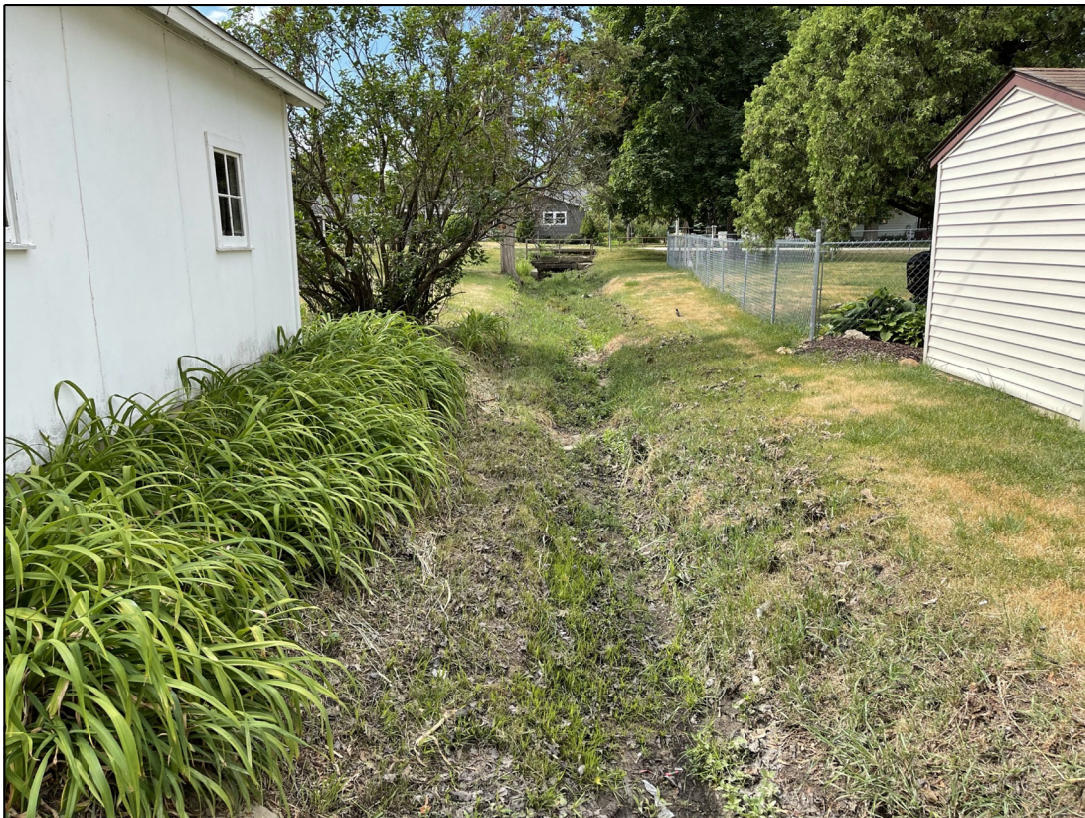
LEFT PHOTO:  
SEGMENT 2  
LOOKING SOUTH FROM  
ALLEY CULVERT

The channel in Segment 2 is a trapezoidal channel with established short to medium grasses lining the bottom and sides. The channel bottom and sides do not show any significant signs of erosion; however, it does appear that eroded material has been deposited and collecting in this channel for a significant amount of time. The capacity of this section of the drainage channel will be discussed later in this report.

Based on this philosophy, the widening of the channel cross-sectional area in conjunction with the establishment of a stabilized turf lining as described in Alternative No. 1 appears to be the ideal improvement methodology for Segments 2 and 3. Increasing the cross-sectional area while maintaining a turf channel lining will reduce the velocity in the channel which will reduce the erosion that is currently taking place. The widening of the channel also provides an increased volume of storage upstream of the restrictions in the flow at the crossroads culverts. This increased volume will serve as further peak flow attenuation and provide positive impacts downstream while reducing flooding elevations upstream. Finally, the flattened side slopes of the channel will allow the adjacent property owners easier access to the channel for mowing and overall channel maintenance.

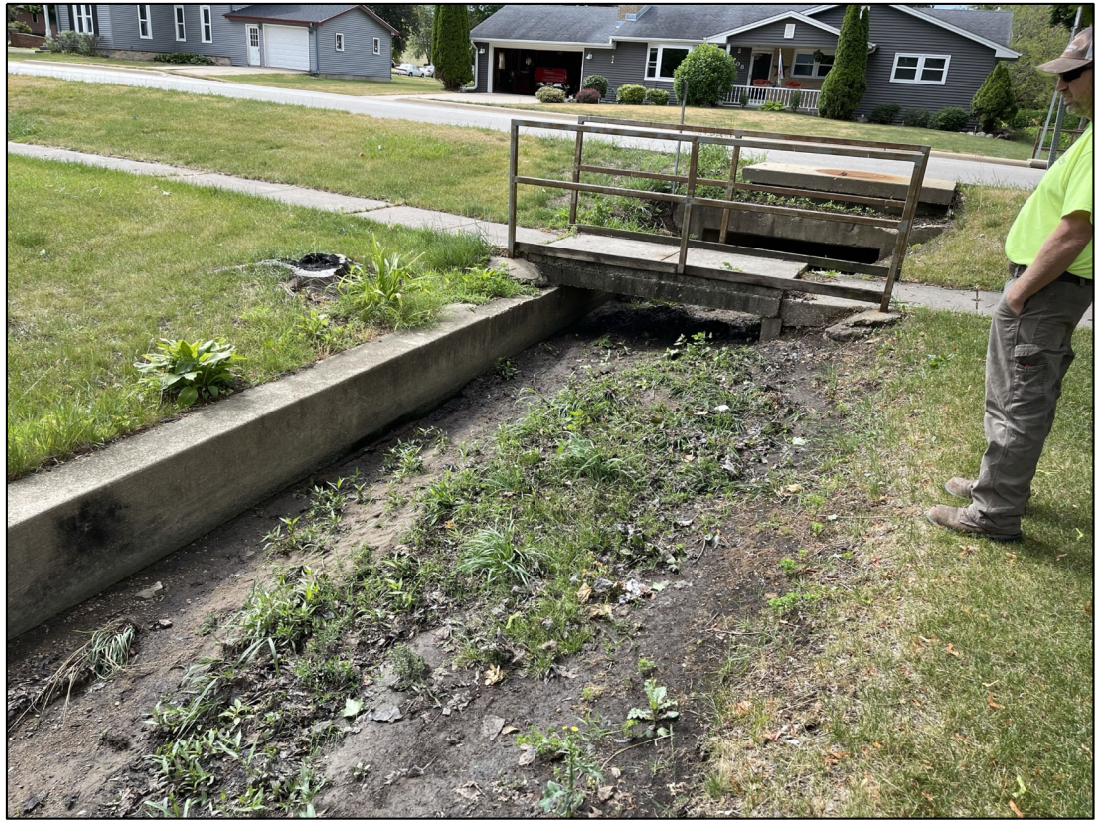
RIGHT PHOTO:

SEGMENT 2  
NORTH SIDE OF  
ROOSEVELT STREET (IL RTE 72)  
CULVERT

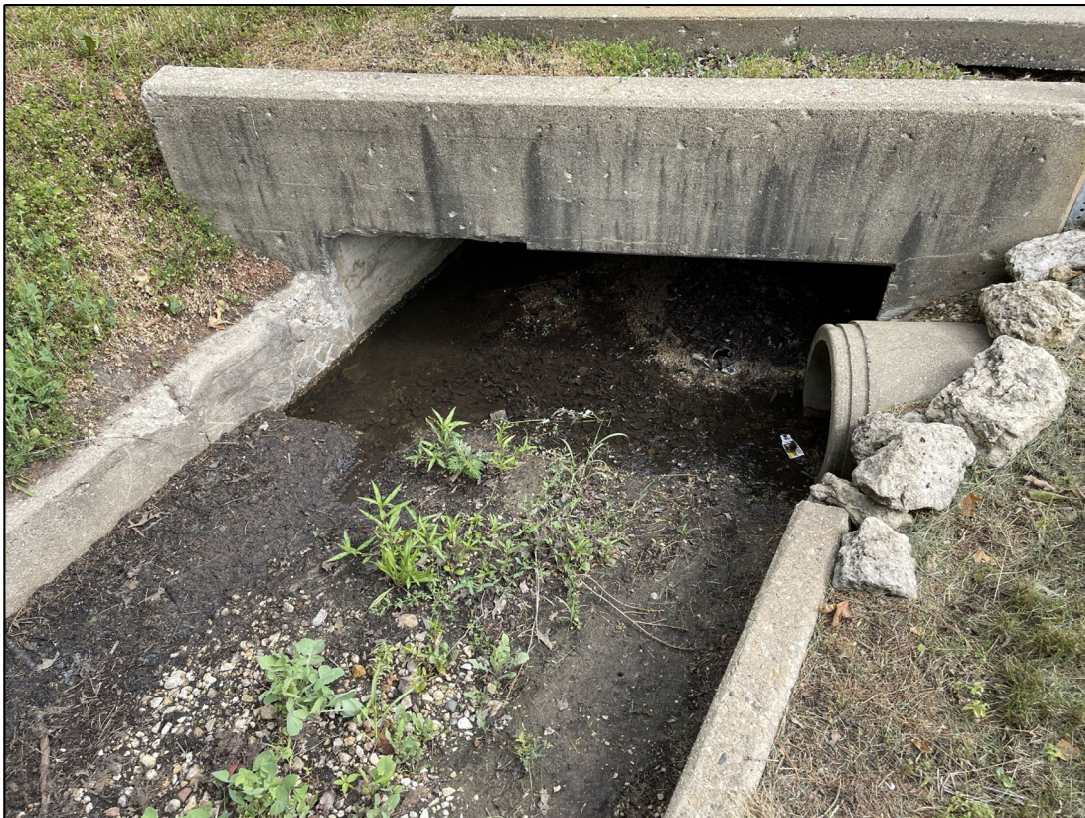
LEFT PHOTO:

SEGMENT 3  
SOUTH SIDE OF  
ROOSEVELT STREET (IL RTE 72)  
CULVERT

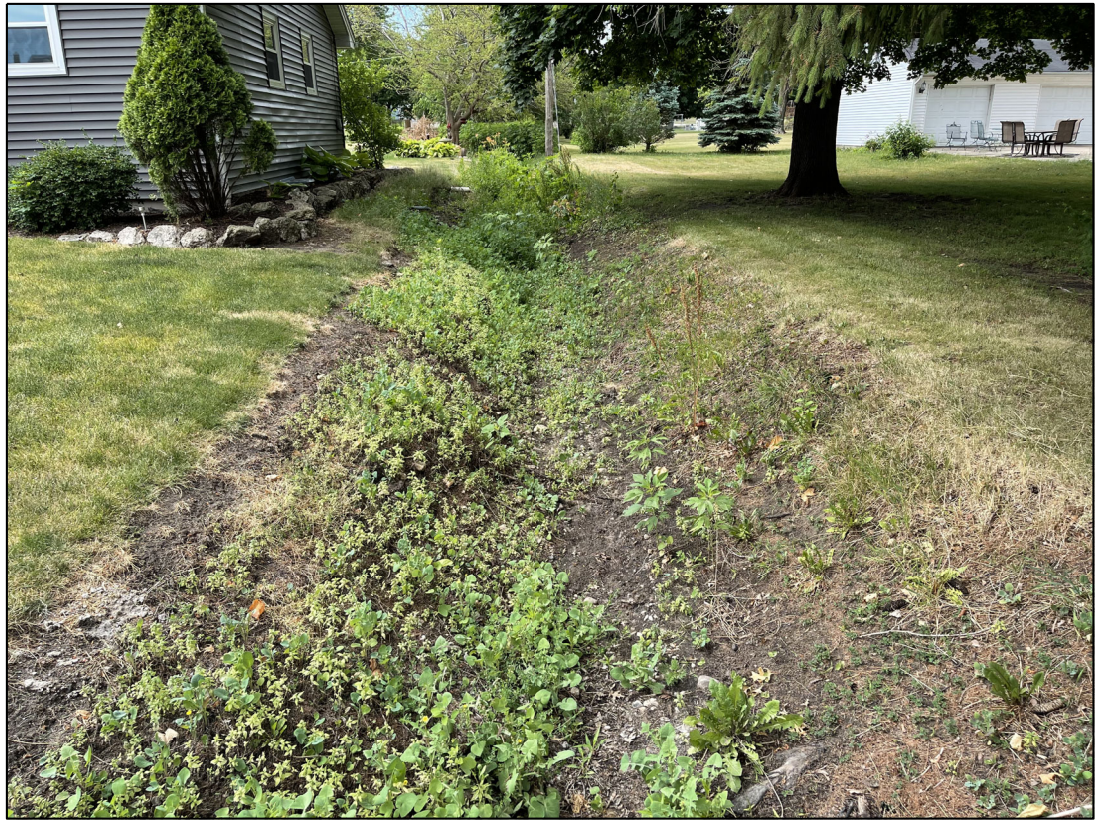
RIGHT PHOTO:

SEGMENT 3  
LOOKING SOUTH FROM  
ROOSEVELT STREET (IL RTE 72)  
CULVERT

The channel in Segment 3 is also trapezoidal with varying lining as the channel drains from south to north. At the south end, Segment 3 is densely overgrown with trees, brush, and reeds which eventually recede into a section with a lining combination of dirt, rock, and medium height weeds as the channel extends to the north. The south end of the channel has been poorly maintained and the tree and brush growth will have a significant impact on the flow conveyance capacity of the drainage channel. At the north end, it appears that the adjacent homeowners have attempted to clean and maintain the ditch to a certain degree.

The capacity of this section of the drainage channel will be discussed later in this report. This cleaning has created a larger and uniform section while also removing a significant amount of the existing turf lining.

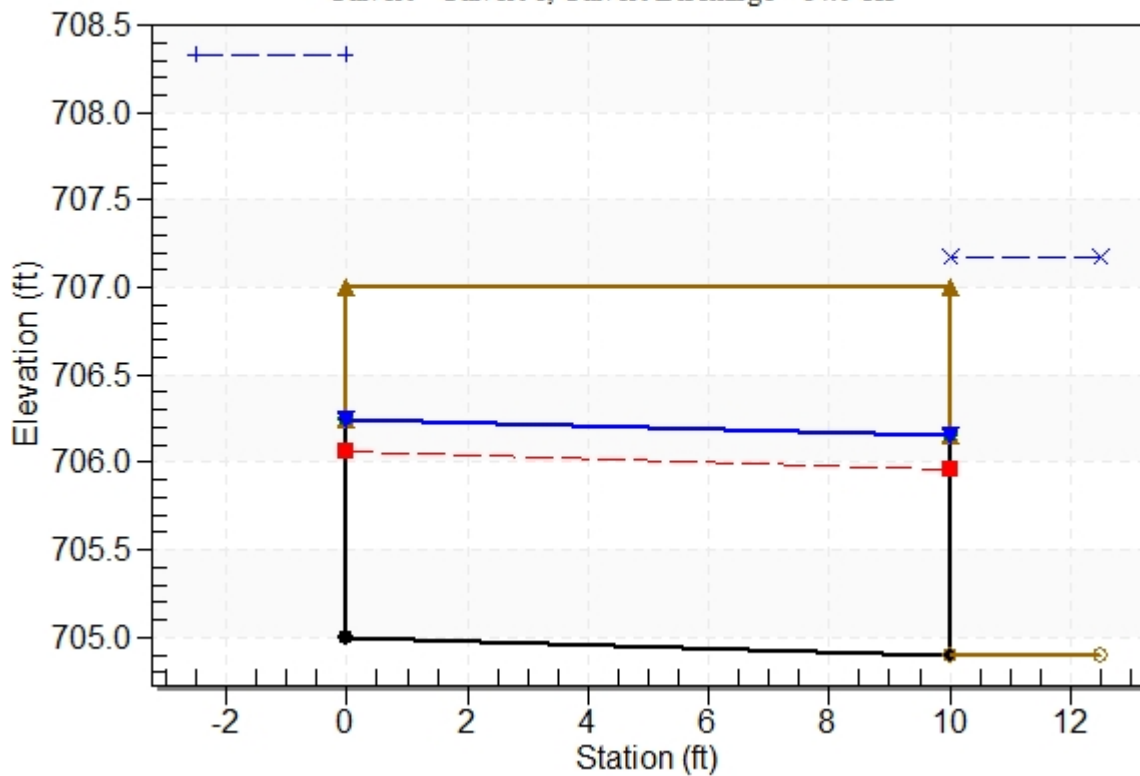
Crossing: Alley

Crossing - Alley, Design Discharge - 330.9 cfs

Culvert - Culvert 1, Culvert Discharge - 14.0 cfs
