CAPITOLA WHARF RESILIENCY AND PUBLIC ACCESS IMPROVEMENT PHASE 2

WHARF STORM DAMAGE EMERGENCY DRAWINGS 1 OF 3

Sheet Reference No.
C-100
INDEX: 1 OF 3

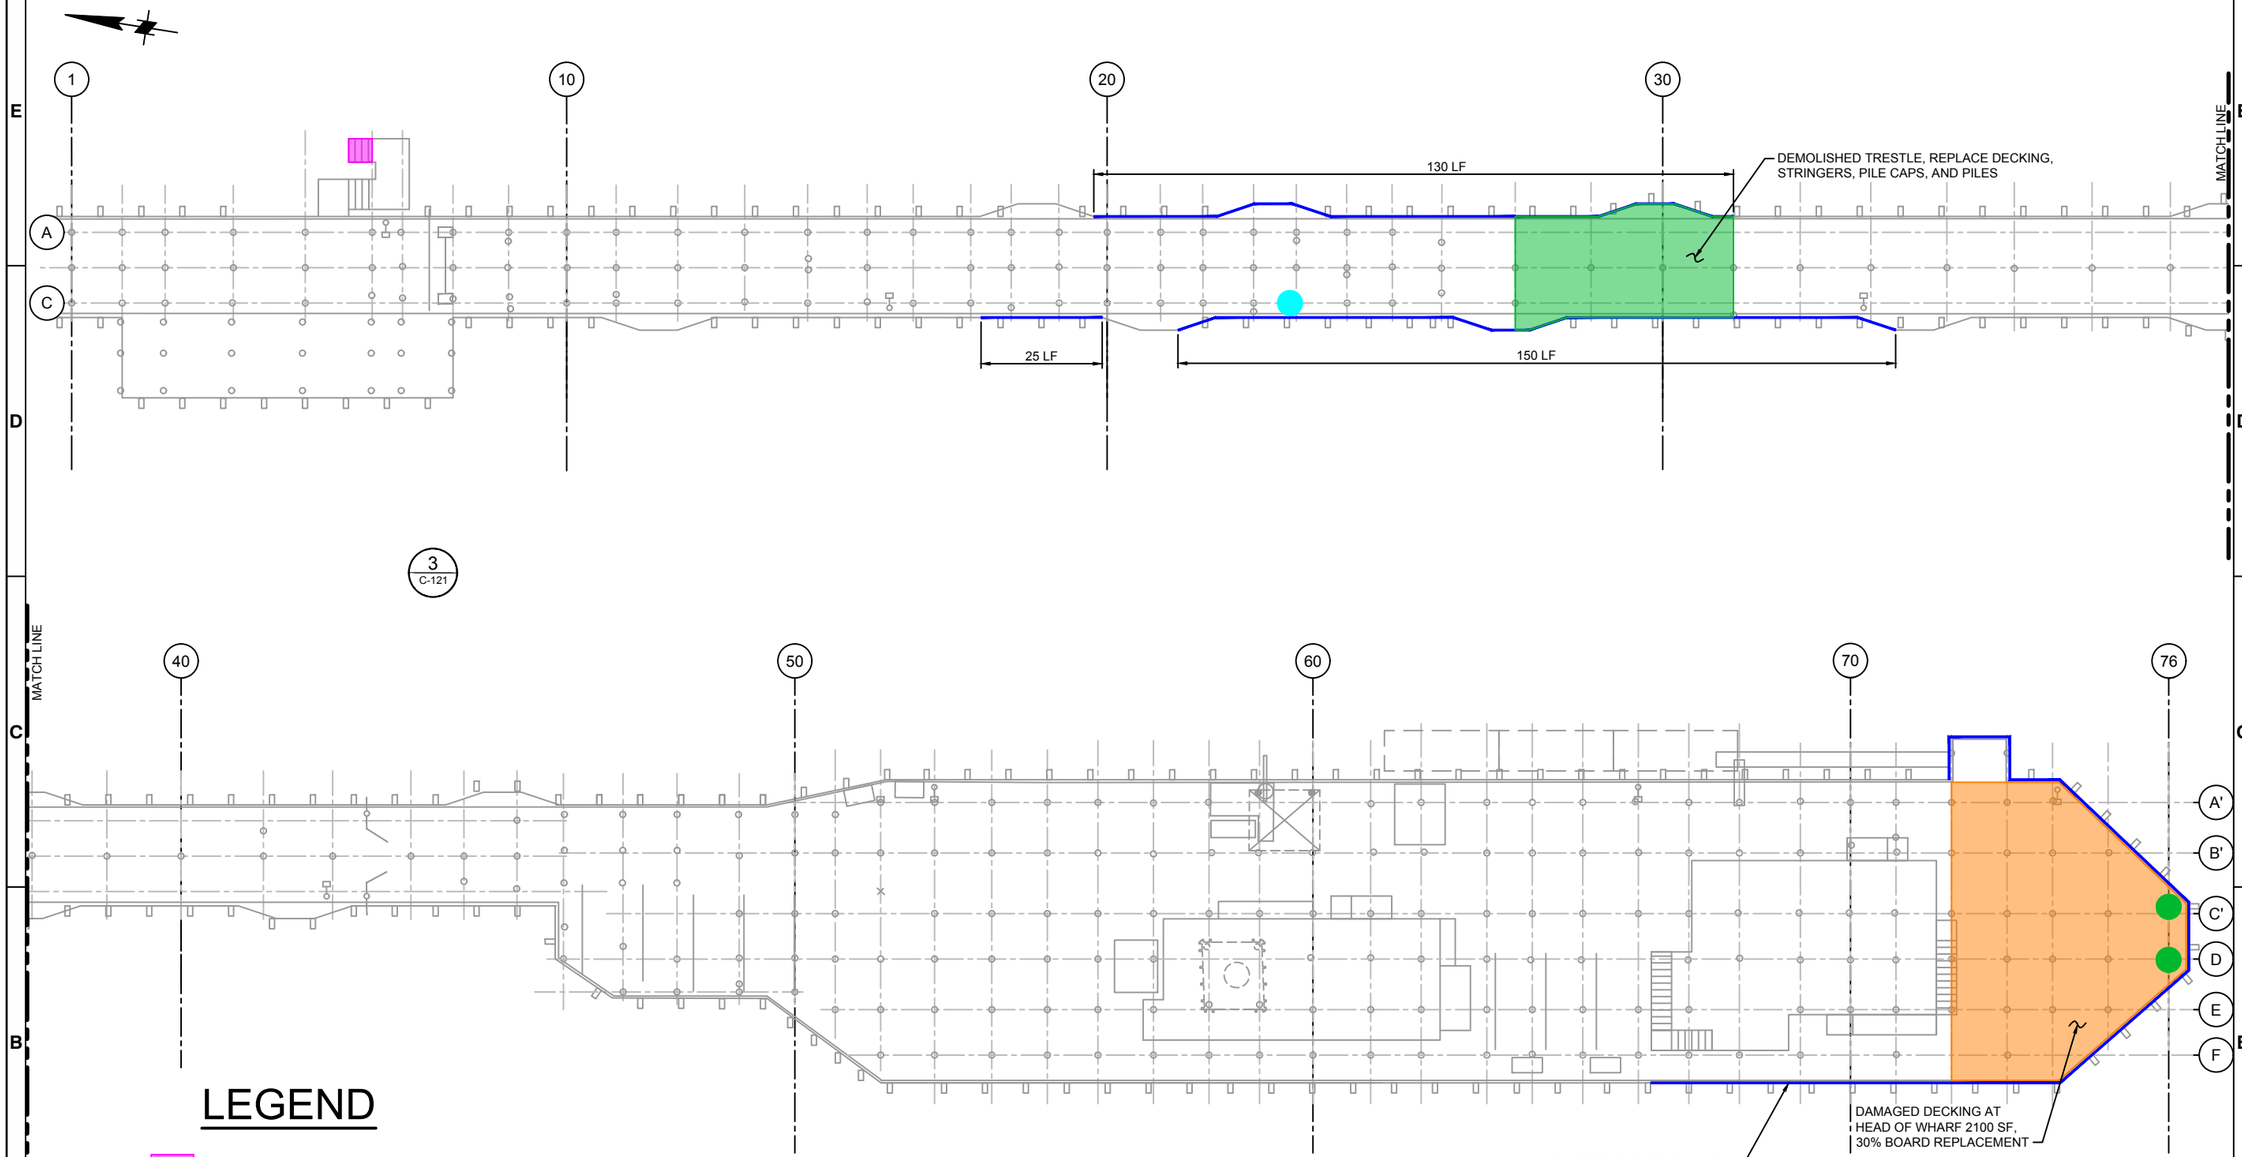
1 WHARF REPAIRS
SCALE: 1" = 15'

- CONSTRUCT BOTTOM FLIGHT OF STAIRS
- DEMOLISHED TRESTLE
- DAMAGED DECKING AT HEAD OF WHARF
- CONSTRUCT RAILING
- CONSTRUCT LIGHT POST
- RESET DISPLACED PILES
