Subject: Damages to Shelby ISICS Tower Due to Lightning Strike and Power Surge from Heavy Storms on May 17, 2026
Department of Public Safety
Claim dated June 3, 2026
AOS Claim ID: 4366

Captain Heath Hove
Iowa Department of Public Safety
Interoperability Communications Bureau
215 E. 7th St.
Des Moines, IA 50319
RE: Shelby ISICS Tower – Storm Damage Repairs

Shelby Tower – Storm Damage Report

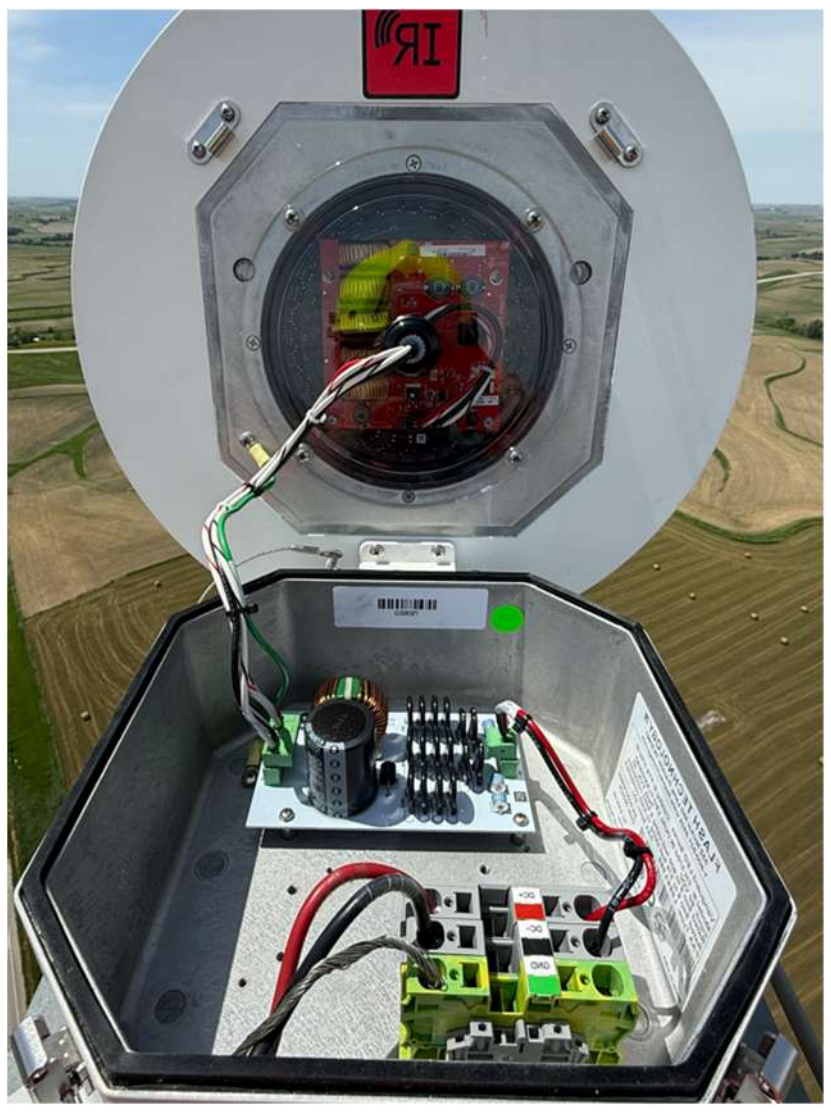
Before and After Photos

The tower lights were not working properly and in alarm. It was determined that the top beacon was damaged and needed to be replaced.

On June 2, 2026 Motorola had a tower crew replace to top beacon. While on the tower they visually inspected that antennas and lines for and damage. There was no visual damage.
