Subject: Damages to Lourdes ISICS Tower Due to High Winds and Extreme Weather on March 15, 2026
Department of Public Safety
Claim dated April 3, 2026
AOS Claim ID: 4281

Reference: 29C.20 reimbursement claim for loose tower cables at the Lourdes ISICS tower site. AOS claim #4281

Lourdes Tower – Storm Damage Report

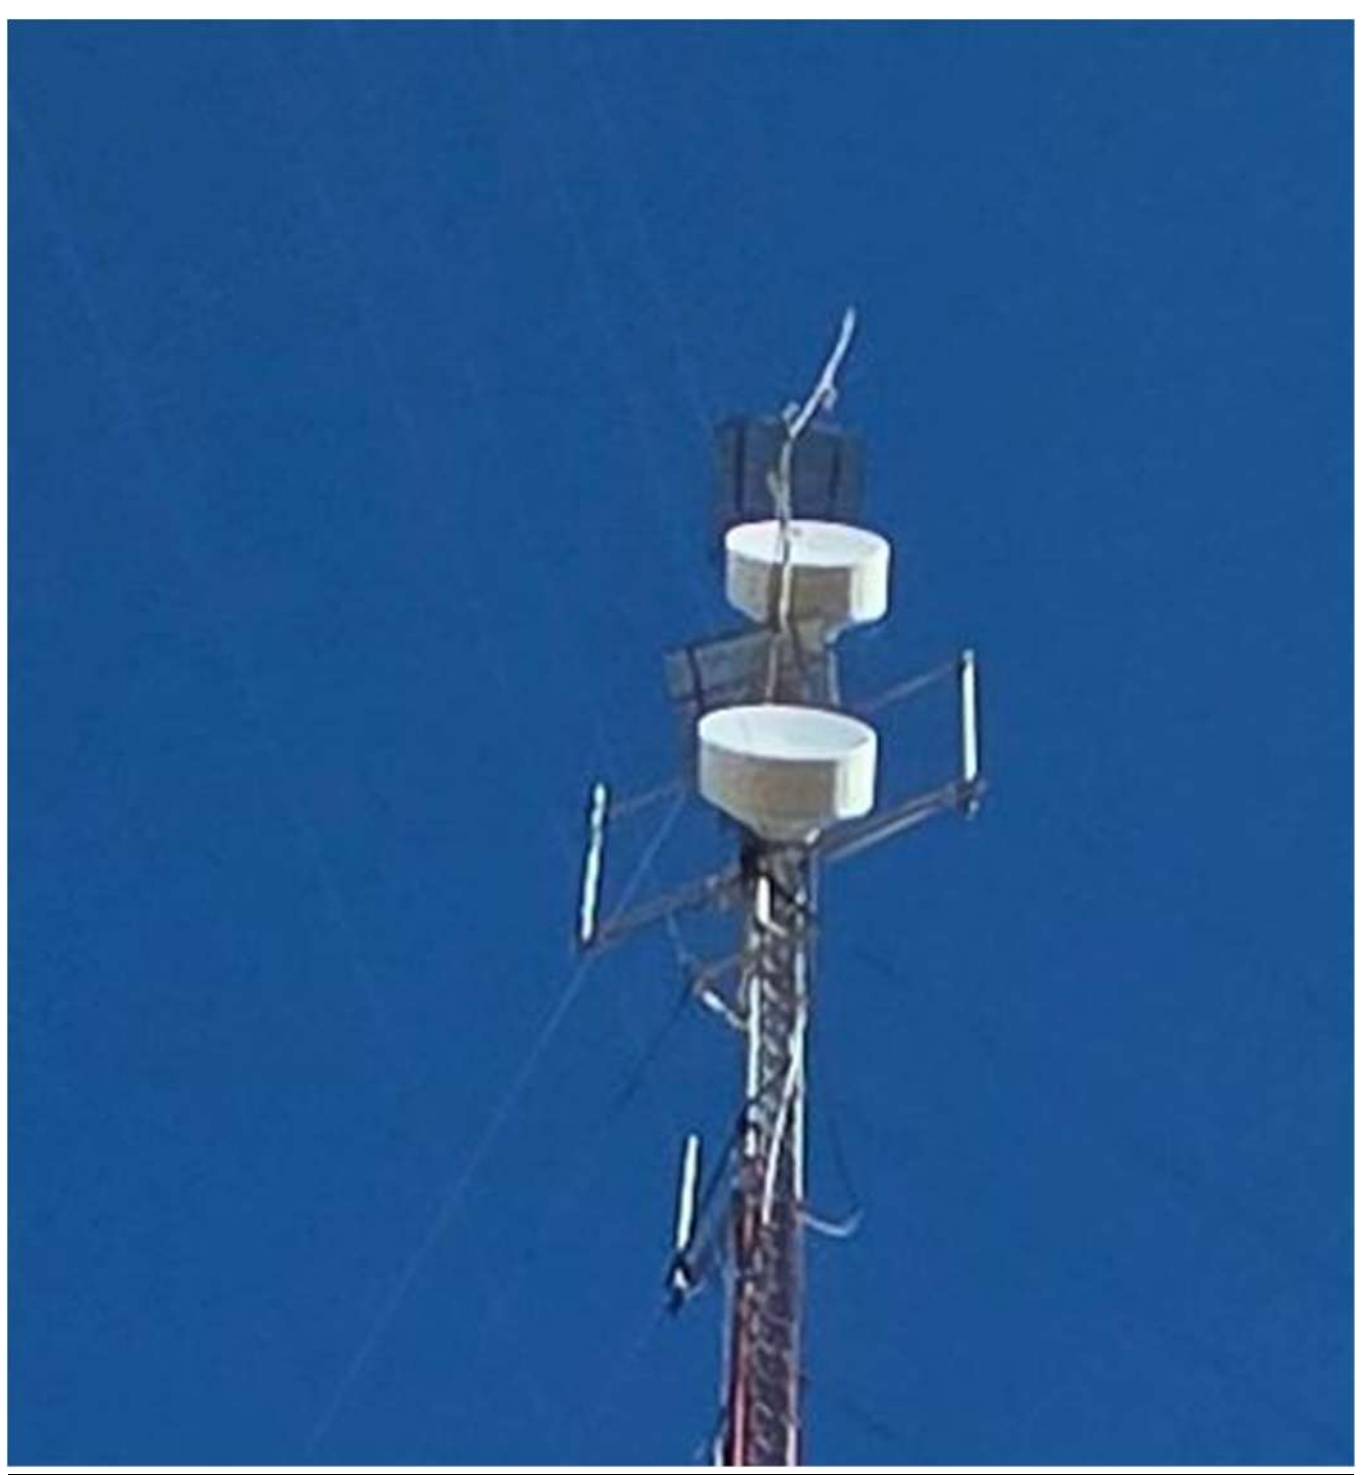
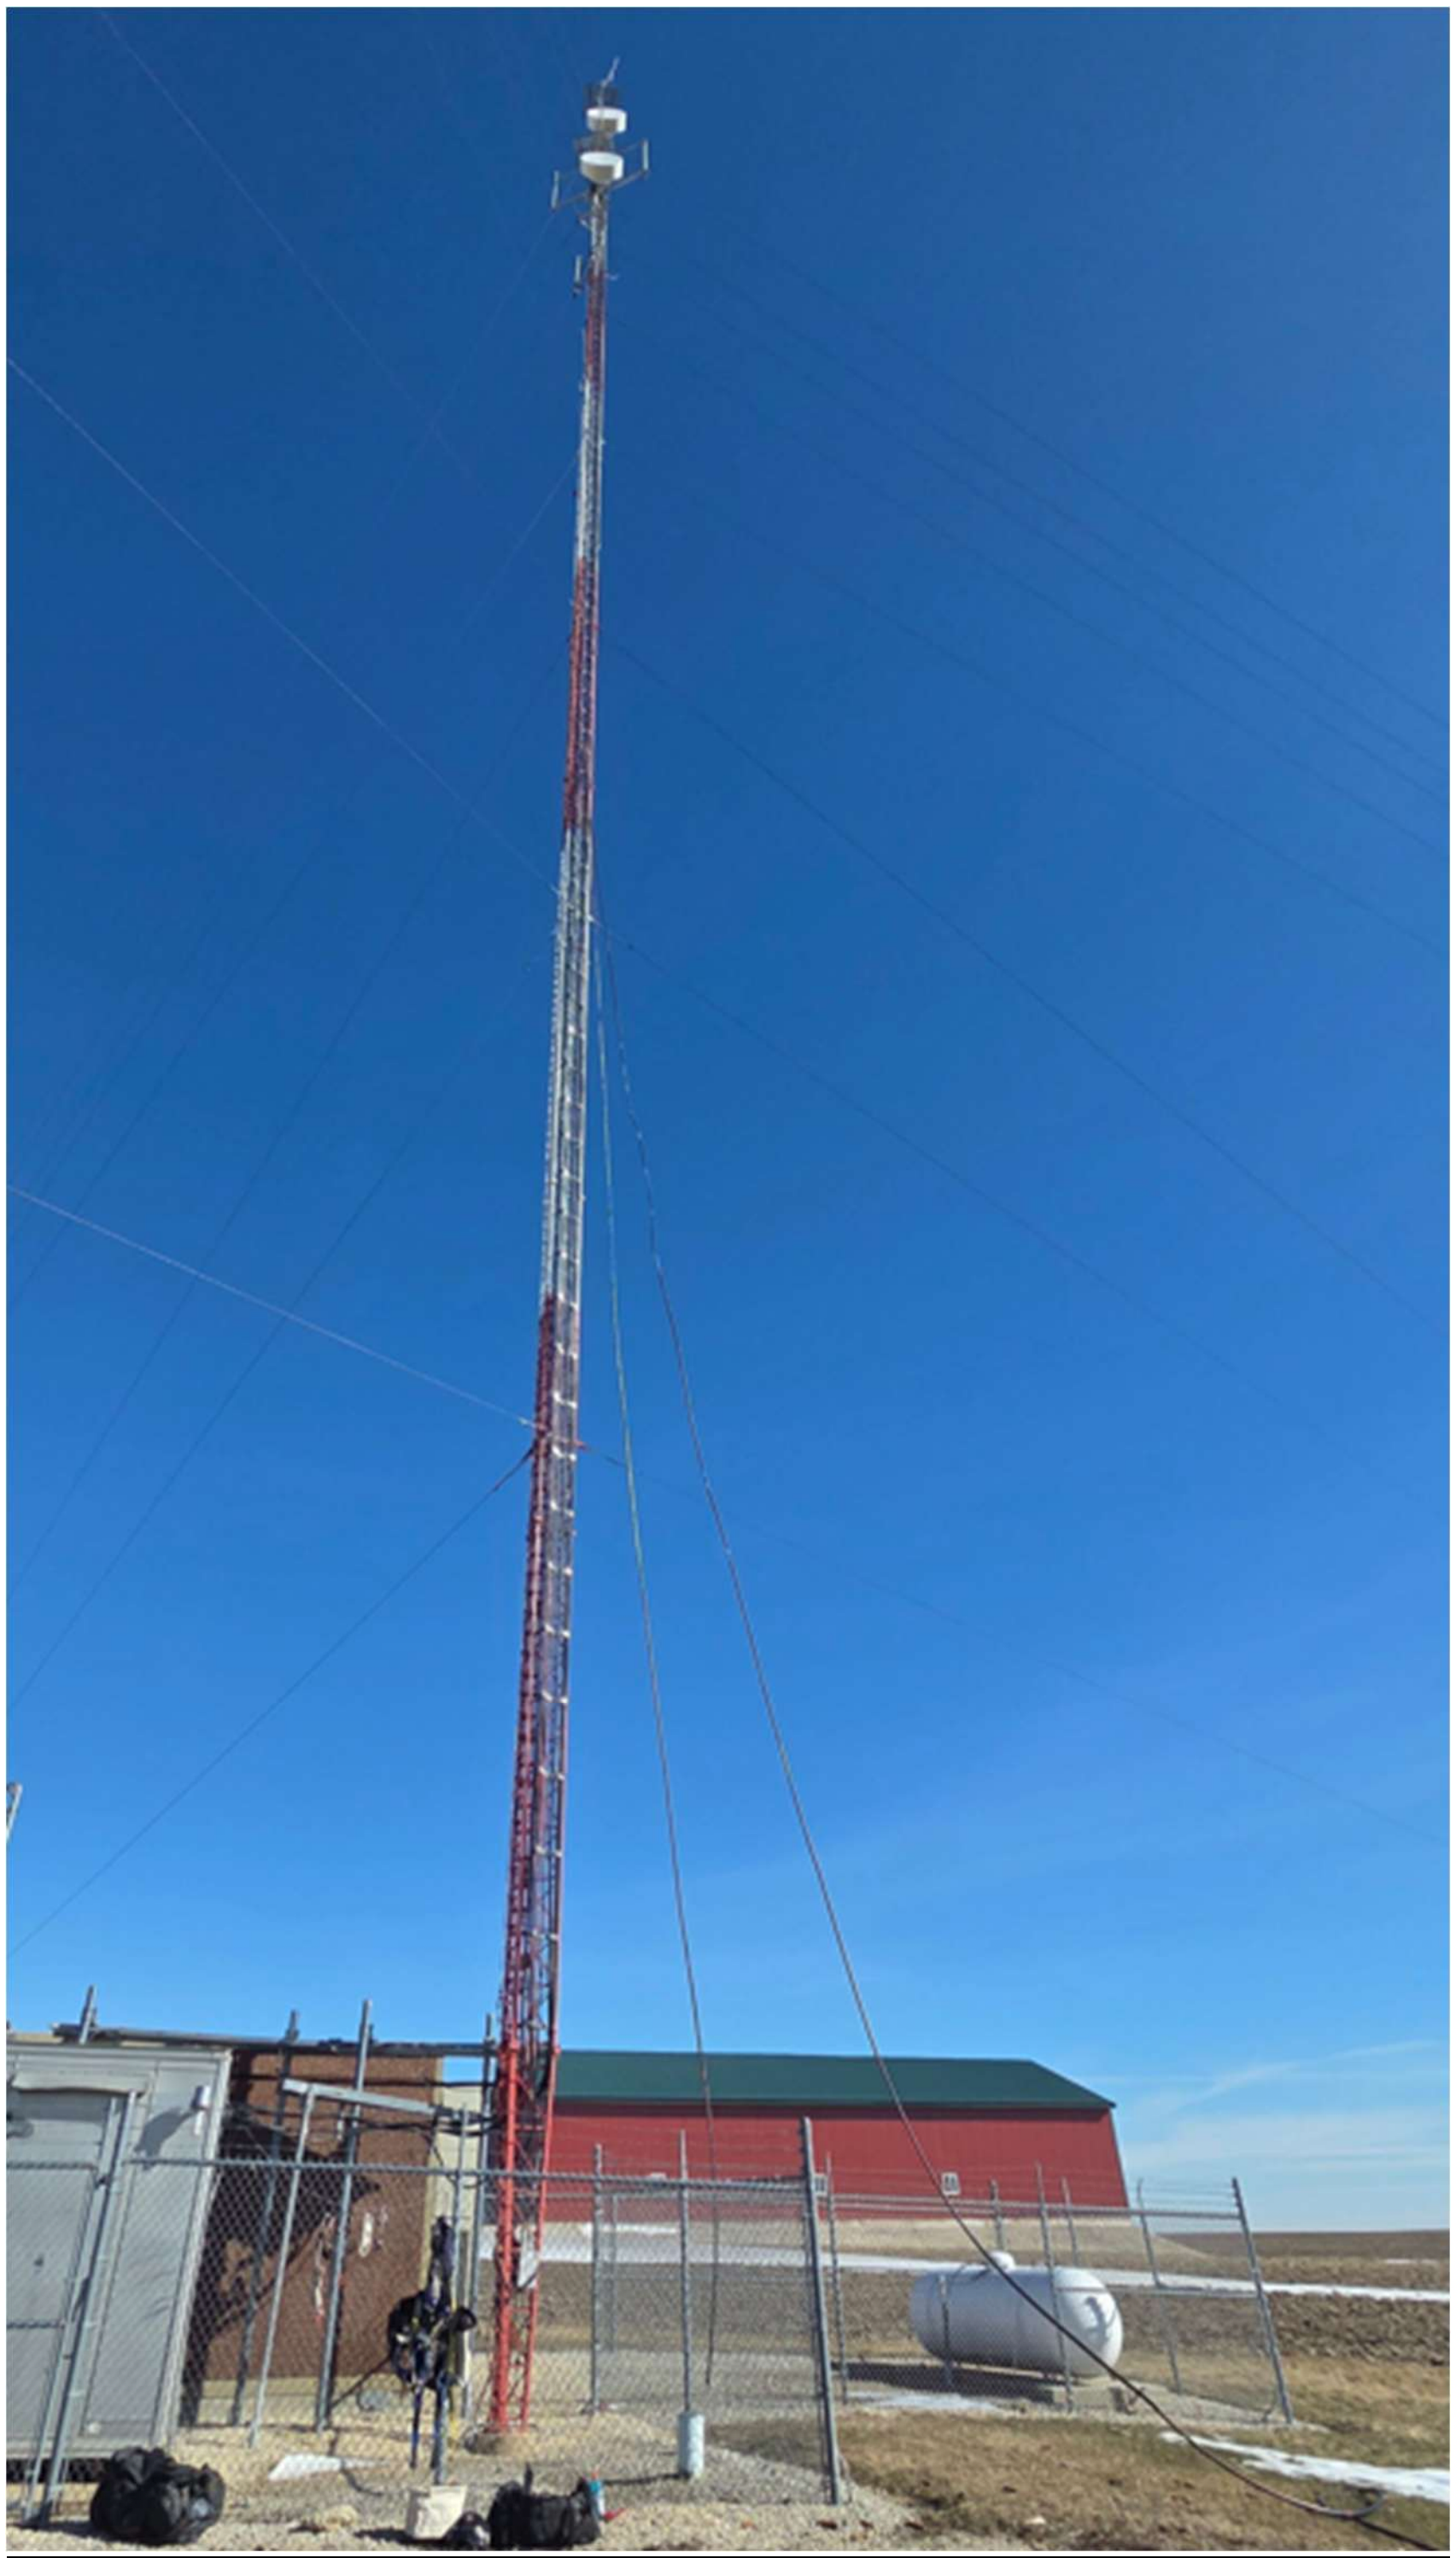
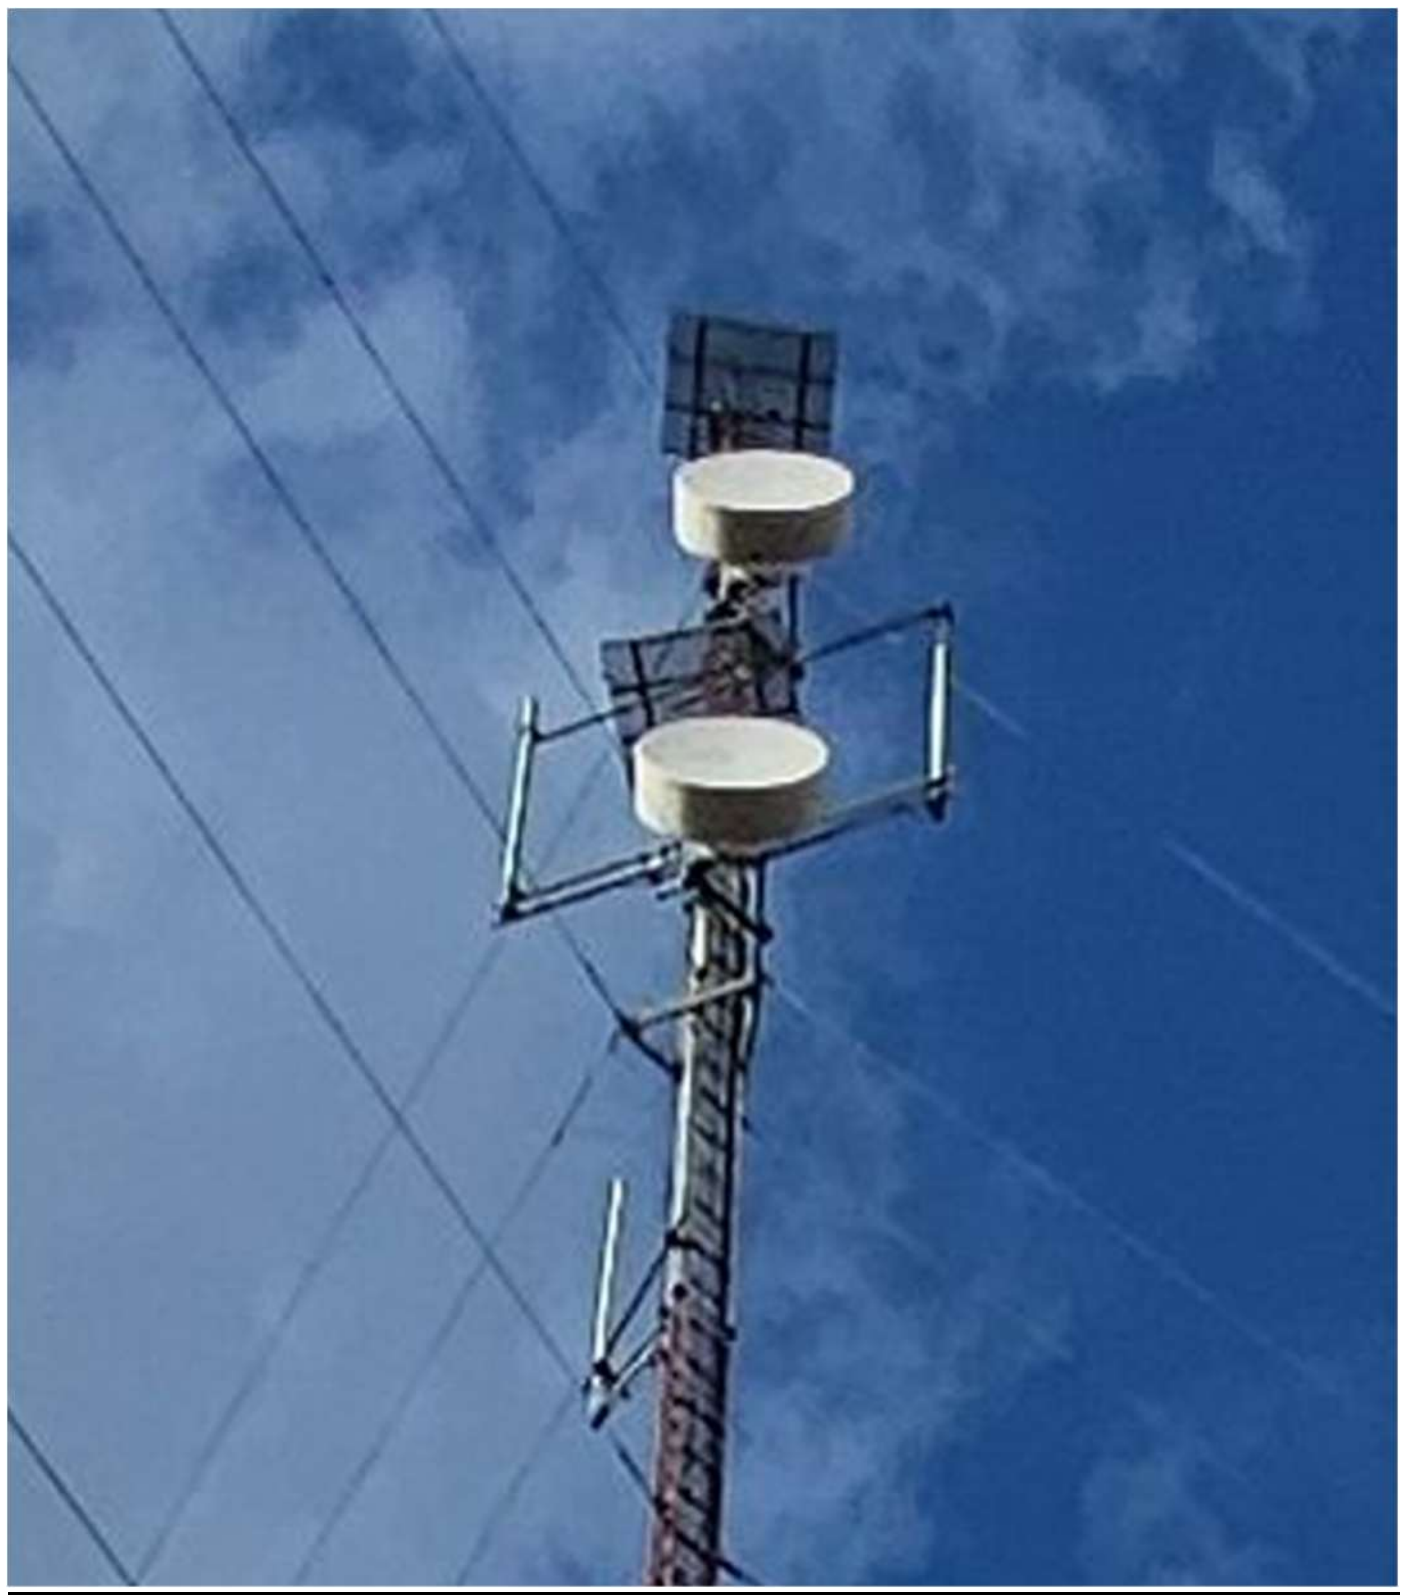
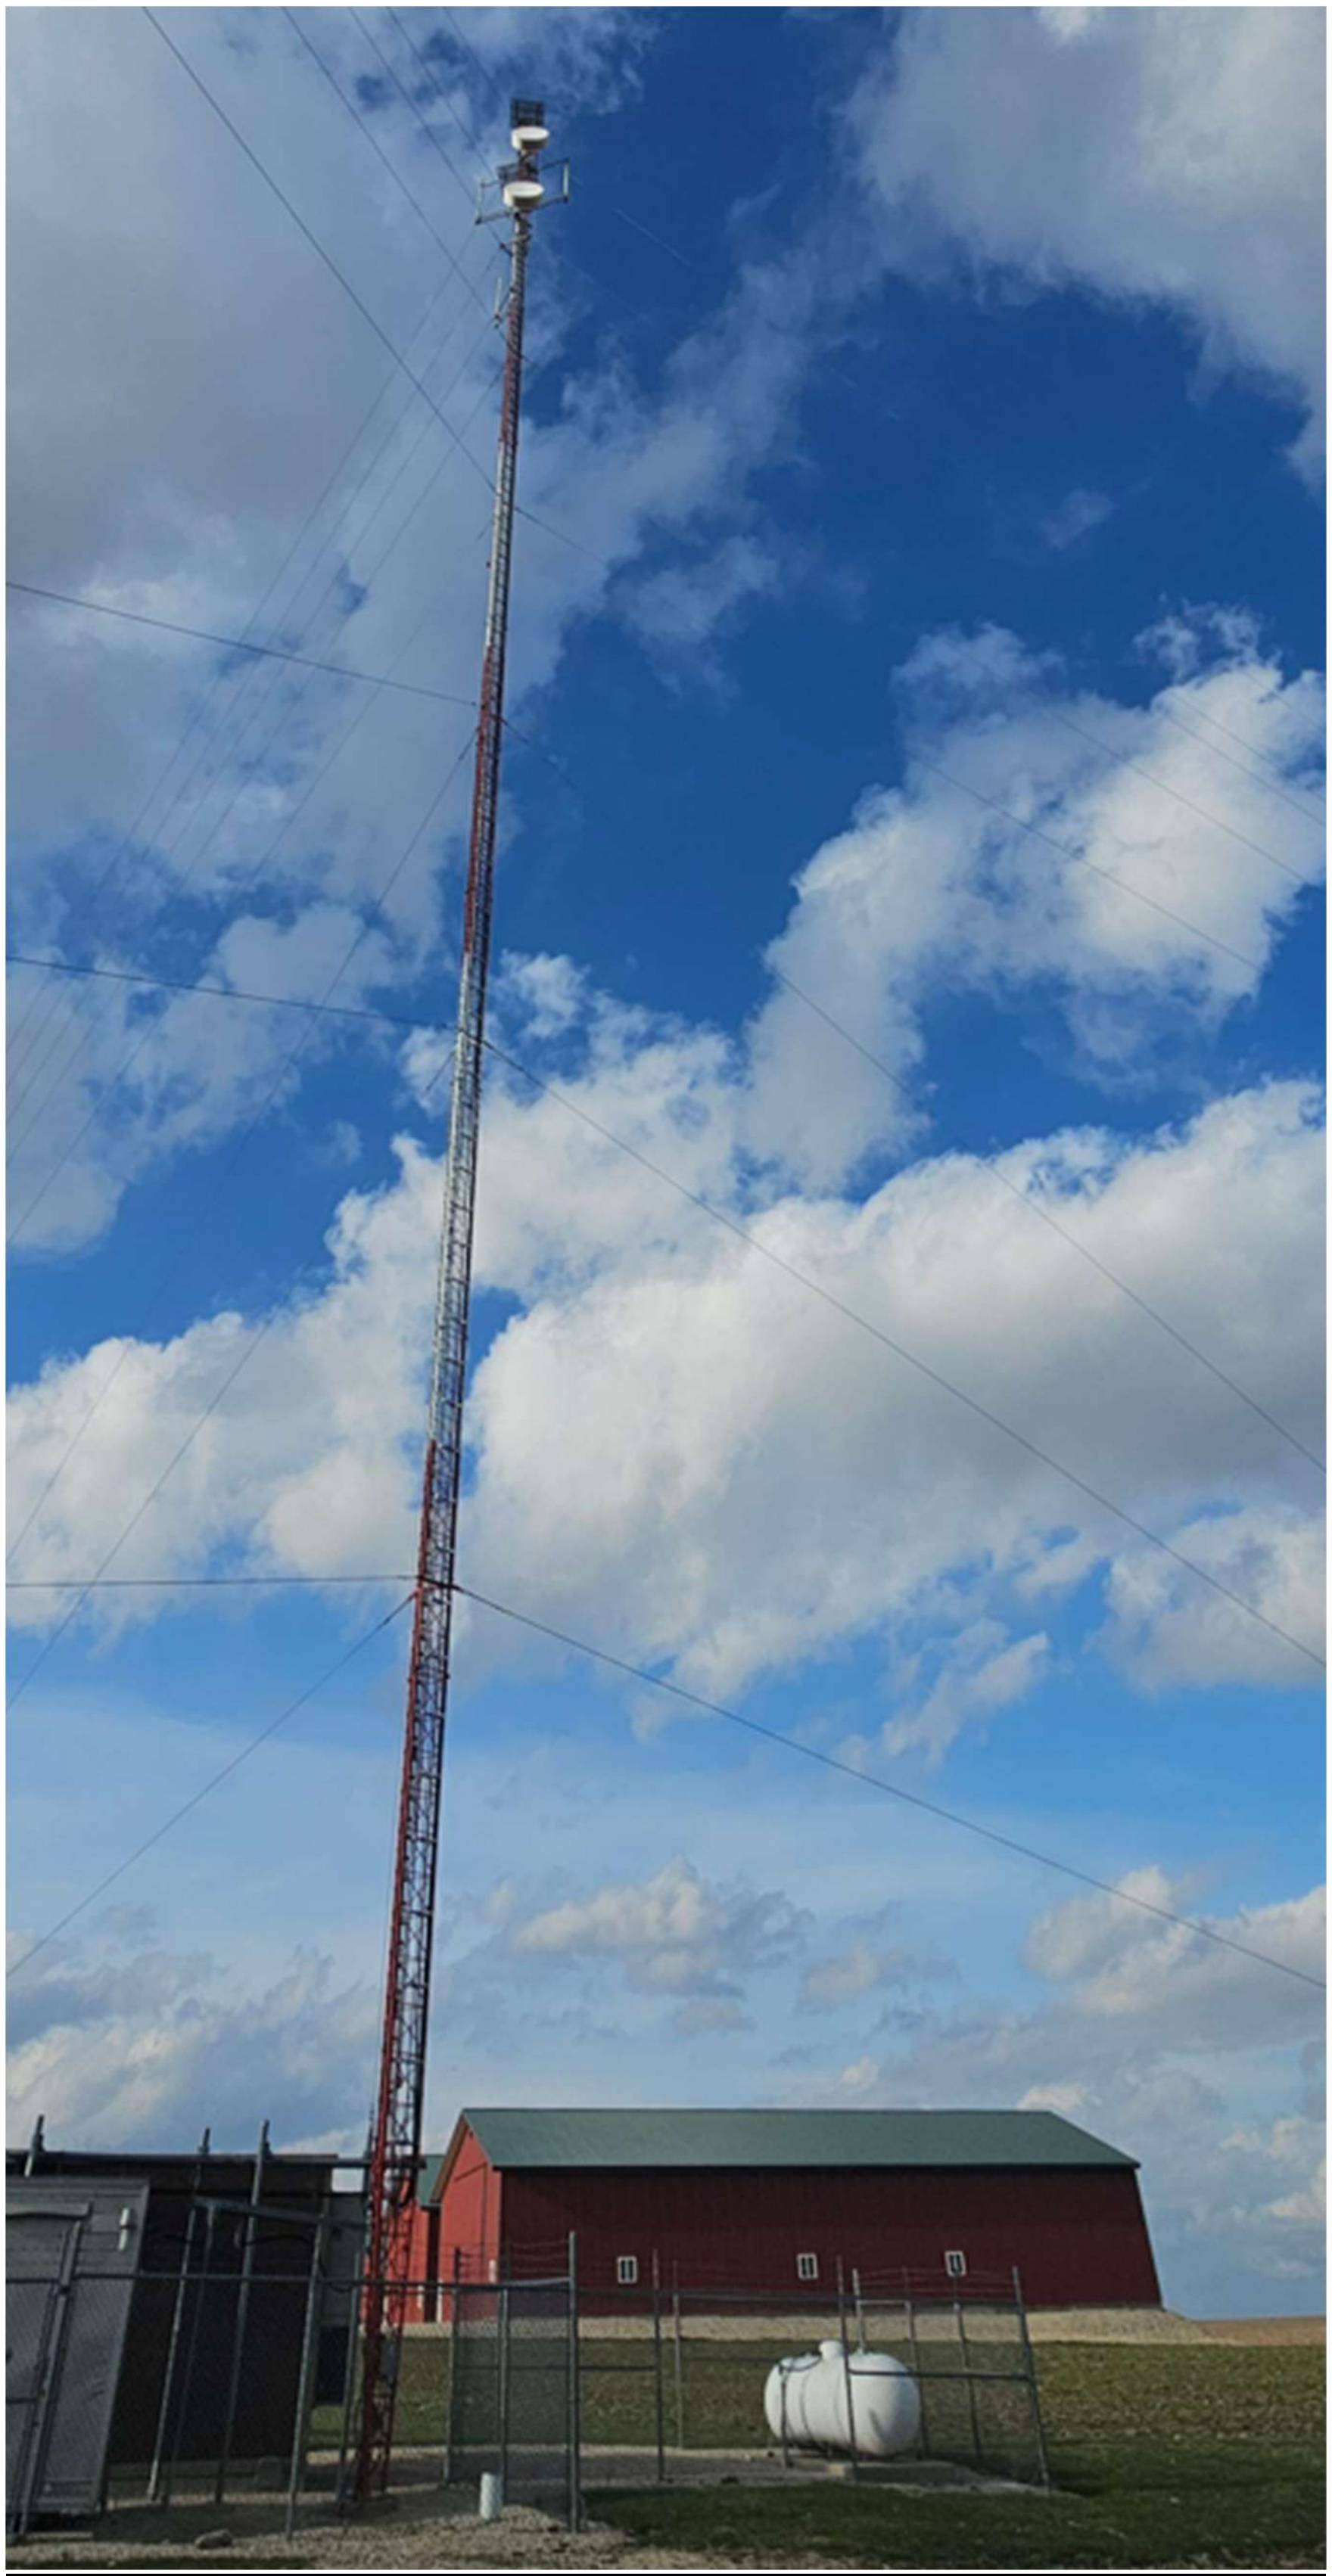
Before and After Photos

On March 17, 2026 DPS reported cables dangling from the Lourdes tower after high winds.

On March 20, 2026 Motorola has a tower crew onsite to investigate. The tower crew did their pre-climb safety check and reported that the guy wires were extremely loose and they could not climb for safety reasons. The crew was able to remove some of the cables from the ground that had been pulled off the tower due to the wind. They also marked the tower for the safety concerns with the remaining loose cables and guy wires. They also reported that the antennas were tilted and looked unsafe from the ground.

On April 1, 2026 the tower crew returned to perform an emergency plumb and tension on the guy wires on the tower. This had to be done to make the tower safe to climb to remove the rest of the loose cables.

On April 13, 2026 the tower crew returned to remove the remaining loose cables and antennas from the tower that were no longer being used.
