PHASE I ESA PHASE I ENVIRONMENTAL SITE ASSESSMENT

545 150th Ave
Madeira Beach, Florida

NOVA Project Number: 10142-3026084
September 25, 2026

Subject: **PHASE I ENVIRONMENTAL SITE ASSESSMENT**
545 150th Ave
Madeira Beach, Pinellas County, Florida
NOVA Project Number 10142-3026084

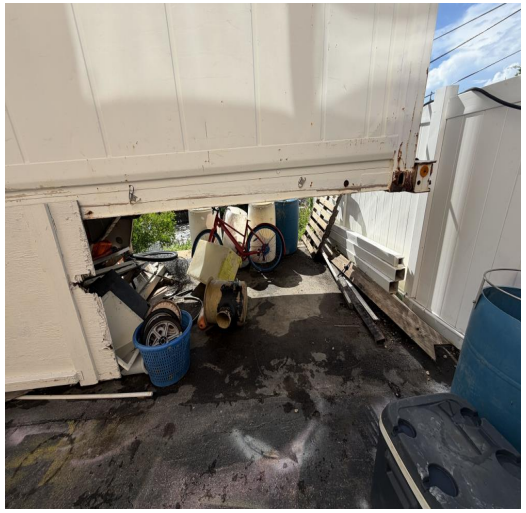
Photo 12
Comments: Subject Property - trash and debris under ice box area.

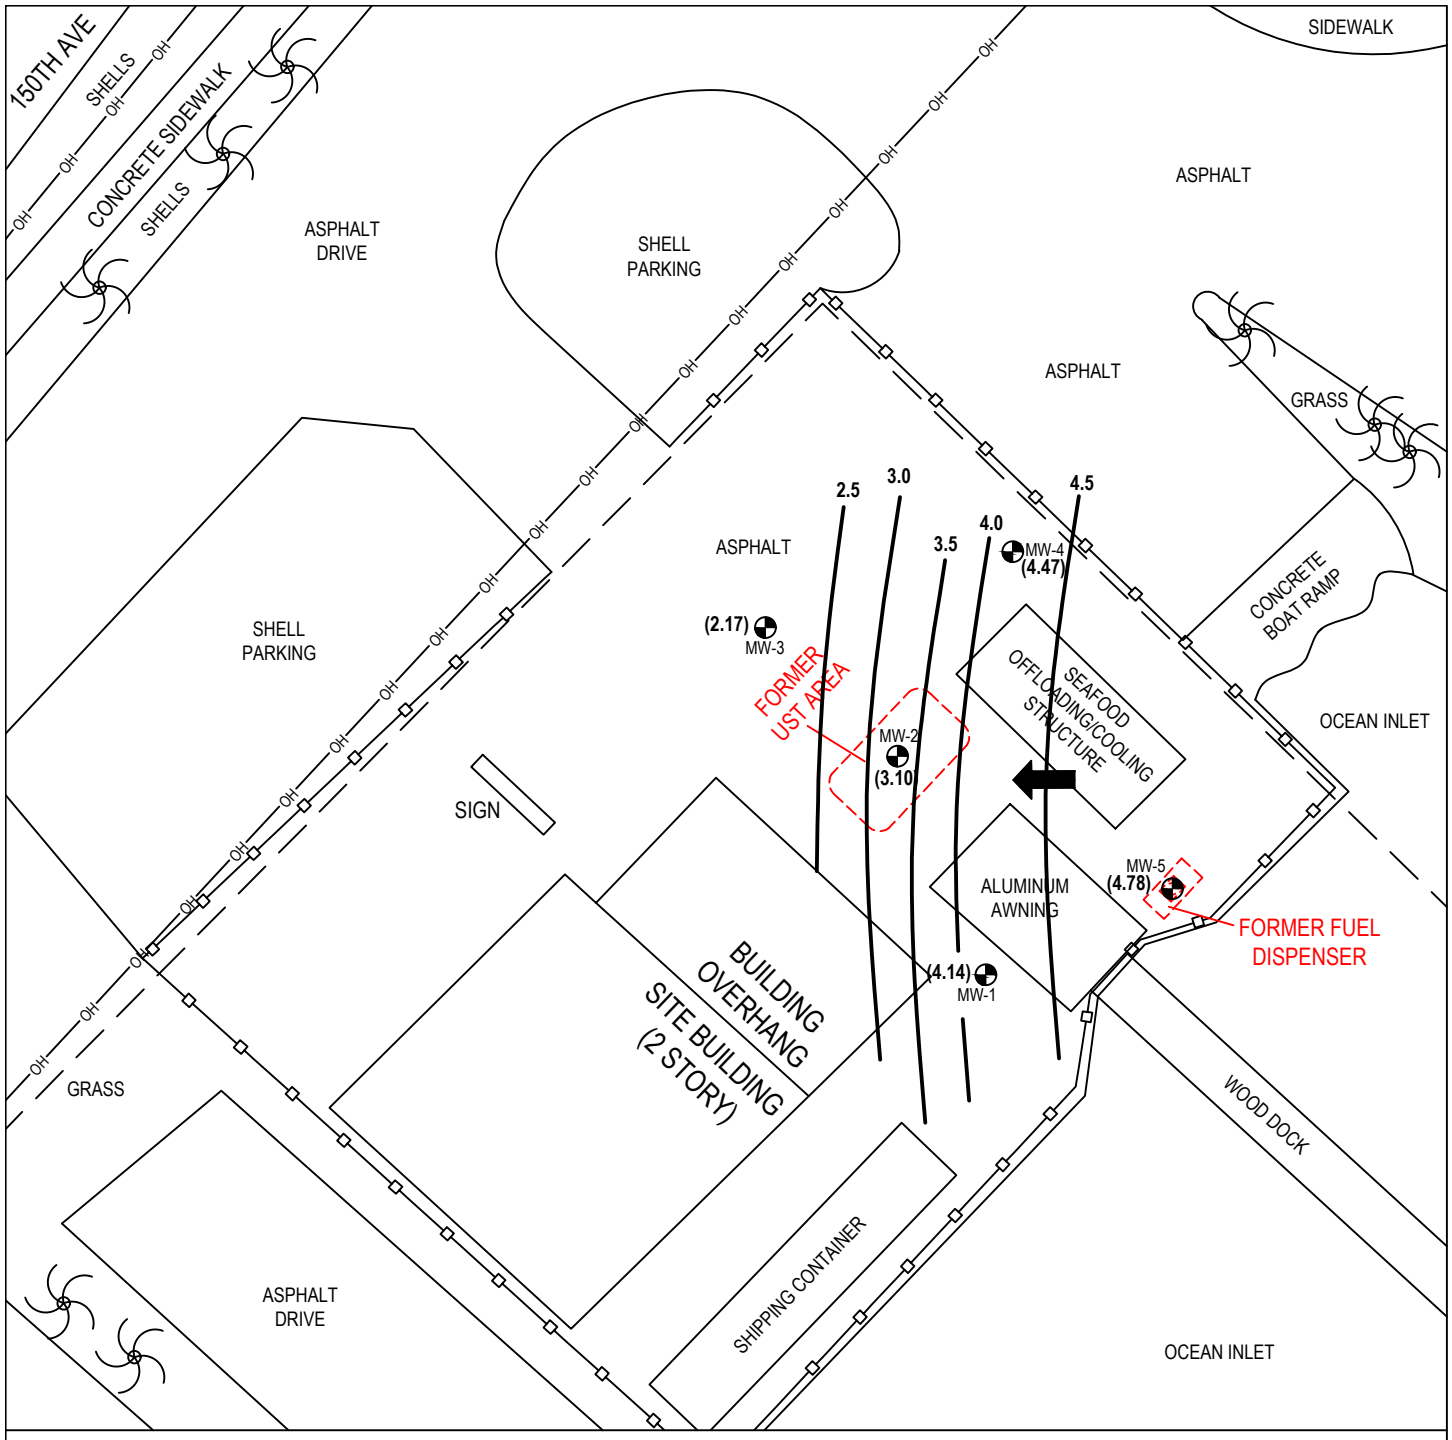
FIGURE
2
PROJECT No.
L00014

On November 13, 2020, MAS personnel advanced a total of eight (8) soil borings, SB-9R, and SB-15 through SB-21 for the purpose of delineating previously identified impacts of carcinogenic PAHs in the soil. The soil borings were completed to a total depth of two (2) feet bls using a hand auger at the locations shown on **Figure 2**.

A summary of the previous OVA data is provided in **Table 1** and the summary of the analytical results is provided in **Tables 2A, 2B, 2C, and 2D** and presented on **Figure 2**.

Based on the results provided herein, soil impacts were confirmed and have not been adequately delineated. Additionally, the soil impacts are not thought to be caused by background concentrations in the soil based on the results of the background soil study. Therefore, MAS recommends advancing six (6) additional soil borings as shown on **Figure 2** for the purpose of delineating the soil impacts. Once the soil impacts are delineated, an excavation plan can be prepared to address the soil as needed for closure.

SOIL ANALYTICAL SUMMARY MAP (08/18/16, 01/16/17, 6/14/17, 11/13/20, 03/17/21 & 04/27/21)

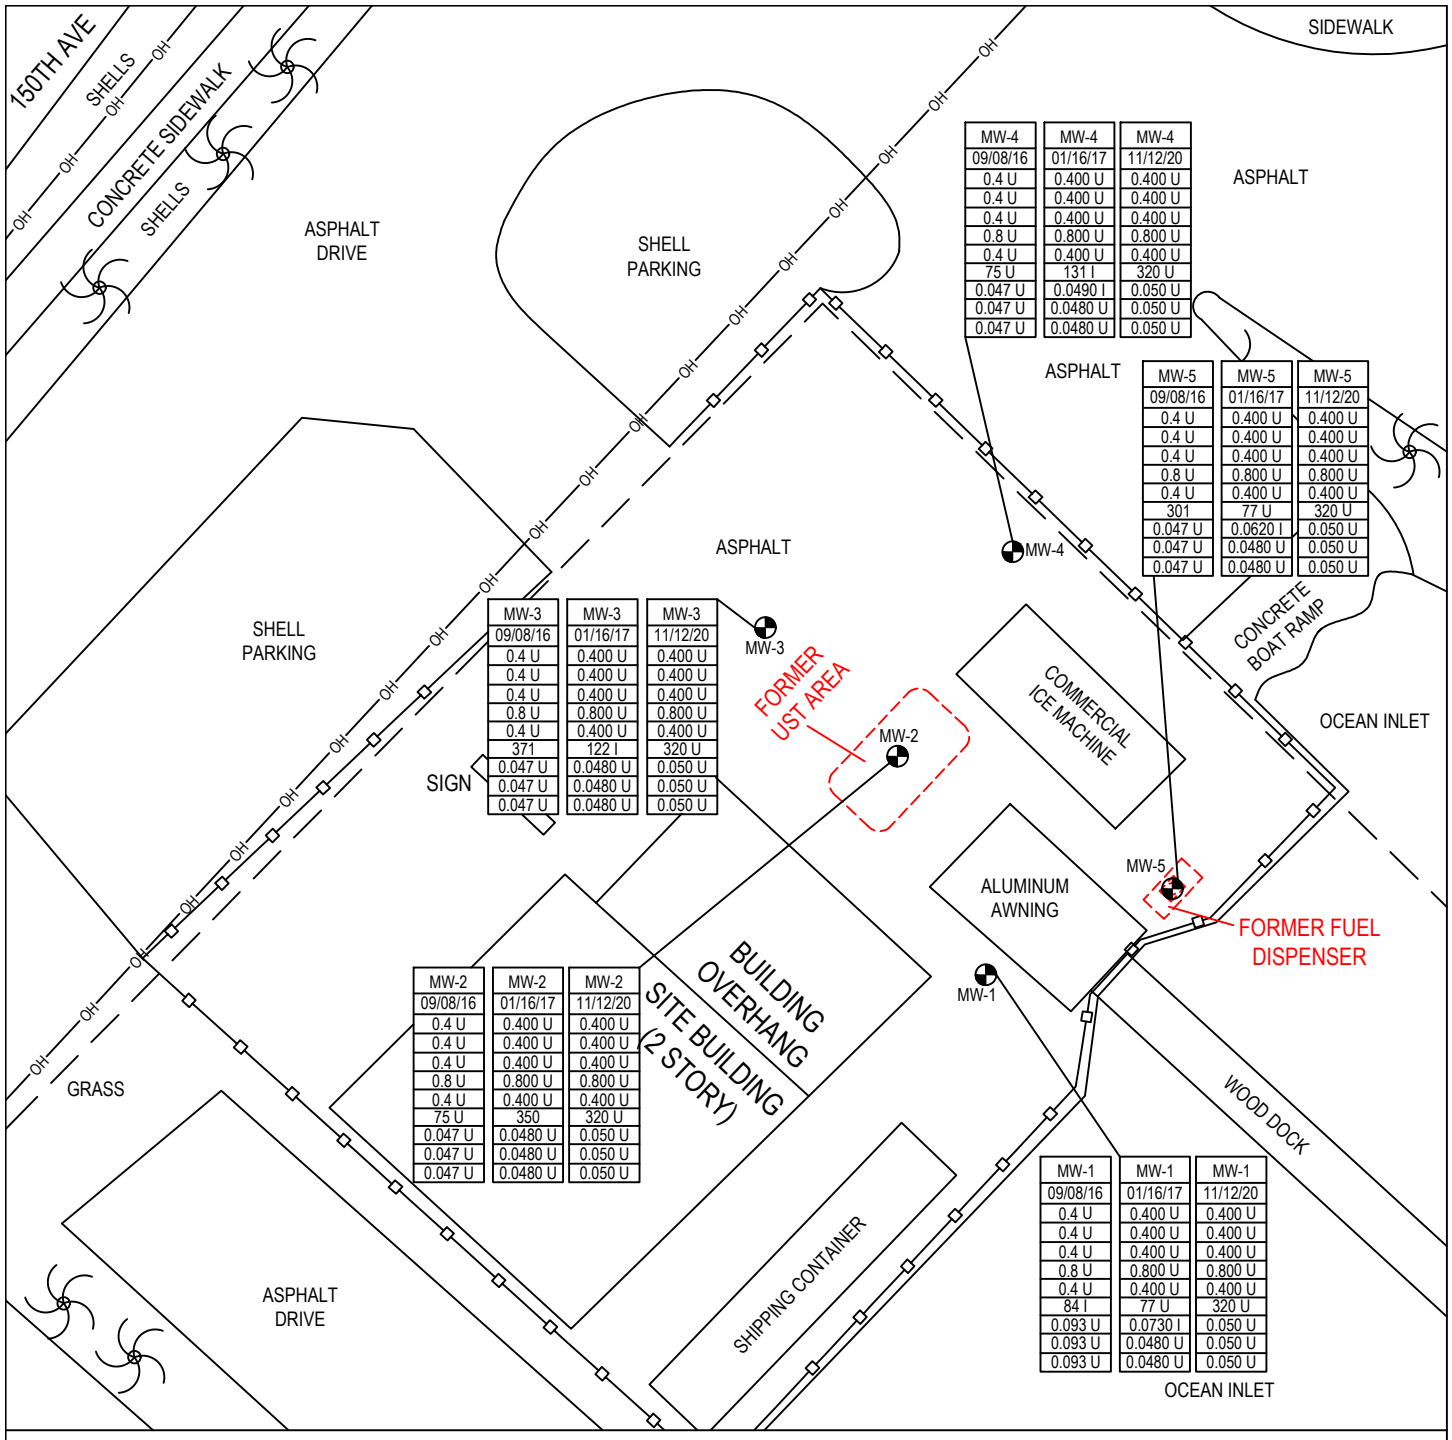
FIGURE
3
PROJECT No.
L00014

On November 12, 2020, the depth to groundwater ranged from 1.87 to 2.96 feet below top of casing (ft btc). A summary of the groundwater elevation data is presented in **Table 3.** The groundwater flow direction beneath the site on November 12, 2020 was observed to be towards the west as shown on **Figure 3**.

In regard to the groundwater at the site, since the absence of groundwater impacts has been confirmed for two (2) consecutive quarters and the there are no soil impacts above the leachability CTLs, MAS recommends abandoning the monitoring wells at this time to prevent future surface spills from entering the open conduits to the groundwater.

GROUNDWATER ELEVATION CONTOUR MAP (11/12/20)
