# Albion, NE

Fin Folk Underwater Services

# Tank information

- Year built 2000
- Max capacity- 300,000 gallons
- Type- pedosphere
- Height-80ft

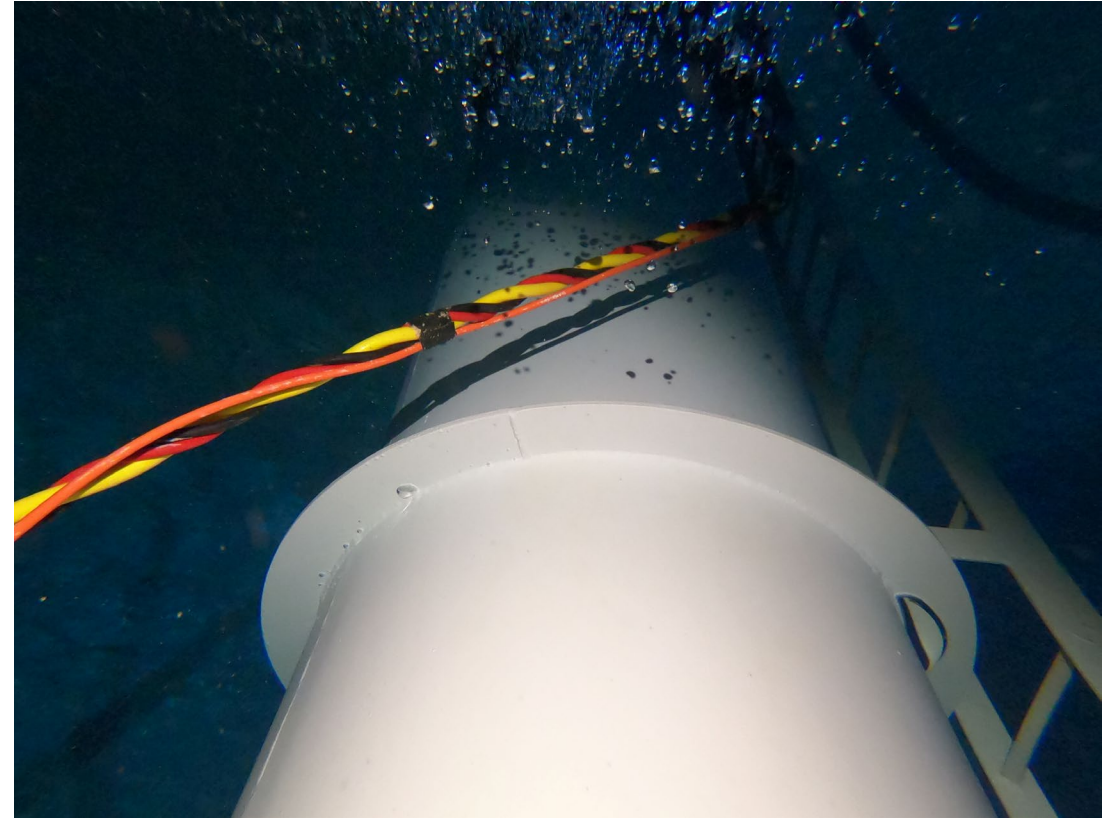
# Center Tube

- Location- Center
- Rust Grade- 9
- Center Tube appears to be in very good condition with little to no rust, pitting, or coating failures.
