Appendix A: Public Outreach

Site Accessibility Evaluation

Angleton Recreation Center & Natatorium

BG Peck Soccer Complex
709 Kelly Blvd
Angleton, TX 77515
Accessibility Evaluation
Evaluation Date: 03/24/2022
Evaluators: Kristi Avalos

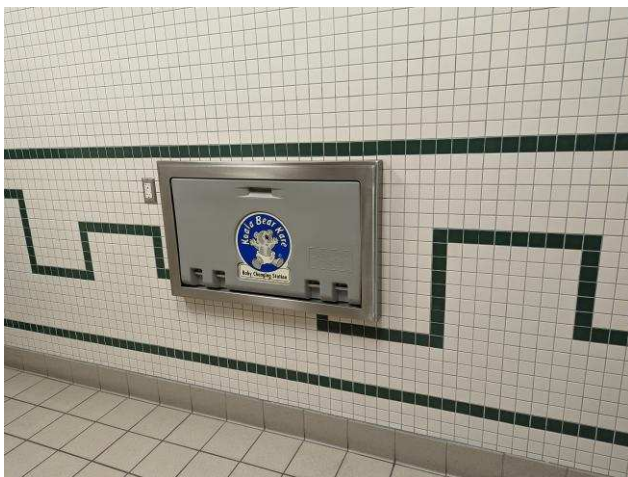
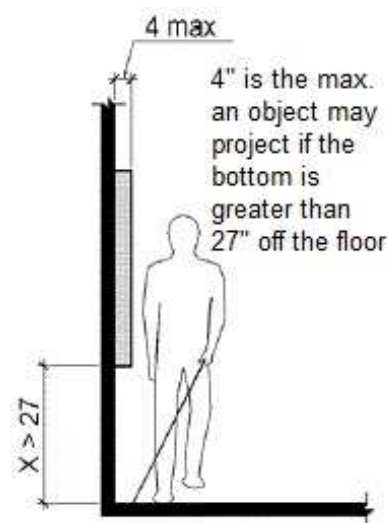
Barrier: 8

Wall-mounted objects that have leading edges between 27 inches and 80 inches from the floor must not project more than 4 inches into the circulation path. Protruding objects that extend to the floor or within 27 inches of the floor are cane detectable and are therefore not hazardous. Where it is necessary or desirable to have objects protrude from the wall, a manner of cane detection must be provided.

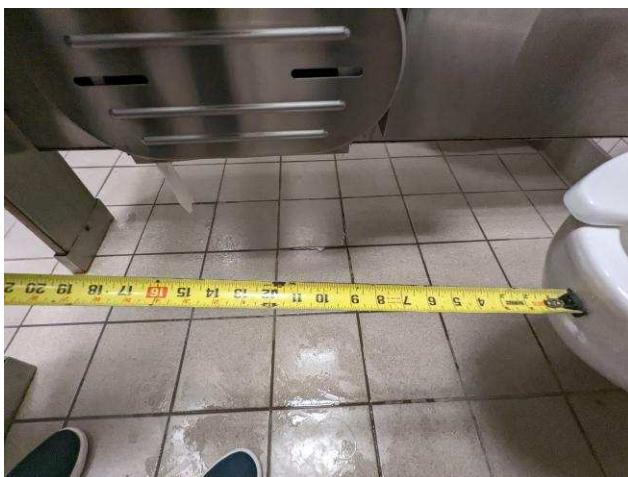
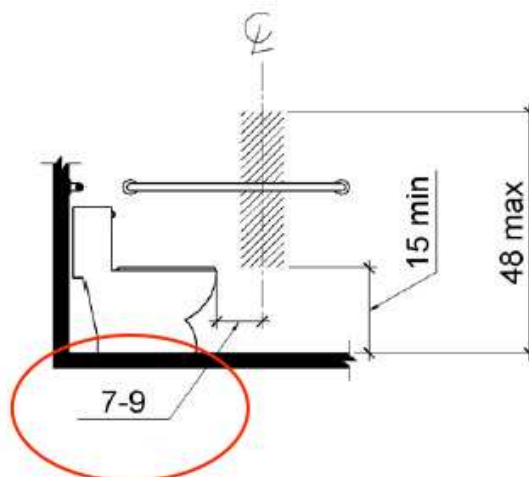
Barrier: 13

Restrooms: Women's Locker Rooms

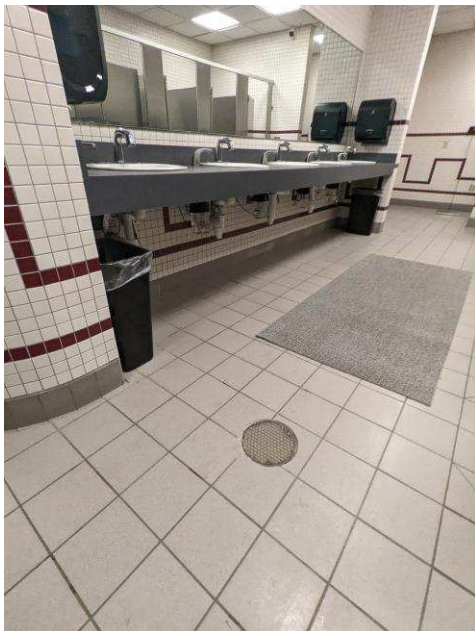
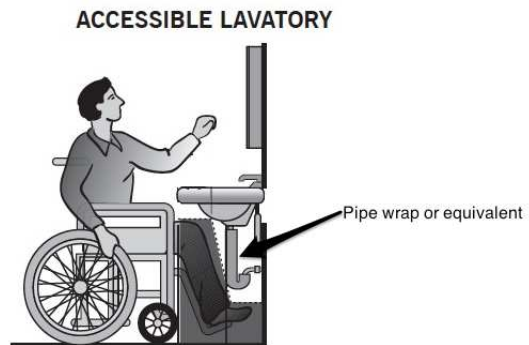
Barrier: 14

Restrooms: Women's Locker Rooms

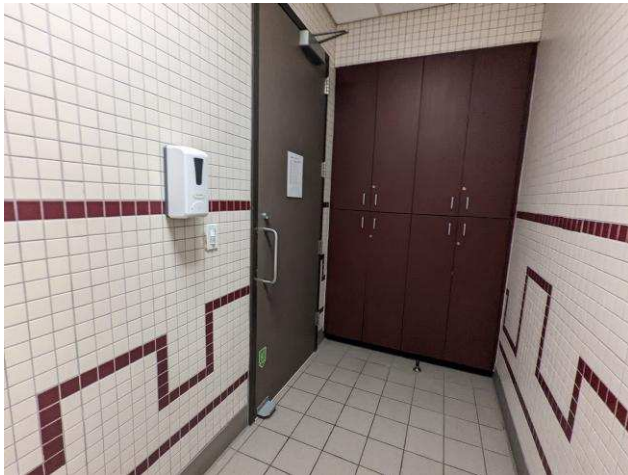
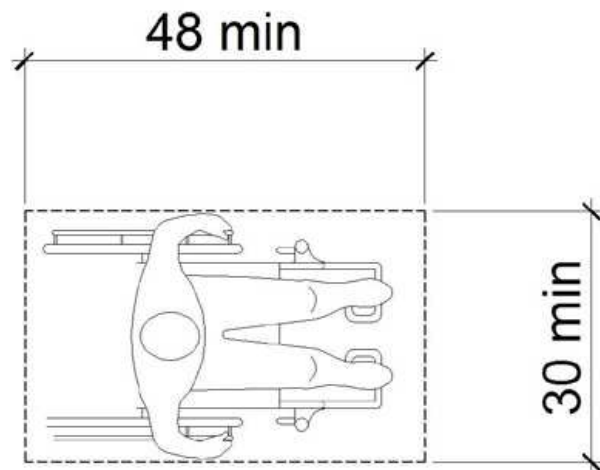
Barrier: 15

Restrooms: Men's Locker Rooms

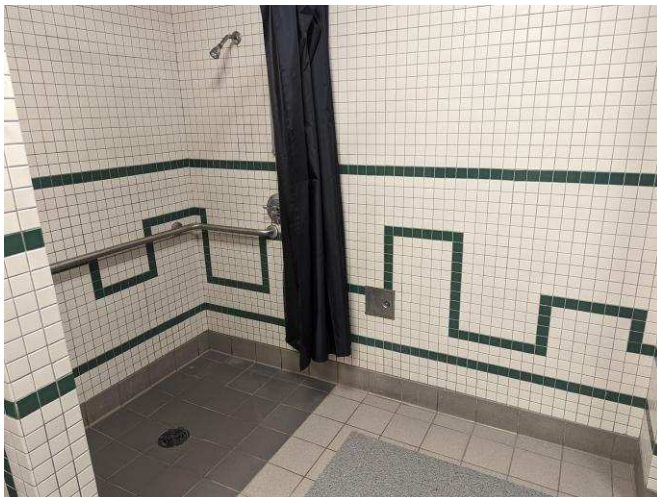
Barrier: 16

Restrooms: Men's Locker Rooms

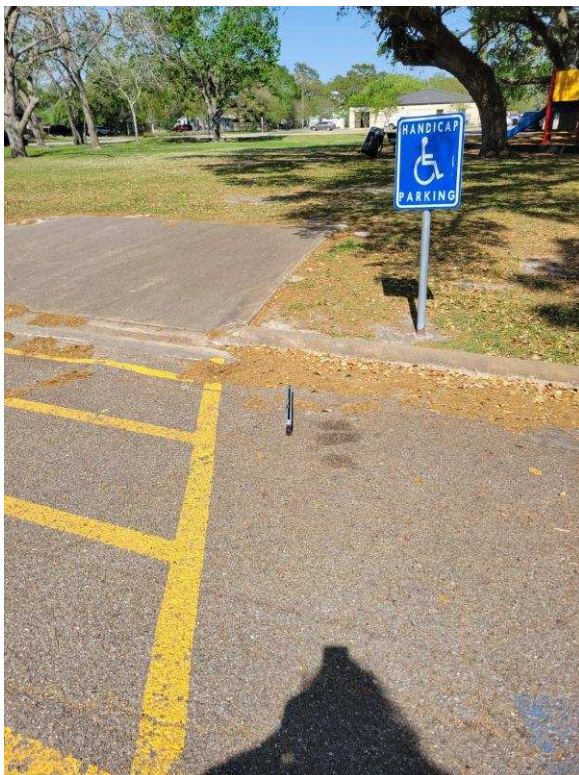
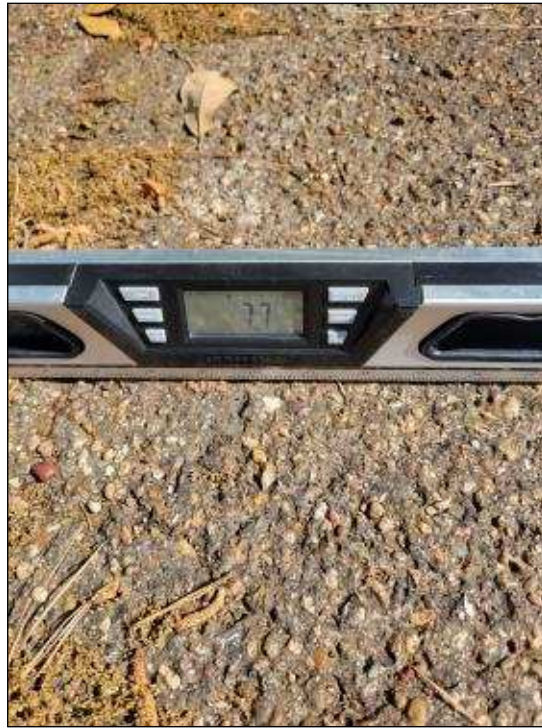
Barrier #1 Additional Barrier Photos

Level 2 (High): Parking and exterior accessible routes (DOJ Level 1) – severely out of compliance; near a hospital, school, transit stop, govt. bldg., or other pedestrian attractor

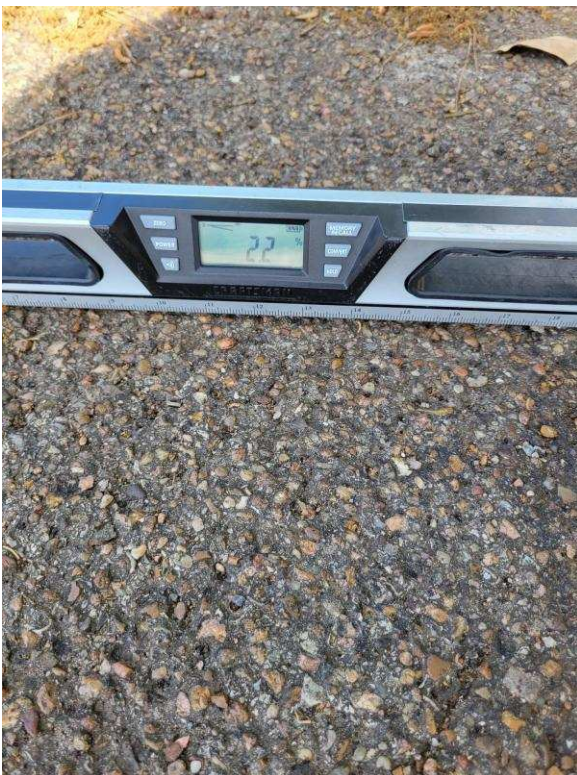
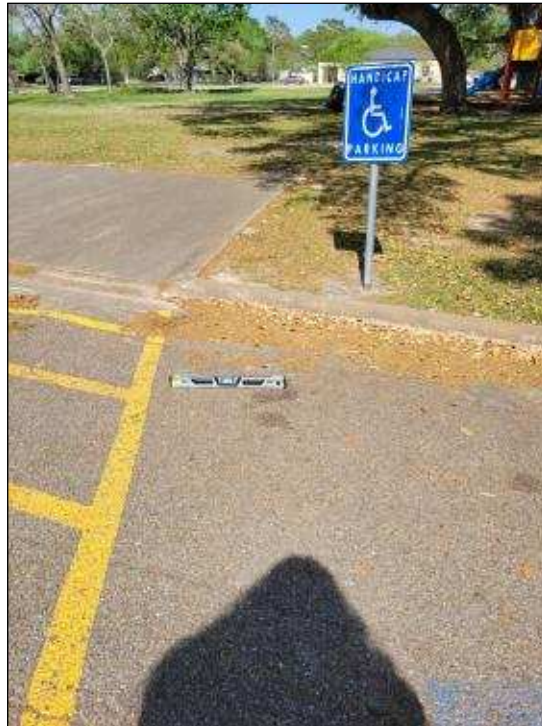
Barrier #2 Additional Barrier Photos

Level 2 (High): Parking and exterior accessible routes (DOJ Level 1) – severely out of compliance; near a hospital, school, transit stop, govt. bldg., or other pedestrian attractor

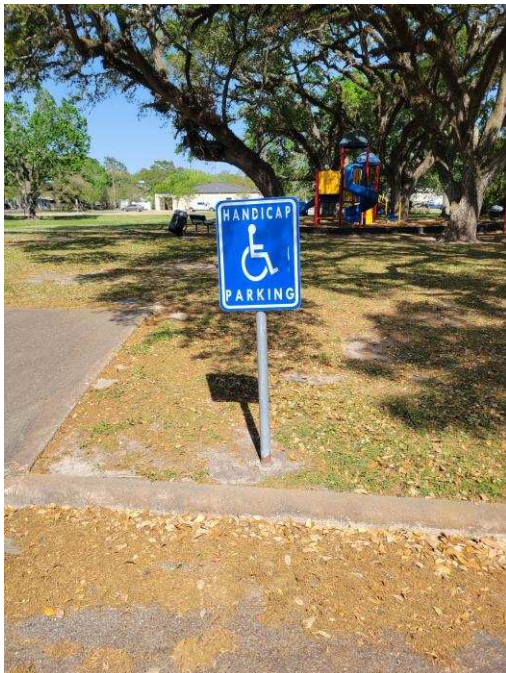
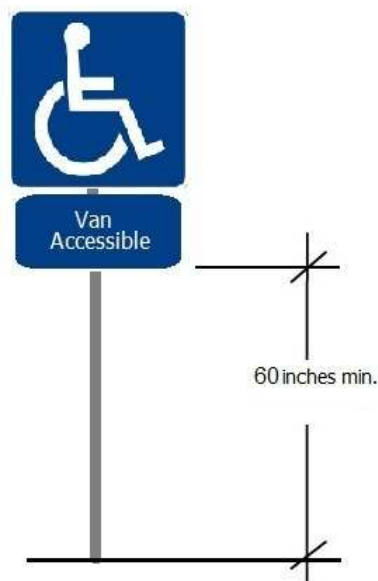
Barrier: 4

Parking: Parking

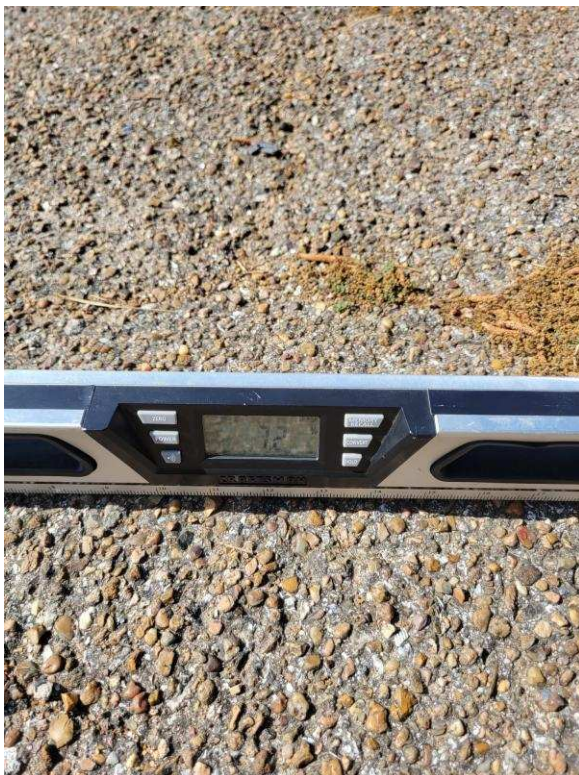
Level 2 (High): Parking and exterior accessible routes (DOJ Level 1) – severely out of compliance; near a hospital, school, transit stop, govt. bldg., or other pedestrian attractor

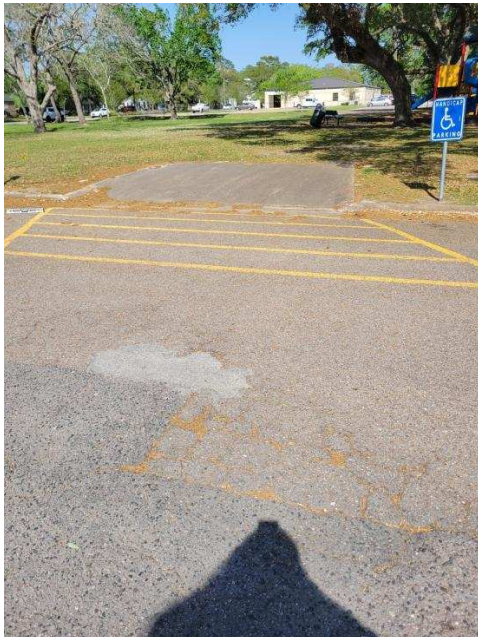
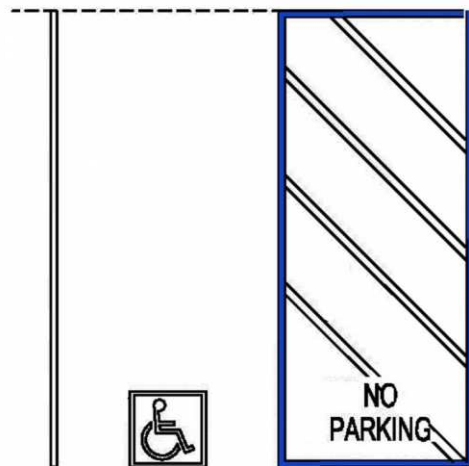
Barrier: 8

The striping for the accessible parking stalls loading/unloading access aisle is missing.

The words "NO PARKING" is missing from the access aisle adjacent to the parking space per Texas Administrative Code.

Level 5 (Medium): Access to goods and services issues (DOJ Level 2) – severely out of compliance

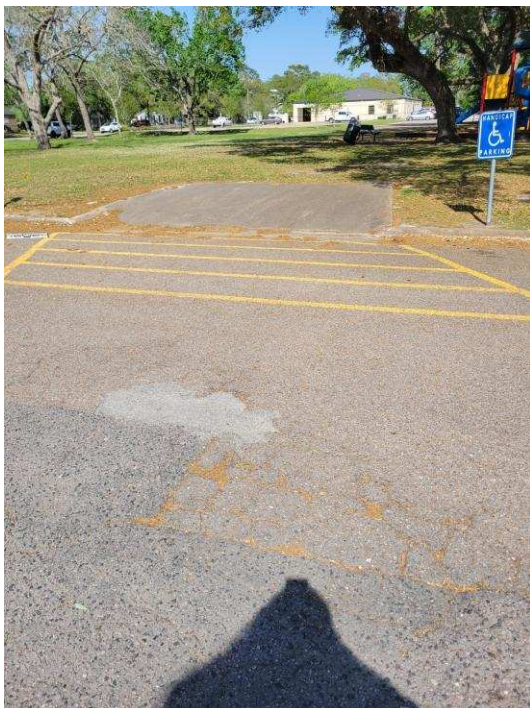
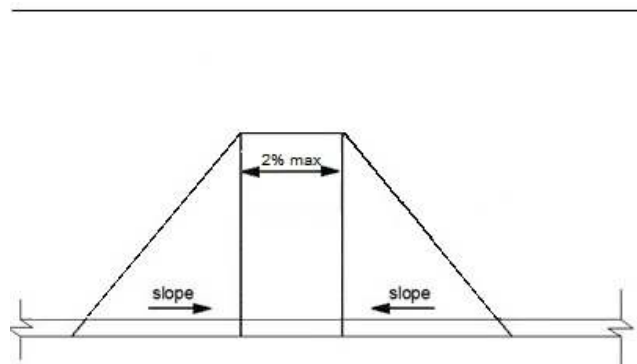
Level 2 (High): Parking and exterior accessible routes (DOJ Level 1) – severely out of compliance; near a hospital, school, transit stop, govt. bldg., or other pedestrian attractor

Remove and replace curb ramp.

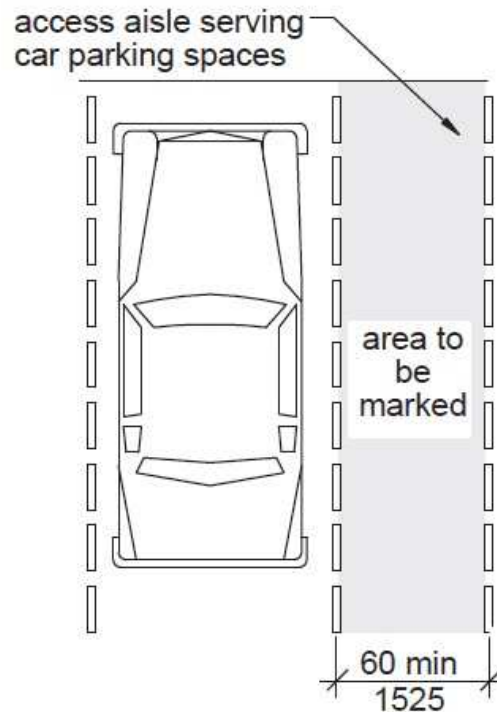
The access aisle is missing at the majority of the accessible parking stalls.

Level 3 (High): Parking and exterior accessible routes (DOJ Level 1) – severely out of compliance; NOT near a hospital, school, transit stop, govt. bldg., or other pedestrian attractor

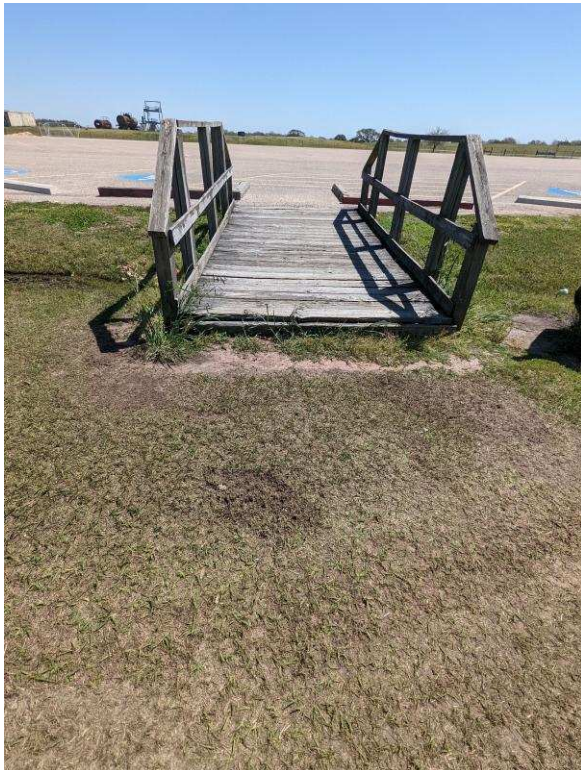
Level 5 (Medium): Access to goods and services issues (DOJ Level 2) – severely out of compliance

Replace the pedestrian bridge with a fully compliant accessible route.

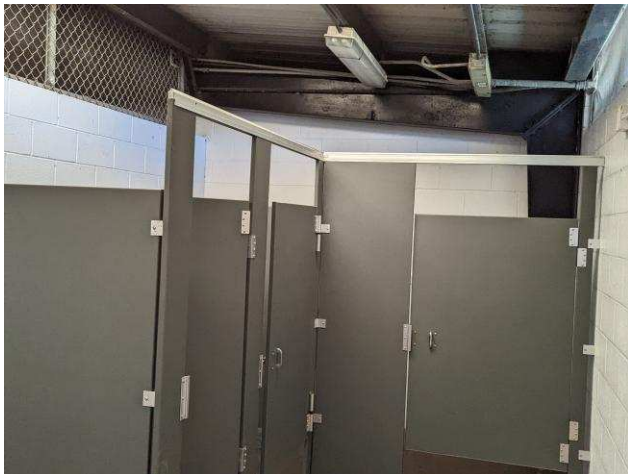
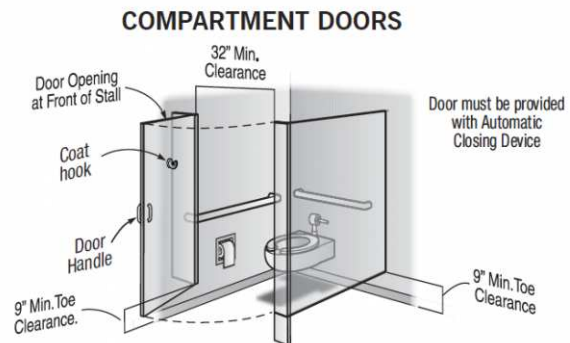
Barrier: 9

Level 9 (Low): Restrooms (DOJ Level 3) – minimally out of compliance

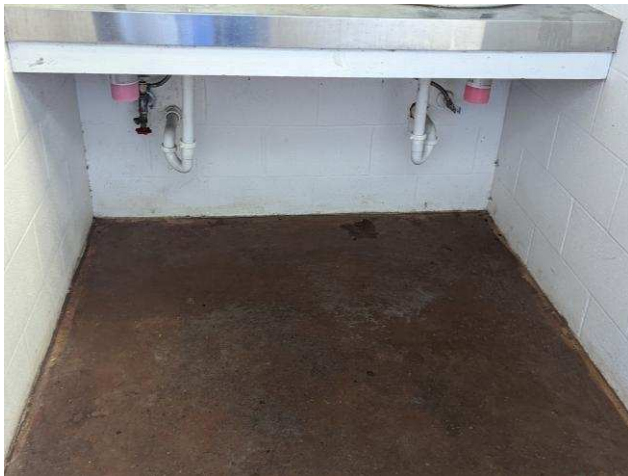
Barrier: 10

Level 8 (Medium): Drinking fountains and public phones (DOJ Level 4 & 5) – moderately out of compliance

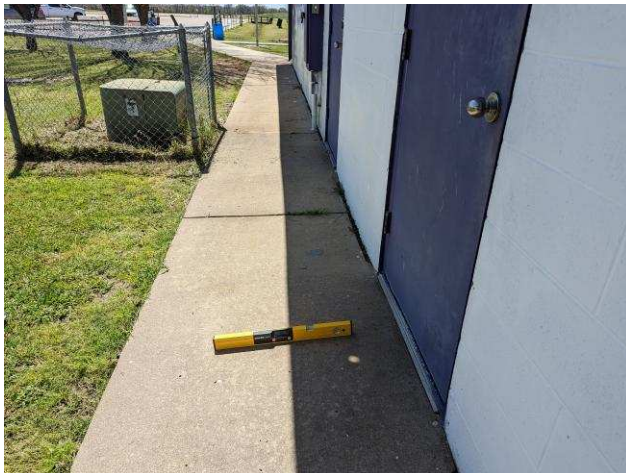
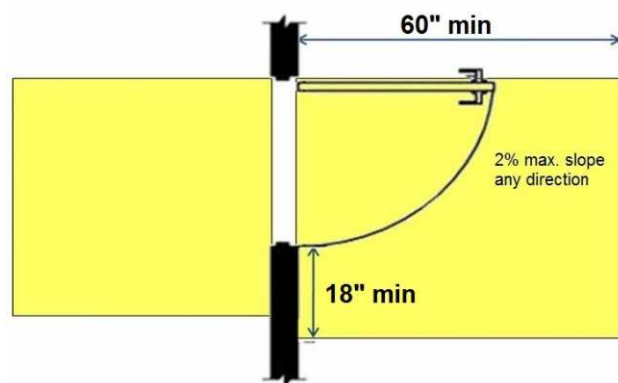
Barrier: 11

Level 6 (Medium): Parking or exterior accessible routes (DOJ Level 1) – minimally out of compliance
Access to goods and services (DOJ Level 2) – moderately out of compliance
Restrooms (DOJ Level 3) – severely out of compliance

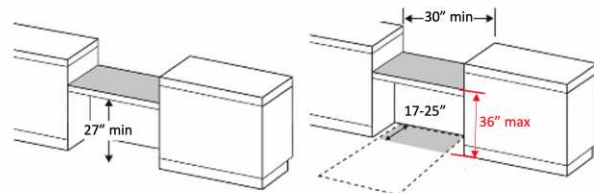
Barrier: 12

Restrooms (DOJ Level 3) – moderately out of compliance

Drinking fountains and public phones (DOJ Level 4 & 5) – severely out of compliance

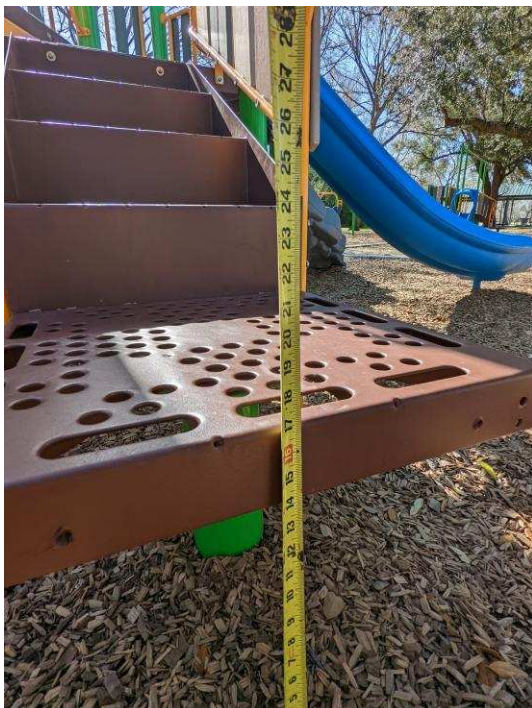
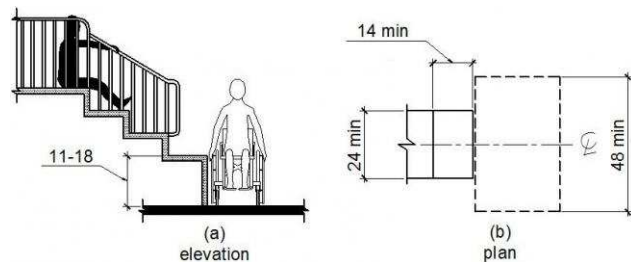
Barrier: 2

Transfer support missing.

Access to goods and services (DOJ Level 2) – moderately out of compliance

Restrooms (DOJ Level 3) – severely out of compliance

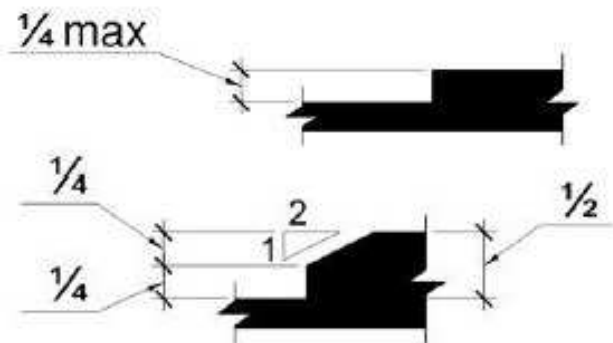
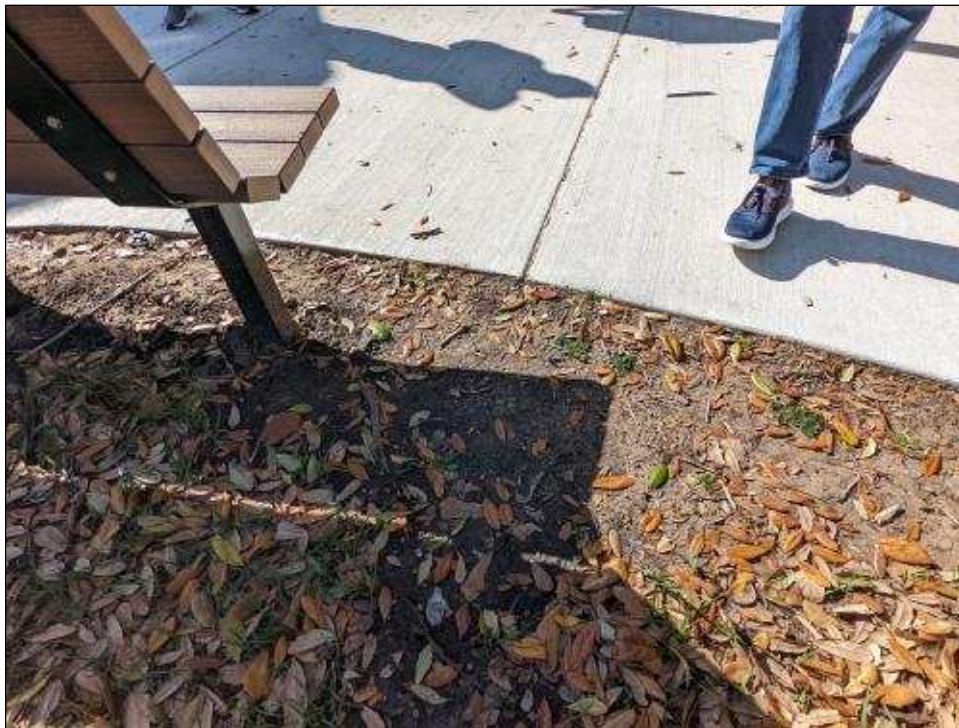
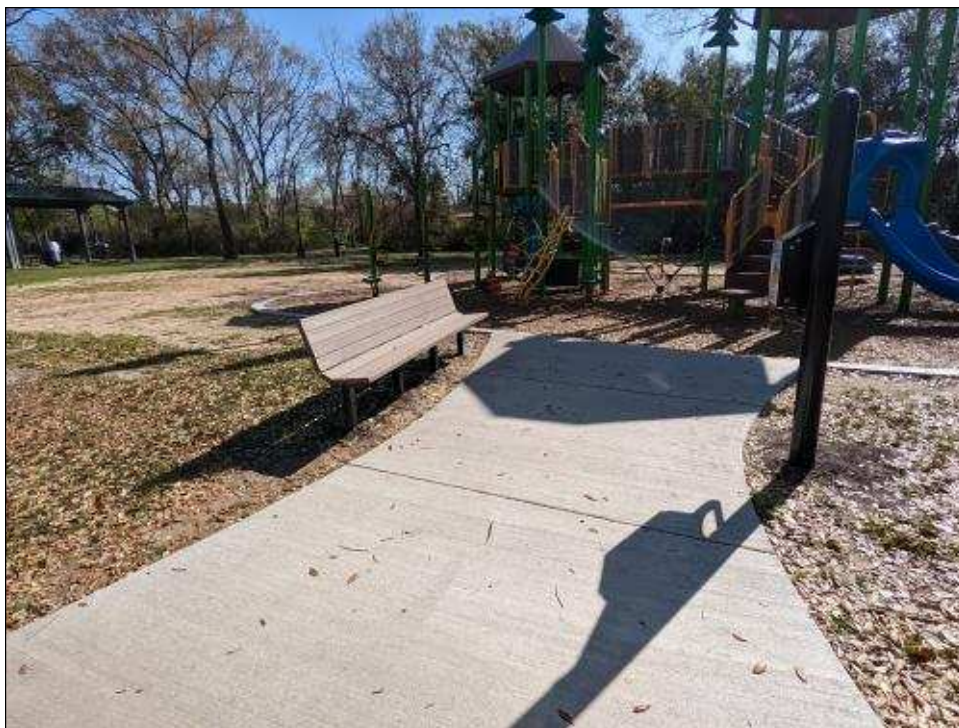
Barrier: 3

Access to goods and services (DOJ Level 2) – moderately out of compliance

Restrooms (DOJ Level 3) – severely out of compliance

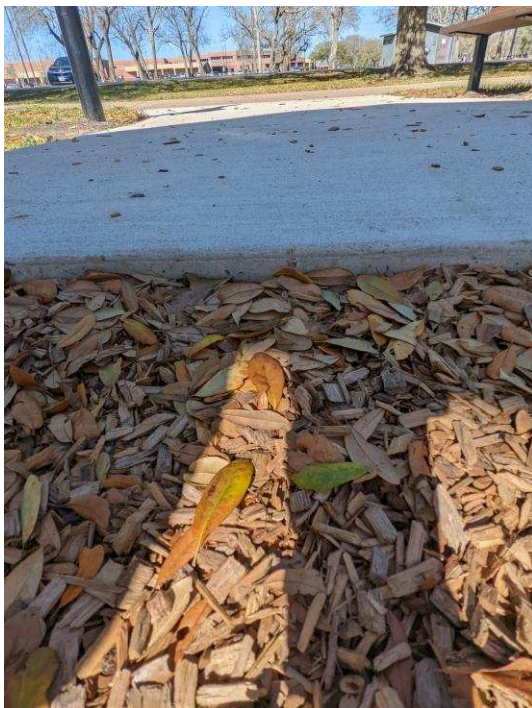
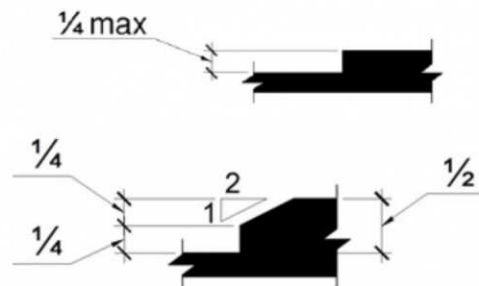
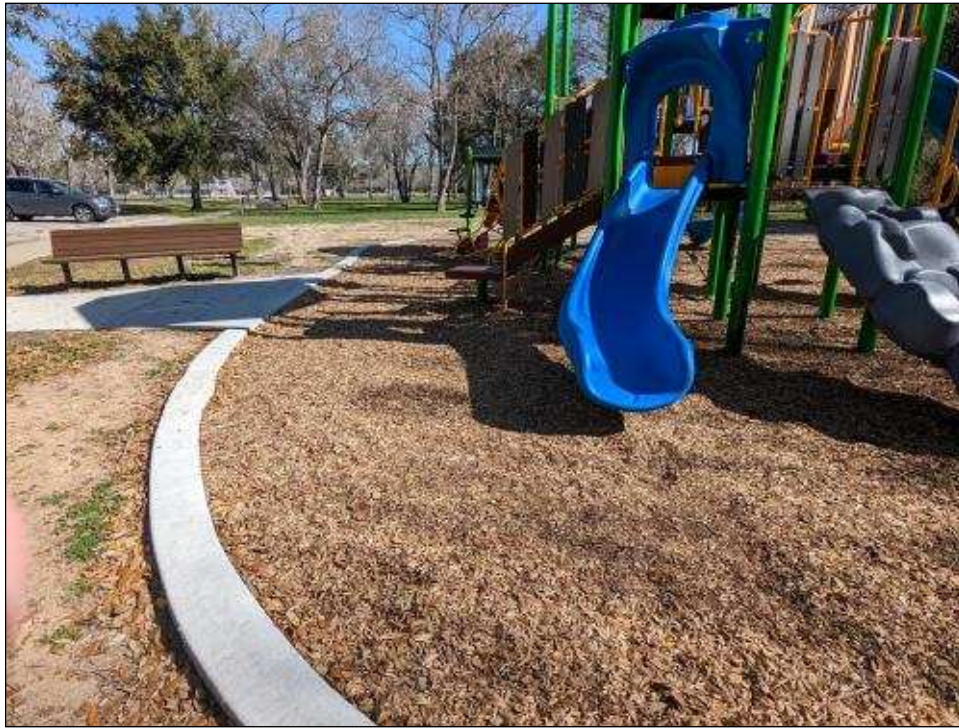
Barrier: 4

Level 5 (Medium): Access to goods and services issues (DOJ Level 2) – severely out of compliance

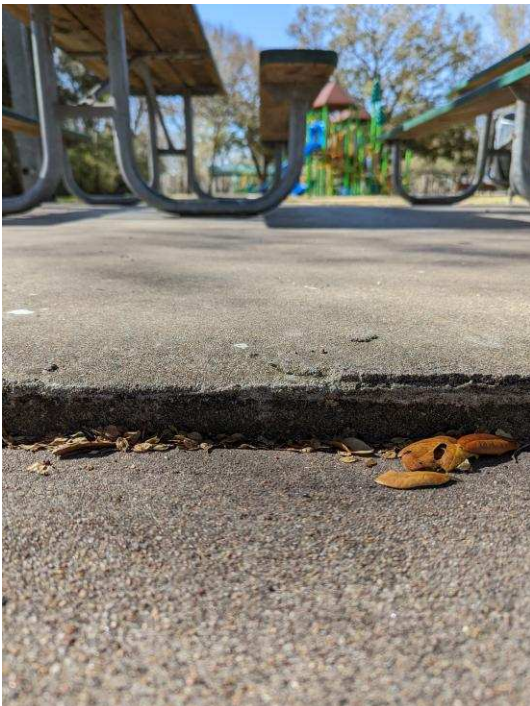
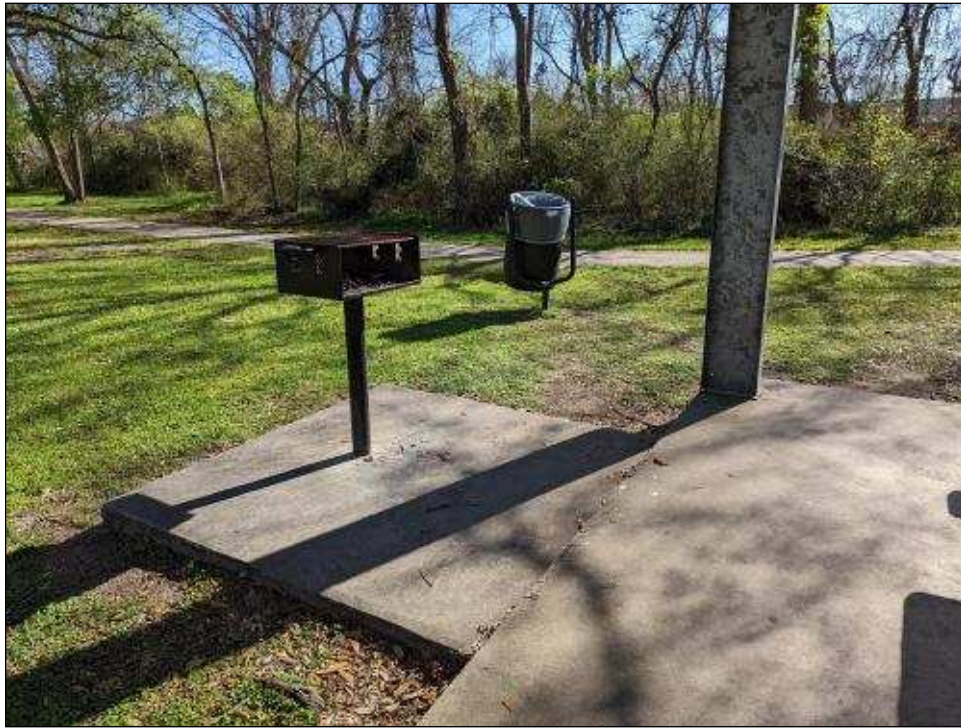
Barrier: 6

Level 5 (Medium): Access to goods and services issues (DOJ Level 2) – severely out of compliance

Repair ground surface to provide a smooth transition to the grill.

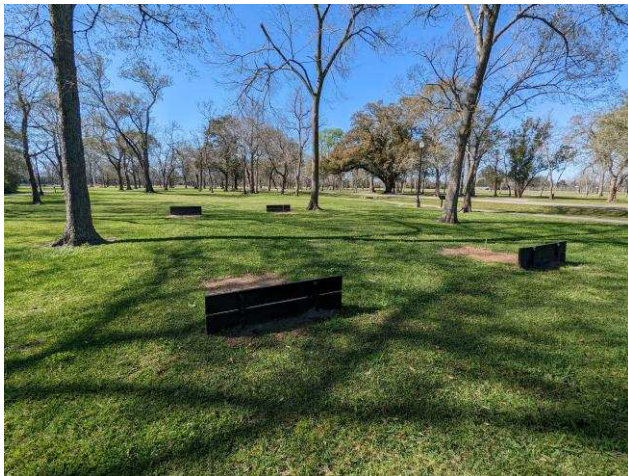
Barrier: 7

Level 5 (Medium): Access to goods and services issues (DOJ Level 2) – severely out of compliance

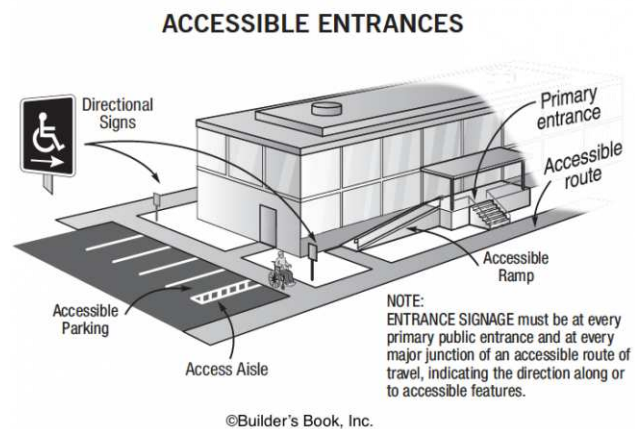
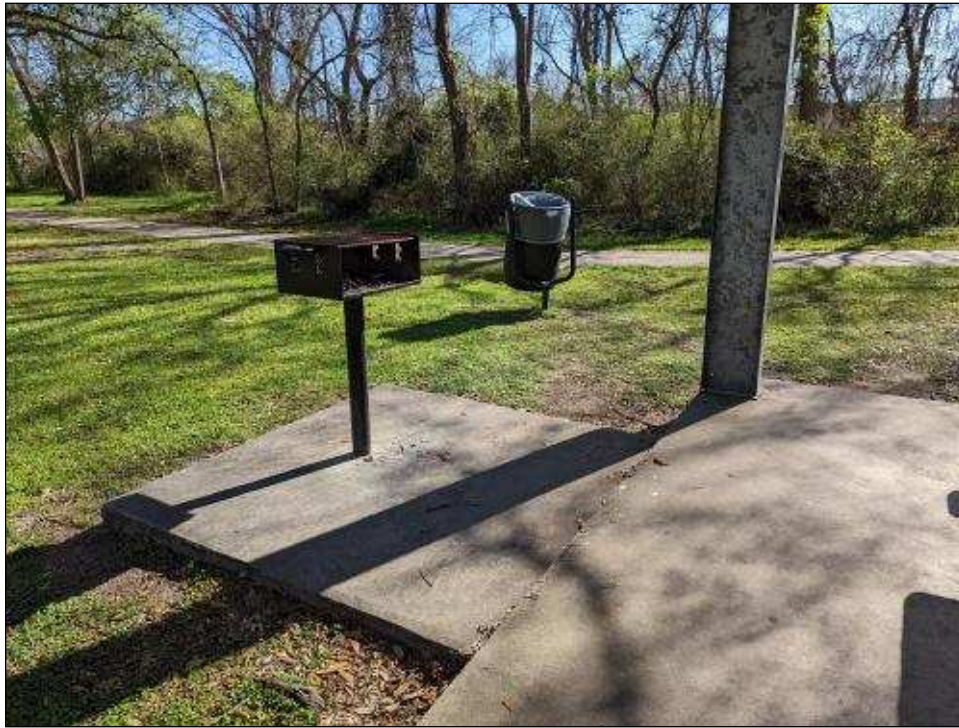
Barrier: 8

Access to goods and services (DOJ Level 2) – moderately out of compliance

Restrooms (DOJ Level 3) – severely out of compliance

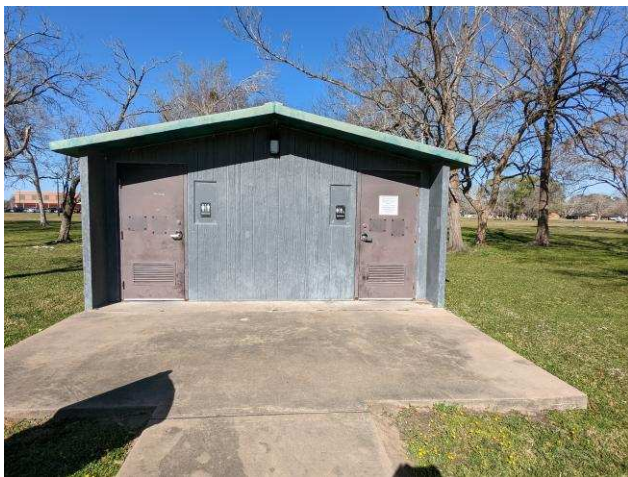
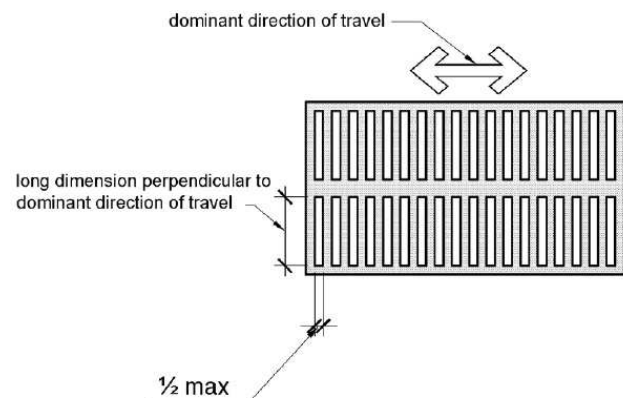
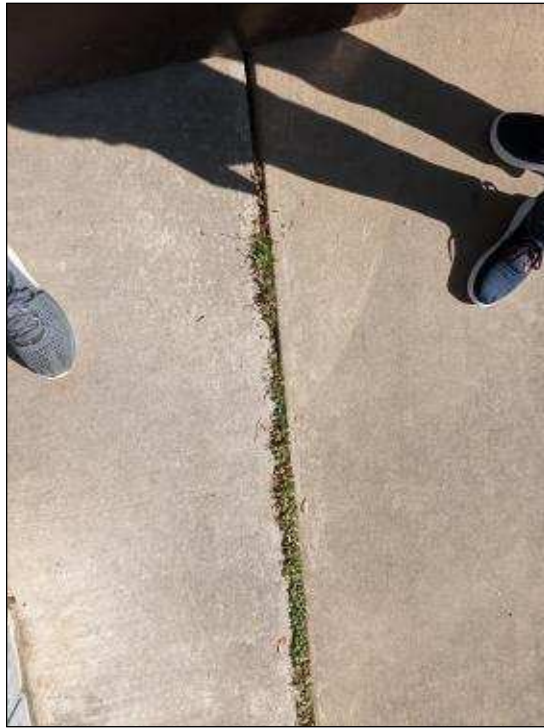
Barrier: 10

Access to goods and services (DOJ Level 2) – moderately out of compliance

Restrooms (DOJ Level 3) – severely out of compliance

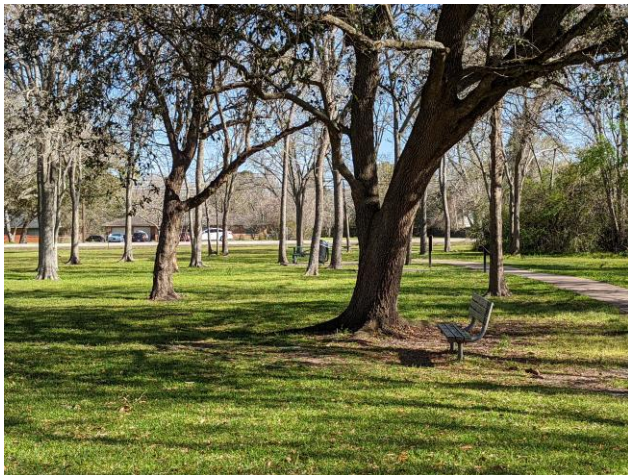
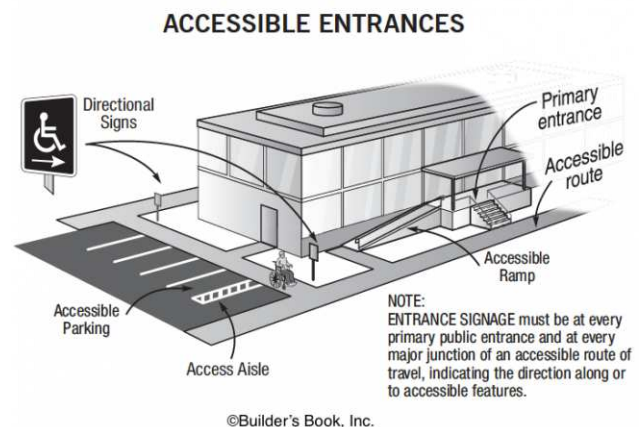
Barrier: 11

Access to goods and services (DOJ Level 2) – moderately out of compliance

Restrooms (DOJ Level 3) – severely out of compliance

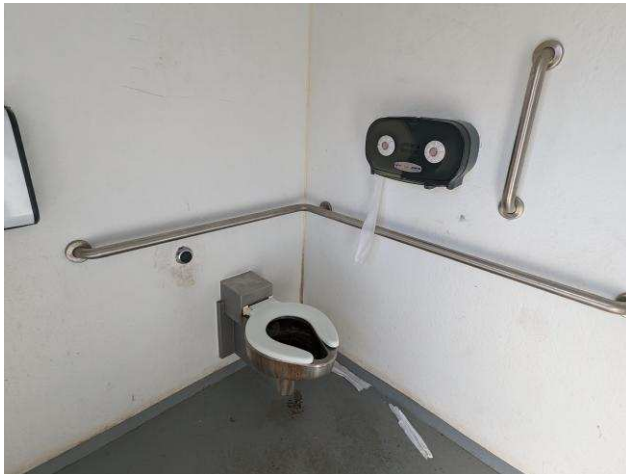
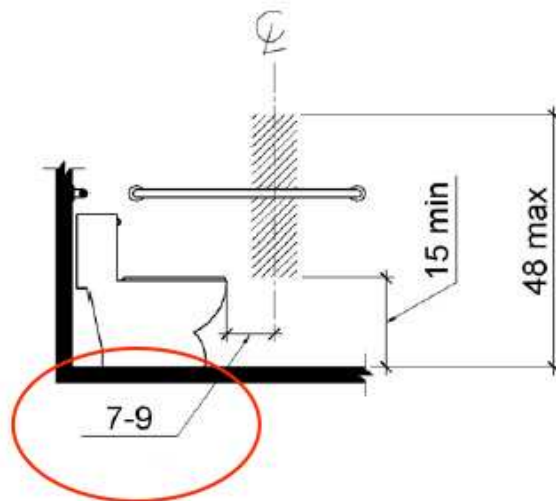
Barrier: 12

Level 9 (Low): Restrooms (DOJ Level 3) – minimally out of compliance

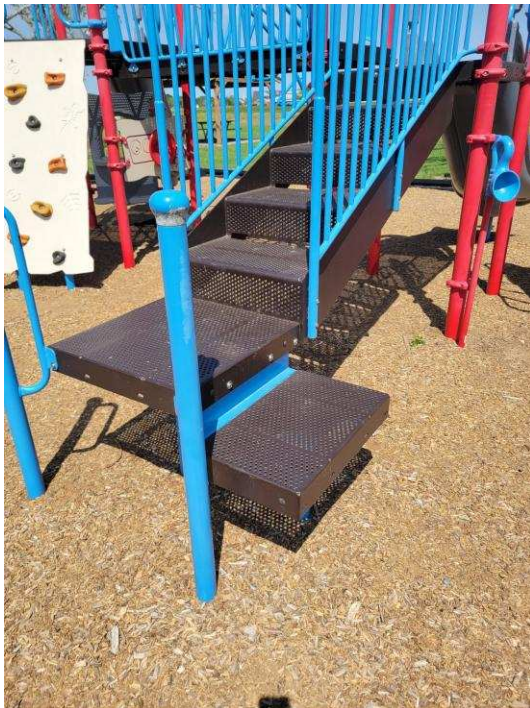
Barrier: 3

Playground: Equipment

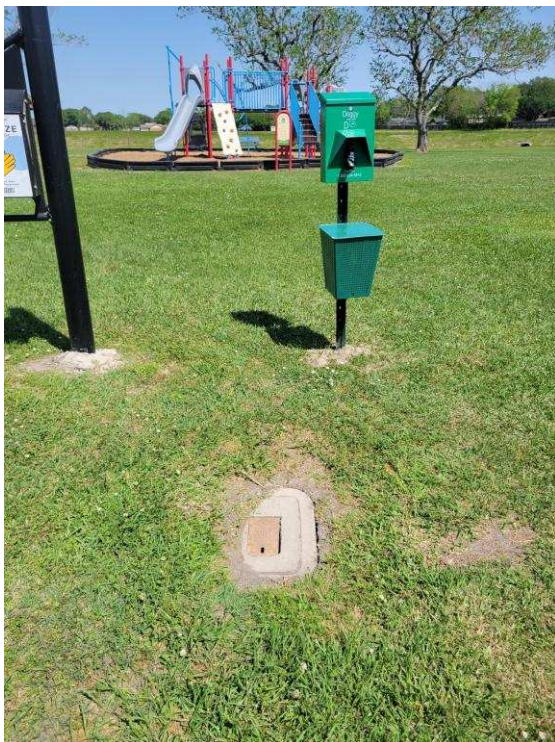
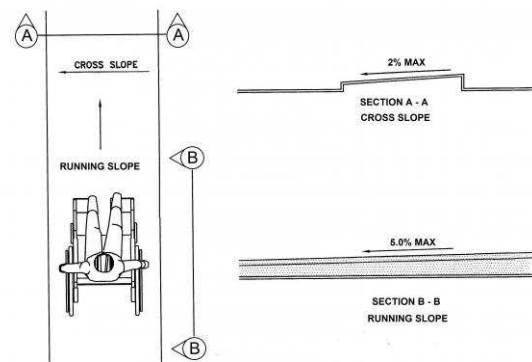
Barrier: 5

Playground: Equipment

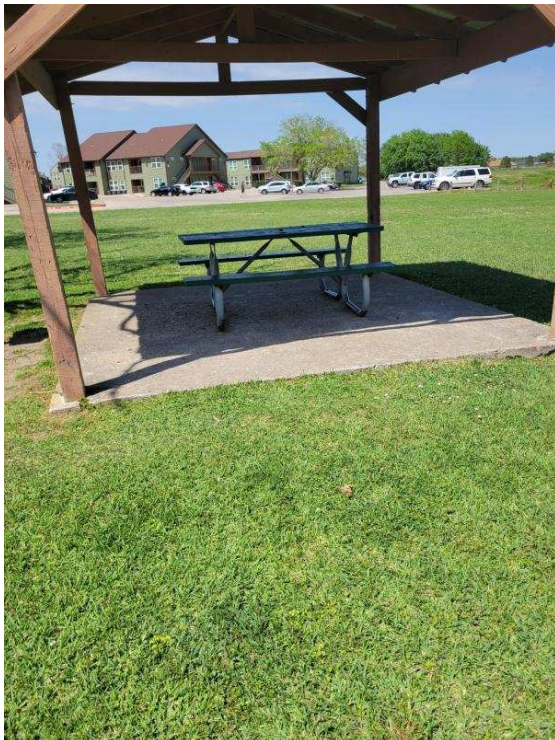
Barrier: 7

Pavillion: Accessible Route

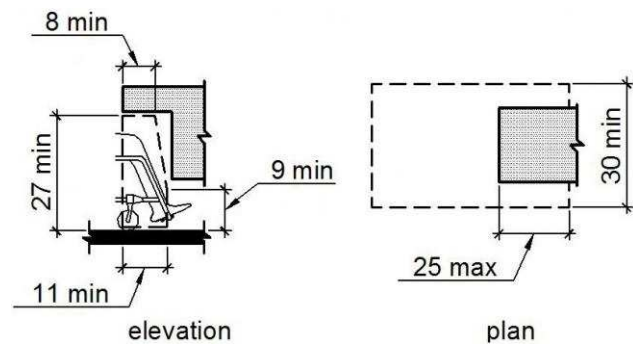
Barrier: 8

Pavillion: Accessible Route

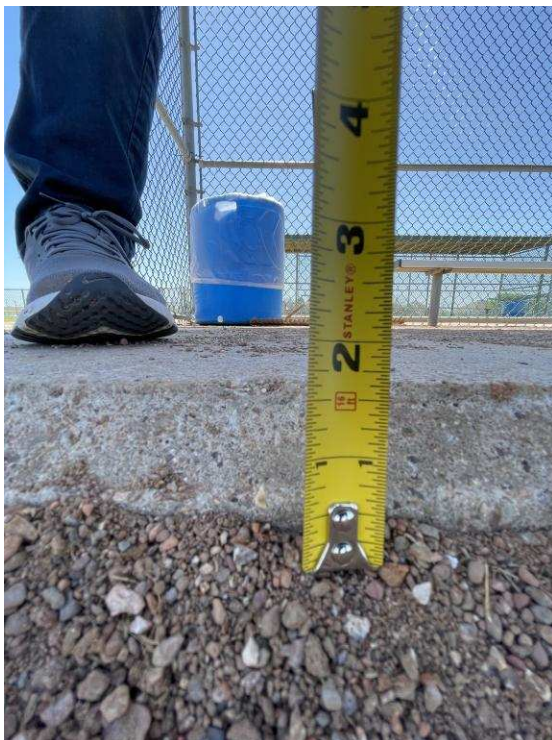
Barrier: 7

Restrooms: Playground Restrooms

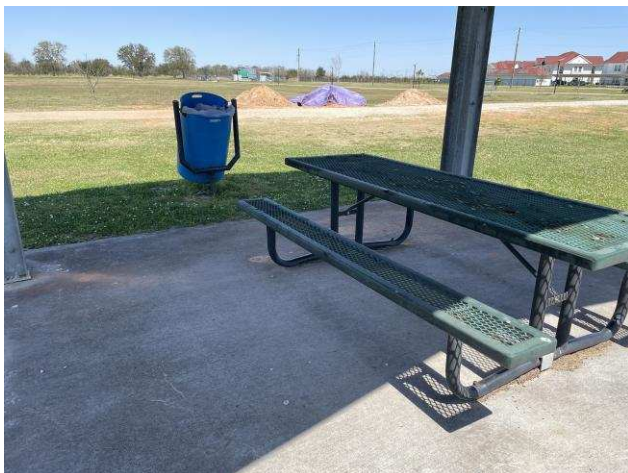
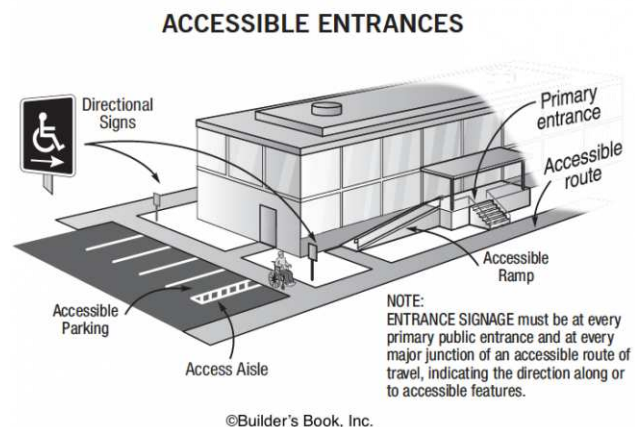
Barrier: 9

Path of Travel: Pavillion

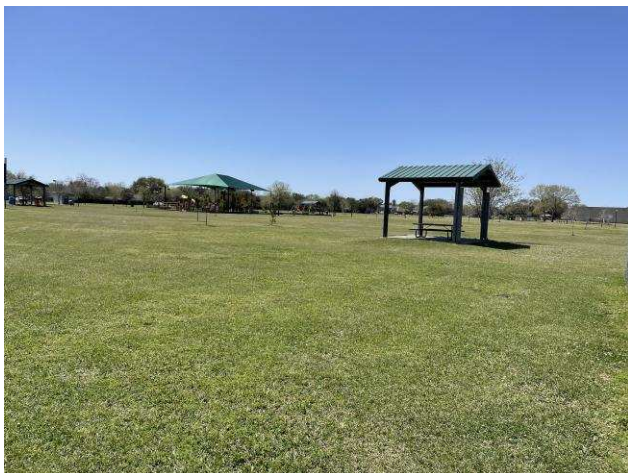
Barrier: 10

Path of Travel: Pavillion

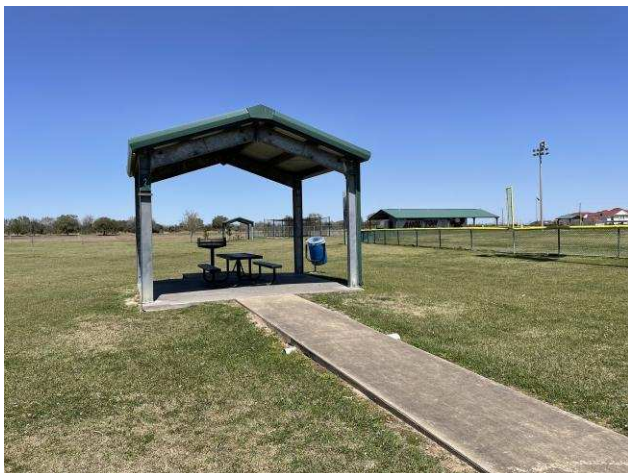
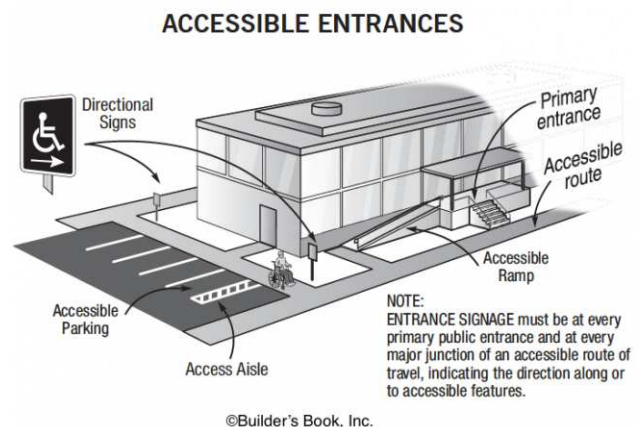
Path of Travel: Pavillion

Restrooms (DOJ Level 3) – moderately out of compliance

Drinking fountains and public phones (DOJ Level 4 & 5) – severely out of compliance

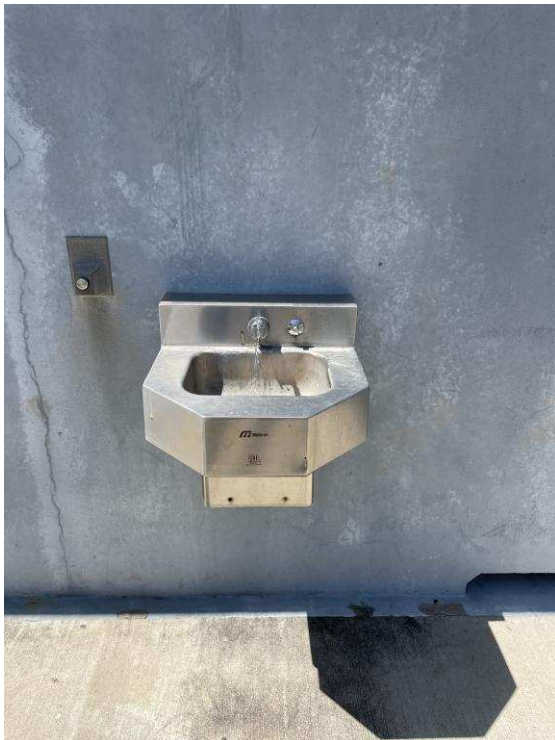
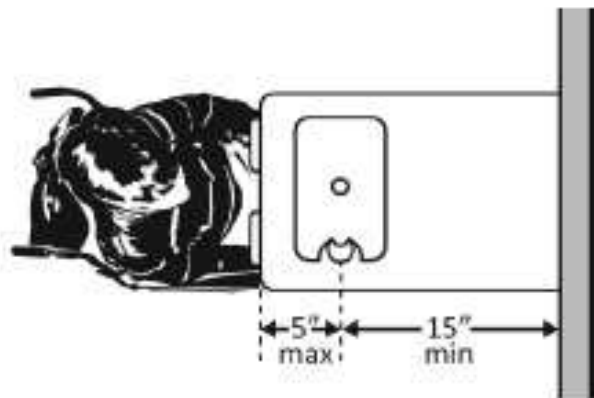
Barrier: 14

Level 8 (Medium): Drinking fountains and public phones (DOJ Level 4 & 5) – moderately out of compliance

Replace the drinking fountain with a compliant fountain.

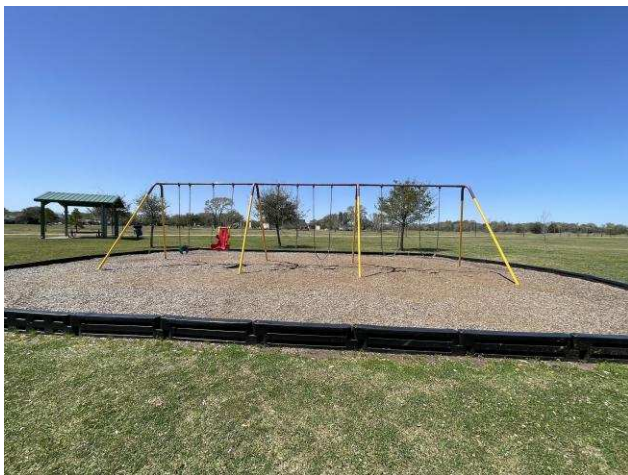
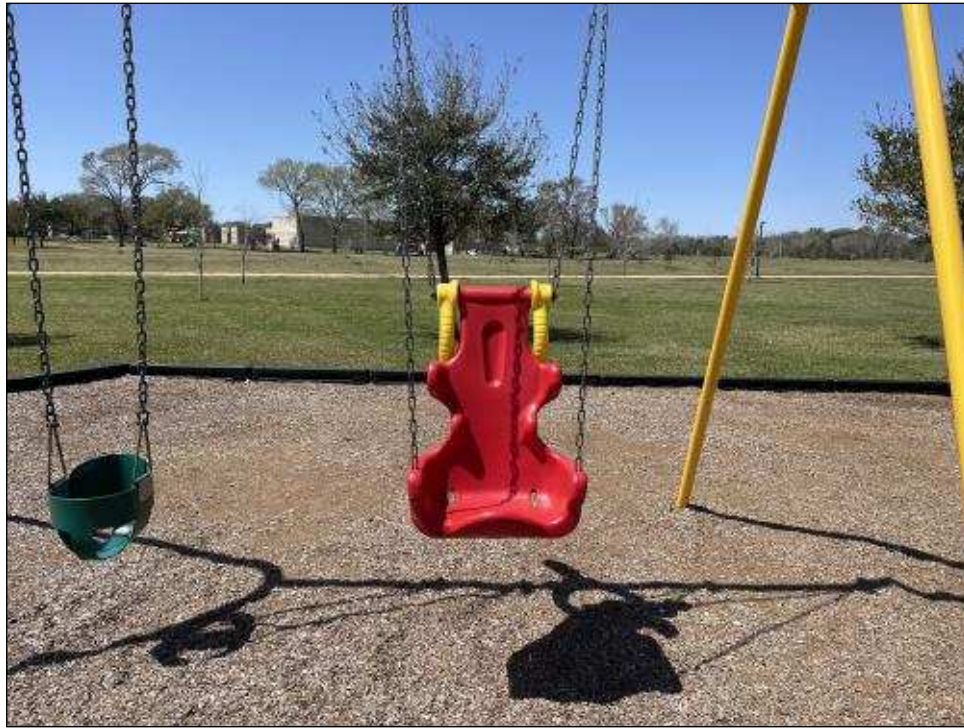
Barrier #15 Additional Barrier Photos

Restrooms (DOJ Level 3) – moderately out of compliance

Drinking fountains and public phones (DOJ Level 4 & 5) – severely out of compliance
