Appendix A: Public Outreach

Site Accessibility Evaluation

Angleton Recreation Center & Natatorium

BG Peck Soccer Complex
709 Kelly Blvd
Angleton, TX 77515
Accessibility Evaluation
Evaluation Date: 03/24/2022
Evaluators: Kristi Avalos

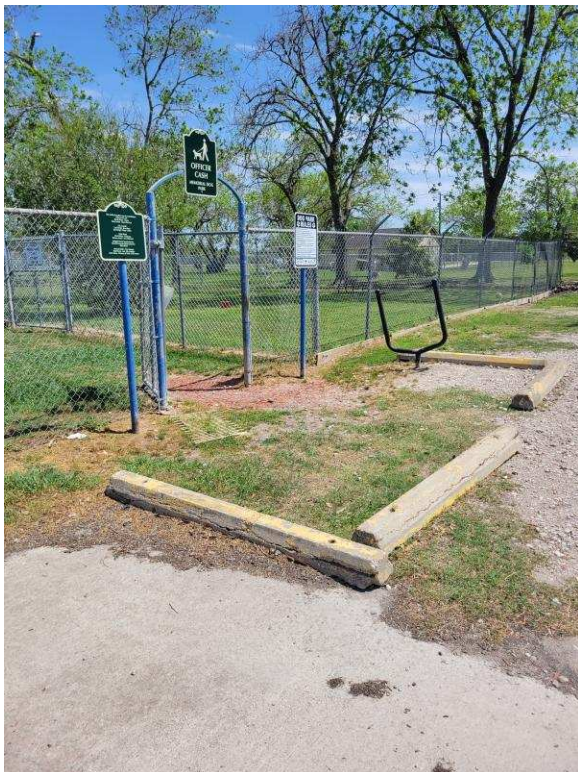
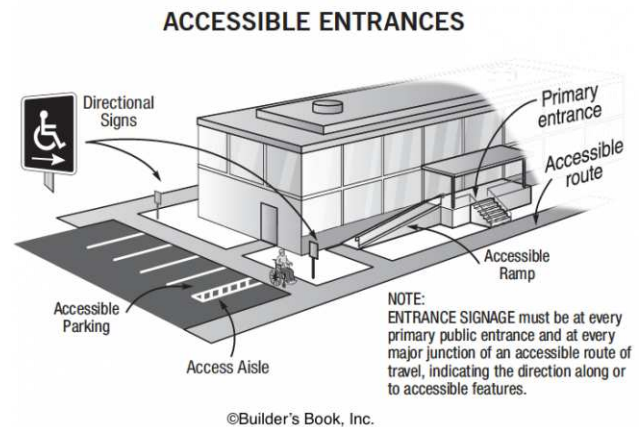
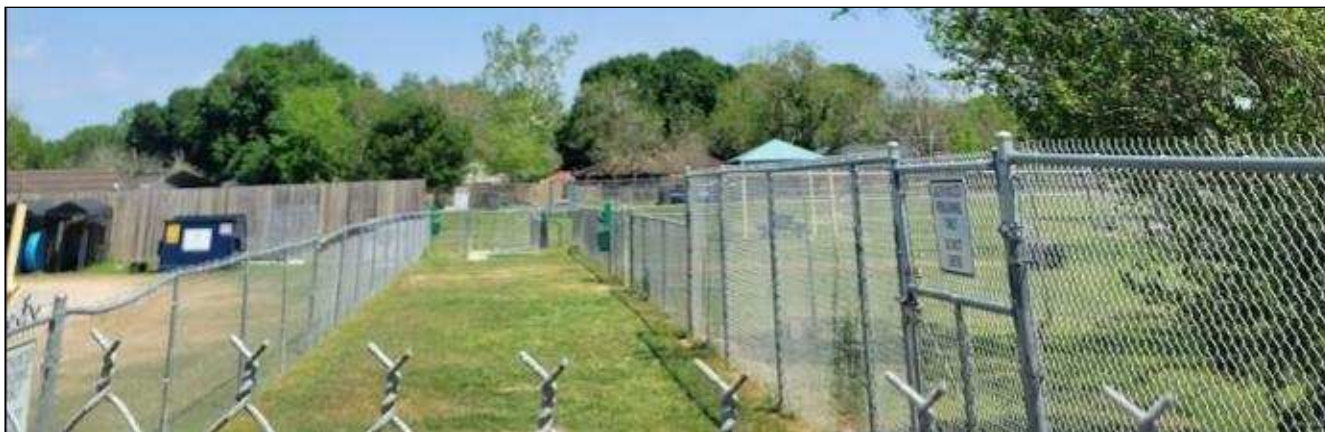
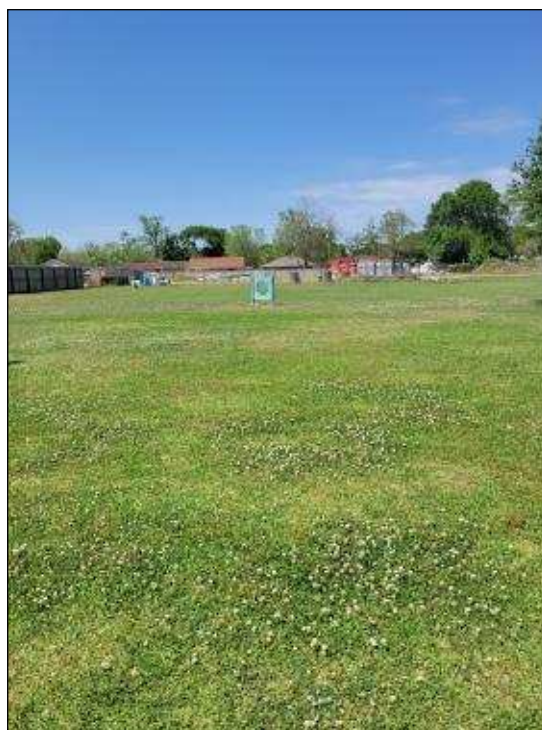
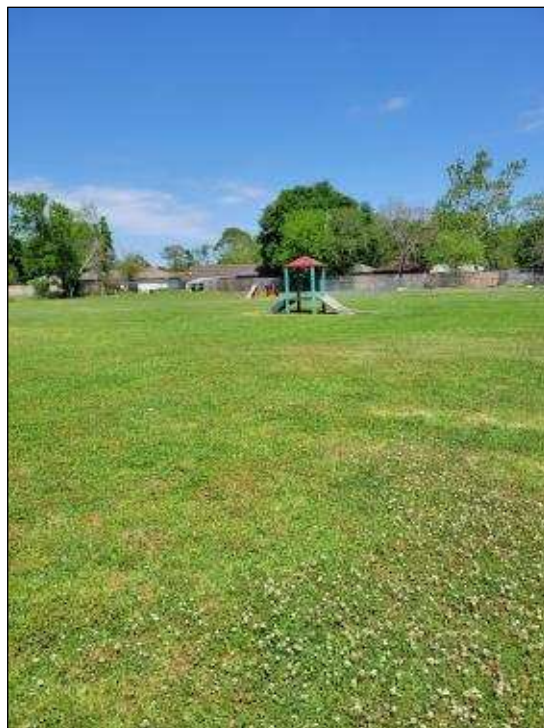
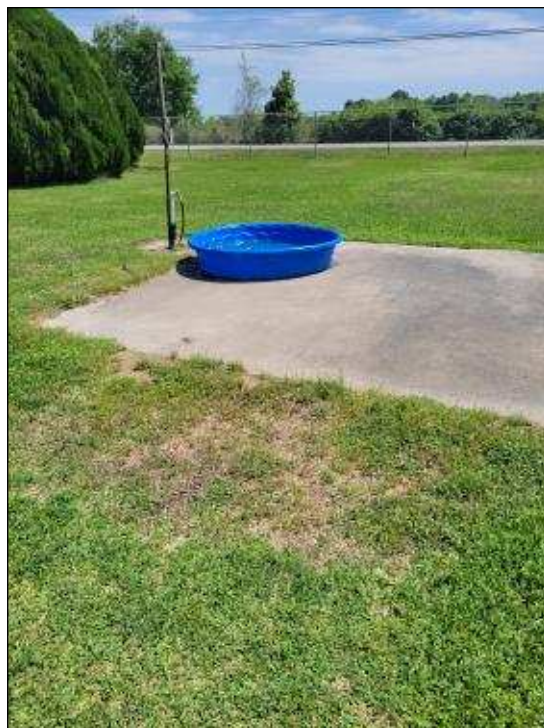
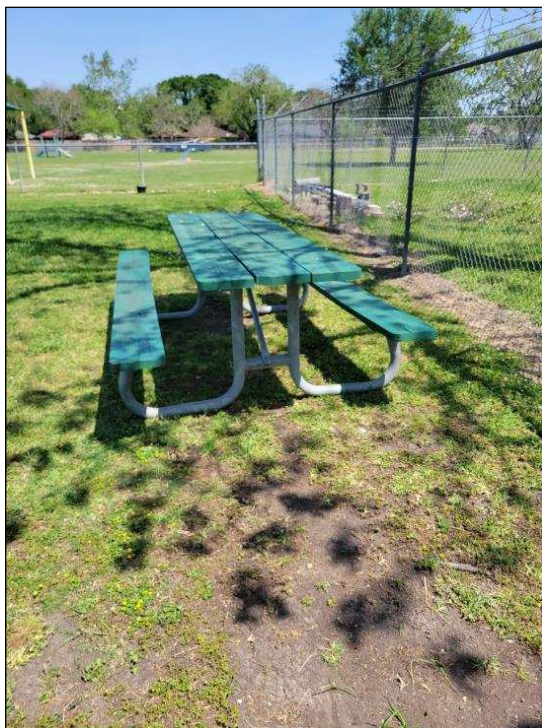
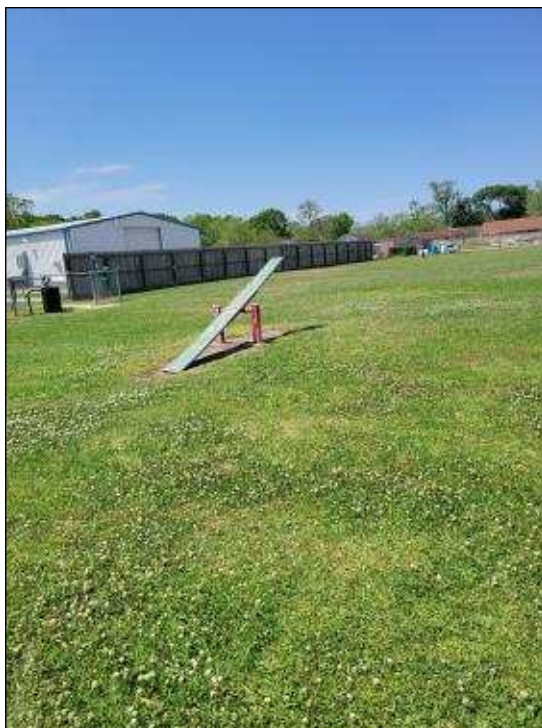
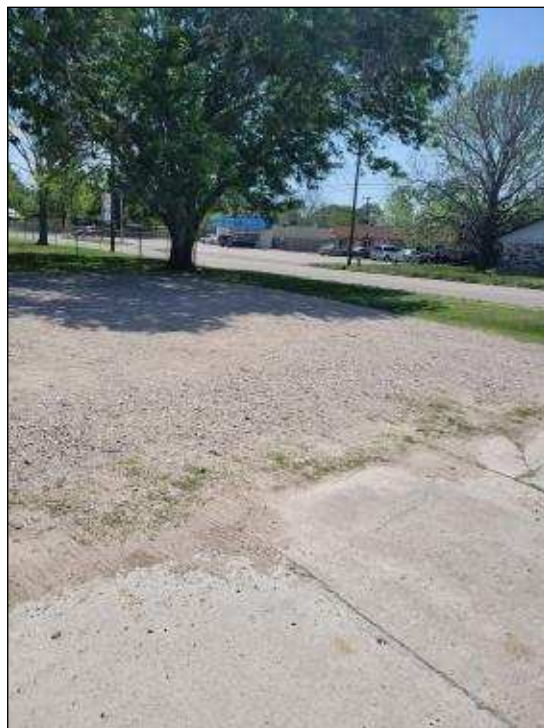
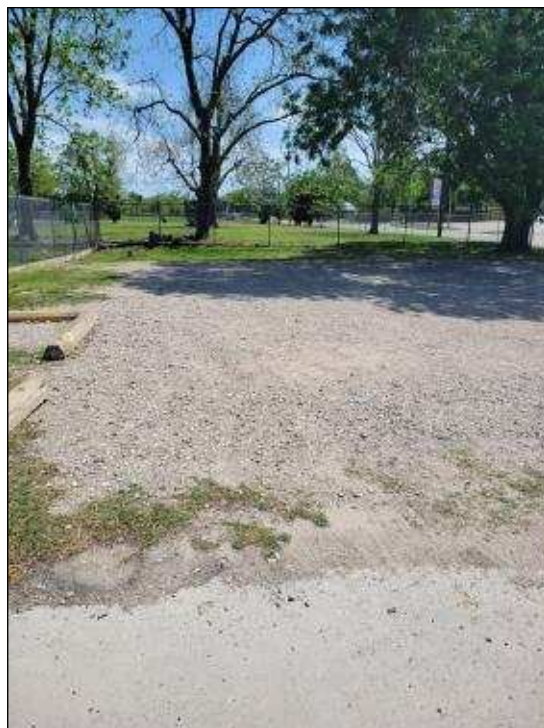
Barrier #1 Additional Barrier Photos

Level 5 (Medium): Access to goods and services issues (DOJ Level 2) – severely out of compliance

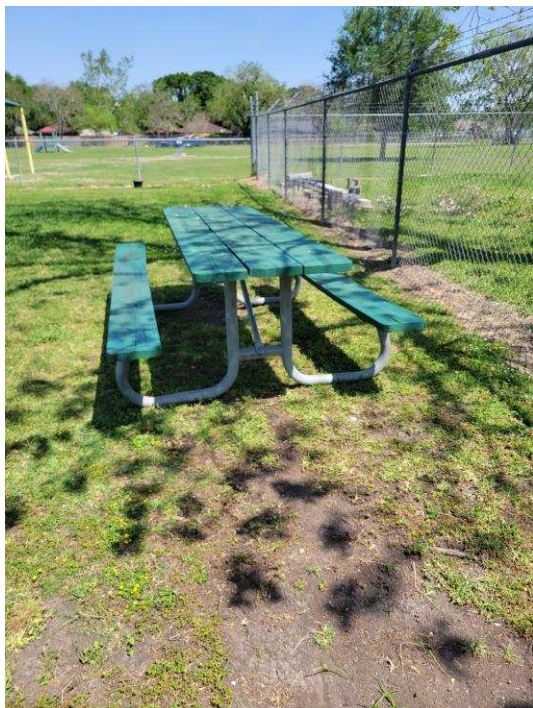
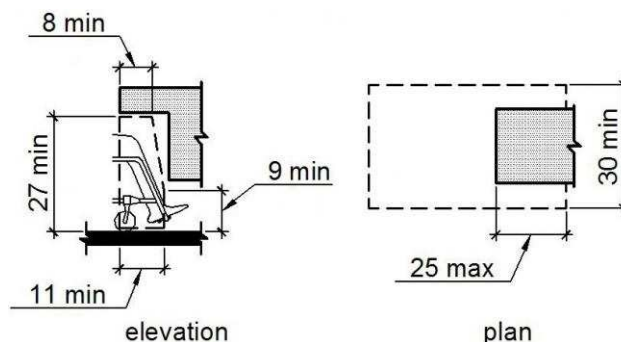
Barrier: 3

Level 6 (Medium): Parking or exterior accessible routes (DOJ Level 1) – minimally out of compliance
Access to goods and services (DOJ Level 2) – moderately out of compliance
Restrooms (DOJ Level 3) – severely out of compliance

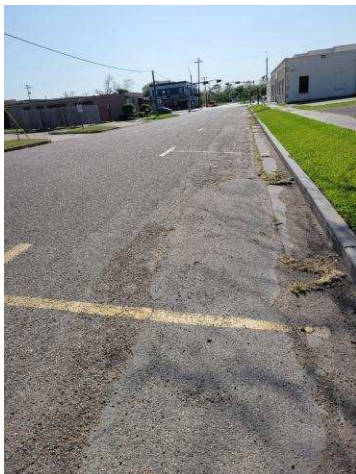
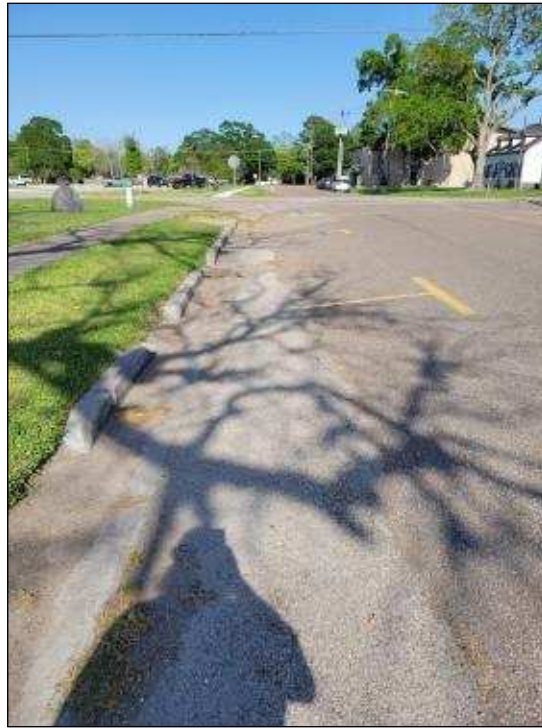
Barrier #1 Additional Barrier Photos

Level 2 (High): Parking and exterior accessible routes (DOJ Level 1) – severely out of compliance; near a hospital, school, transit stop, govt. bldg., or other pedestrian attractor

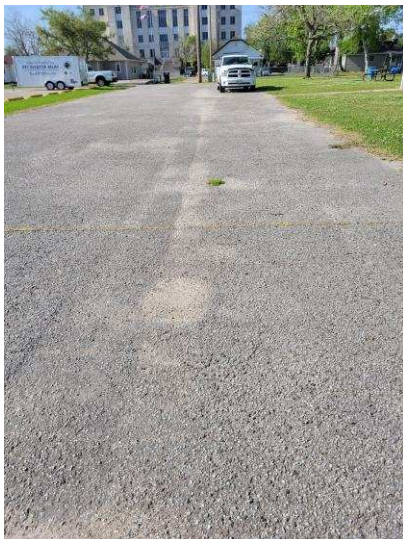
Barrier: 2

Level 2 (High): Parking and exterior accessible routes (DOJ Level 1) – severely out of compliance; near a hospital, school, transit stop, govt. bldg., or other pedestrian attractor

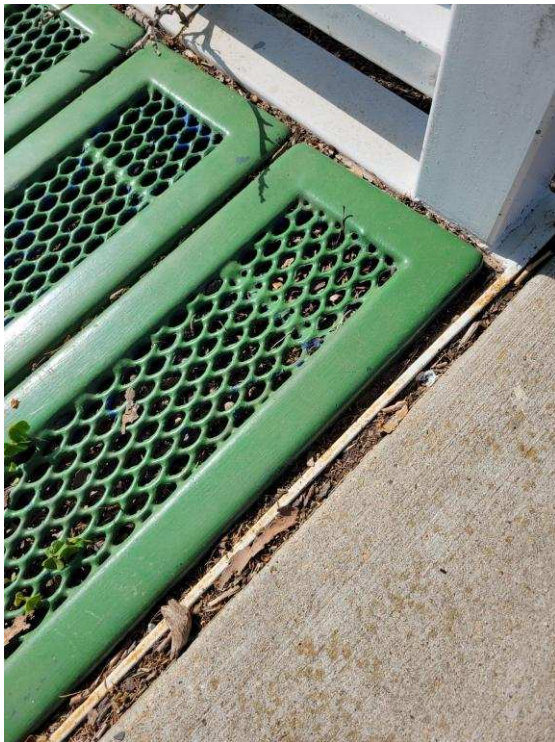
Level 4 (High): Parking and exterior accessible routes (DOJ Level 1) – moderately out of compliance

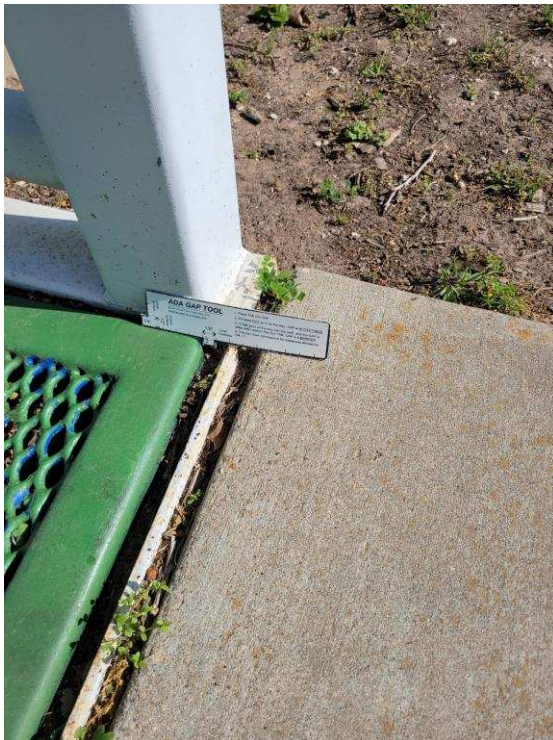
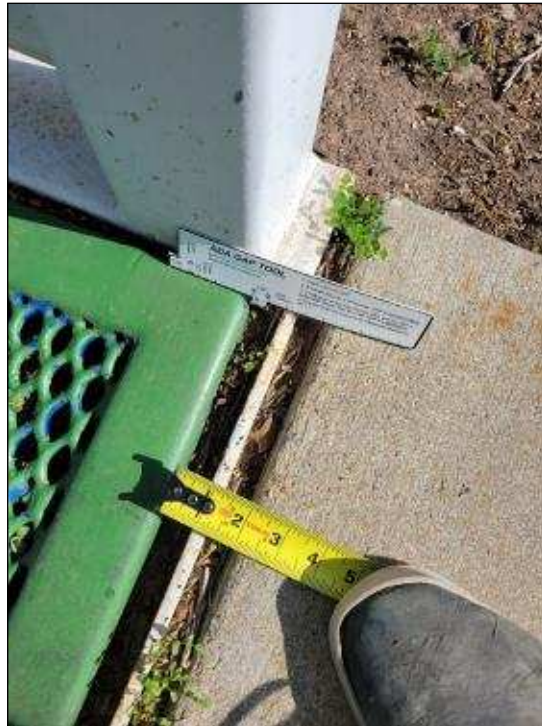
Barrier #4 Additional Barrier Photos

Level 4 (High): Parking and exterior accessible routes (DOJ Level 1) – moderately out of compliance

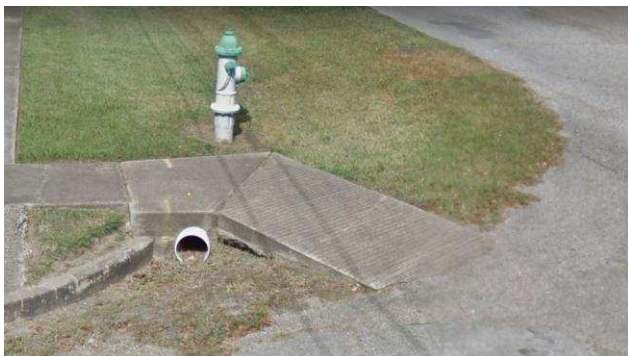
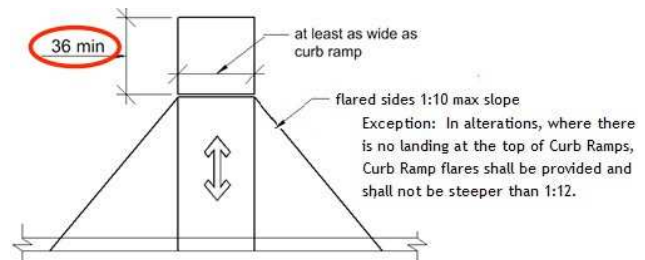
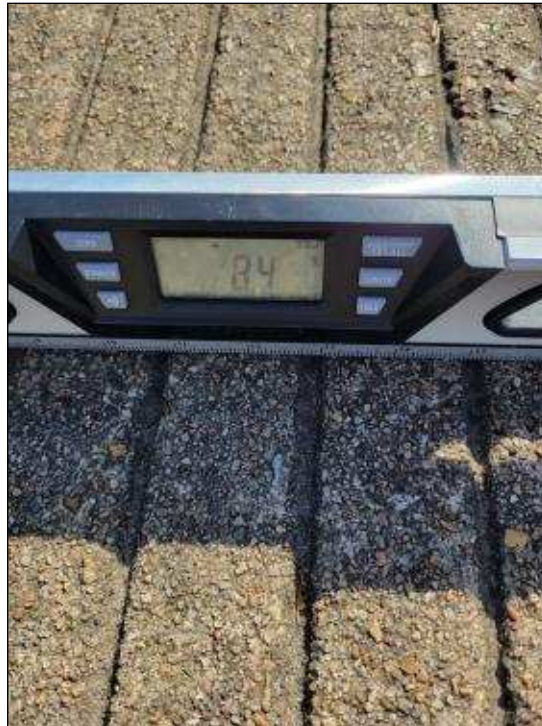
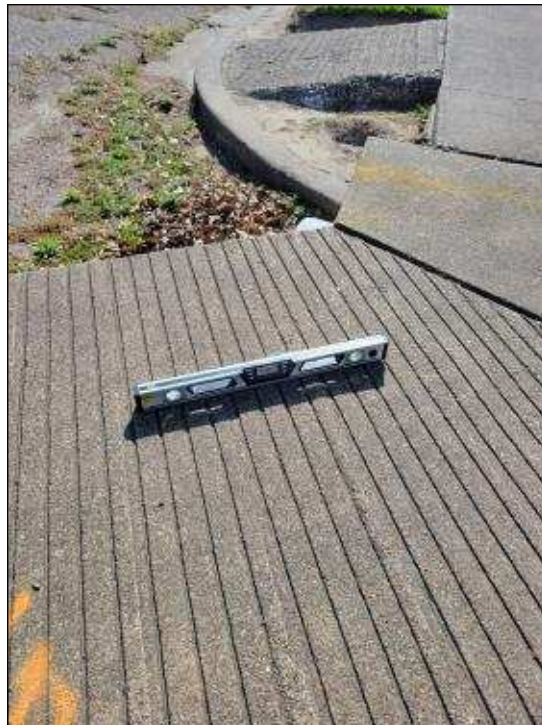
Barrier #5 Additional Barrier Photos

Level 4 (High): Parking and exterior accessible routes (DOJ Level 1) – moderately out of compliance

Replace the curb ramp with a fully compliant curb ramp that includes a level landing area at the top.

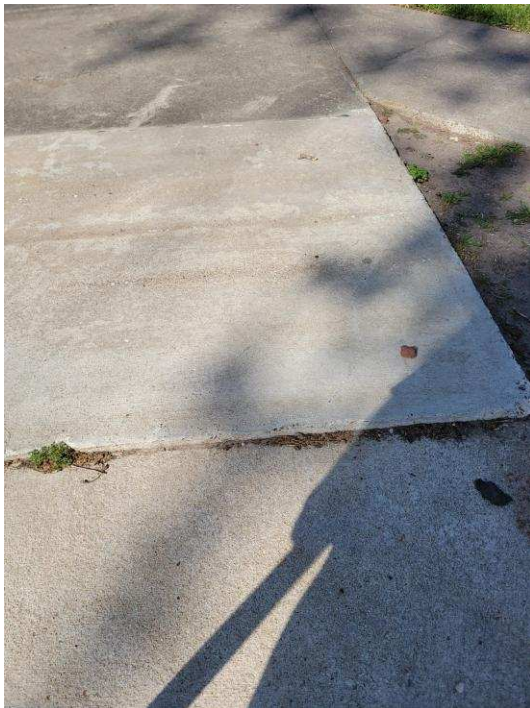
Barrier: 6

Level 4 (High): Parking and exterior accessible routes (DOJ Level 1) – moderately out of compliance

Remove and replace the section of concrete that has the level change.

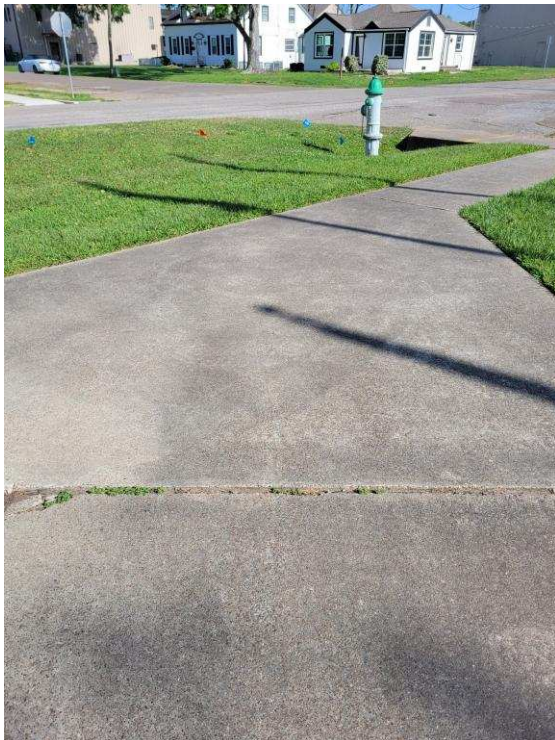
Barrier: 8

Level 4 (High): Parking and exterior accessible routes (DOJ Level 1) – moderately out of compliance

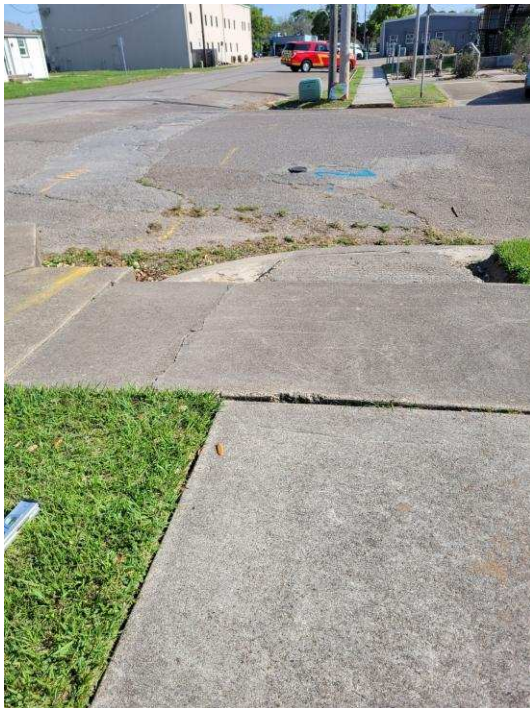
Barrier: 9

Level 4 (High): Parking and exterior accessible routes (DOJ Level 1) – moderately out of compliance

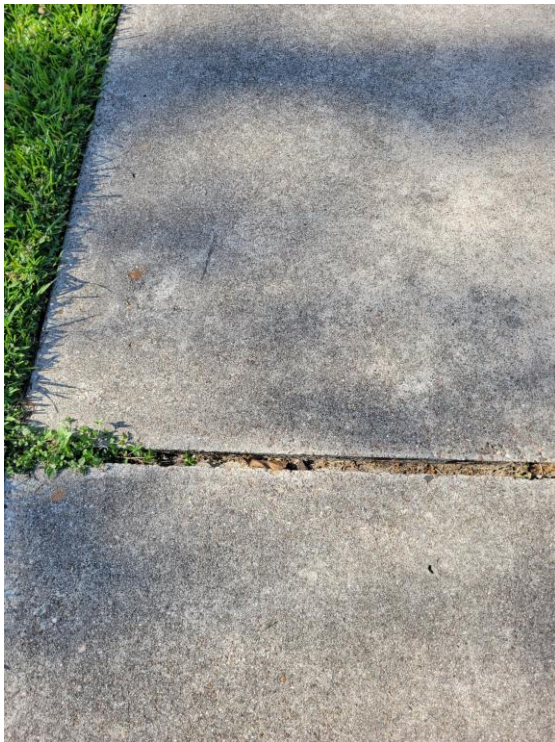
Barrier: 11

Level 4 (High): Parking and exterior accessible routes (DOJ Level 1) – moderately out of compliance

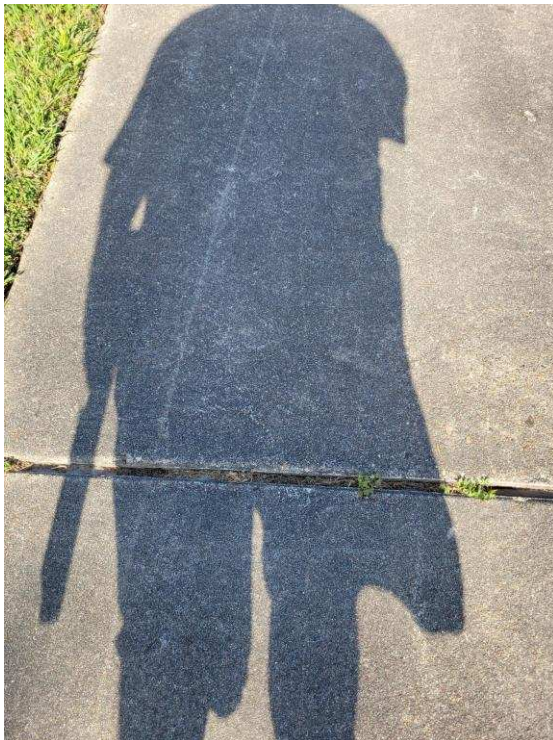
Barrier: 13

Level 4 (High): Parking and exterior accessible routes (DOJ Level 1) – moderately out of compliance

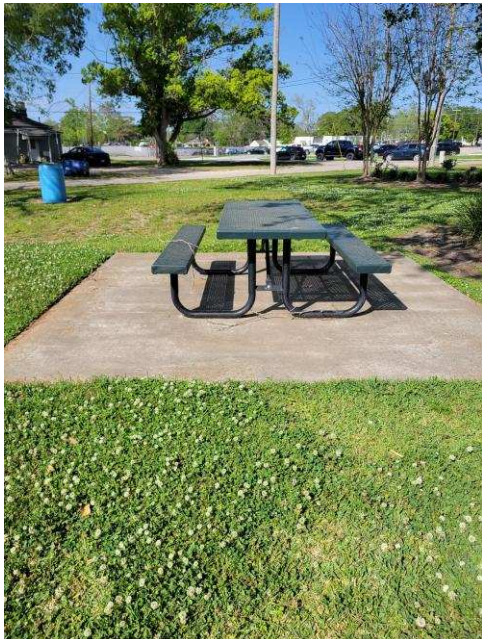
Barrier: 14

Level 6 (Medium): Parking or exterior accessible routes (DOJ Level 1) – minimally out of compliance
Access to goods and services (DOJ Level 2) – moderately out of compliance
Restrooms (DOJ Level 3) – severely out of compliance

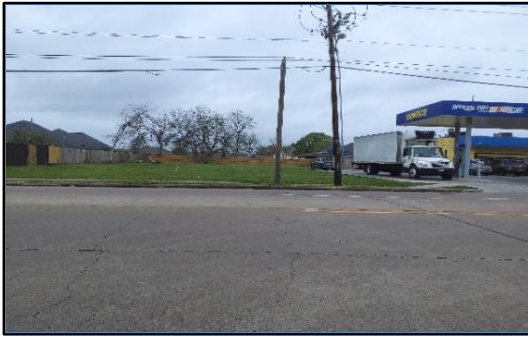
Corner 1 No Ramp (1z)

Curb Ramp Issues	Curb Ramp ID ('z', 'i', or 'CN' in ramp label indicates no existing ramp)				Possible Solutions
	1z	2A	3A	4z	
Curb ramp does not exist and is needed	X			X	Install curb ramp; if median improvement, see shapefile
Curb ramp does not land in crosswalk					
No 4' x 4' clear space at base of curb ramp					
Curbed side is not 90° or has traversable adjacent surface					Remove and replace curb ramp
Flare cross slope is greater than 10%					
Curb ramp running slope is greater than 8.3%		X	X		
Blended transition running slope is greater than 5%					
Cut-thru ramp running slope is greater than 5%					
Curb ramp cross slope is greater than 2%					
Cut-thru ramp cross slope is greater than 2%					
Curb ramp width is less than 48"					
Cut-thru ramp width is less than 60"					
Permanent obstruction (>0.25') in curb ramp/landings/flares		X			
Turning space does not exist and is needed		X	X		Remove temporary obstruction

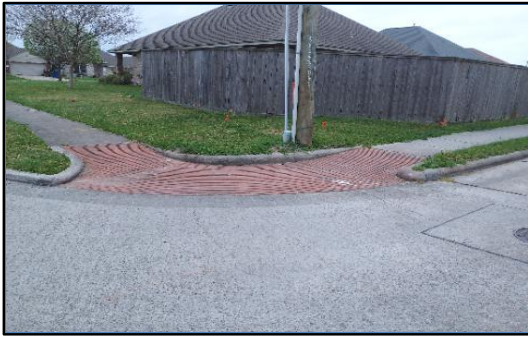
Ramp 1A

Curb Ramp Issues	Curb Ramp ID ('z', 'i', or 'CN' in ramp label indicates no existing ramp)				Possible Solutions
	1A	2A	3A	4A	
Curb ramp does not exist and is needed					Remove and replace curb ramp
Curb ramp does not land in crosswalk					
No 4' x 4' clear space at base of curb ramp					
Curbed side is not 90° or has traversable adjacent surface					
Flare cross slope is greater than 10%					
Curb ramp running slope is greater than 8.3%	X	X	X	X	
Blended transition running slope is greater than 5%					
Cut-thru ramp running slope is greater than 5%					
Curb ramp cross slope is greater than 2%		X	X		
Cut-thru ramp cross slope is greater than 2%					
Curb ramp width is less than 48"			X	X	
Cut-thru ramp width is less than 60"					
Permanent obstruction (>0.25') in curb ramp/landing/flares					
Turning space does not exist and is needed		X			
Turning space length is less than 4' (or 5' when constrained)

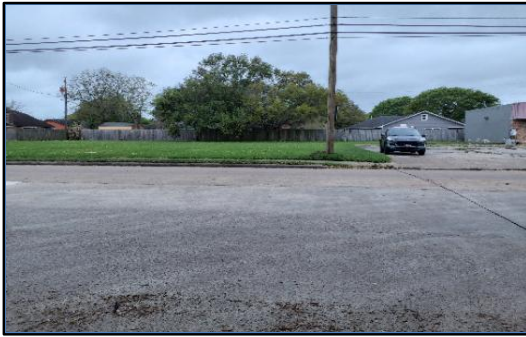
Corner 1 No Ramp (1z)

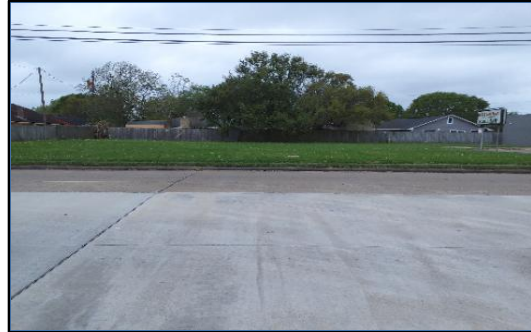
Corner 4 No Ramp (4z)

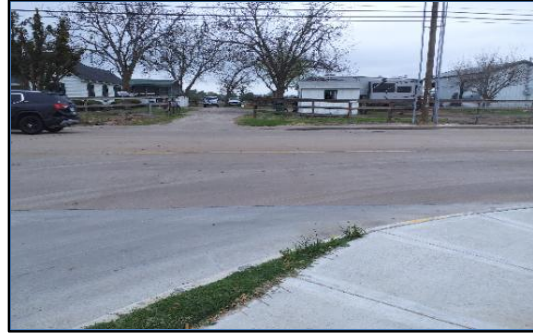
Corner 1 No Ramp (1z)

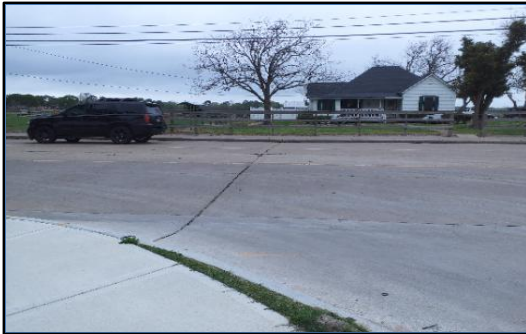
Corner 4 No Ramp (4z)

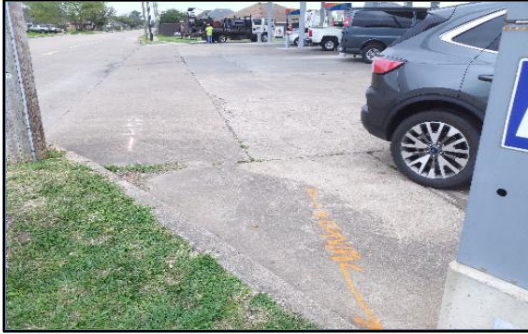
Corner 1 No Ramp (1z)
