FACILITY EVALUATION REPORT

ARKANSAS CITY, KANSAS

PARIS PARK POOL

**FACILITY EVALUATION REPORT
OF
PARIS PARK POOL
FOR THE CITY OF
ARKANSAS CITY, KANSAS
JUNE 8, 2021**

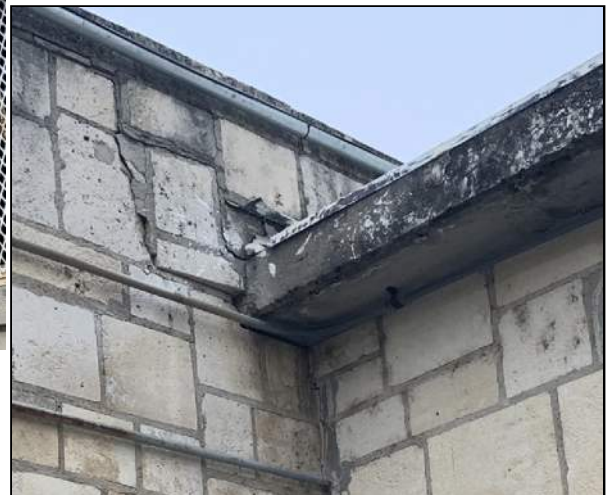
Another example of differential movement and rotation of the exterior wall, relative to the adjoining wall. This is in the southwest corner of men's changing area; wall on right is part of storage room on southwest corner.

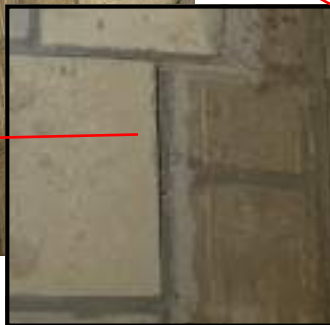
Note a gap has opened up since the tuck point repair indicating continued movement in the structure. This is in the storage room on southwest corner of building.

Streaking from water leakage is also evident on this wall.

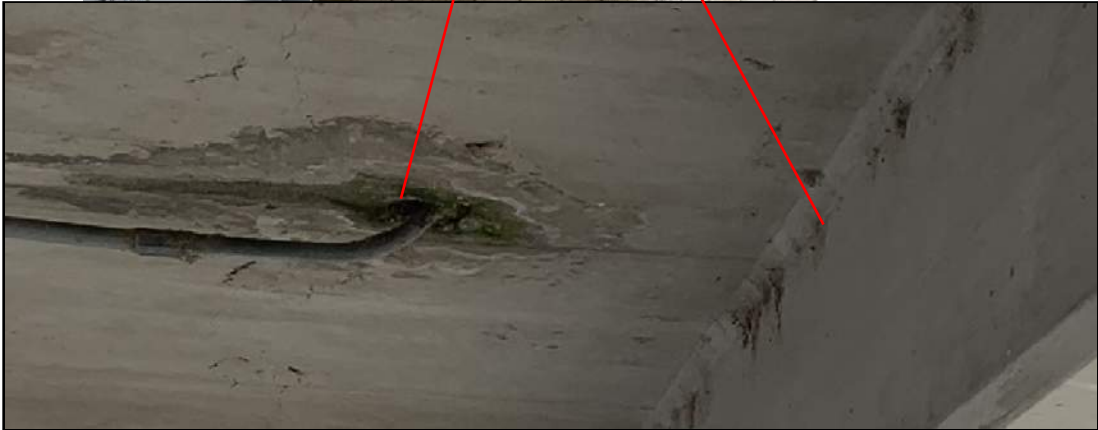
Also note the signs of water intrusion in the men's overhang. Note the efflorescence and mold around the electrical conduit penetration and the distress/discoloration in where the slab meets the beam.

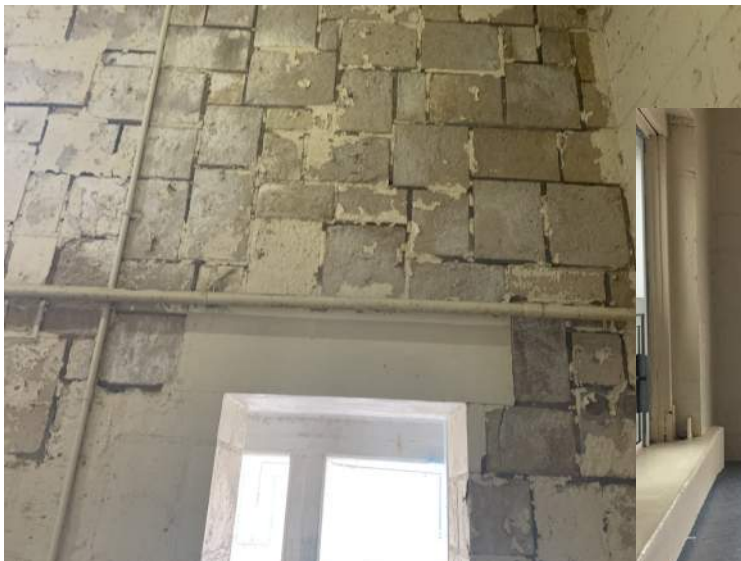
These conditions can also cause deterioration and delamination of the rock itself.wt

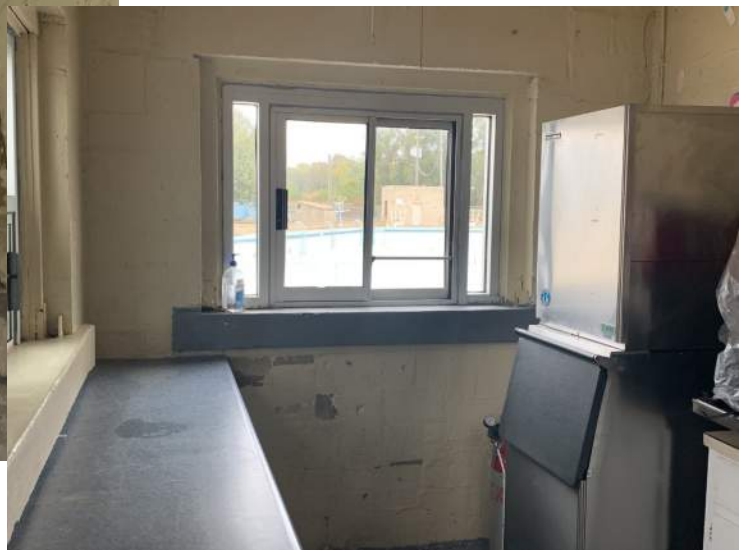
A couple more examples.

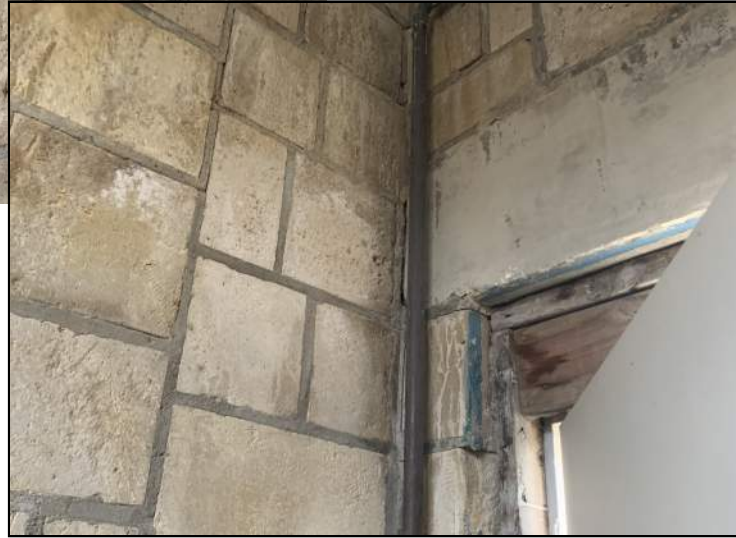
The casework around window openings and door frames needs attention. The age and environmental conditions have resulted in what appears to be some degree of wood rot.

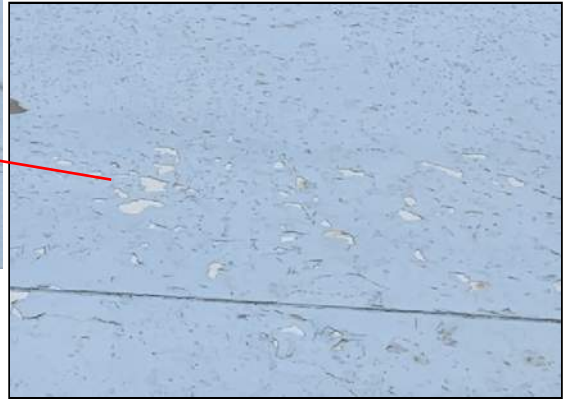
The floor built in 2002 is acceptable condition. No significant damage was observed around joints. A few cracks were observed in some of the slabs. The painted surface is in poor condition, exhibiting significant peeling.

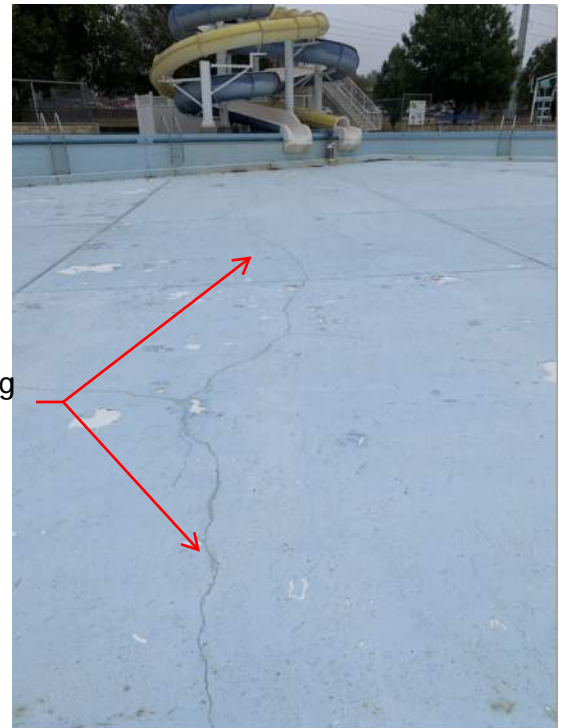
Note cracking in slab

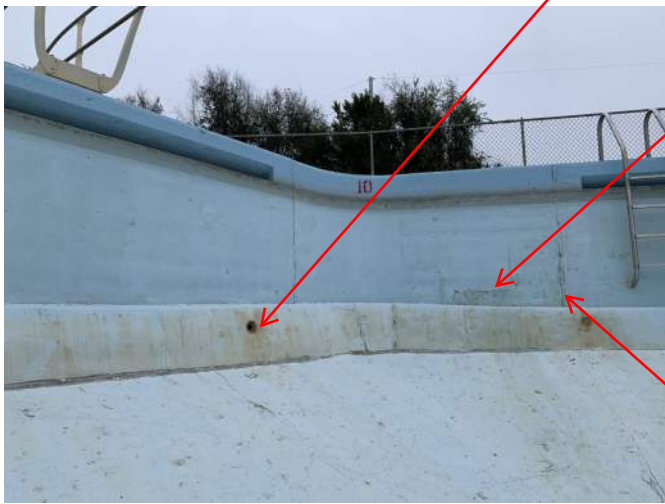
Cracking in dive well wall suggests water penetration.

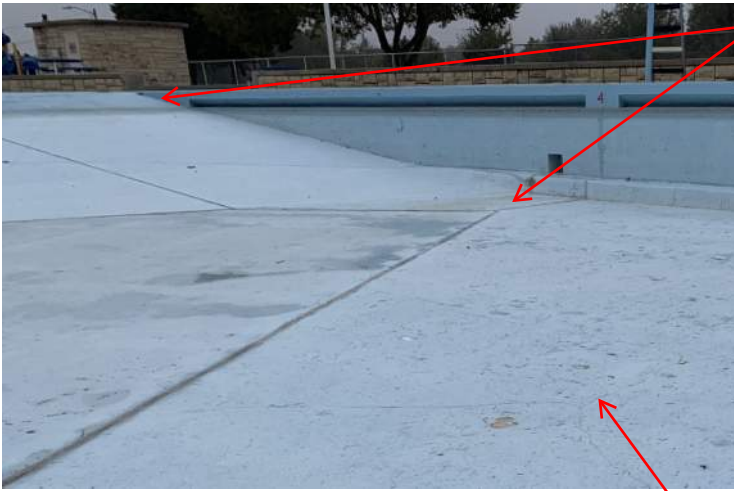
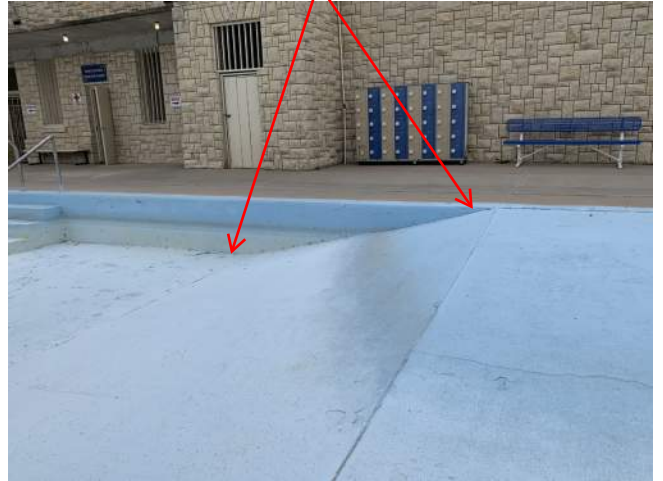
Slope appears to be about 12% (1:8) which is steeper than allowed by current codes. Code allows 8% (1:12) in water 5 feet or less deep.

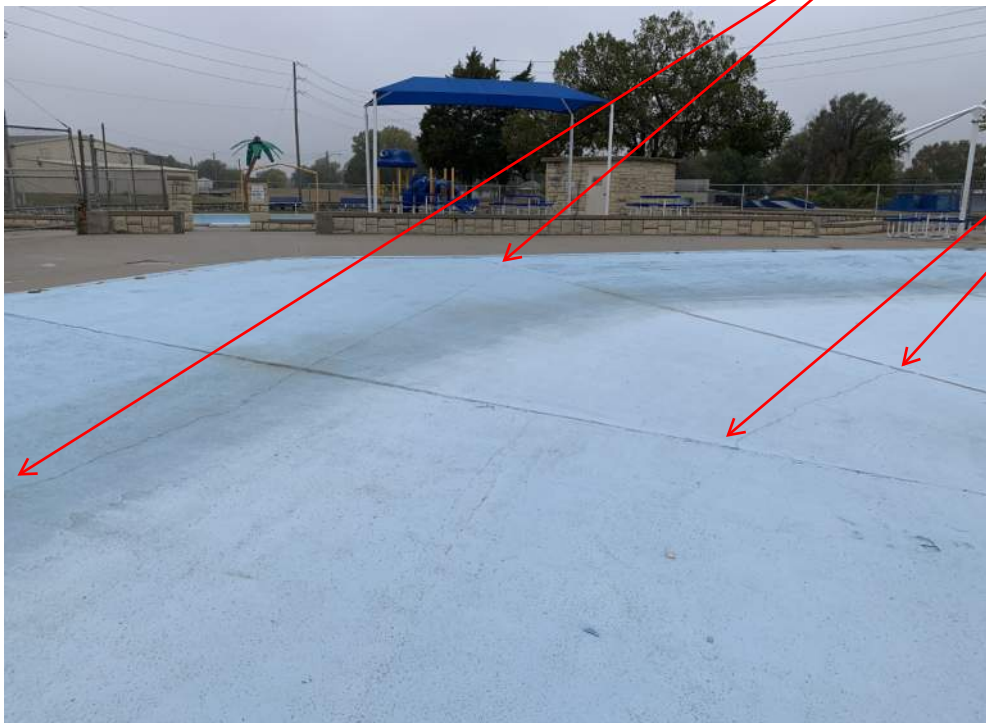
Note cracking and delamination in 36-year old beach slab. Cracks likely formed at time of construction, but appear have gotten progressively wider with time.
