# BUILDING ASSESSMENT AND PREDESIGN REPORT

## BAY CITY PUBLIC SAFETY HEADQUARTERS

### 4000 AVENUE F, BAY CITY, TEXAS

BUILDING ASSESMENT REPORT - 06/07/2021

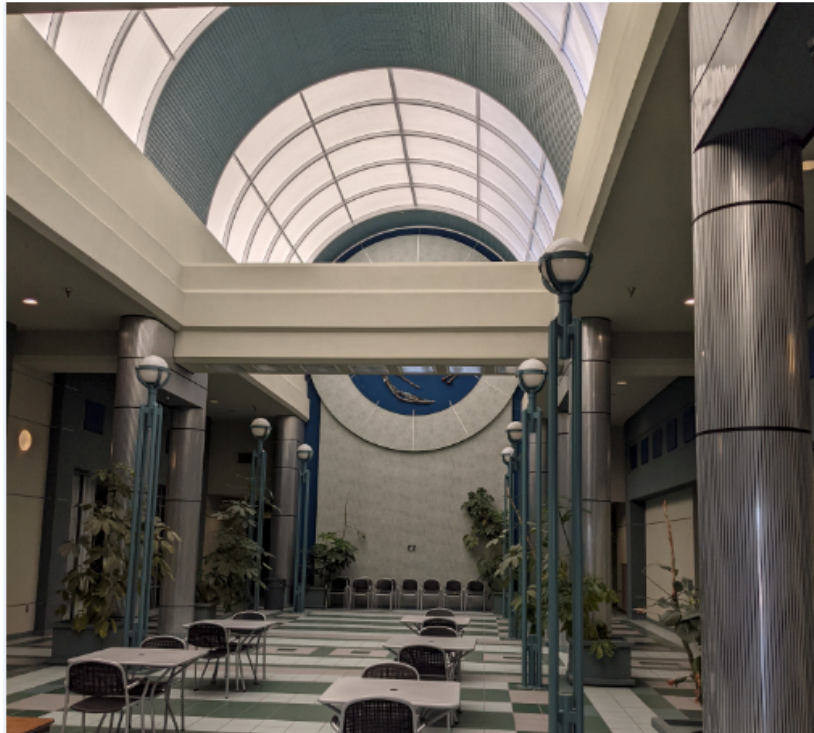
**Figure 2 – Interior View at Lobby Entrance**

The renovation in 2007 included major modifications to the structure at the building entry, in order to remove a portion of the existing roof structure and add a taller, rolled skylight roof in that location (ref. Fig. 2). New steel columns and concrete footings were cast to support the newly added entrance façade and roof elements.

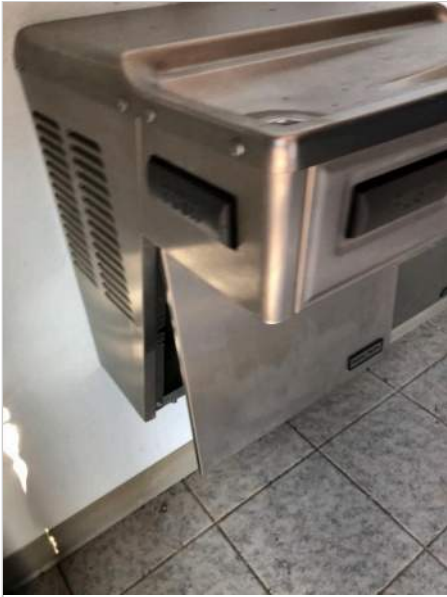
Elec drinking fountain  
Functioning

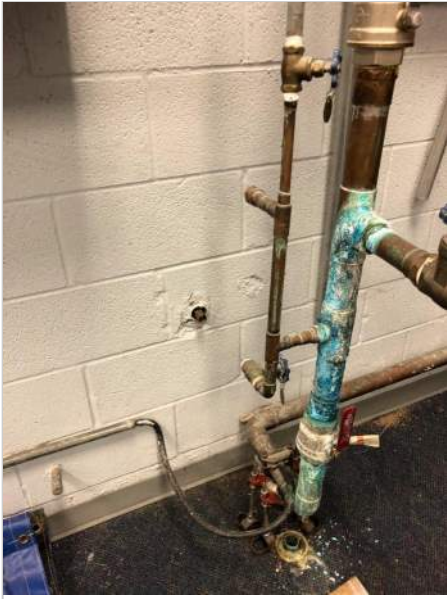
Domestic water entry

The plumbing system appears to be in fair to good condition and there were no reports of issues with the system.

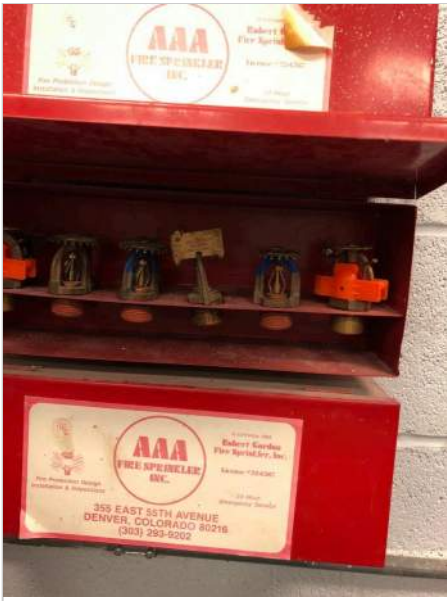
Fire sprinkler entry

There is a full coverage sprinkler system in the building. The entire building is served by a single utility entry that is split into two zones. It appears to be sufficient if the proposed renovation matches the current "business" occupancy. We observed a PVC pipe exiting the building on the south end, at about 12' elevation, extending about 12" and then turning down and terminating at the paving in the pedestrian walkway. Investigation showed this to be an auxiliary drain line for the fire sprinkler system.

The fire sprinkler system appears to be in good condition.

The auxiliary drain line that extends outside of the building should be rerouted so it's not subject to damage.

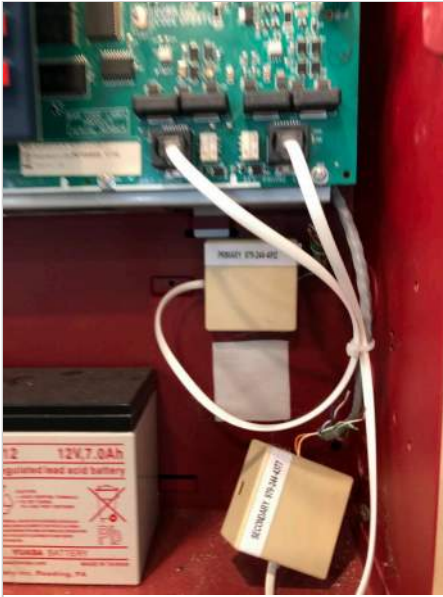
Fire alarm

The fire alarm system appears to be in good condition.
