Property Assessment Report

232 Citizen Street
Bay Saint Louis, Mississippi 39520

Inspected by:
Home Inspection Building Specialist Inc.

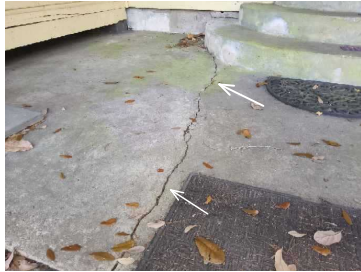
1. Acceptable Walks: Concrete Pavers, Concrete
2. Acceptable Driveway: Dirt, Gravel
3. Attention Needed Porch: Concrete - The front porch has some settlement cracks. Recommend a licensed contractor make the needed corrections.

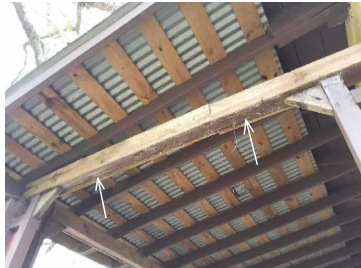
4. Major Concern Porch: Wood - The wood framing supporting the front porch shows visible deterioration consistent with wood destroying insect activity. Structural wood members exhibiting insect damage may have reduced structural capacity and may continue to deteriorate if the infestation remains active. Recommend evaluation by a licensed pest control professional to determine if active infestation is present and a qualified contractor remove and replace all structurally compromised wood components.

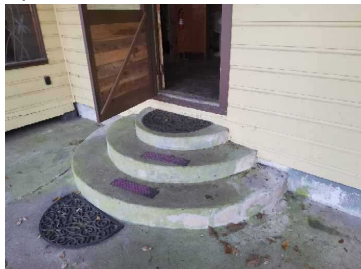
5. Safety Hazards Steps/Stoops: Concrete - Exterior steps had no handrail. Generally-accepted modern safety standards dictate that stairs with 4 or more risers should have a handrail. You should consult with a qualified contractor before the expiration of your Inspection Objection Deadline to discuss options and costs for handrail installation.

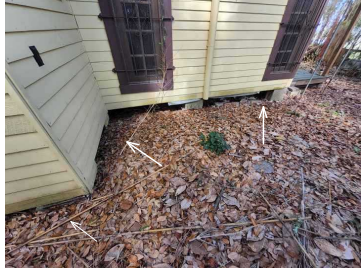
10. Major Concern Grading: Negative slope - The exterior grade slopes toward the structure allowing rainwater to collect beneath the crawlspace. Standing moisture was observed beneath the structure during the inspection despite no recent rainfall. Chronic moisture conditions in crawlspaces can accelerate wood deterioration and create conditions conducive to termite activity and fungal growth. Recommend correction of site grading and drainage to divert surface water away from the structure.

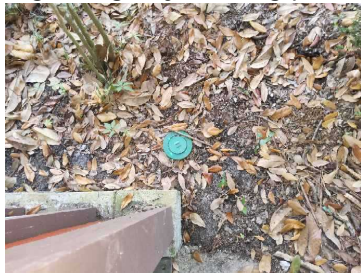
11. Attention Needed Grading: Minor slope - Bait traps were observed around the perimeter of the home, indicating a possible termite or pest control program. Recommend consulting with the seller for details regarding any existing pest control contracts, treatment history, or ongoing service agreements.

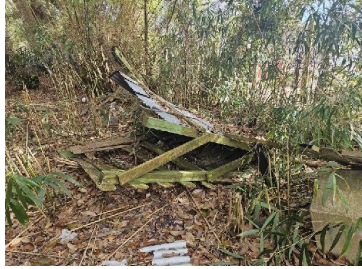
13. Not Inspected Fences: Wood - Inspection of fencing lies beyond the scope of the general home inspection. The fences were not inspected. *Note: Fence and / or gates are in need of repair.

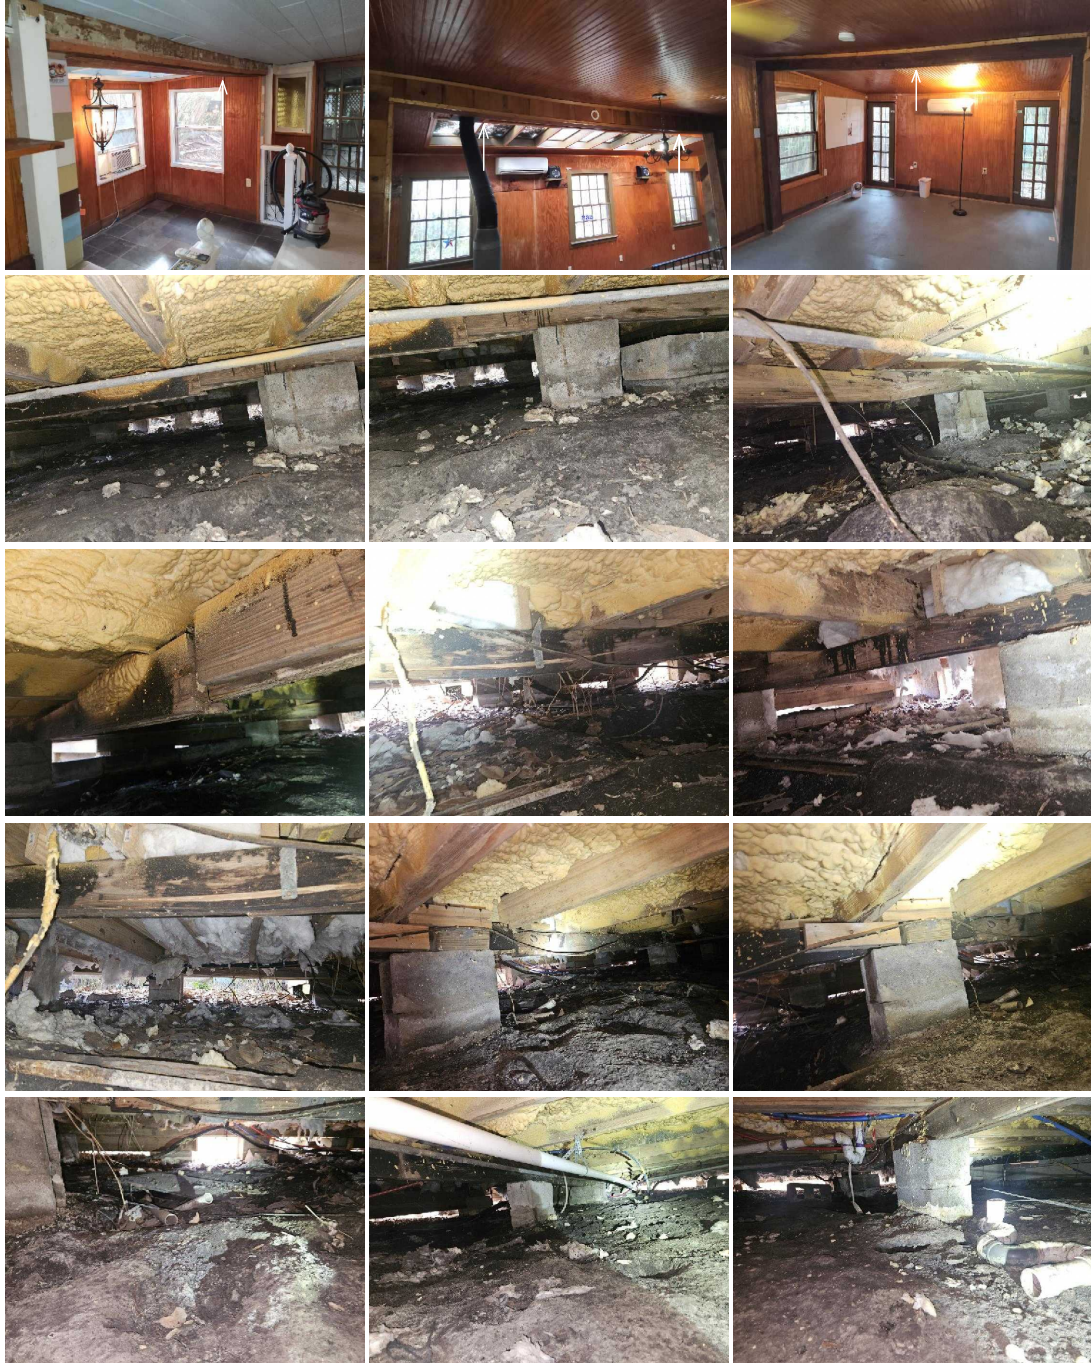
2. Major Concern Foundation: Pier / Beam
3. Acceptable Structure Type: Wood frame
4. Major Concern Differential Movement: Sloping floors
5. Major Concern Beams: Wood - Structural beams supporting the floor framing were observed deteriorated, sagging, and in some locations broken or improperly spliced without adequate pier support. Several supporting piers also appear deteriorated from long-term moisture exposure and possible termite activity. These conditions indicate significant structural distress within the crawlspace framing system. Recommend a qualified contractor or structural professional further evaluate the structural support system and repair or replace all compromised beams and piers.

Due to the extent of deterioration observed, the structural integrity of the floor framing system is considered significantly compromised. The full extent of structural damage cannot be determined without removal of insulation and additional invasive evaluation.

Substantial structural repairs or reconstruction may be required to restore structural integrity.

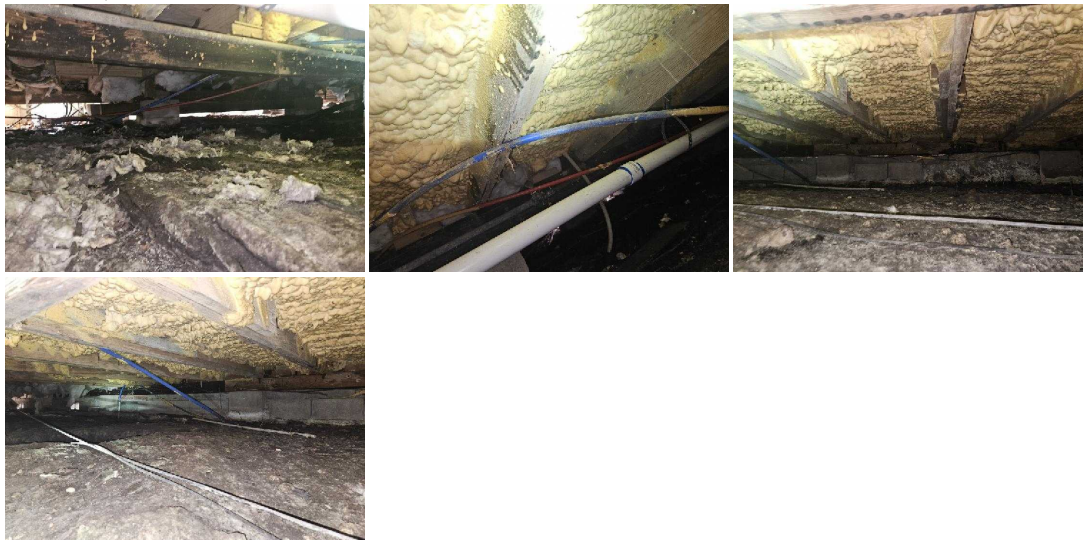
Joists/Trusses: Wood - Many floor joists were observed deteriorated and structurally compromised throughout the crawlspace. Several joists appear to have been previously repaired by scabbing additional lumber to damaged members; however, the existing joists and repair members show continued deterioration consistent with moisture exposure and termite damage. Significant sagging of the floor structure was observed in the rear right portion of the home. Recommend a qualified contractor or structural professional evaluate the framing system and replace damaged joists as necessary to restore structural integrity.

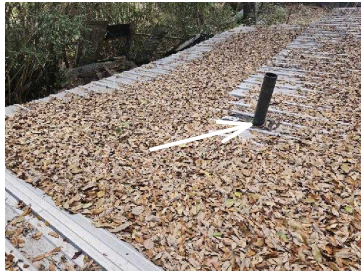
8. Major Concern Plumbing Vent Flashings: None present - The plumbing vent penetration through the roof is not properly flashed. Recommend repair or replacement of the flashing to provide a proper watertight seal.

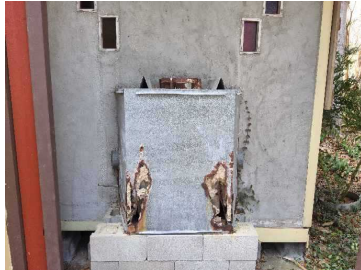
Left side Chimney

9. Safety Hazards Chimney: Metal - The chimney is damaged, and missing several components needed for safe use. Recommend a qualified chimney sweep further evaluate to determine the scope of work needed for replacement.

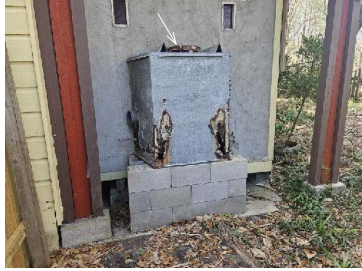
10. Major Concern Flue/Flue Cap: Missing - The flue pipe was not installed above the firebox. Without a properly installed flue, combustion gases and heat cannot be safely vented from the fireplace, which may allow smoke and carbon monoxide to enter the home. Recommend a qualified fireplace contractor evaluate and install the proper flue and venting components before the fireplace is used.

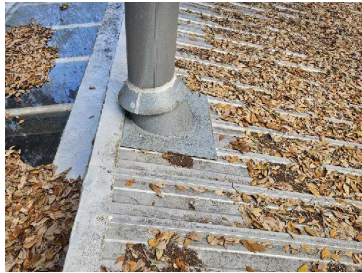
Chimney Flashing: Metal - The flashing installed at the roof penetration around the fireplace flue pipe appears to be improper. Improper flashing at this location can allow water intrusion into the roof structure and interior building materials. Recommend a qualified roofing contractor evaluate the flashing installation and make the necessary corrections to ensure the roof penetration is properly sealed and weather-tight.

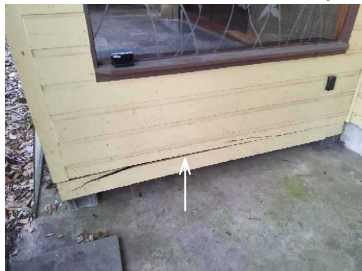
1. Attention Needed Type: Wood - Damaged wood was observed at the front of the home. Recommend a licensed contractor remove and replace all damaged wood.

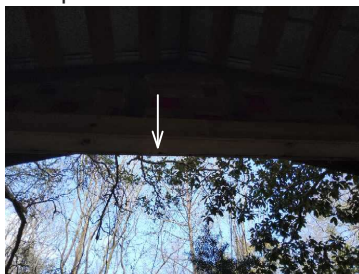
- 6. Attention Needed Trim: Wood - Wood boring bee damage was observed. Recommend filling holes with wood filler and paint.

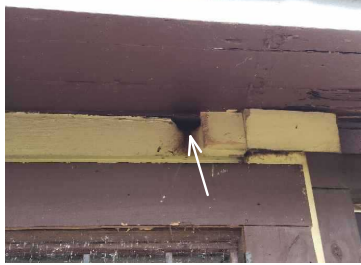
8. Attention Needed Fascia / Soffit: Open (Exposed rafter tails), Wood - Holes were observed chewed where rodents are gaining access to the attic. Recommend repairs.

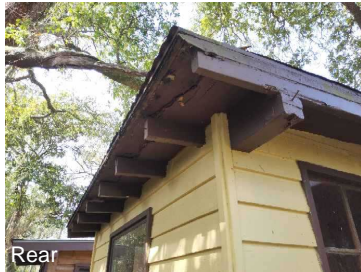
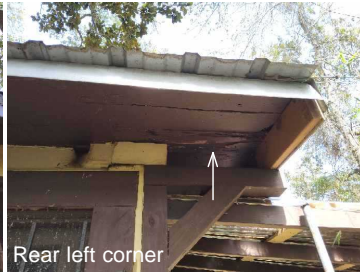
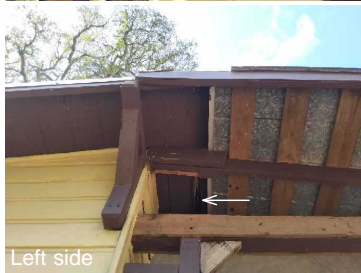
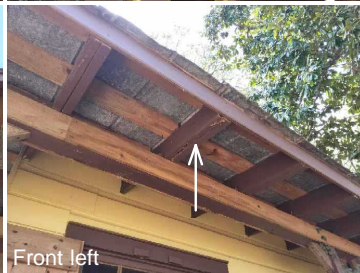
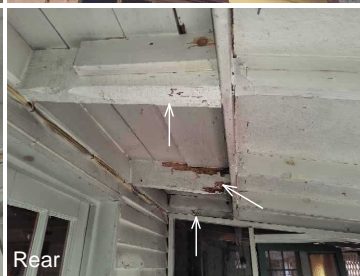
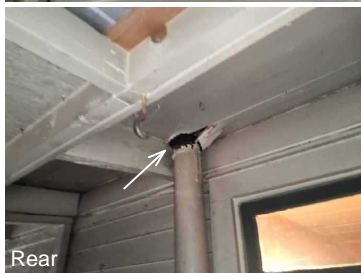
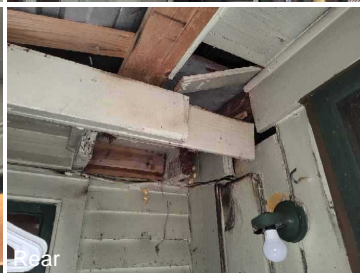
9. Major Concern Fascia / Soffit: Open (Exposed rafter tails), Wood - Fascia observed with wood damage at several locations. Recommend removing / replacing damaged wood. *The inspector was unable to determine if this was from moisture / wood destroying insect.

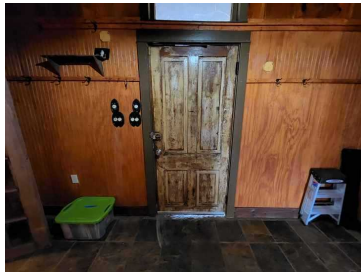
14. Attention Needed Entry Doors: Wood - Door does not seal to the weather stripping at all sides of the door. Recommend correction.

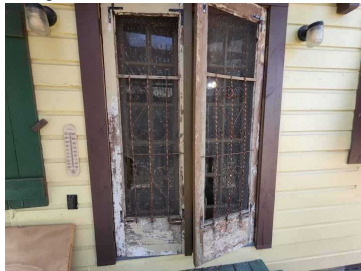
15. Attention Needed Patio Door: French door - Loose peeling paint conditions are in need of maintenance. Recommend scraping and recoating the areas with this condition. *Note: Houses built prior to 1978 may have concerns for lead base paint. Proceed with caution when prepping paint that may contain lead and / or consult with qualified professionals.

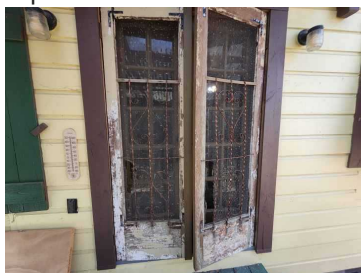
16. Attention Needed Patio Door: French door - Torn screens are observed on the outer door. Recommend repair / replace.

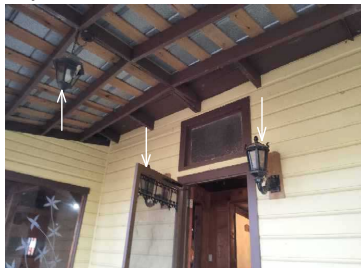
19. Attention Needed Exterior Lighting: Surface mount, Ceiling mount - The light fixtures did not function. Recommend replace the bulbs and retest.

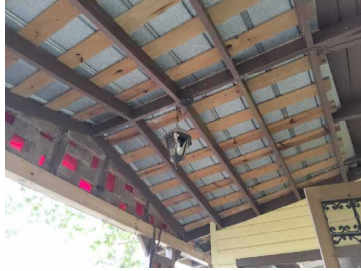
20. Attention Needed Exterior Lighting: Surface mount, Ceiling mount - Glass pane was loose. Recommend replace.

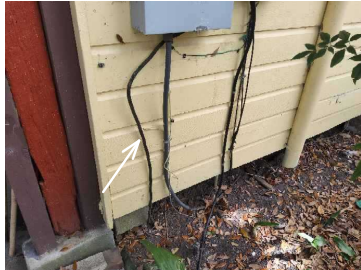
21. Safety Hazards Exterior Electrical: 110V - Romex wiring was observed run outside of conduit. Recommend a licensed electrician make the needed corrections.

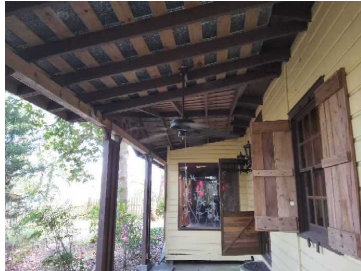
22. Attention Needed Ceiling Fans: Surface mount - The ceiling fan is operable but the blades are sagging from humidity. Recommend replace.

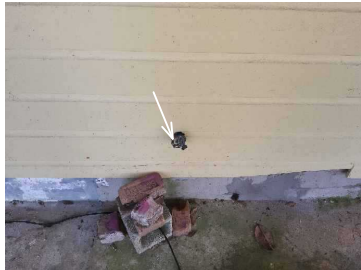
23. Attention Needed Hose Bibs: Gate - The hose bib at the front of the home is not secured to the home. Recommend repairs.

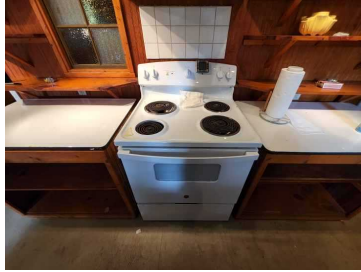
1. Safety Hazards Cooking Appliances: General Electric - Anti-tip bracket not installed to avoid tipping. Recommend installing anti-tip per manufacture instruction.

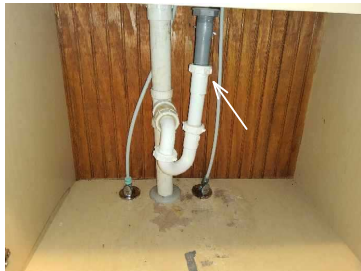
- 1. Acceptable Floor: Wood, Tile
- 2. Acceptable Walls: Paneling
- 3. Acceptable Ceiling: Wood
- 4. Acceptable Doors: Wood
- 5. Acceptable Windows: Wood
- 6. Acceptable Cabinets: Wood
- 7. Acceptable Counter Tops: Plastic
- 8. Major Concern Sink/Basin: Plastic - The vanity sink drain is leaking in the primary bathroom. Recommend a licensed plumber make the needed corrections.

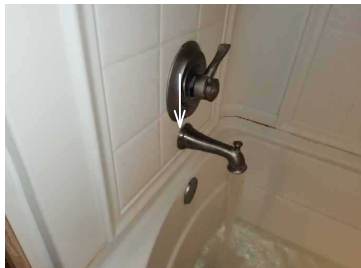
- 9. Attention Needed Plumbing / Fixtures: Double Valve Split Fixture, Single Valve Scald Proof Fixture - Spigot is not sealed to the tubs surround. Recommend sealing.

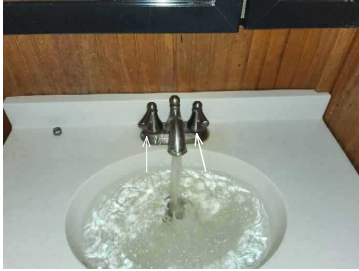
10. Major Concern Plumbing / Fixtures: Double Valve Split Fixture, Single Valve Scald Proof Fixture - The vanity sink faucet leaks at the valve stems. Recommend a licensed plumber make the needed corrections.

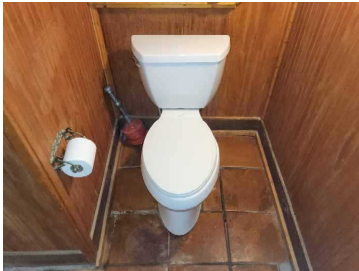
11. Acceptable Tub/Surround: Fiberglass tub and fiberglass surround
12. Attention Needed Toilets: Kohler - The toilet bowl in the bathroom is loose at the floor, which can lead to movement during use. This condition may cause damage to the wax gasket seal, potentially resulting in leaks and water damage. To maintain proper function and avoid further issues, Recommend that the toilet be properly secured to the floor by a qualified professional.

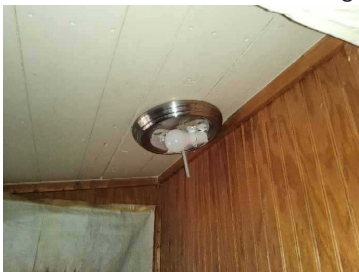
16. Acceptable Ceiling: Paneling
17. Acceptable Walls: Paneling , Wood
18. Acceptable Floor: Wood, Other
19. Attention Needed Doors: Wood with glass, Wood - The door to the commode drags the casing when closed. Recommend adjustments.
20. Acceptable Windows: Wood
21. Attention Needed Electrical: 110 VAC - The light fixture is missing its globe. Recommend replace.

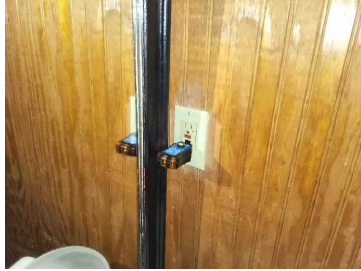
22. Major Concern Electrical: 110 VAC GFCI - The GFCI outlet was tripped and will not reset. Recommend a licensed electrician replace the outlet.

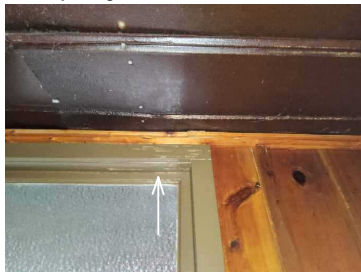
1. Acceptable Closet: Open
2. Acceptable Floor: Tile
3. Major Concern Walls: Wood, Paneling, Drywall - Dirt tubes and wood destroying insect damage were observed above the front door. Recommend having the home further evaluated by a qualified pest control company as well as a licensed contractor remove and replace all damaged wood.

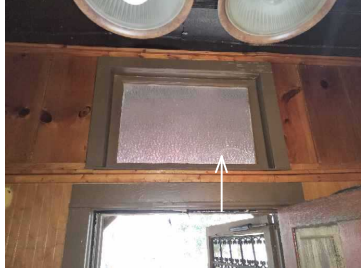
6. Safety Hazards Windows: Non-opening - The window in the foyer has cracked glass. Recommend replace.

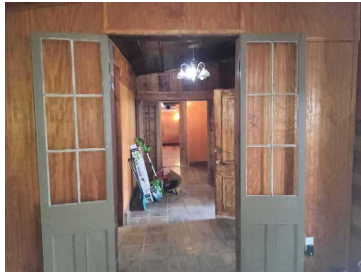
12. Attention Needed Doors: Wood with glass - Doors are missing glass panes. Recommend replace.

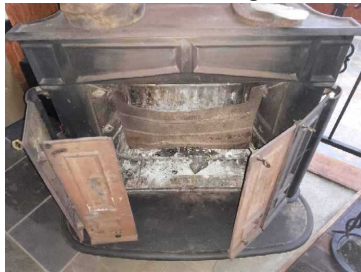
5. Major Concern Freestanding Stove: Wood burning - Due to the age and condition of this unit the inspector recommends having further evaluated by a qualified chimney sweep before use.

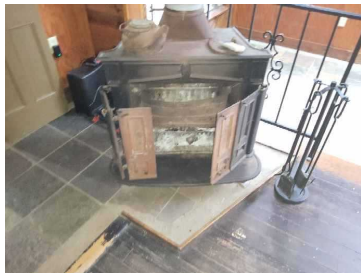
6. Type: Wood burning
7. Acceptable Flue: Metal
8. Safety Hazards Hearth: Flush mounted - The hearth at the wood burning stove is incorrect. Recommend a licensed contractor make the needed corrections.

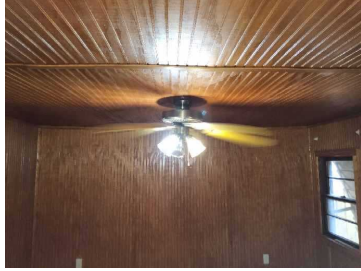
1. Acceptable Floor: Wood
2. Acceptable Walls: Paneling
3. Acceptable Ceiling: Paneling
4. Acceptable Doors: Wood
5. Acceptable Windows: Wood
6. Acceptable Electrical: 110 VAC
7. Attention Needed Ceiling Fan Switched - Low head height on the ceiling fan. Recommend removing.

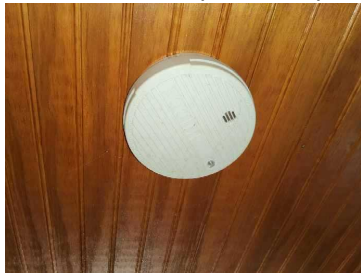
Smoke Detector: Battery operated - Smoke detected did not function when manually tested. Recommend repair or replace.

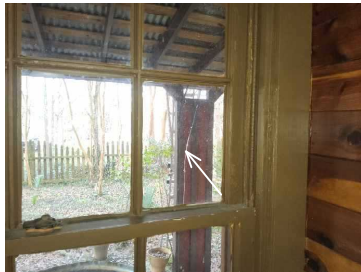
Windows: Wood - The window has cracked glass in the primary bedroom. Recommend replace.

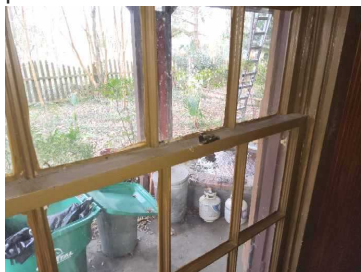
Windows: Wood - The window locking hardware is damaged, breaching the security of the home. It is recommended to repair or replace the locking mechanisms to restore security and prevent unauthorized access.

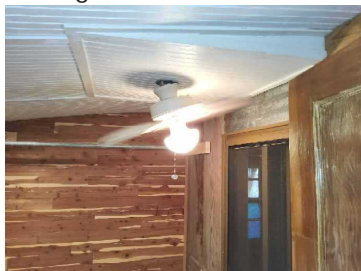
18. Acceptable Electrical: 110 VAC
19. Safety Hazards Ceiling Fan Switched - The ceiling fan is hanging by its wiring in the closet. Recommend repairs.

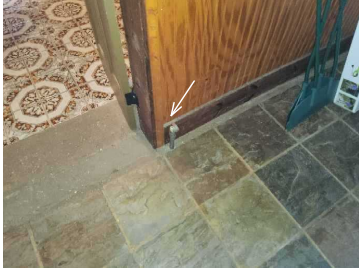
Gas Service Lines: Galvanized - Gas lines were not capped off. If plans of restoring gas the inspector recommends capping unused gas lines.

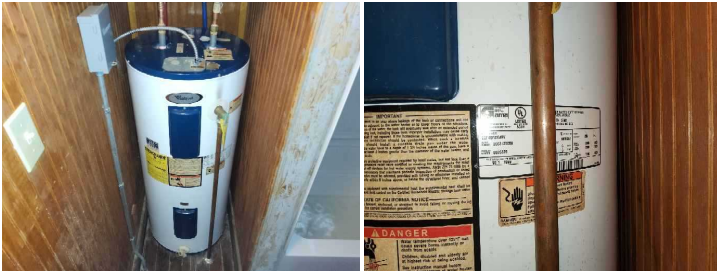
10. Attention Needed Water Heater Operation: Functional at time of inspection - The water heater appears to be at or beyond the typical service life expected for this type of equipment. While the unit operated at the time of inspection, aging water heaters may fail without warning and can cause water damage when leakage occurs. Proactive replacement should be considered.

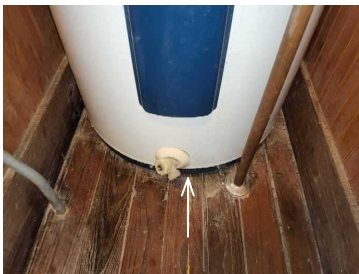
16. Major Concern Drip Pan Not installed - A drip pan was not installed beneath the water heater. A pan helps limit water damage in the event of leakage. Recommend installing a properly drained pan beneath the water heater.

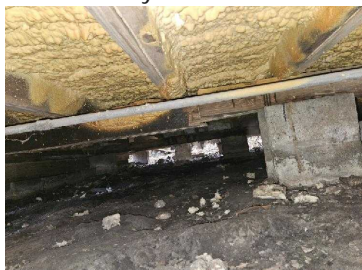
8. Major Concern Vapor Barrier: Not installed - No soil cover was installed at the time of the inspection. Soil covers help reduce humidity levels in crawlspaces by limiting moisture evaporation into the air from soil. Reducing humidity levels can help prevent conditions that encourage mold growth and wood decay.

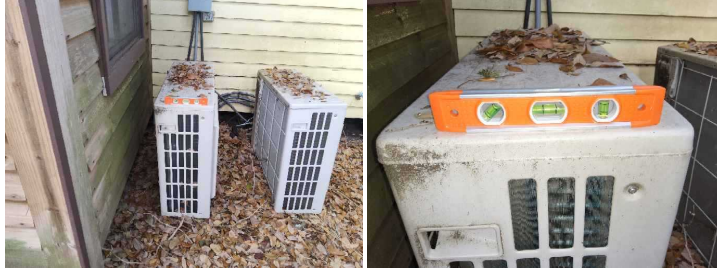
1. Attention Needed A/C System Operation: Functional - The HVAC system appears older based on available labeling and observed condition. Heating and cooling equipment typically has a service life of approximately 12 to 20 years depending on maintenance and operating conditions. The system responded to testing but performance issues were observed during the inspection. Due to the age of the equipment and the operational concerns noted, further evaluation by a licensed HVAC contractor is recommended to determine the scope of repairs needed and to assess the remaining serviceability of the system.
2. Attention Needed Exterior Unit: Pad mounted - Out of level - The pad supporting the air-conditioner compressor housing was not level. Recommend that the compressor housing be leveled.

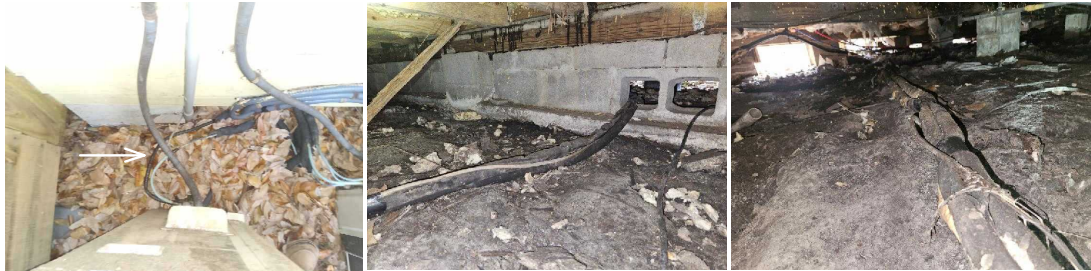
8. Attention Needed Refrigerant Lines: Suction line and liquid line - Insulation on the air-conditioning suction (large, insulated) line was damaged or missing at areas and should be replaced by a qualified HVAC contractor.

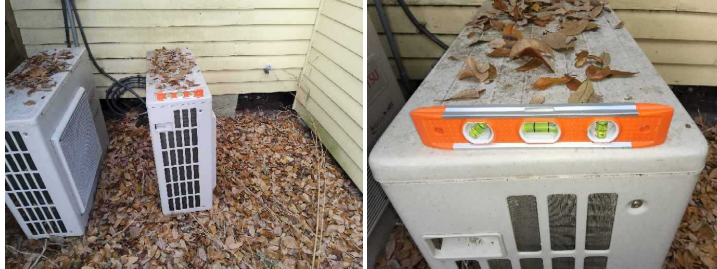
12. Attention Needed Exterior Unit: Pad mounted - Out of level - The pad supporting the air-conditioner compressor housing was not level. Recommend that the compressor housing be leveled.

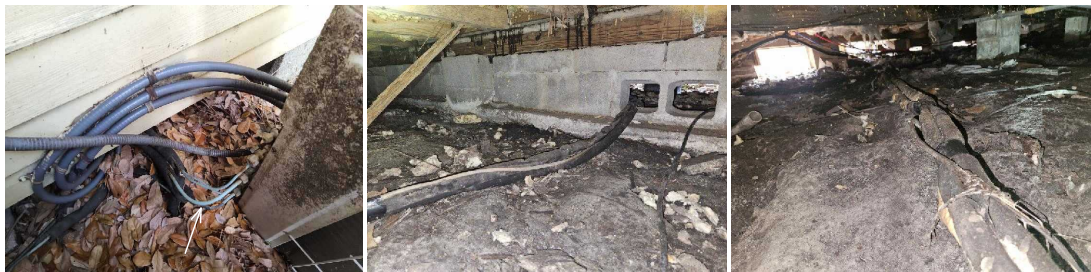
19. Attention Needed Refrigerant Lines: Suction line and liquid line - Insulation on the air-conditioning suction (large, insulated) line was damaged or missing at areas and should be replaced by a qualified HVAC contractor.

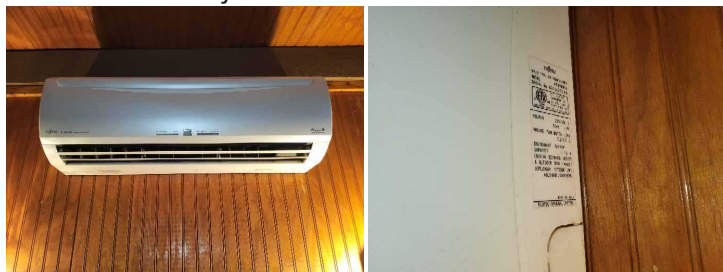
1. Major Concern Heating System Operation: Inoperable - The unit did not function in heat mode when tested. Recommend a licensed HVAC technician service the units.
2. Manufacturer: Fujitsu

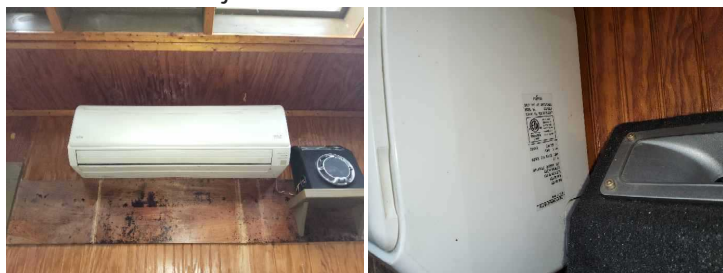
9. Major Concern Heating System Operation: Inoperable - The unit did not function in heat mode when tested. Recommend a licensed HVAC technician service the units.
10. Manufacturer: Fujitsu

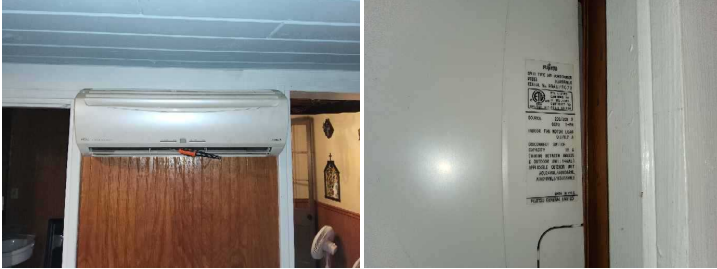
17. Major Concern Heating System Operation: Inoperable - The unit did not function in heat mode when tested. Recommend a licensed HVAC technician service the units.
18. Manufacturer: Fujitsu

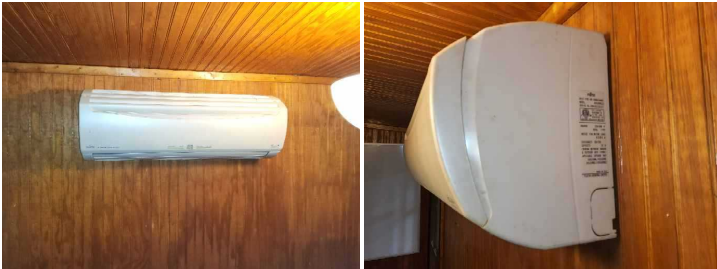
25. Major Concern Heating System Operation: Inoperable - The unit did not function in heat mode when tested. Recommend a licensed HVAC technician service the units.

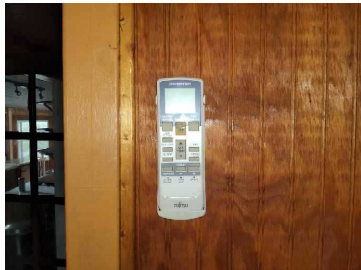
33. Major Concern Thermostats: Remote controlled - The remote for the left bedroom Mini-split did not respond, batteries were replaced and unit still did not function. Recommend repair / replace.

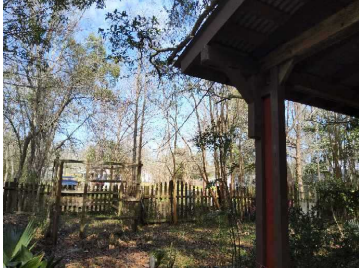
2. Safety Hazards Service: Milbank - Service wire from the street is in contact with the tree limbs. Recommend tree limbs are trimmed away from the service wire.

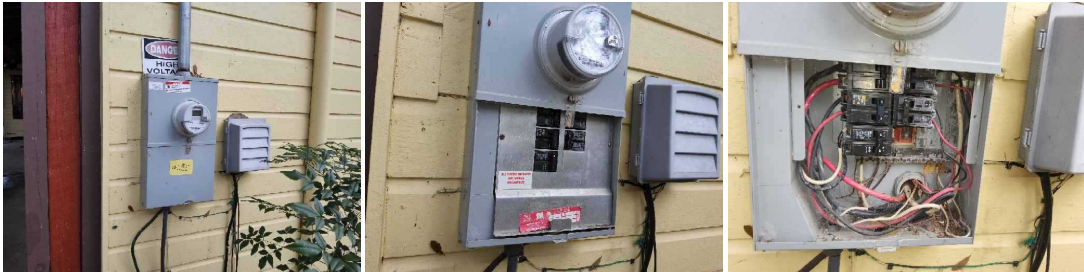
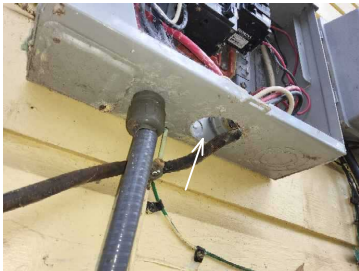
3. Safety Hazards Service: Milbank - Open knockout was observed in the base of the main panel. Recommend a licensed electrician make the needed corrections.

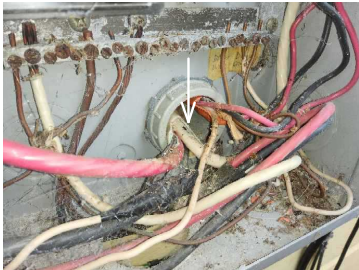
4. Safety Hazards 240 VAC Branch Circuits: Copper - Wiring in the main panel appears to have had the sheathing chewed by an animal. Recommend a licensed electrician make the needed corrections.

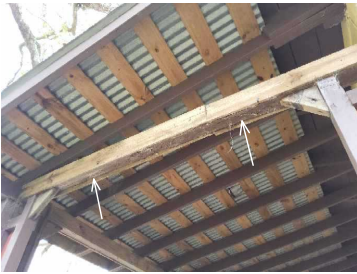
1. Porch: Wood - The wood framing supporting the front porch shows visible deterioration consistent with wood destroying insect activity. Structural wood members exhibiting insect damage may have reduced structural capacity and may continue to deteriorate if the infestation remains active. Recommend evaluation by a licensed pest control professional to determine if active infestation is present and a qualified contractor remove and replace all structurally compromised wood components.

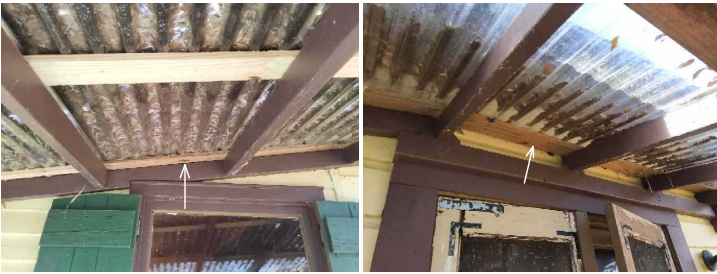
2. Patio Cover: Wood - The left side patio cover is not properly attached / flashed to the home. Recommend a licensed contractor make the needed corrections.

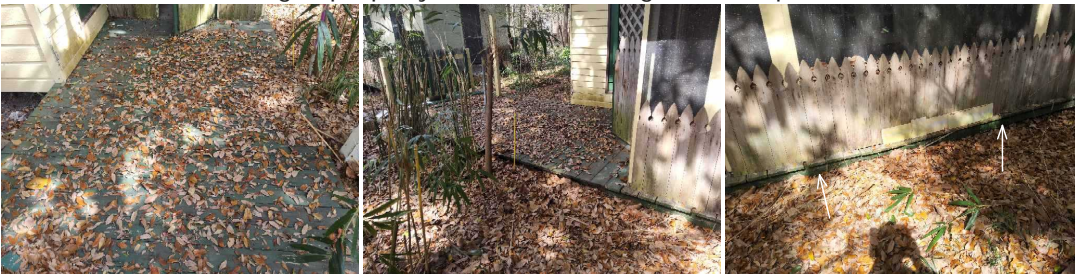
3. Deck: Wood - Damaged wood was observed at the deck framing and portions of the deck appear to be constructed in direct contact with soil. Wood in soil contact is highly susceptible to accelerated deterioration and termite activity. Structural members showing deterioration should be replaced and the deck should be reconstructed so that structural framing is properly elevated above grade and protected from moisture exposure.

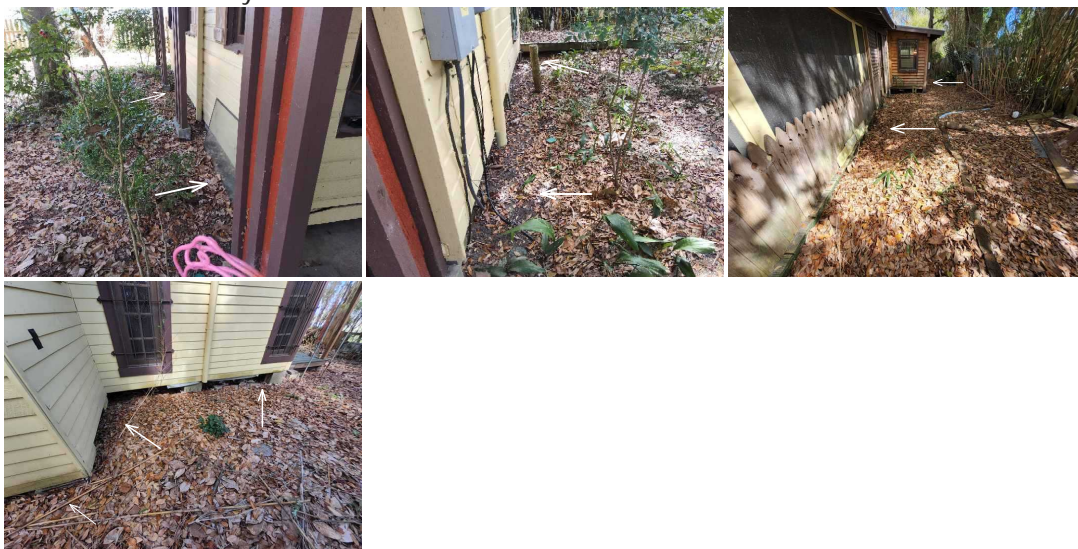
5. Grading: Negative slope - The exterior grade slopes toward the structure allowing rainwater to collect beneath the crawlspace. Standing moisture was observed beneath the structure during the inspection despite no recent rainfall. Chronic moisture conditions in crawlspaces can accelerate wood deterioration and create conditions conducive to termite activity and fungal growth. Recommend correction of site grading and drainage to divert surface water away from the structure.

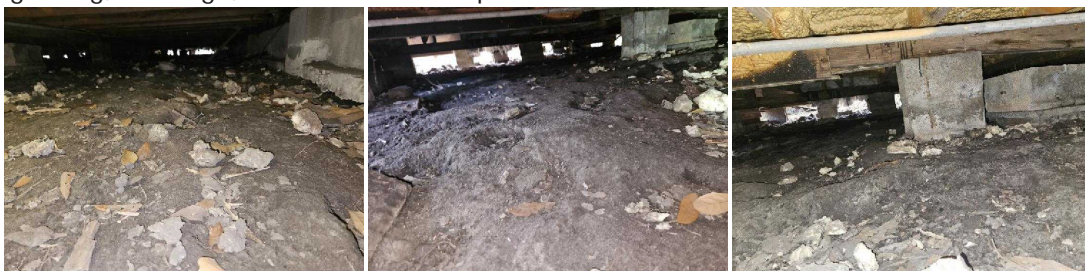
6. Floor/Slab: Dirt - Wet soil conditions were observed beneath the structure during the inspection despite no recent rainfall. Persistent crawlspace moisture can accelerate wood deterioration and contribute to conditions favorable for termite activity and fungal growth. Recommend further evaluation and correction of moisture sources including grading, drainage, and ventilation improvements.

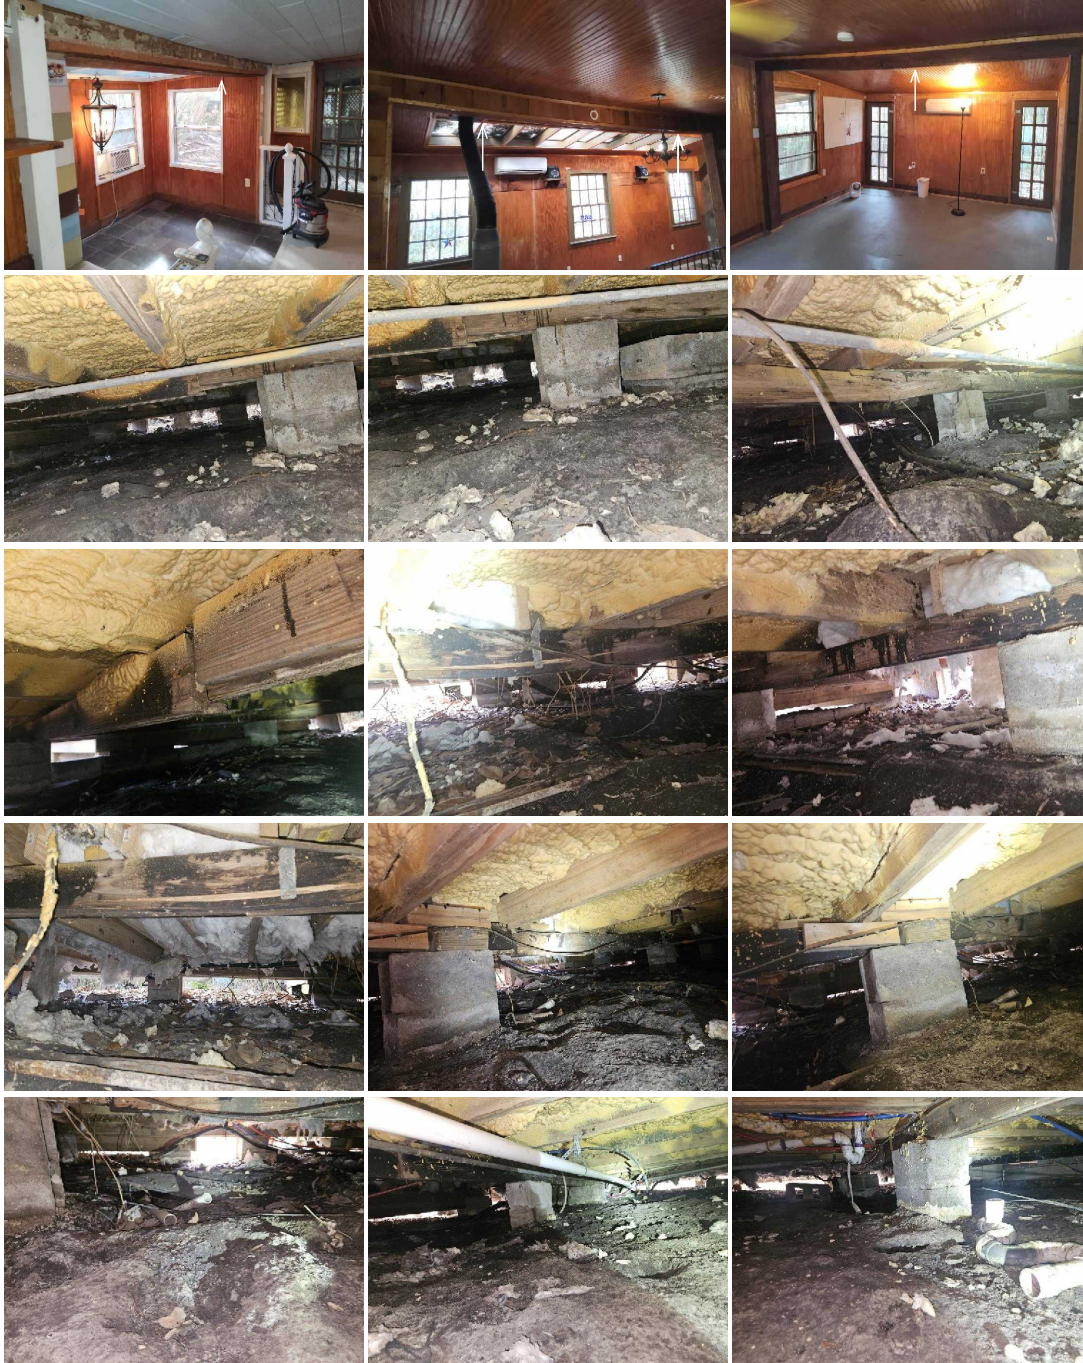
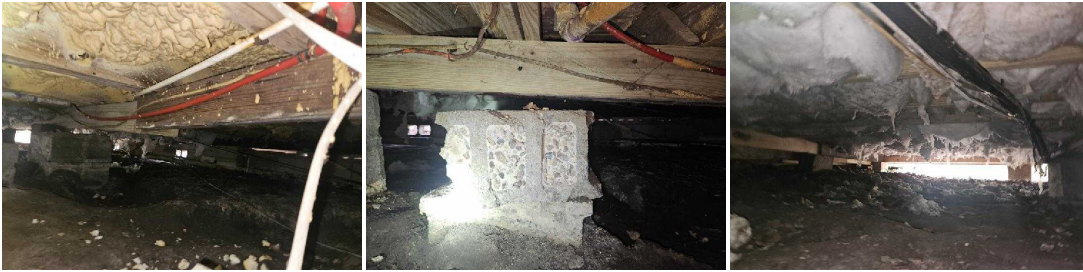
7. Foundation: Pier / Beam
8. Differential Movement: Sloping floors
9. Beams: Wood - Structural beams supporting the floor framing were observed deteriorated, sagging, and in some locations broken or improperly spliced without adequate pier support. Several supporting piers also appear deteriorated from long-term moisture exposure and possible termite activity. These conditions indicate significant structural distress within the crawlspace framing system. Recommend a qualified contractor or structural professional further evaluate the structural support system and repair or replace all compromised beams and piers.

Due to the extent of deterioration observed, the structural integrity of the floor framing system is considered significantly compromised. The full extent of structural damage cannot be determined without removal of insulation and additional invasive evaluation.

Substantial structural repairs or reconstruction may be required to restore structural integrity.

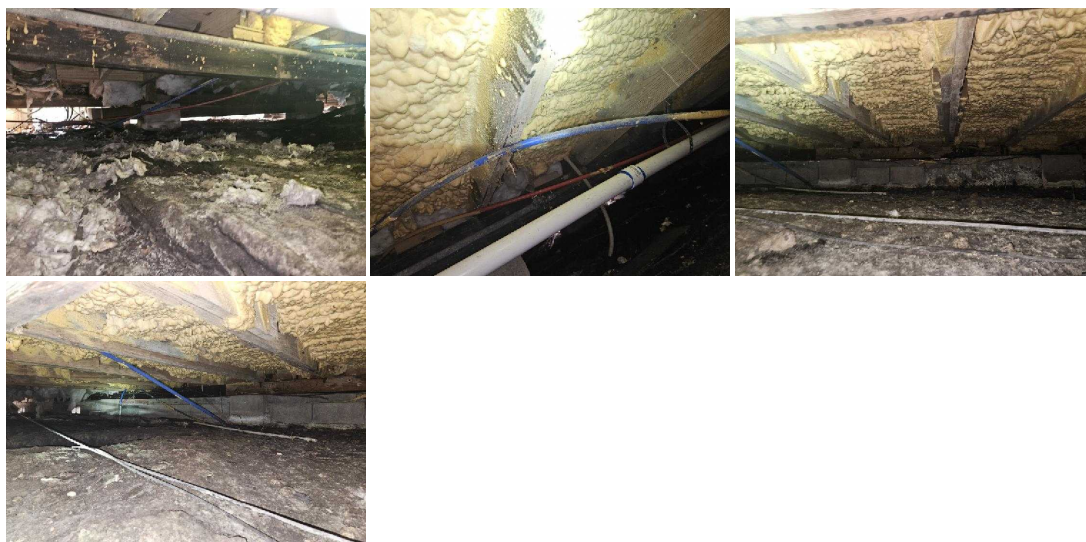
10. Joists/Trusses: Wood - Many floor joists were observed deteriorated and structurally compromised throughout the crawlspace. Several joists appear to have been previously repaired by scabbing additional lumber to damaged members; however, the existing joists and repair members show continued deterioration consistent with moisture exposure and termite damage. Significant sagging of the floor structure was observed in the rear right portion of the home. Recommend a qualified contractor or structural professional evaluate the framing system and replace damaged joists as necessary to restore structural integrity.

11. Piers/Posts: Masonry
12. Subfloor: Wood
13. Structure Advisory: Distressed Structure - The residence inspected appears to be experiencing significant structural deterioration and long-term environmental exposure typical of older coastal structures. Visible damage was observed in portions of the structural framing system including deteriorated beams, damaged floor joists, structural sagging, and evidence of wood destroying insect activity. In addition, large portions of the floor structure beneath the home are concealed by spray foam and fiberglass insulation, preventing full visual evaluation of the structural framing system.

Because the majority of the structural components are concealed and deterioration was observed in the limited areas that were visible, it is possible that additional structural damage exists within areas that could not be inspected. Determining the complete condition of the structural system would likely require removal of insulation and further invasive evaluation beyond the scope of a general home inspection.

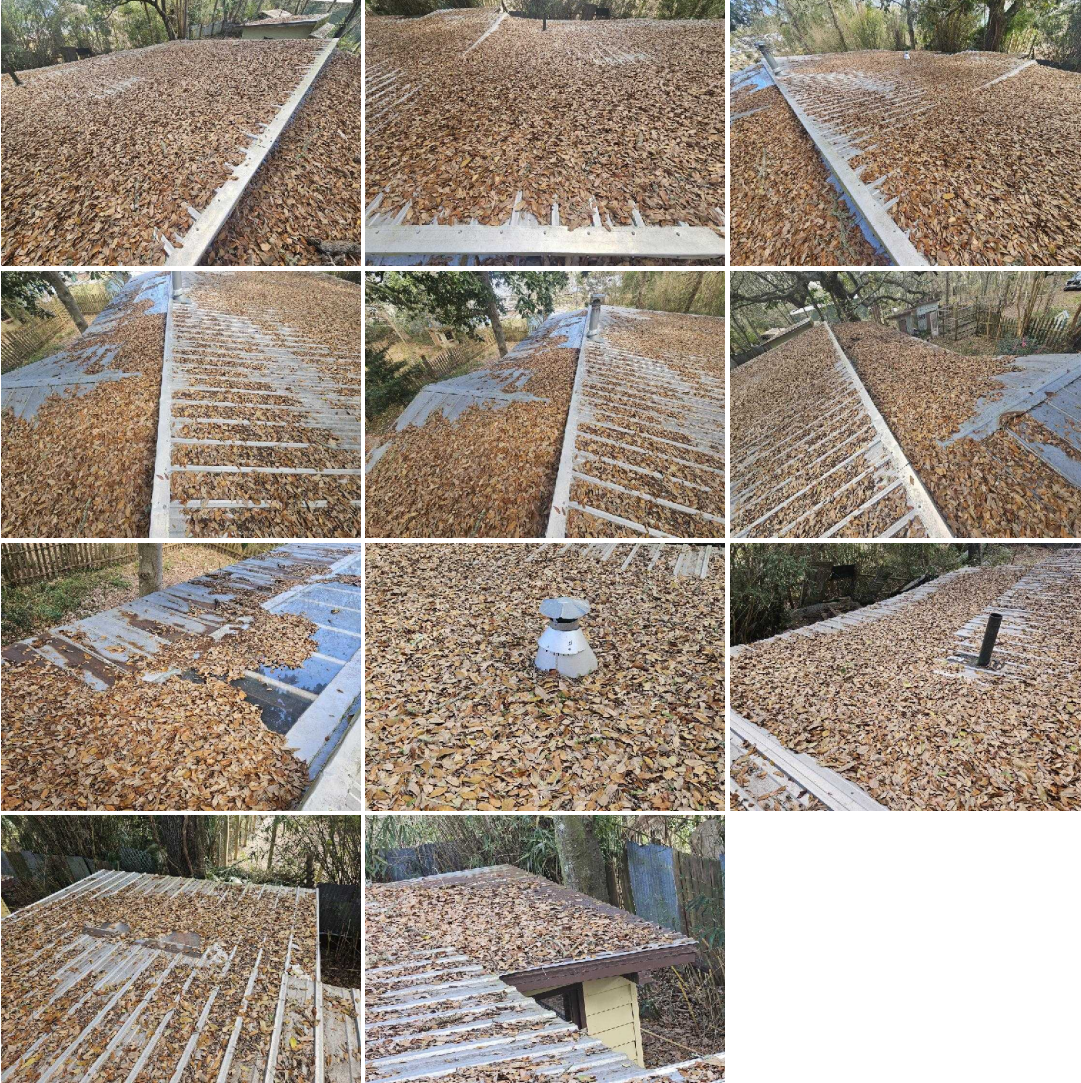
further evaluation of the roof structure and covering by a qualified roofing contractor.

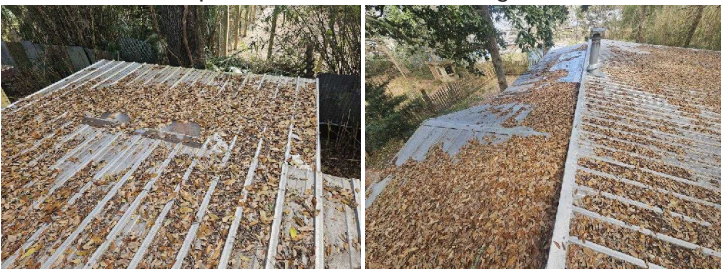
15. Skylights: DIY, Non engineered/ manufactured - Glass panels were installed as makeshift skylights and do not appear to be part of a manufactured skylight system. These panels are not properly flashed and may allow water intrusion into the roof structure. Improvised installations can lead to roof leakage and structural deterioration over time. Recommend removal of these panels and installation of properly manufactured and flashed skylight assemblies or replacement of the roofing materials in these areas.

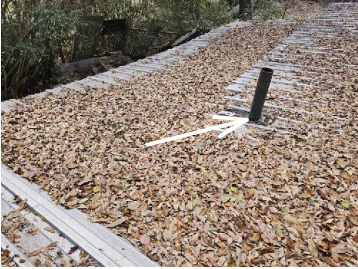
16. Plumbing Vent Flashings: None present - The plumbing vent penetration through the roof is not properly flashed. Recommend repair or replacement of the flashing to provide a proper watertight seal.

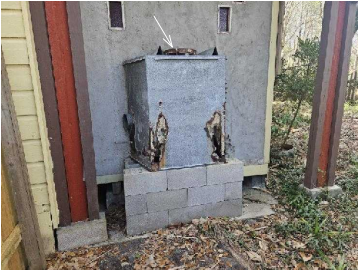
17. Left side Chimney Flue/Flue Cap: Missing - The flue pipe was not installed above the firebox. Without a properly installed flue, combustion gases and heat cannot be safely vented from the fireplace, which may allow smoke and carbon monoxide to enter the home. Recommend a qualified fireplace contractor evaluate and install the proper flue and venting components before the fireplace is used.

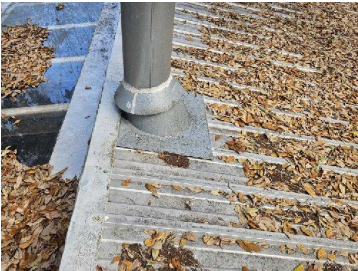
18. Middle Chimney Chimney Flashing: Metal - The flashing installed at the roof penetration around the fireplace flue pipe appears to be improper. Improper flashing at this location can allow water intrusion into the roof structure and interior building materials. Recommend a qualified roofing contractor evaluate the flashing installation and make the necessary corrections to ensure the roof penetration is properly sealed and weather-tight.

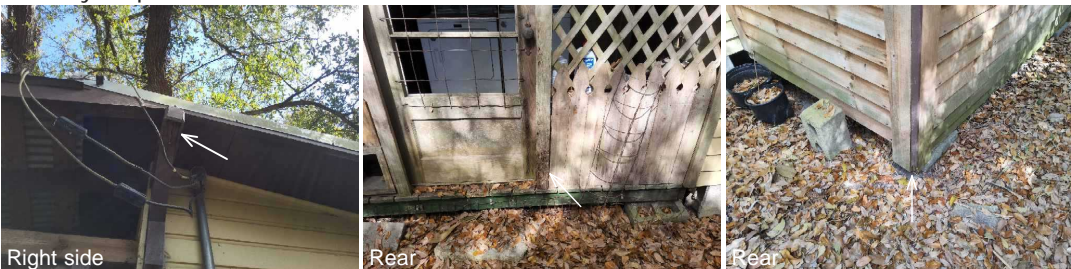
19. Trim: Wood - Damaged wood consistent with wood destroying insect activity was observed at several areas of the exterior siding and trim. Wood components affected by insect damage may continue to deteriorate if infestation remains active. Recommend evaluation by a licensed pest control professional and replacement of all damaged wood by a qualified contractor.

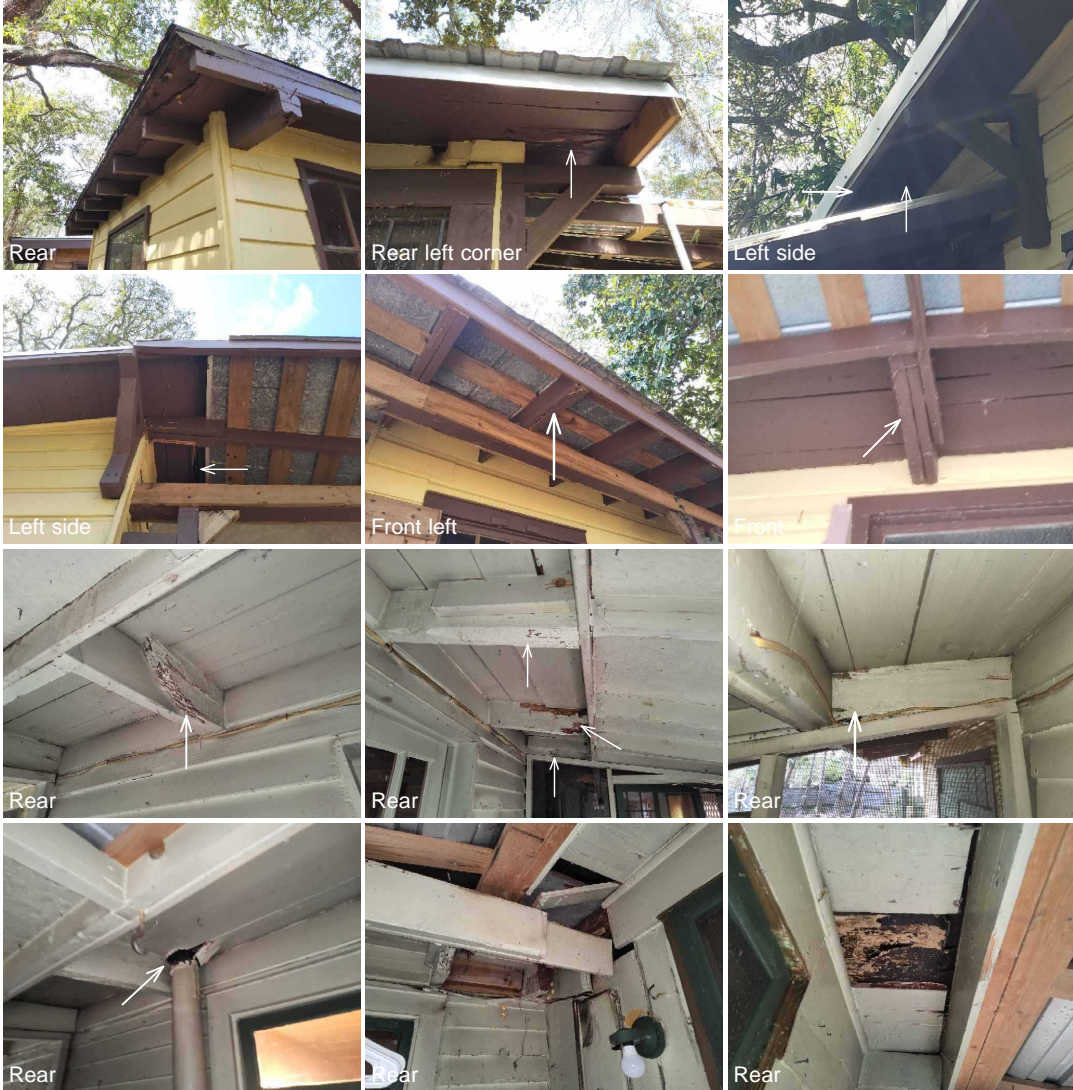
20. Fascia / Soffit: Open (Exposed rafter tails), Wood - Fascia observed with wood damage at several locations. Recommend removing / replacing damaged wood. *The inspector was unable to determine if this was from moisture / wood destroying insect.

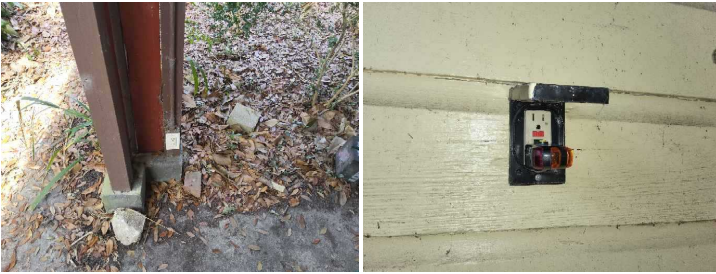
21. Exterior Electric Outlets: 110 VAC GFCI - The GFCI outlet was tripped and will not reset. Recommend a licensed electrician make the needed corrections.
