Property Assessment Report

232 Citizen Street
Bay Saint Louis, Mississippi 39520

Inspected by:
Home Inspection Building Specialist Inc.

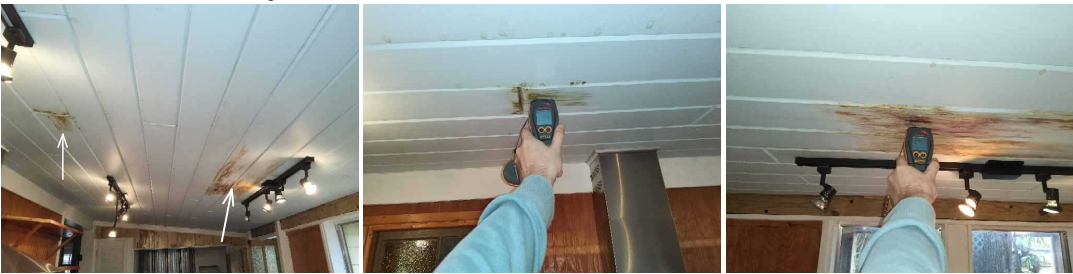
22. Middle Kitchen Ceiling: Wood - Moisture staining was observed on the kitchen ceiling and elevated moisture readings were detected during the inspection. Elevated moisture levels indicate an active or recent moisture intrusion source. Continued exposure to moisture may lead to structural deterioration and microbial growth. Recommend a qualified contractor locate and repair the source of moisture and replace damaged building materials as necessary.

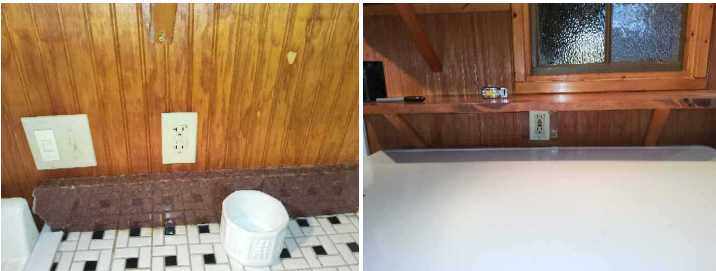
23. Middle Kitchen Electrical: 110 VAC GFCI - GFCI outlets were tripped and will not reset. Recommend a licensed electrician replace the outlets.

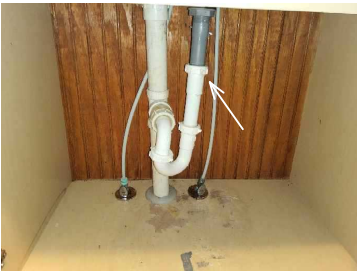
24. Primary Bathroom Sink/Basin: Plastic - The vanity sink drain is leaking in the primary bathroom. Recommend a licensed plumber make the needed corrections.

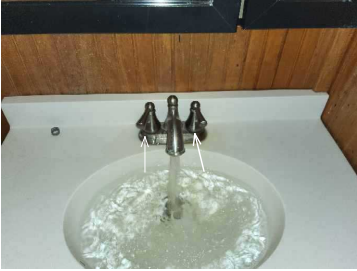
25. Primary Bathroom Plumbing / Fixtures: Double Valve Split Fixture, Single Valve Scald Proof Fixture - The vanity sink faucet leaks at the valve stems. Recommend a licensed plumber make the needed corrections.

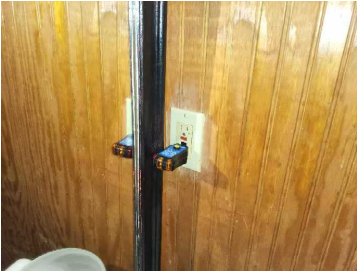
26. Rear Half Bathroom Electrical: 110 VAC GFCI - The GFCI outlet was tripped and will not reset. Recommend a licensed electrician replace the outlet.

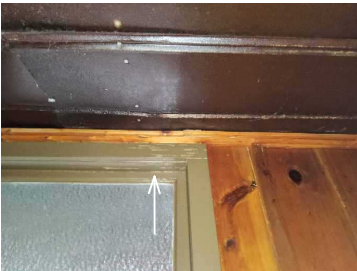
27. Foyer Living Space Walls: Wood, Paneling, Drywall - Dirt tubes and wood destroying insect damage were observed above the front door. Recommend having the home further evaluated by a qualified pest control company as well as a licensed contractor remove and replace all damaged wood.

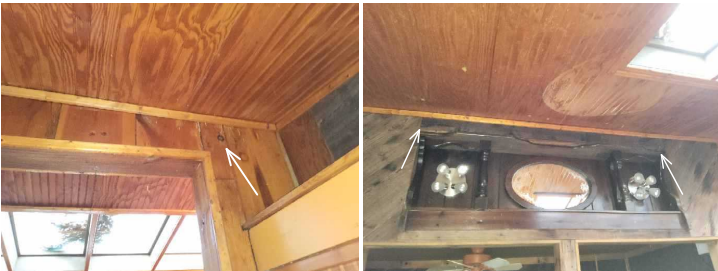
28. Family Room, Bar Living Space Walls: Paneling - Dirt tubes and wood destroying insect damage were observed above the beam. Recommend having the home further evaluated by a qualified pest control company as well as a licensed contractor remove and replace all damaged wood.

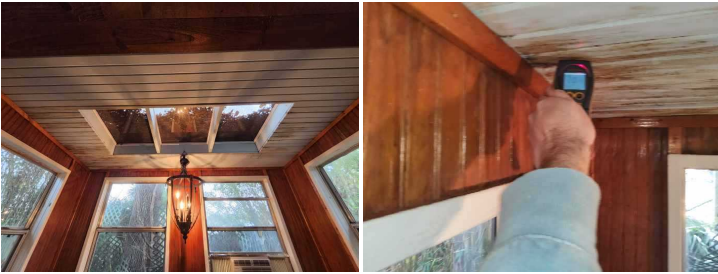
29. Rear Dining Area Living Space Ceiling: Wood - Moisture stains observed on the ceiling. Upon moisture survey this area tested elevated for moisture. Recommend a licensed contractor remove and replace all damaged wood.

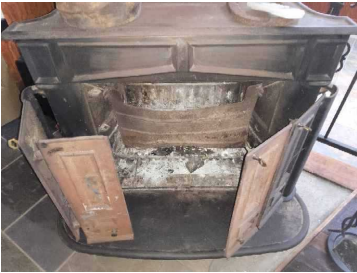
30. Family Room Fireplace Freestanding Stove: Wood burning - Due to the age and condition of this unit the inspector recommends having further evaluated by a qualified chimney sweep before use.

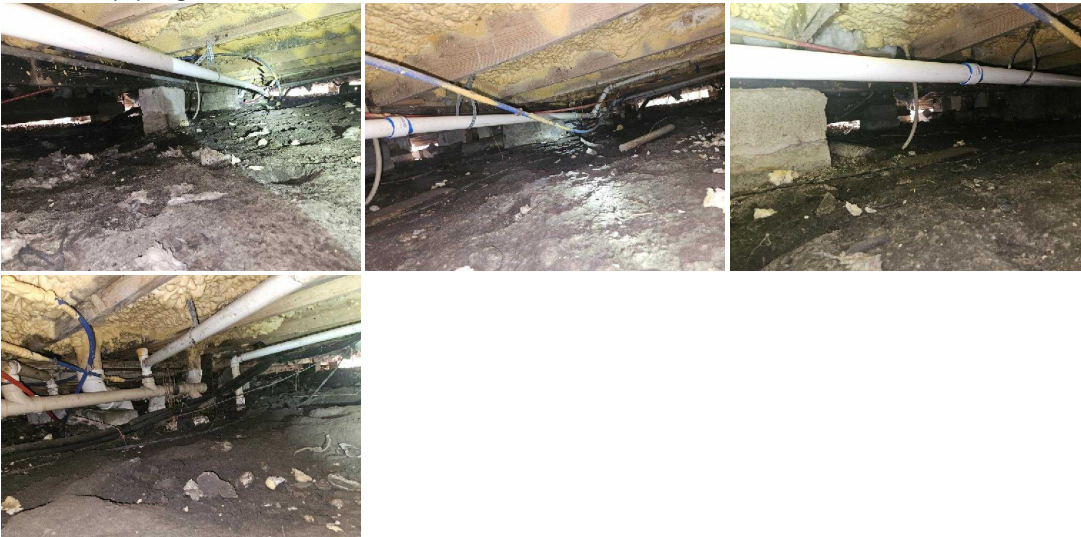
32. Drain piping: PVC - Drain piping beneath the structure appears improperly installed in areas. Portions of the piping run up and over structural framing members rather than maintaining a continuous downward slope toward the discharge point. Improper slope can restrict drainage and allow waste accumulation within the piping. Some sections also appear inadequately supported. Recommend a qualified plumbing contractor evaluate and correct the drain piping installation.

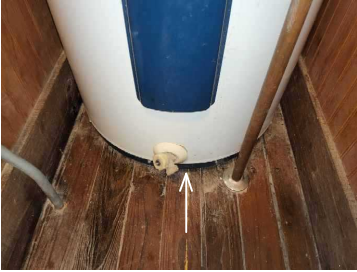
33. Primary bathroom Water Heater Drip Pan Not installed - A drip pan was not installed beneath the water heater. A pan helps limit water damage in the event of leakage. Recommend installing a properly drained pan beneath the water heater.

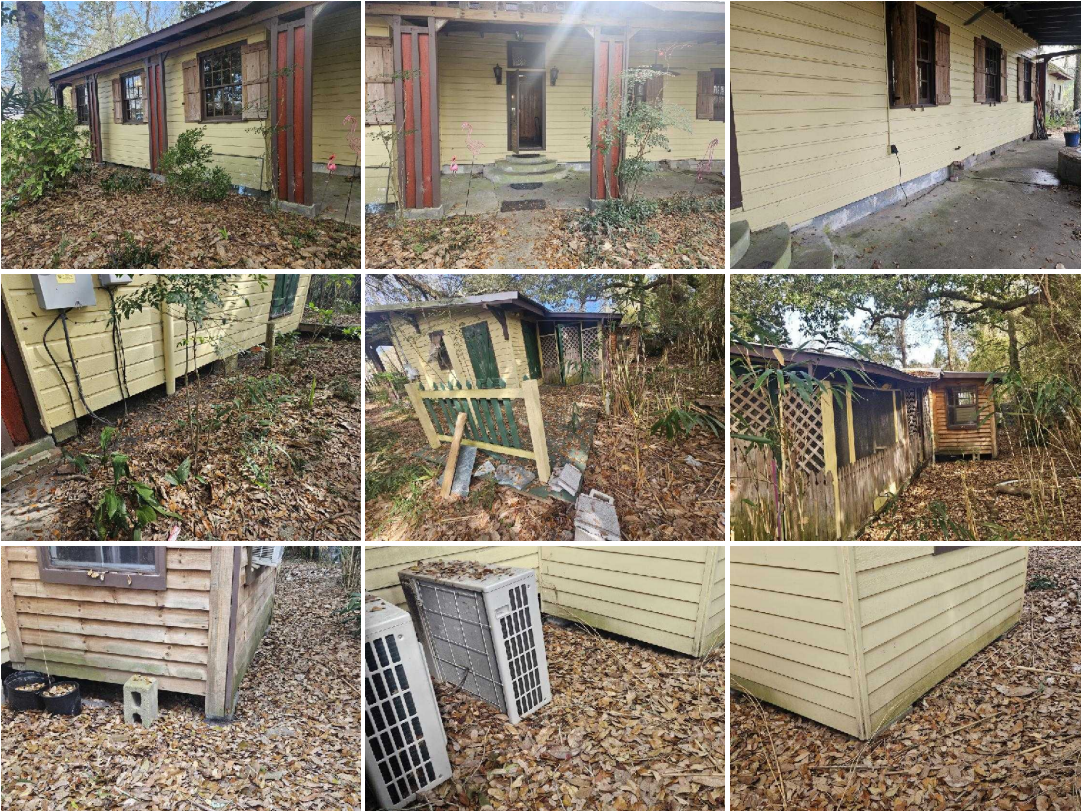
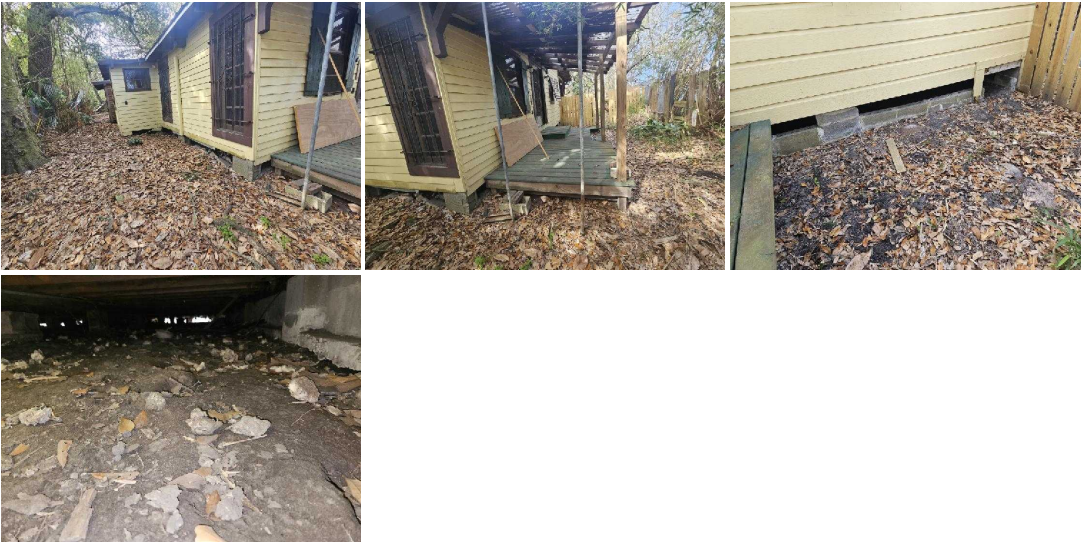
34. All Crawl Space Moisture Penetration: Ongoing source for moisture - Reference structure page for soil conditions in the crawlspace.
35. All Crawl Space Ventilation: Open at perimeter (3 Sides) - Crawlspace ventilation was observed to be open along much of the perimeter, with limited venting present only at portions of the front and rear right corner of the structure. Soil conditions beneath the home were wet at the time of the inspection despite no recent rain events, which suggests moisture may be accumulating beneath the structure. Excessive crawlspace moisture can contribute to wood deterioration, elevated humidity levels within the home, and conditions conducive to fungal growth or wood-destroying organisms. Recommend a qualified contractor further evaluate the crawlspace moisture conditions and improve drainage and/or ventilation as needed to reduce moisture accumulation beneath the structure.

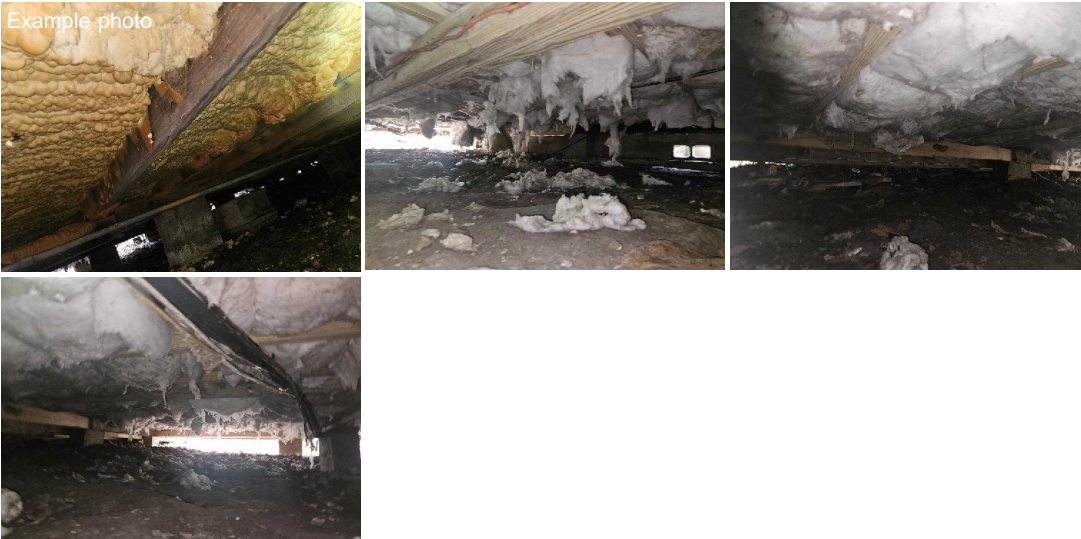
36. All Crawl Space Insulation: Fiberglass batt - The underside of the floor system is insulated with spray foam and fiberglass batt insulation which conceals large portions of the framing system. Evidence of termite damage was observed in accessible areas; however, concealed framing prevents determination of the full extent of deterioration. In the inspector's professional opinion, removal of insulation may be necessary to fully evaluate the structural framing and determine the scope of required repairs.

The spray foam and fiberglass insulation conceal large portions of the framing system, preventing determination of the full extent of termite damage and structural deterioration. In the inspector's professional opinion, removal of insulation and comprehensive structural evaluation is necessary to determine the scope of required repairs.

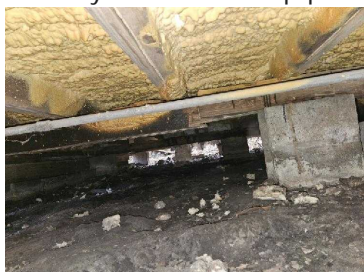
37. All Crawl Space Vapor Barrier: Not installed - No soil cover was installed at the time of the inspection. Soil covers help reduce humidity levels in crawlspaces by limiting moisture evaporation into the air from soil. Reducing humidity levels can help prevent conditions that encourage mold growth and wood decay.

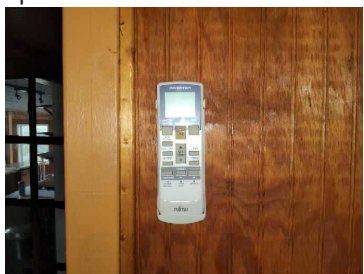
43. Thermostats: Remote controlled - The remote for the left bedroom Mini-split did not respond, batteries were replaced and unit still did not function. Recommend repair / replace.

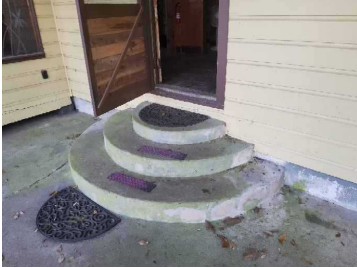
1. Steps/Stoops: Concrete - Exterior steps had no handrail. Generally-accepted modern safety standards dictate that stairs with 4 or more risers should have a handrail. You should consult with a qualified contractor before the expiration of your Inspection Objection Deadline to discuss options and costs for handrail installation.

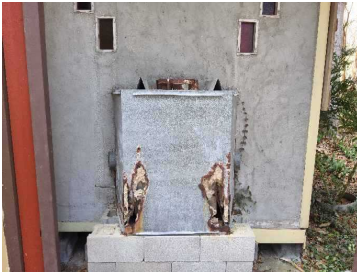
2. Left side Chimney Chimney: Metal - The chimney is damaged, and missing several components needed for safe use. Recommend a qualified chimney sweep further evaluate to determine the scope of work needed for replacement.

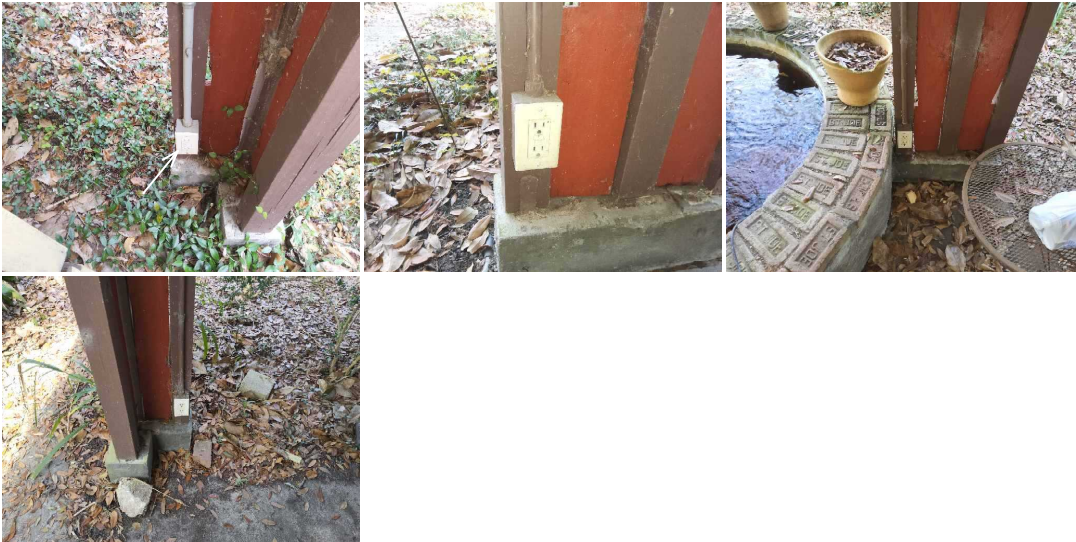
3. Exterior Electric Outlets: 110 VAC GFCI - Exterior outlets are missing weathertight covers. Recommend a licensed electrician replace missing covers.

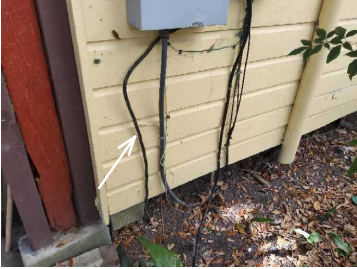
4. Exterior Electrical: 110V - Romex wiring was observed run outside of conduit. Recommend a licensed electrician make the needed corrections.

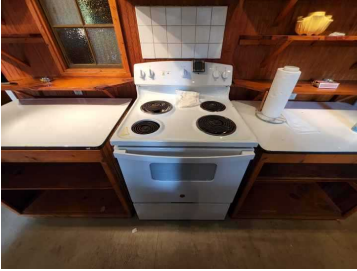
5. Middle Kitchen Cooking Appliances: General Electric - Anti-tip bracket not installed to avoid tipping. Recommend installing anti-tip per manufacture instruction.

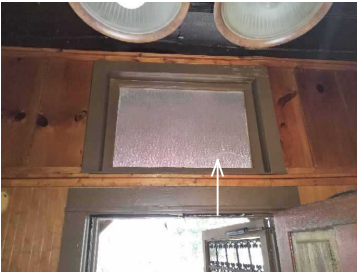
6. Foyer Living Space Windows: Non-opening - The window in the foyer has cracked glass. Recommend replace.

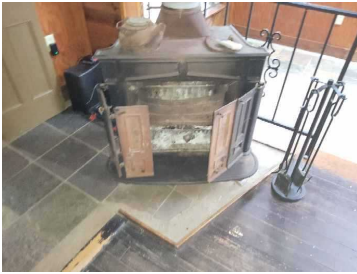
9. Family Room Fireplace Hearth: Flush mounted - The hearth at the wood burning stove is incorrect. Recommend a licensed contractor make the needed corrections.

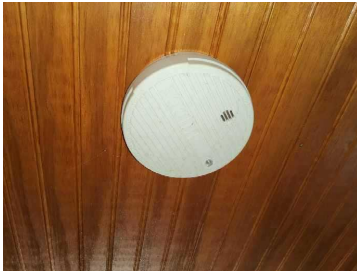
10. Left Bedroom Smoke Detector: Battery operated - Smoke detected did not function when manually tested. Recommend repair or replace.

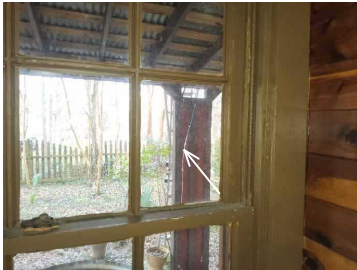
11. Primary Bedroom Windows: Wood - The window has cracked glass in the primary bedroom. Recommend replace.

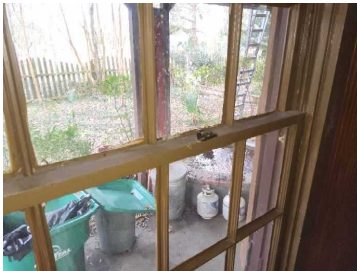
12. Primary Bedroom Windows: Wood - The window locking hardware is damaged, breaching the security of the home. It is recommended to repair or replace the locking mechanisms to restore security and prevent unauthorized access.

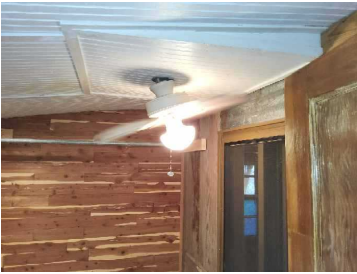
13. Left Bedroom Ceiling Fan Switched - The ceiling fan is hanging by its wiring in the closet. Recommend repairs.

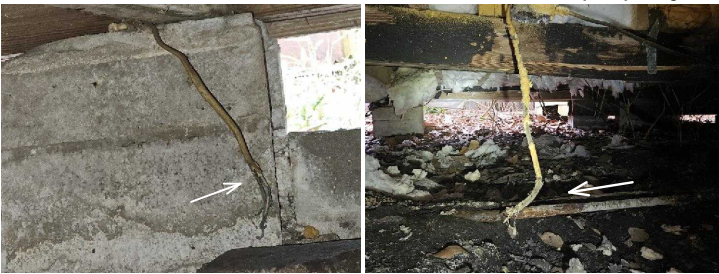
15. All Crawl Space Electrical: Romex - Electrical wiring was observed hanging beneath the floor framing with incomplete or improper terminations. Exposed or unsupported wiring presents potential shock and fire hazards. Recommend a licensed electrician secure and properly terminate wiring in approved electrical boxes.

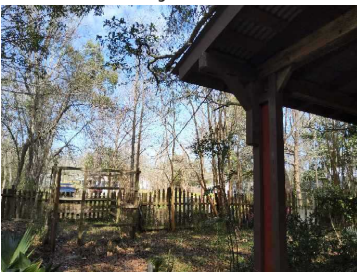
2. Safety Hazards Service: Milbank - Service wire from the street is in contact with the tree limbs. Recommend tree limbs are trimmed away from the service wire.

16. Service: Milbank - Service wire from the street is in contact with the tree limbs. Recommend tree limbs are trimmed away from the service wire.

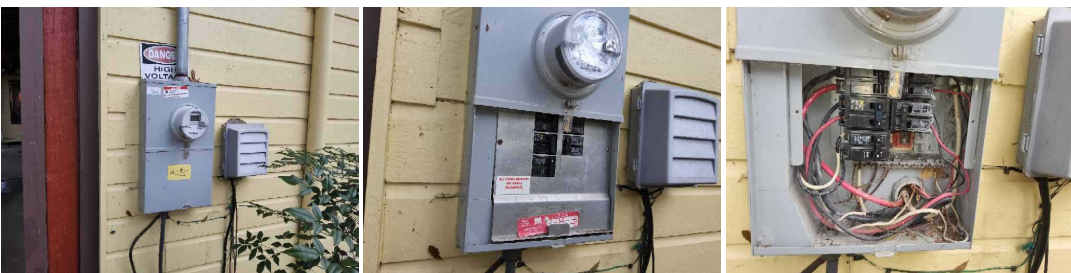
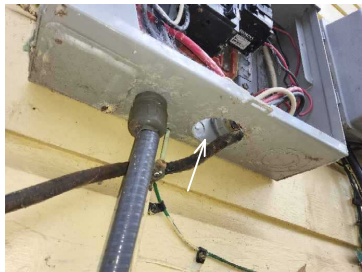
3. Safety Hazards Service: Milbank - Open knockout was observed in the base of the main panel. Recommend a licensed electrician make the needed corrections.

17. Service: Milbank - Open knockout was observed in the base of the main panel. Recommend a licensed electrician make the needed corrections.

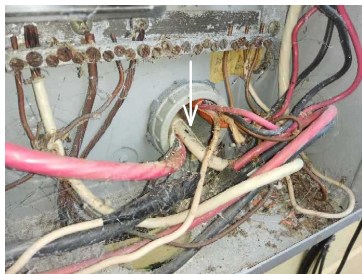
4. Safety Hazards 240 VAC Branch Circuits: Copper - Wiring in the main panel appears to have had the sheathing chewed by an animal. Recommend a licensed electrician make the needed corrections.

18. 240 VAC Branch Circuits: Copper - Wiring in the main panel appears to have had the sheathing chewed by an animal. Recommend a licensed electrician make the needed corrections.
