**129 Railroad Ave.**

**Bay Saint Louis**

**Historical Preservation Report**

**Sept 9, 2024**

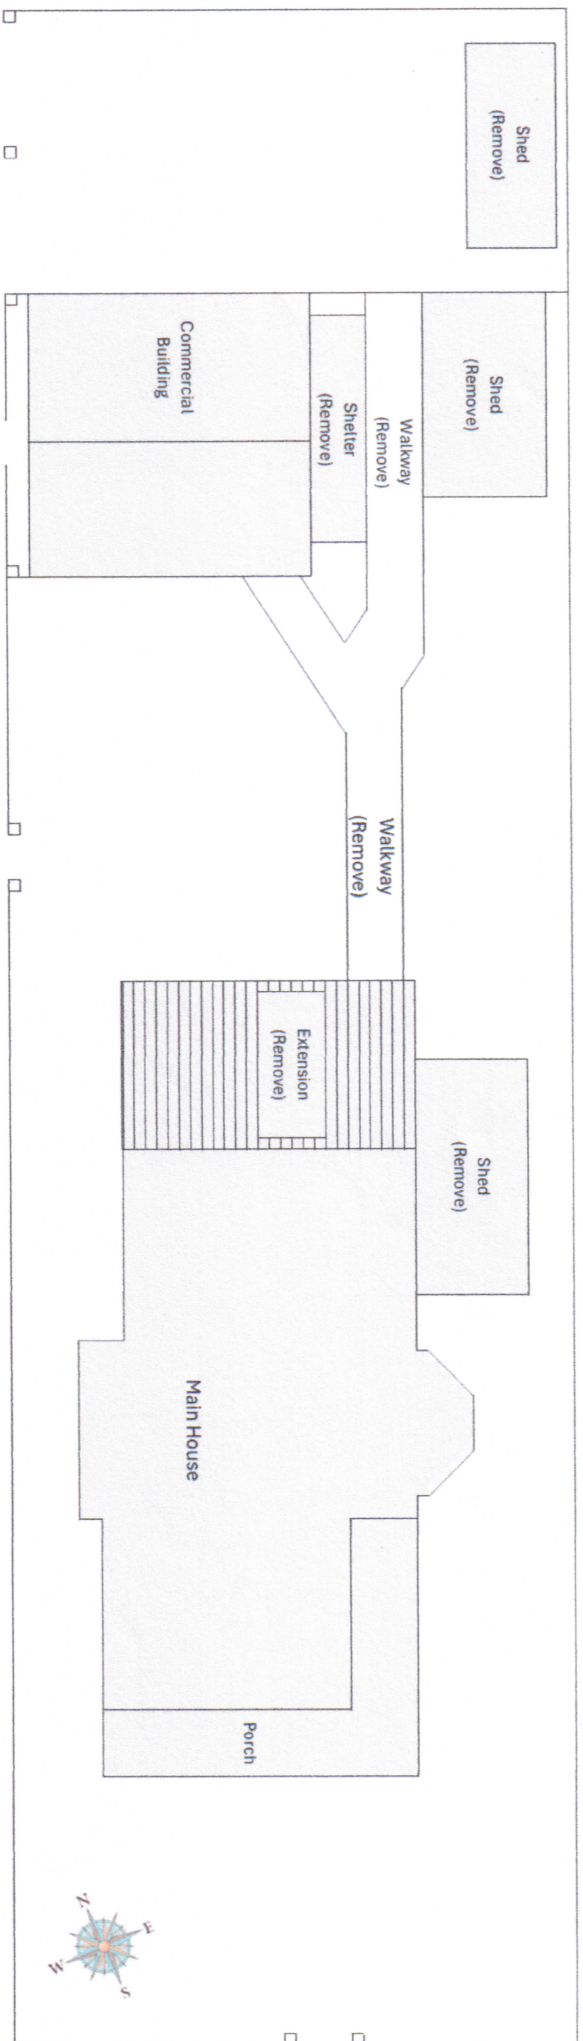
Diagram-1

The buildings of the existing property consist of the main house (circa. 1880), an extension to the rear/north of the main house (circa. 1980), a "storage shed" attached to the east-side of the house (circa. 1980), a commercial building with entrance onto 2<sup>nd</sup> street, a shed at the rear/east of the commercial building, a "storage shed" at the rear/north of the entire property and a covered walkway from the commercial property to the house (See diagram-1)

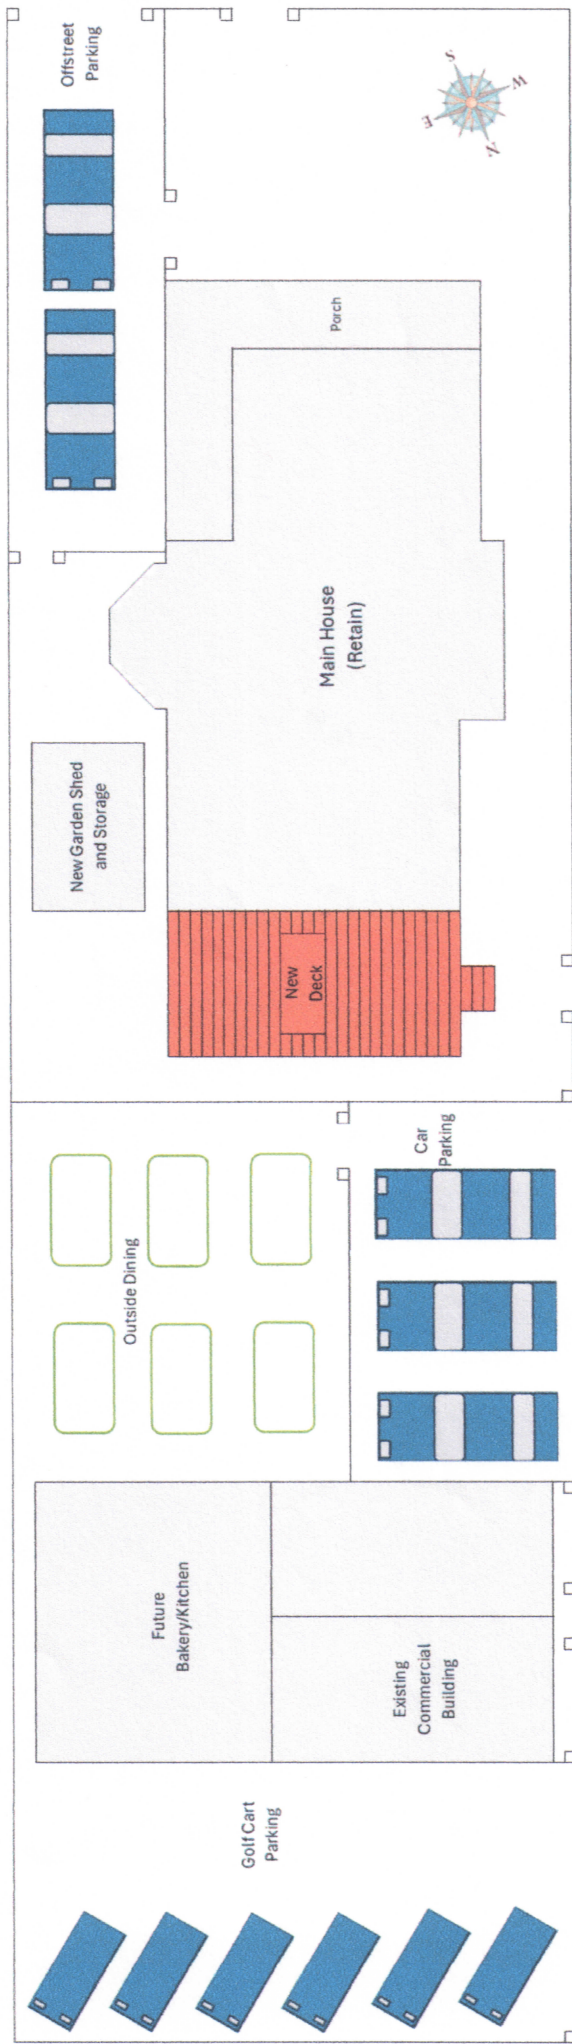
Diagram-2

There is currently off-street parking available for up to 4 vehicles on the rear of the property. The layout of this parking is not suitable for commercial purposes. The intent is to retain this parking for golf cart access, add additional parking (3 spaces) between the commercial building and the house and add additional off-street parking for the main house (see Diagram-2).
