City of Beaumont, California

Beaumont Plunge Pool Study

January 2021

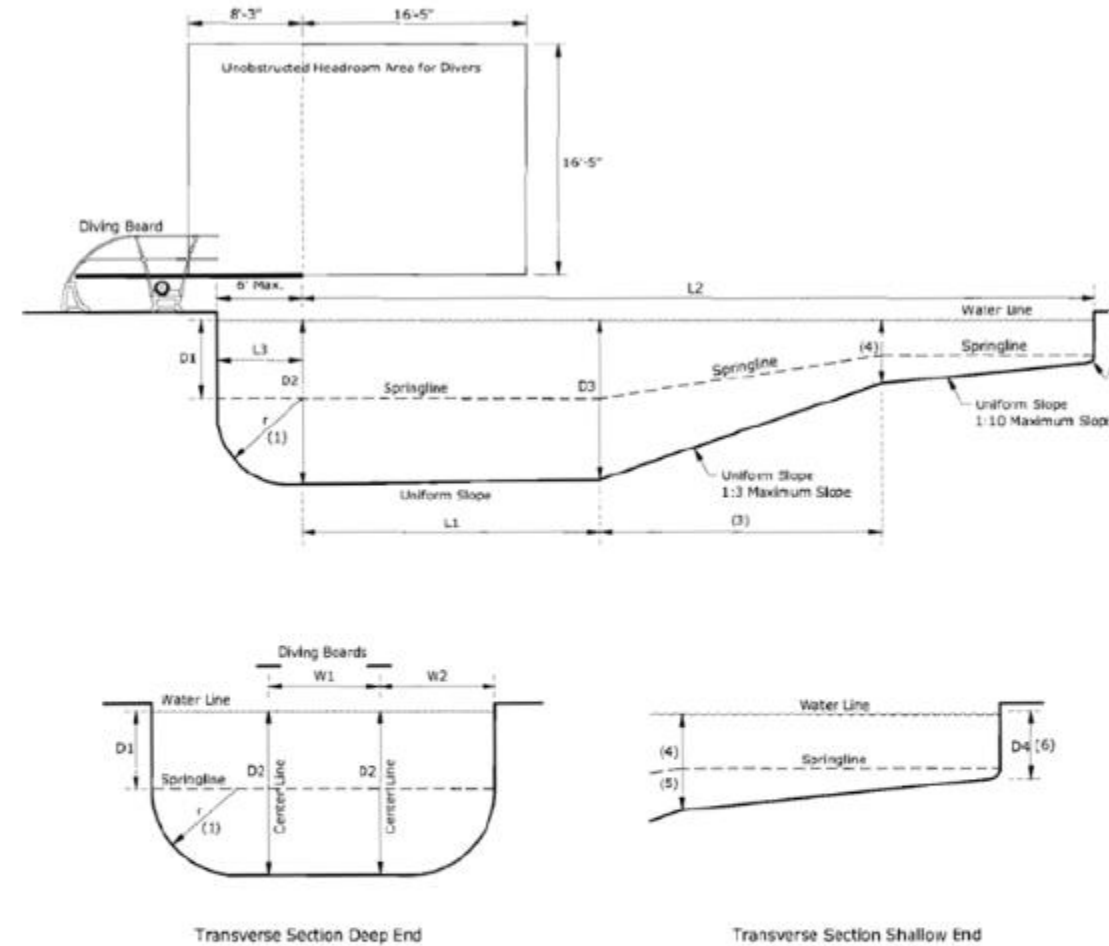
FIGURE 31B-1  
DEPTHS AND CLEARANCES FOR POOLS WITH DIVING BOARDS GREATER THAN 30 INCHES (762 mm) ABOVE THE WATER LINE

- The depth of the diving well does not meet the minimum standards stipulated by the State Code. With a depth of 10 feet, the depth fails the standards by 18 inches.
- The existing slope of the pool floor does not meet the standards stipulated by the State Code. As shown in the picture to the right, the white line denotes the existing pool floor and slope while the red line represents the depth and slope required by the State Code. The pool does not meet the slope or the depth requirement.

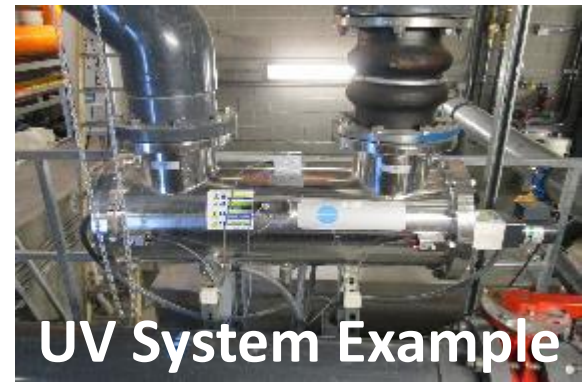
UV System Example

- The children's pool does not have a mechanical system that meets industry design standards since it does not contain an Ultraviolet Treatment (UV) System on the pool (picture – bottom right) to provide secondary sanitation. UV has been shown to be highly effective against chlorine resistant pathogens like Cryptosporidium and Giardia; as well as the vast majority of bacteria, viruses, yeast, and mold.

- According to the Model Aquatic Health Code, "Due to the risk of outbreaks of RWIs associated with the DISINFECTANT tolerant parasite Cryptosporidium, it is strongly recommended that all AQUATIC FACILITIES include SECONDARY DISINFECTION SYSTEMS to minimize the risk to the public associated with these outbreaks."
