## Tree Removal Permit Application – Developed Property

# Arborist Report

For OIA Holdings, 3492 McCoy Rd, Belle Isle, FL, 32812

Date January 9, 2022

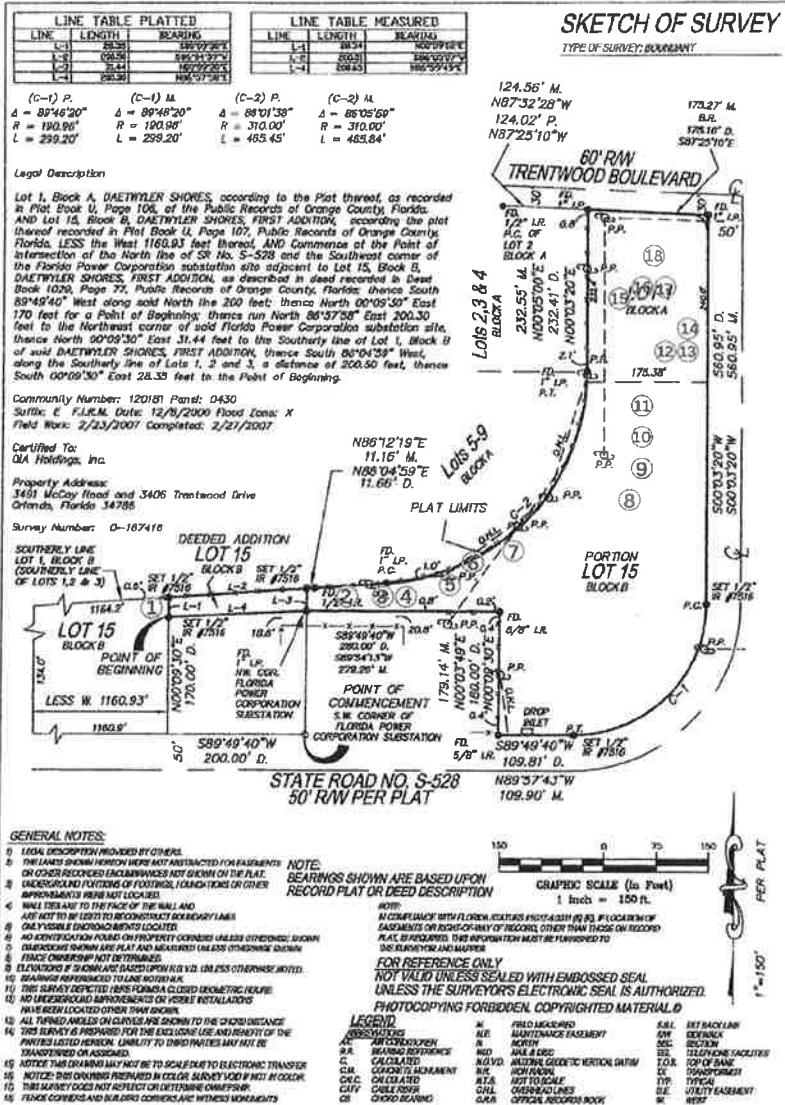
The vast majority of the trees appear to be in poor-to-fair condition overall. Many of them are clearly established volunteers, and they're relatively undesirable specimens of undesirable and/or invasive tree species. Several deficiencies were observed in most of the specimens including unbalanced canopies, heavy leans, dead and broken branches in the crowns, twig and leaf dieback, and/or indicators of decay. None of the trees have static targets in the line of fire with the exception of tree #13 (see survey) which has dead/dying branches directly overhanging the adjacent sidewalk.

*Trees located towards the west/southwest area of the lot.*

Removal to ground level is the recommended course of action for the cabbage palms, ear trees, laurel oaks, and cherry laurels due to their overall conditions, site locations, structural flaws, and species characteristics. Based on the observations made at the site, it is my professional opinion that most of the aforementioned specimens are 'diseased', invasive, and/or structurally unsound. In layman's terms, they're simply garbage trees (most of which are approaching the end of their natural lifespans), and their presence provides virtually no value to the property. Furthermore, they're unlikely to survive any future construction projects if any work is to take place within their critical root zones and/or canopy spreads.
