34 Thomas Heyward Street 2025 Assessment Report

**Meadors, Inc.
PO Box 21758
Charleston, SC 29413**

Date: 08.20.2025

Introduction

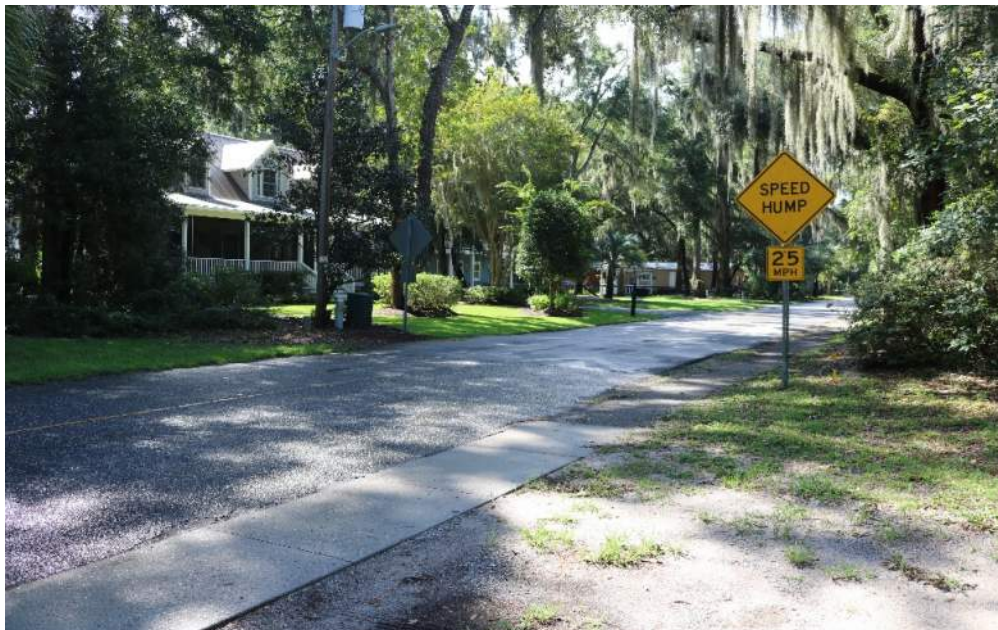
Figure 20: The architecture of the structures in proximity to the subject house varies in style and size. Several of the houses are newer and are more than one-story.

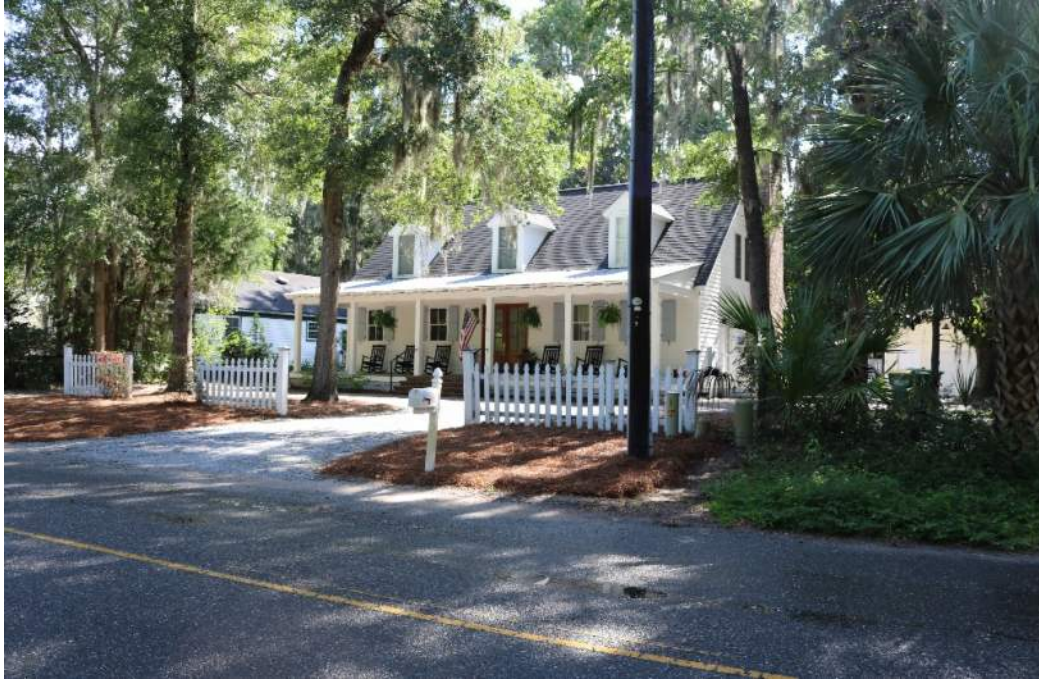
Figure 21: The architecture of the structures in proximity to the subject house varies in style and size. Several of the houses are newer and are more than one-story.

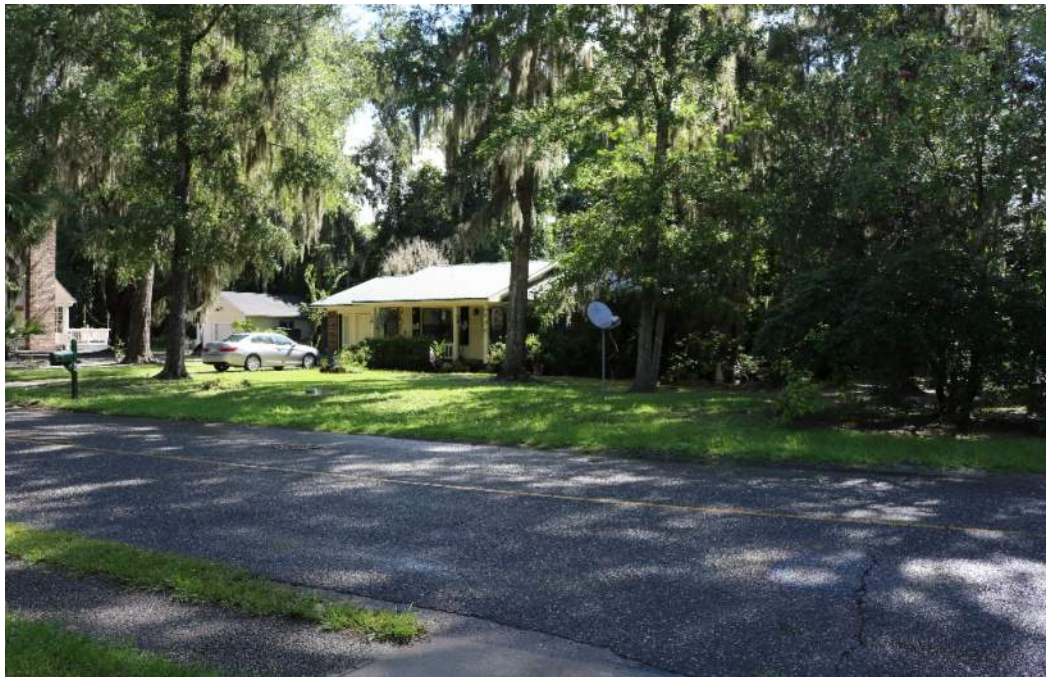
Figure 22: While there are single story houses on the street nearby, they appear to be newer and are architecturally different from the subject structure.

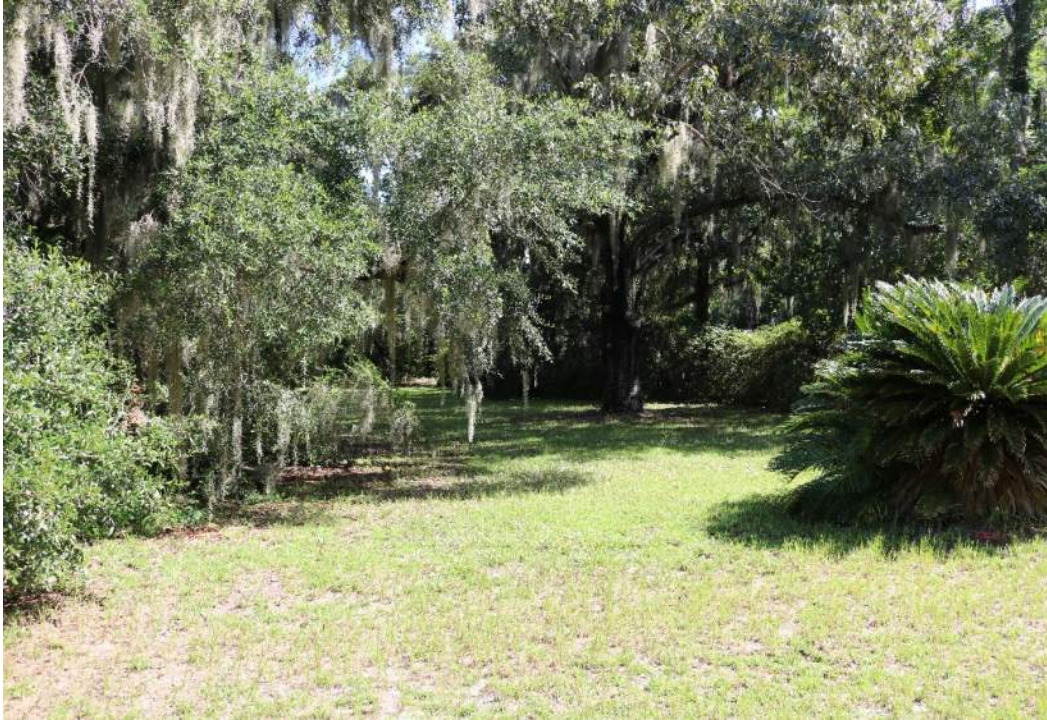
Figure 23: On the side of the street adjacent to the subject property, much of the land is undeveloped, leaving the subject property with little context.
