SARAH RILEY HOOKS COTTAGE 76 Bridge Street

VIABILITY OF PRESERVATION ASSESSMENT

Date: 12.21.2022

RE: Sarah Riley Hooks Cottage Viability of Preservation Assessment Sarah Riley Hooks House 76 Bridge Street

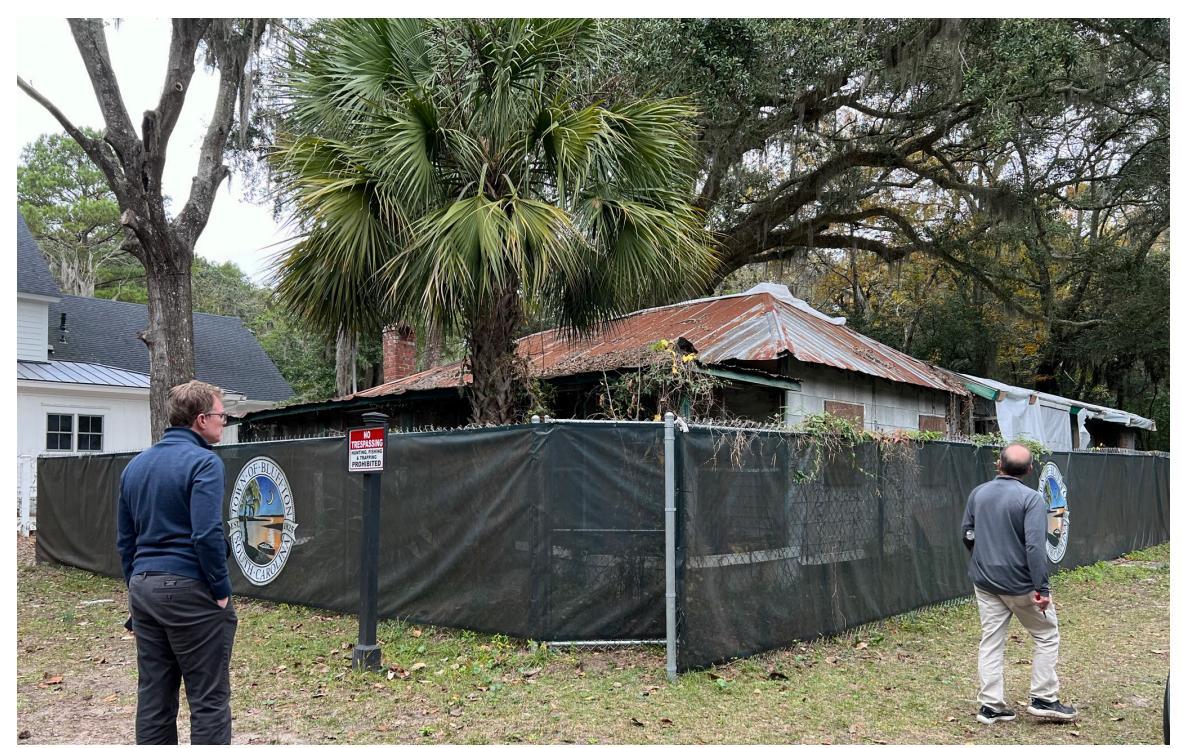
Figure 2: 76 Bridge Street: Front Elevation, facing Bridge Street.

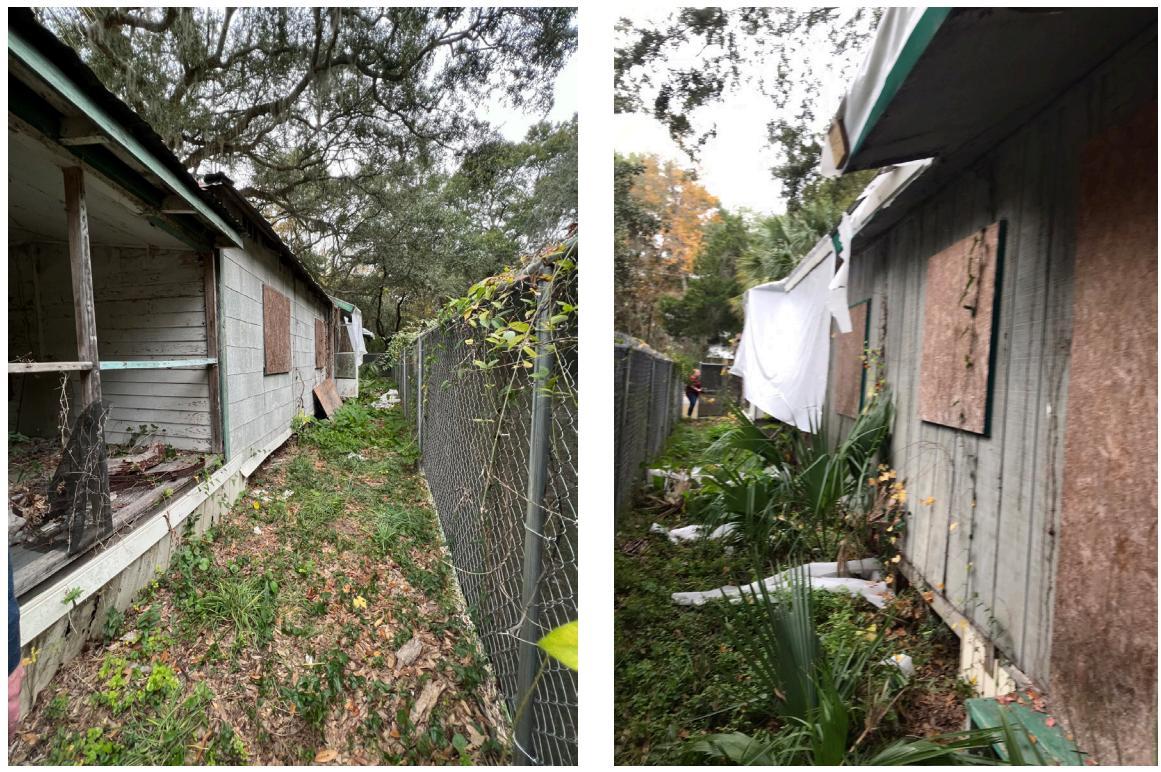
Figure 3: 76 Bridge Street: Side Elevation, adjacent to adjacent open land lots.

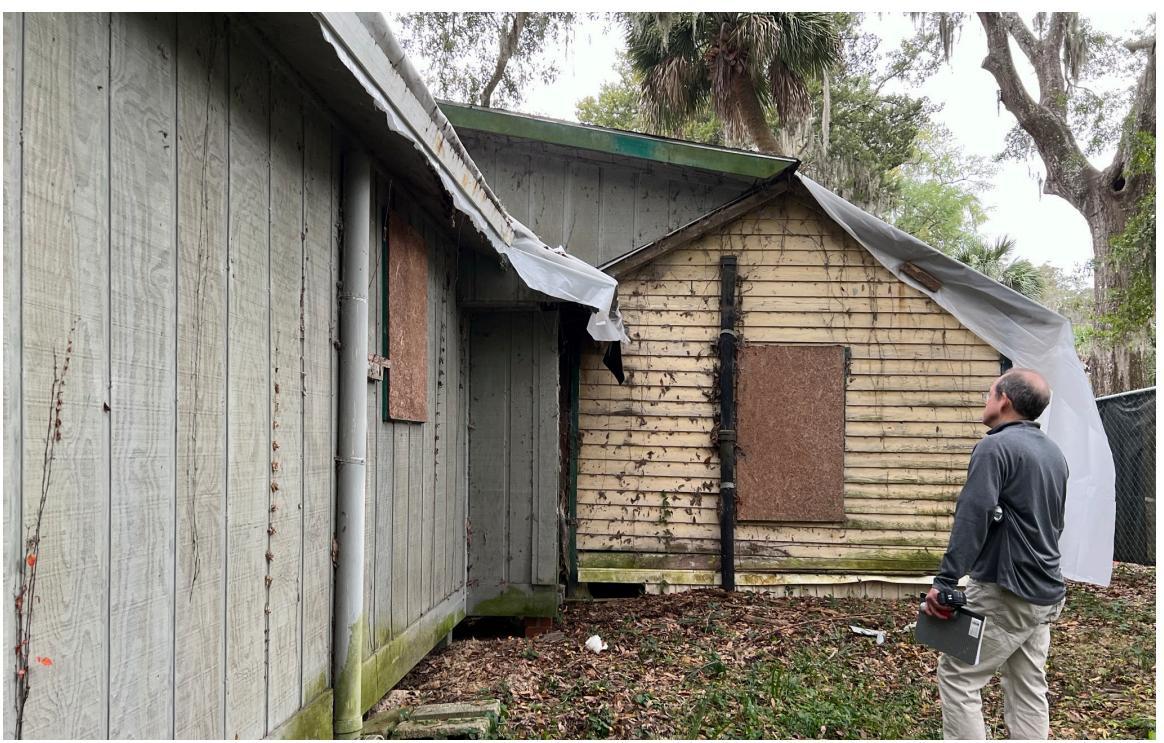
Figure 4: 76 Bridge Street: Rear Elevation looking south. The gray building is an addition. The yellow wall is part of the original cottage.

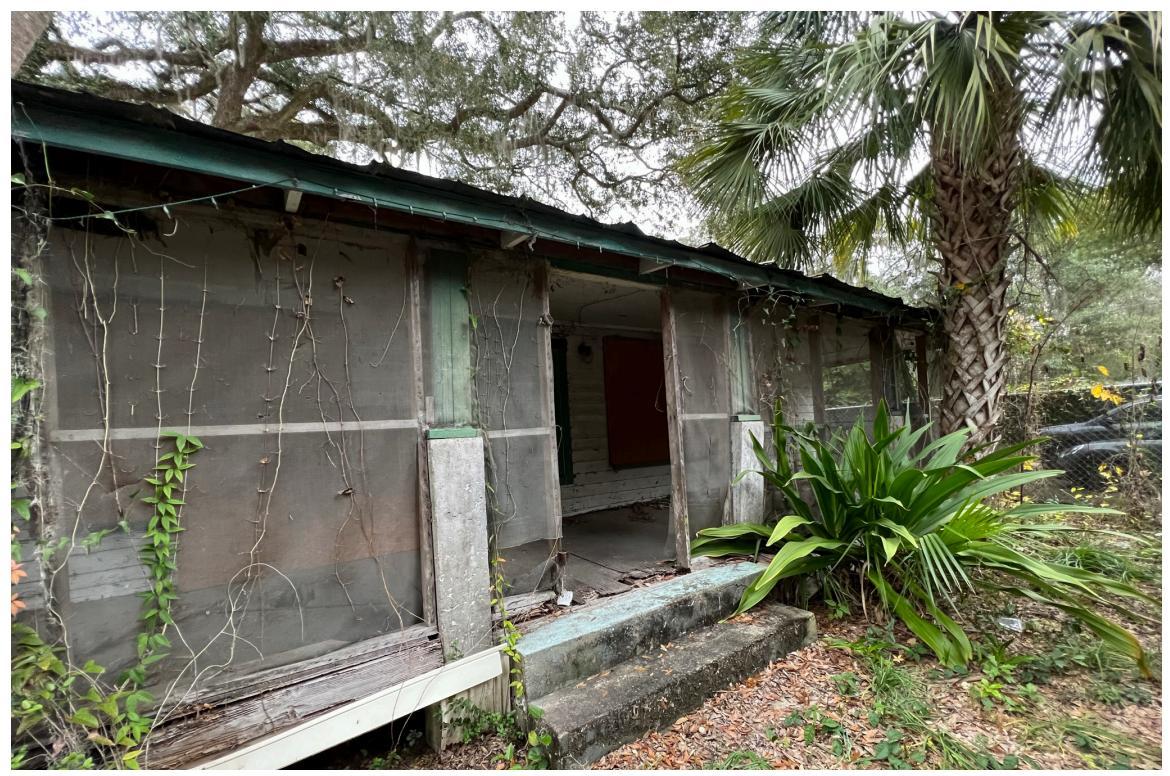
The covered porch at the front of the residence extends the width of the original structure and is covered by a shed roof terminating just below the main roof line. The roof framing is supported by a perimeter beam constructed over wood columns that rest on cast-in-place concrete piers. During the site investigation, water and termite damage was noted at the porch decking and exterior porch girders. Water damage was also noted at the roof framing adjacent to the front door entry, where portions of the ceiling are collapsing. In addition, the cast-in-place concrete piers at the porch perimeter have shifted outward, resulting in the rotation of the columns above and the deflection of the roof beam framing above.

Figure 5: 76 Bridge Street: Front Porch Elevation.
