Re: 9 Bruin Road
Bluffton, SC 29910

Re: Evaluation of Building Structures
9 Bluffton Road
Bluffton, SC

This is to follow-up the two site visits made on April 23 & 26, 2019. During the first visit, I met with Taiwan Scott who provided a brief, verbal history of the house that I inspected. The second visit was to evaluate the barbeque shed situated close to the sidewalk on Bluffton Road (S.R. 46). At the end of the written portion of this report are several photos referenced in the text.

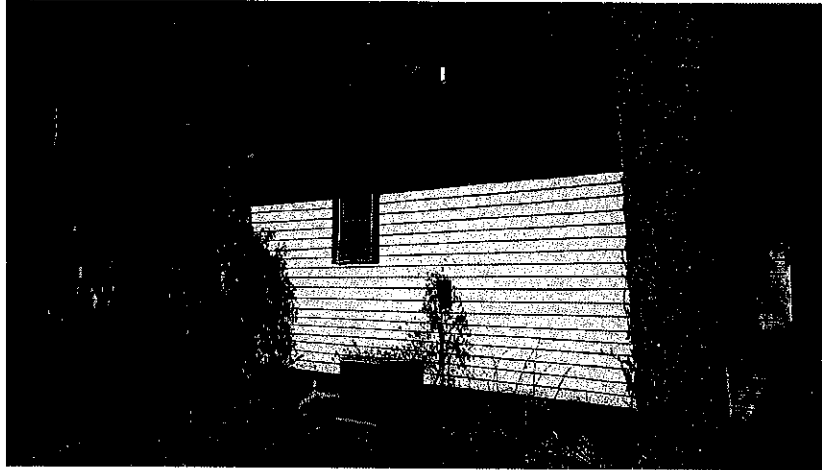
4. East Side

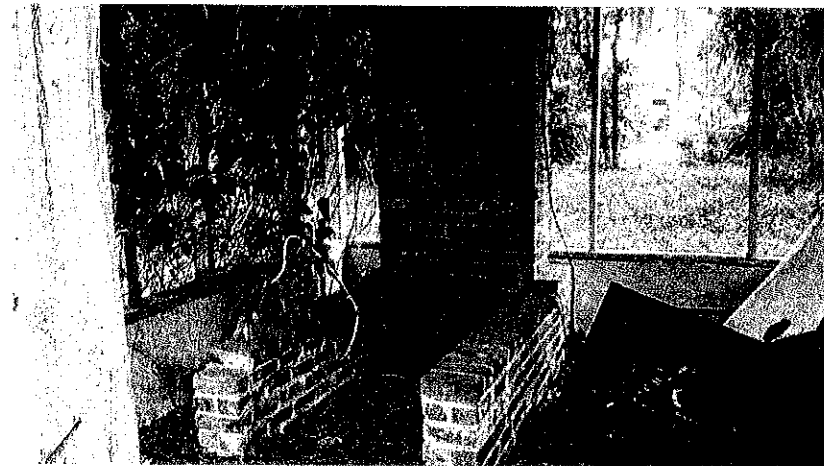
I have no historic information on this structure, but after inspecting it, it can be classified as a derelict building and potential public nuisance. As can be seen in photos 17 through 24, the building is in a state of neglect and suffers severe deterioration of its roof, floor, siding and foundation. It is unsafe to enter this structure. It appears to have harbored animals and perhaps homeless individuals.

24. The barbeque pit
