February 28, 2022

RE: 67 Boundary Street, Lot 1A Arborist Report

RE: 67 Boundary Street, Lot 1B Arborist Report

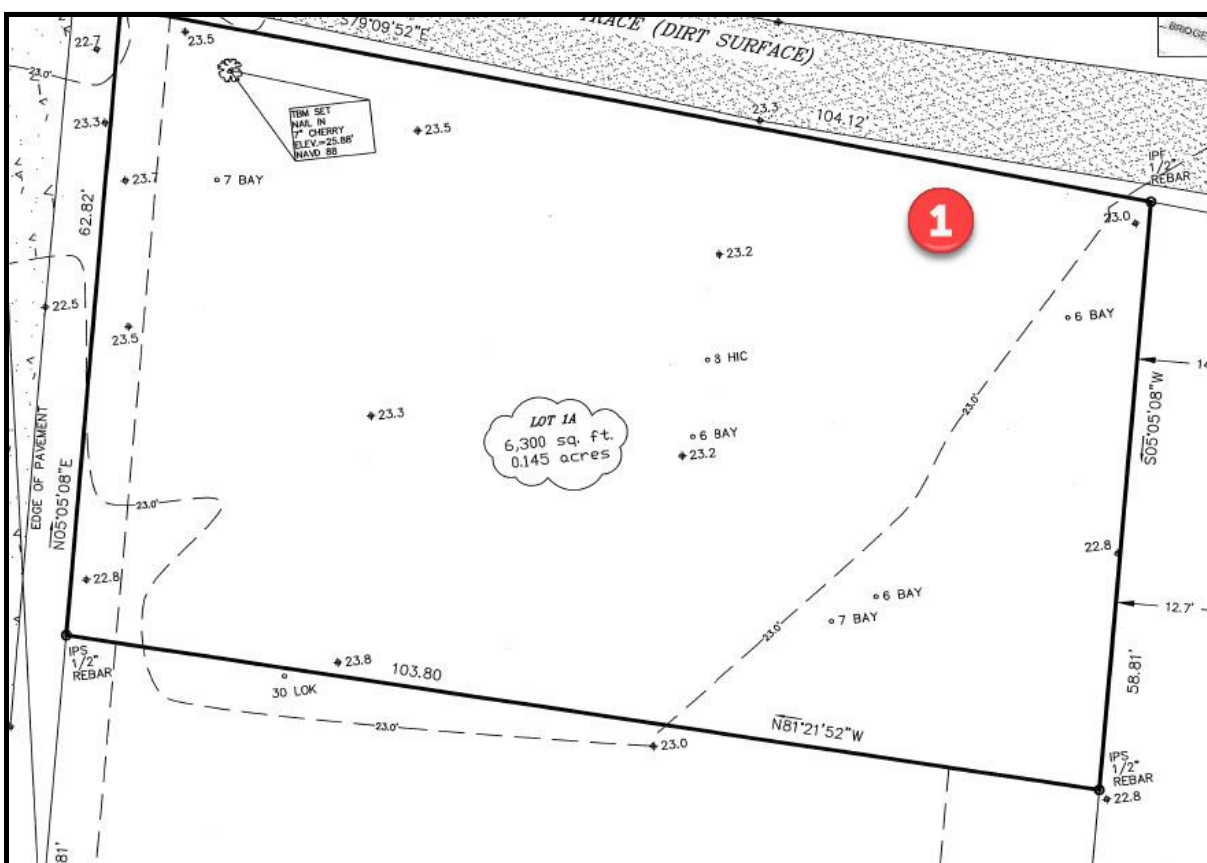
Photo 1

The Hickory (*Carya spp.*) measured 29.2-inches in diameter at breast height (dbh) and is located at the right of the unpaved road labeled "Hickory Trace" near the end of the property (Photo 1).

The tree trunk is structurally sound and did not appear to have any significant cavities or defects of concern. Additionally, the branching structure is normal for the species with no notable large dead limbs. The general health appeared to be good however the tree was observed during the leaf-off season and assessments of tree vitality during this time of the year are limited to observations of the tree structure and live observable buds.

Under the Town of Bluffton Unified Development Ordinance (UDO) this tree would be considered a significant tree due to its size and condition and is therefore protected under the code. This tree is marked as tree #1 on the site plan below. Due to its location on the lot, the building design can likely be adapted to preserve the tree.
