GEOTECHNICAL INVESTIGATION

*Proposed Addition to Residence
338 Kings Road
Brisbane, California*

February 27, 2018

February 27, 2018
Job No. 18-4751

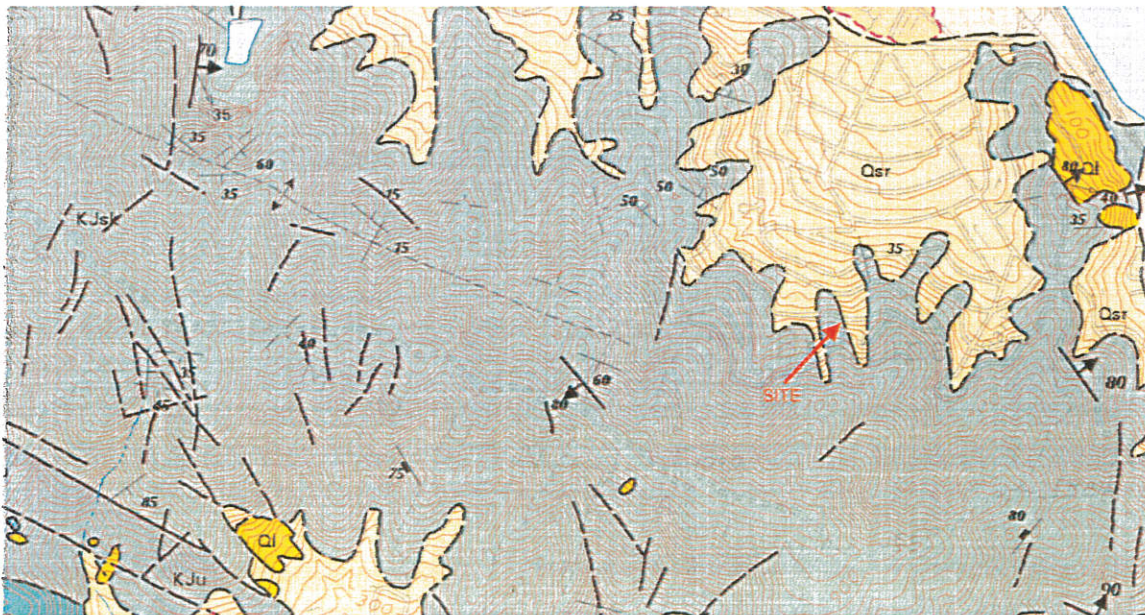
Bolilla (1998)

The site has been mapped by Brabb, Graymer and Jones (1998) and Bonilla (1998) to be underlain by Franciscan sandstone and shale (Kjsk). Brabb, Graymer and Jones describe the sandstone as *dark-gray to yellowish-brown greywacke interbedded with shale, in approximately equal amounts*. As noted, dense Franciscan sandstone was encountered in all of our test borings for the project. A scan of Bonilla's geologic map follows.
