# Bristol Historic District Commission

## Application for Review of Proposed Work - Printable Application

| We would like to demo the existing house and garage and build something new that meets Flood and Velocity codes. |

125 HOPE STREET, BRISTOL, RHODE ISLAND  
STRUCTURAL INSPECTION, JANUARY 16, 2025

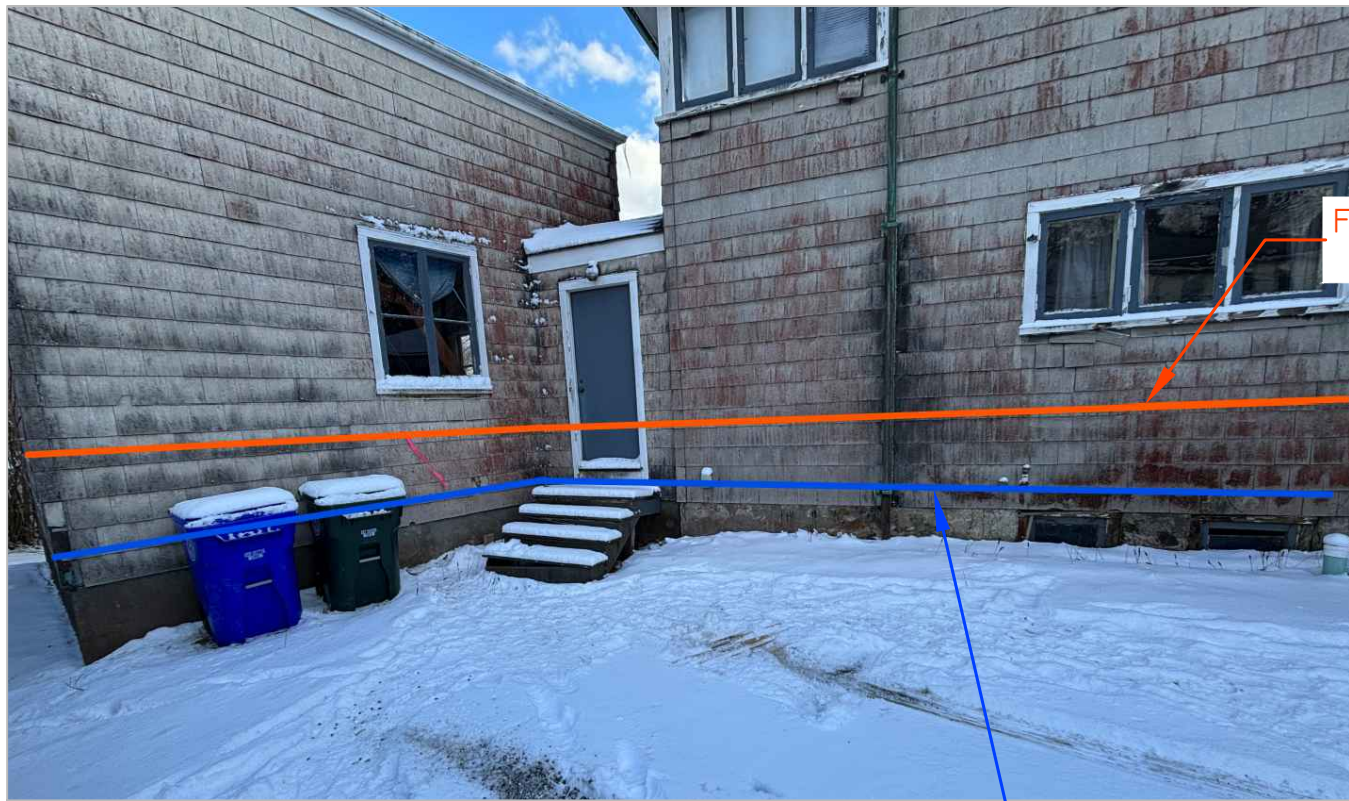
FUTURE FINISH FLOOR  
ELEVATION = 16.25

BASE FLOOD ELEVATION = 14.0

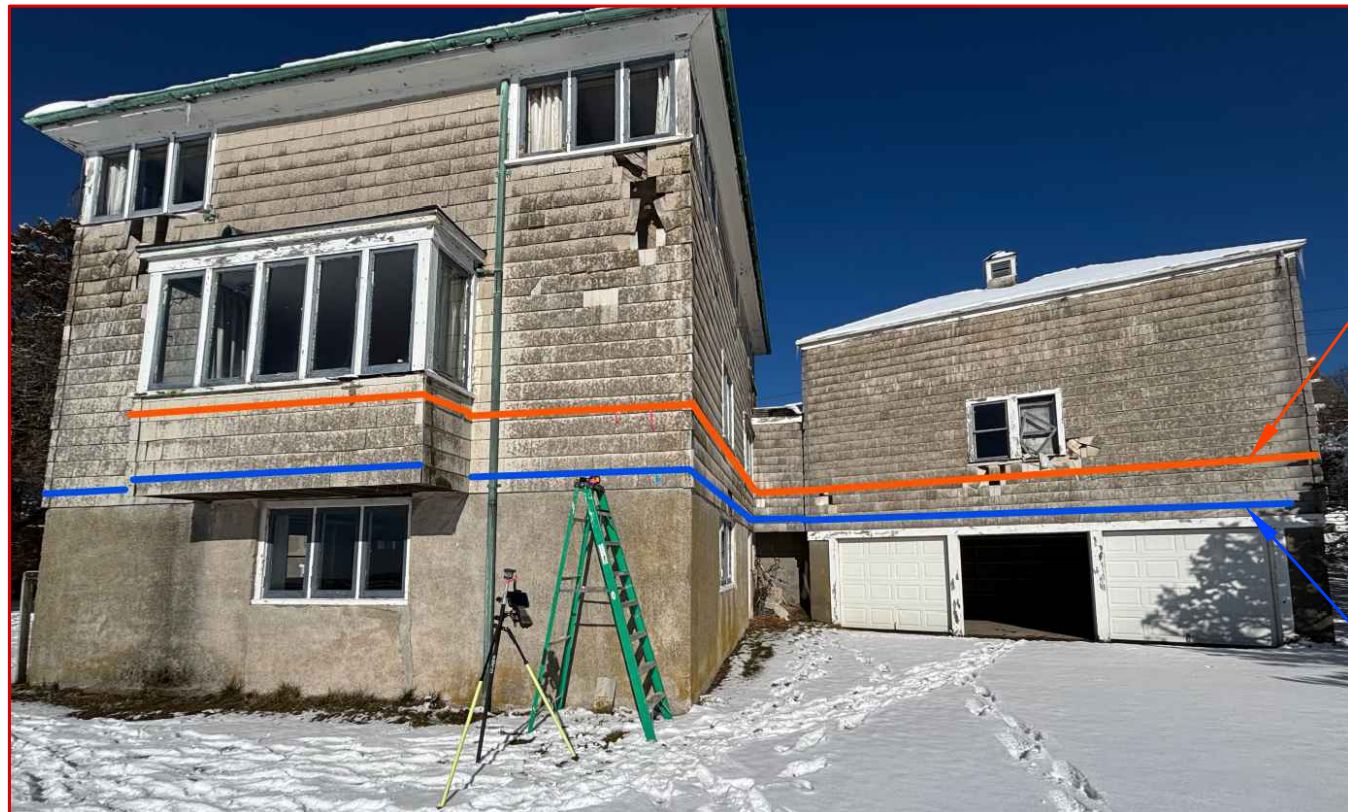
FUTURE FINISH FLOOR  
ELEVATION = 16.25

BASE FLOOD ELEVATION = 14.0

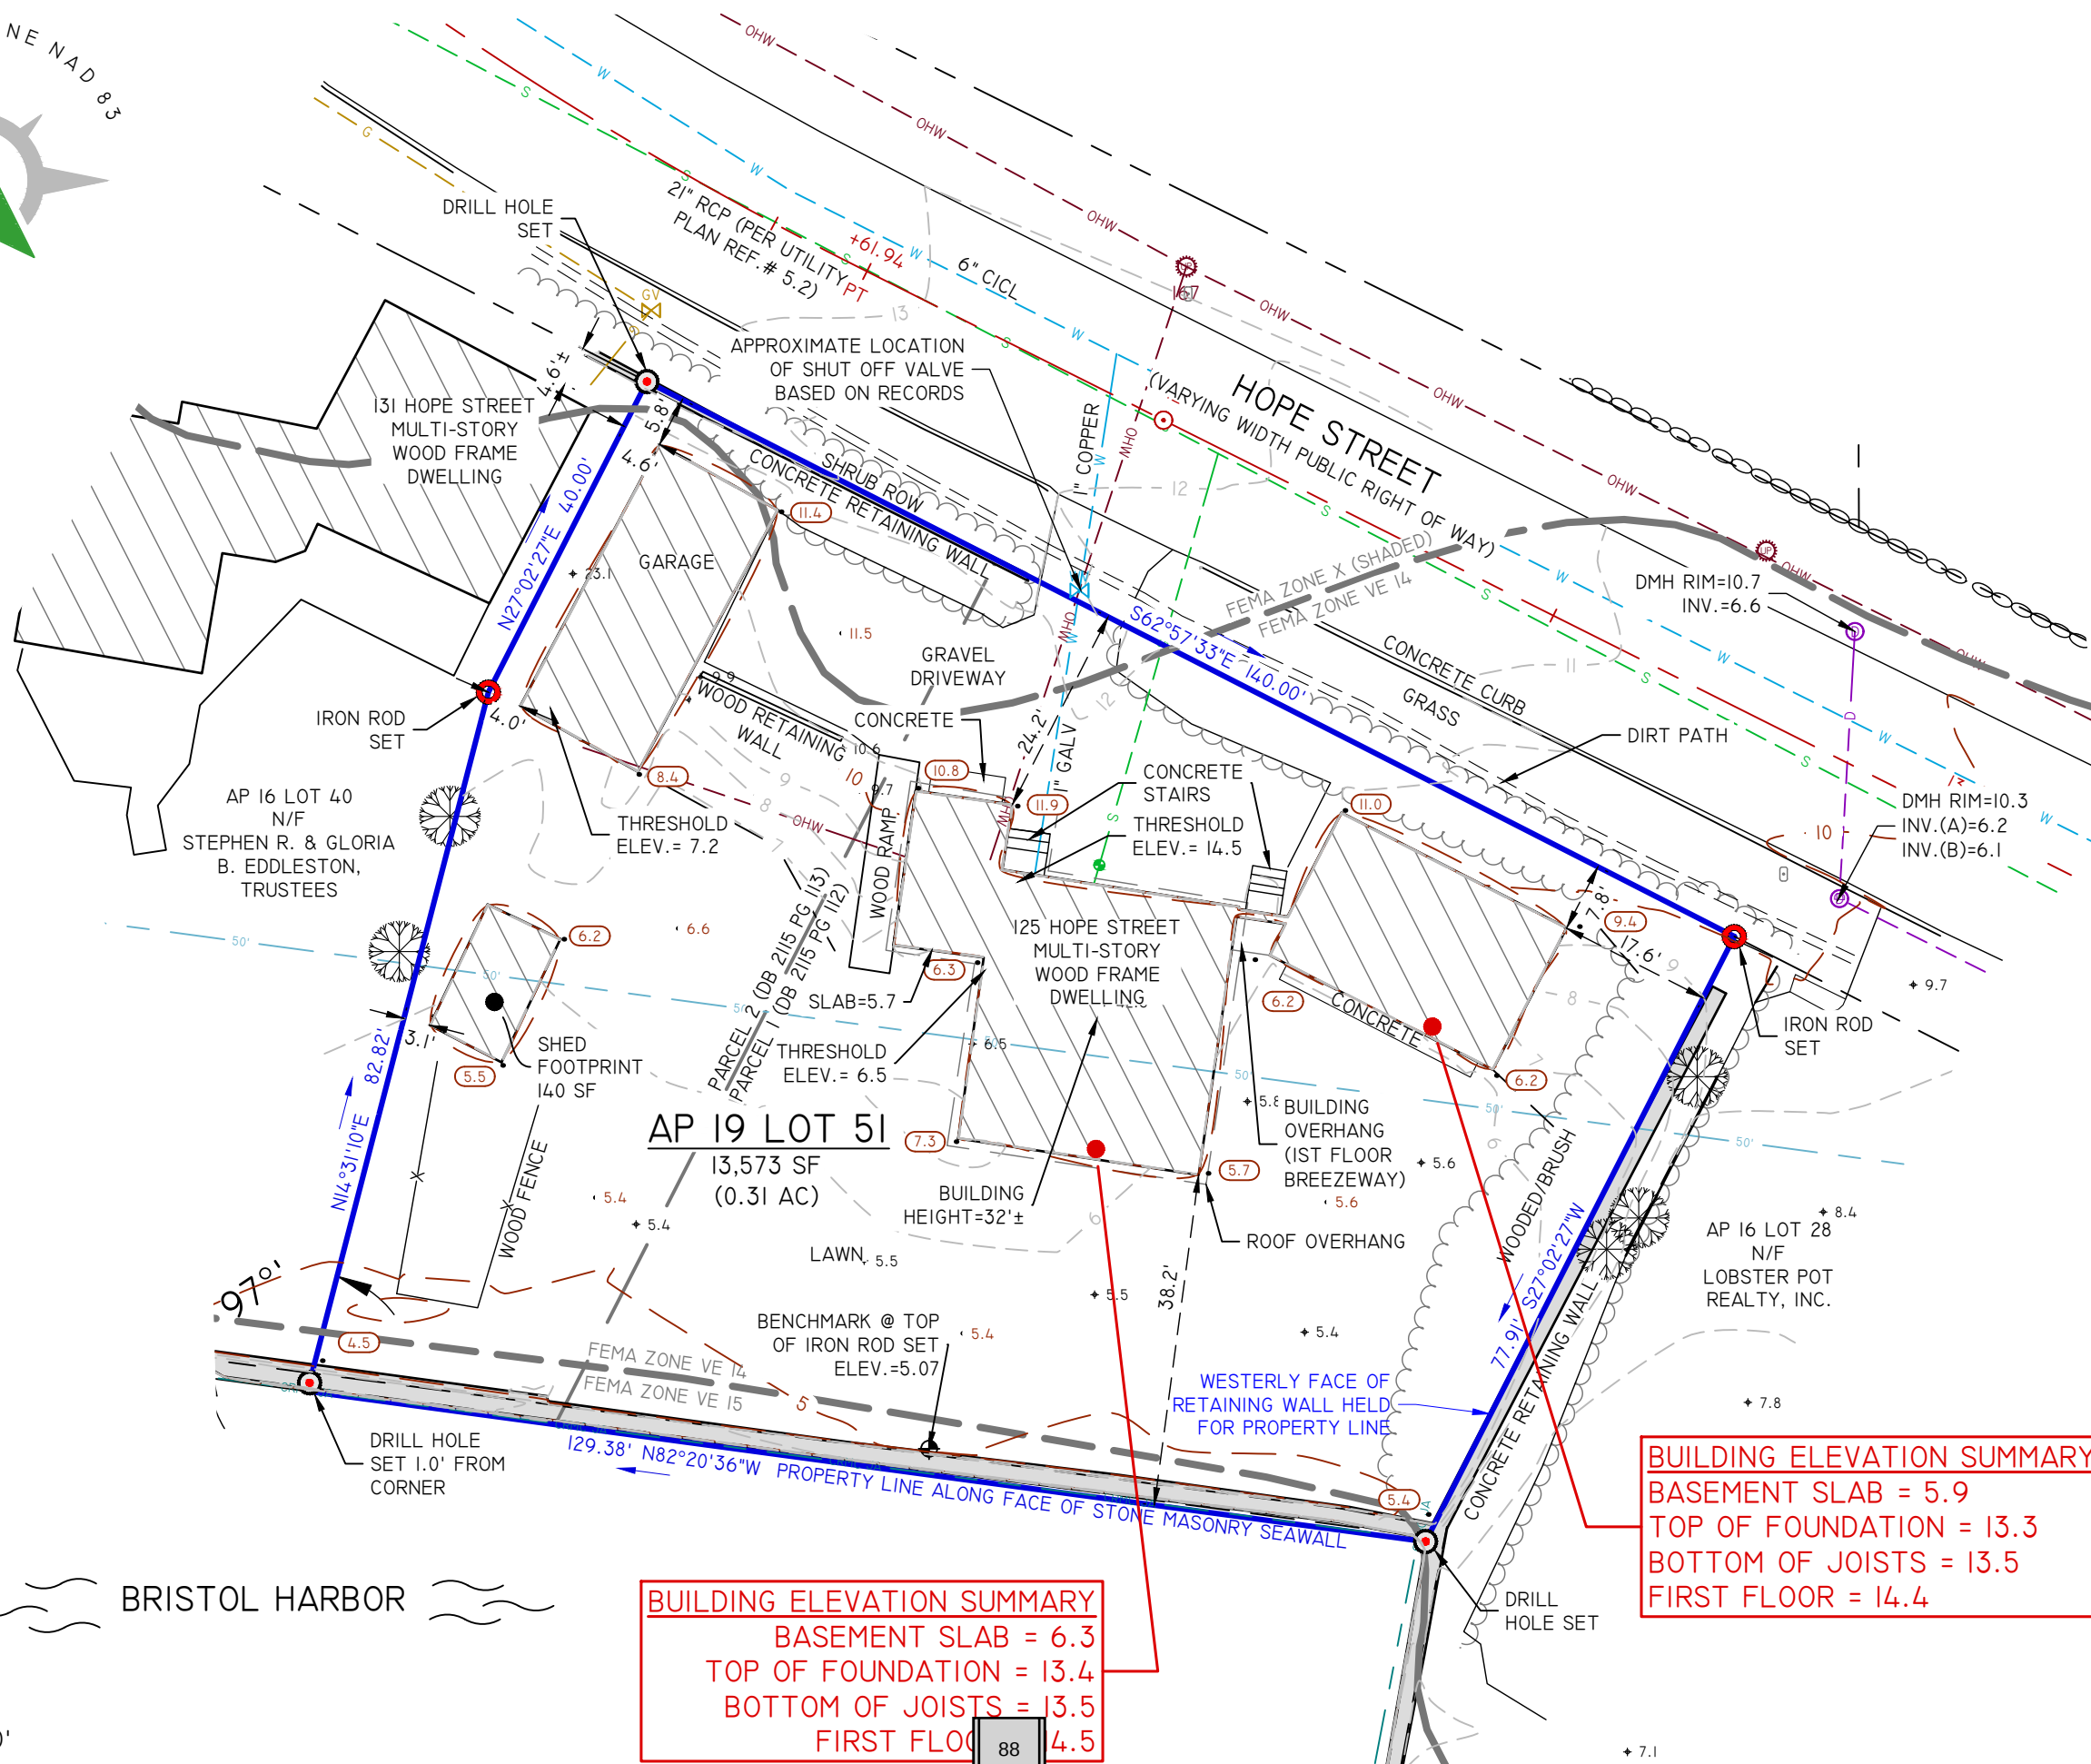
**BUILDING ELEVATION SUMMARY**  
BASEMENT SLAB = 6.3  
TOP OF FOUNDATION = 13.4  
BOTTOM OF JOISTS = 13.5  
FIRST FLOOR = 14.5

**BUILDING ELEVATION SUMMARY**  
BASEMENT SLAB = 5.9  
TOP OF FOUNDATION = 13.3  
BOTTOM OF JOISTS = 13.5  
FIRST FLOOR = 14.4
