# Bristol Historic District Commission

## Application for Review of Proposed Work - Printable Application

Project Address	Assessor's Plat	Assessor's Lot
125 Hope Street	16	51

125 HOPE STREET, BRISTOL, RHODE ISLAND  
STRUCTURAL INSPECTION, JANUARY 16, 2025

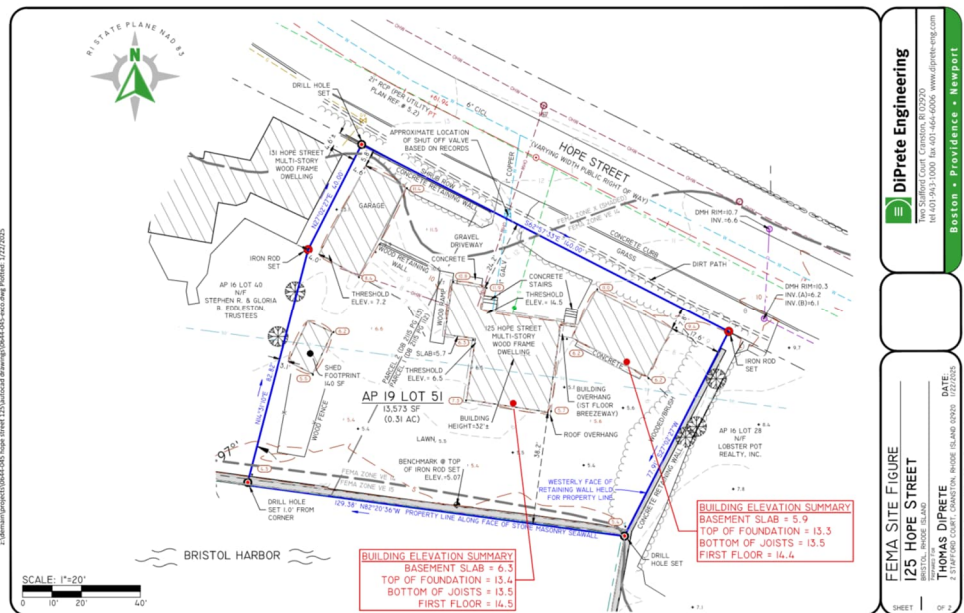
We are in receipt of survey results from DiPrete Engineering dated January 22, 2025 that indicate that "the site is located within a *Special Flood Hazard Area VE wave velocity zone*, Base Flood Elevation = 14.0". According to this report, the bottom of the lowest horizontal structural members are located at elevation 13.5 at both buildings.

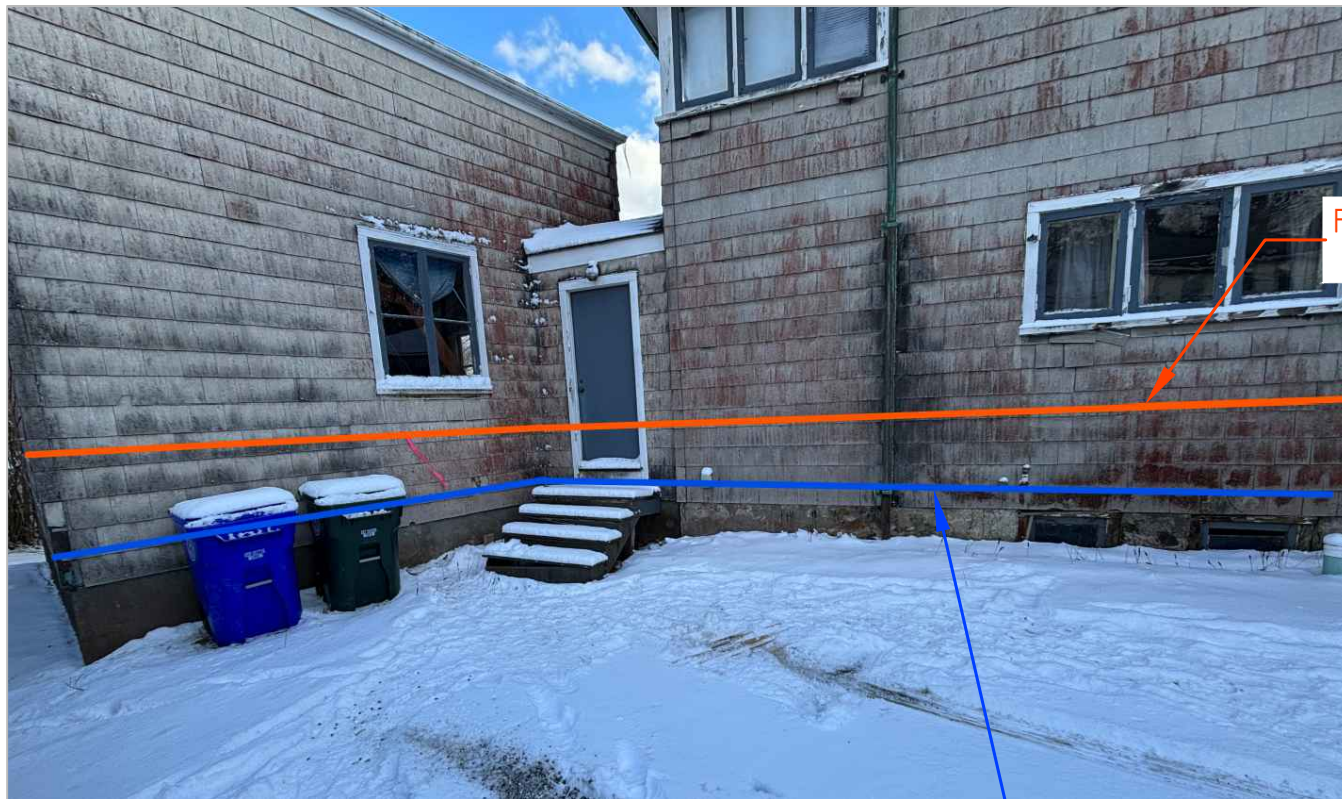
FUTURE FINISH FLOOR ELEVATION = 16.25

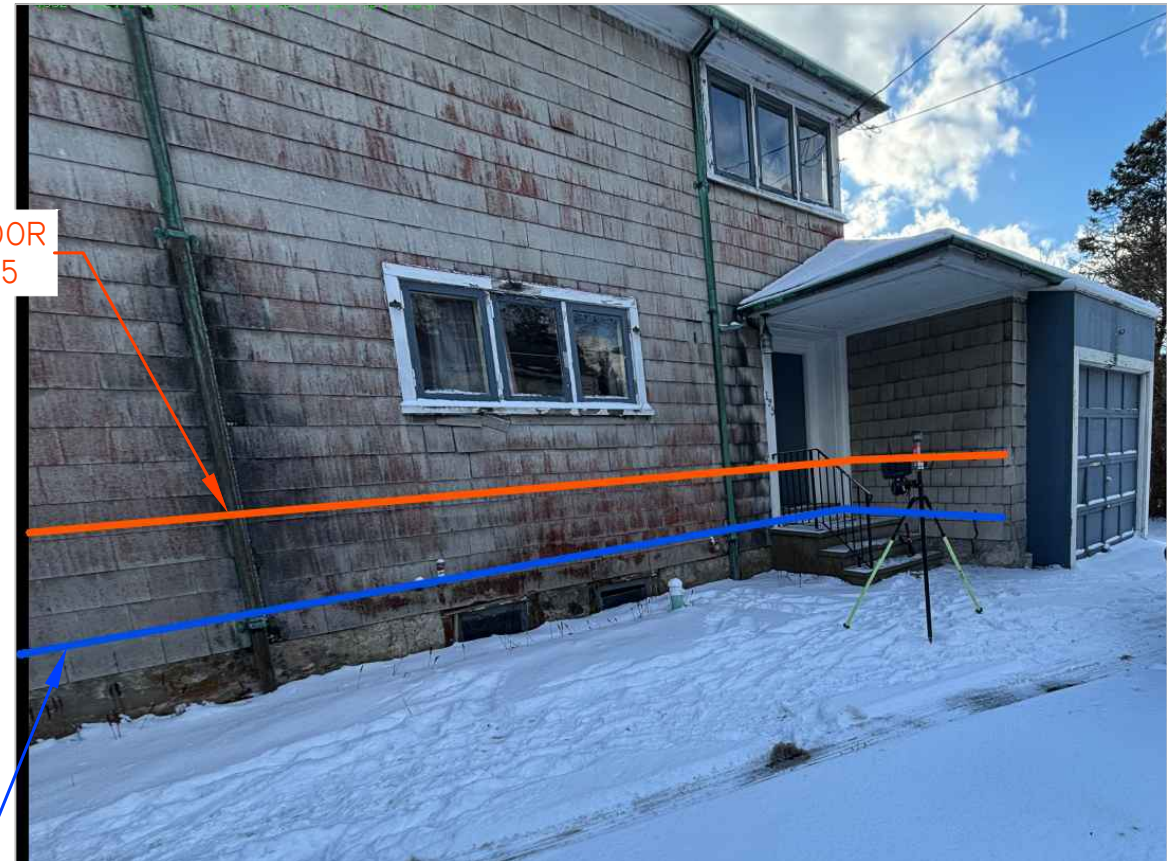
BASE FLOOD ELEVATION = 14.0

FUTURE FINISH FLOOR CALCULATION

BFE + 1.0' TO LOWEST HORIZONTAL MEMBER + 15" (1.25') FUTURE JOISTS AND SUBFLOOR

= 14.0 + 1.0' + 1.25' = 16.25

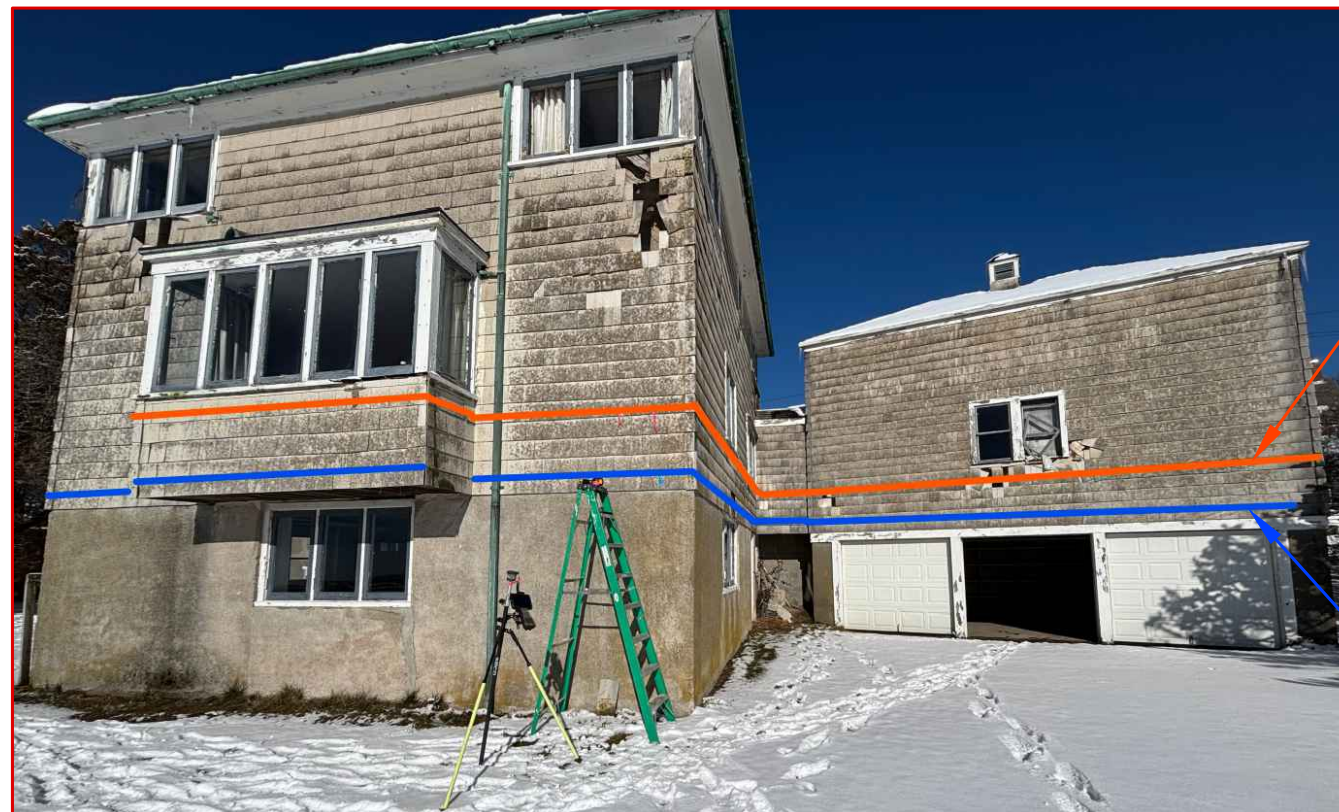
FUTURE FINISH FLOOR ELEVATION = 16.25

BASE FLOOD ELEVATION = 14.0

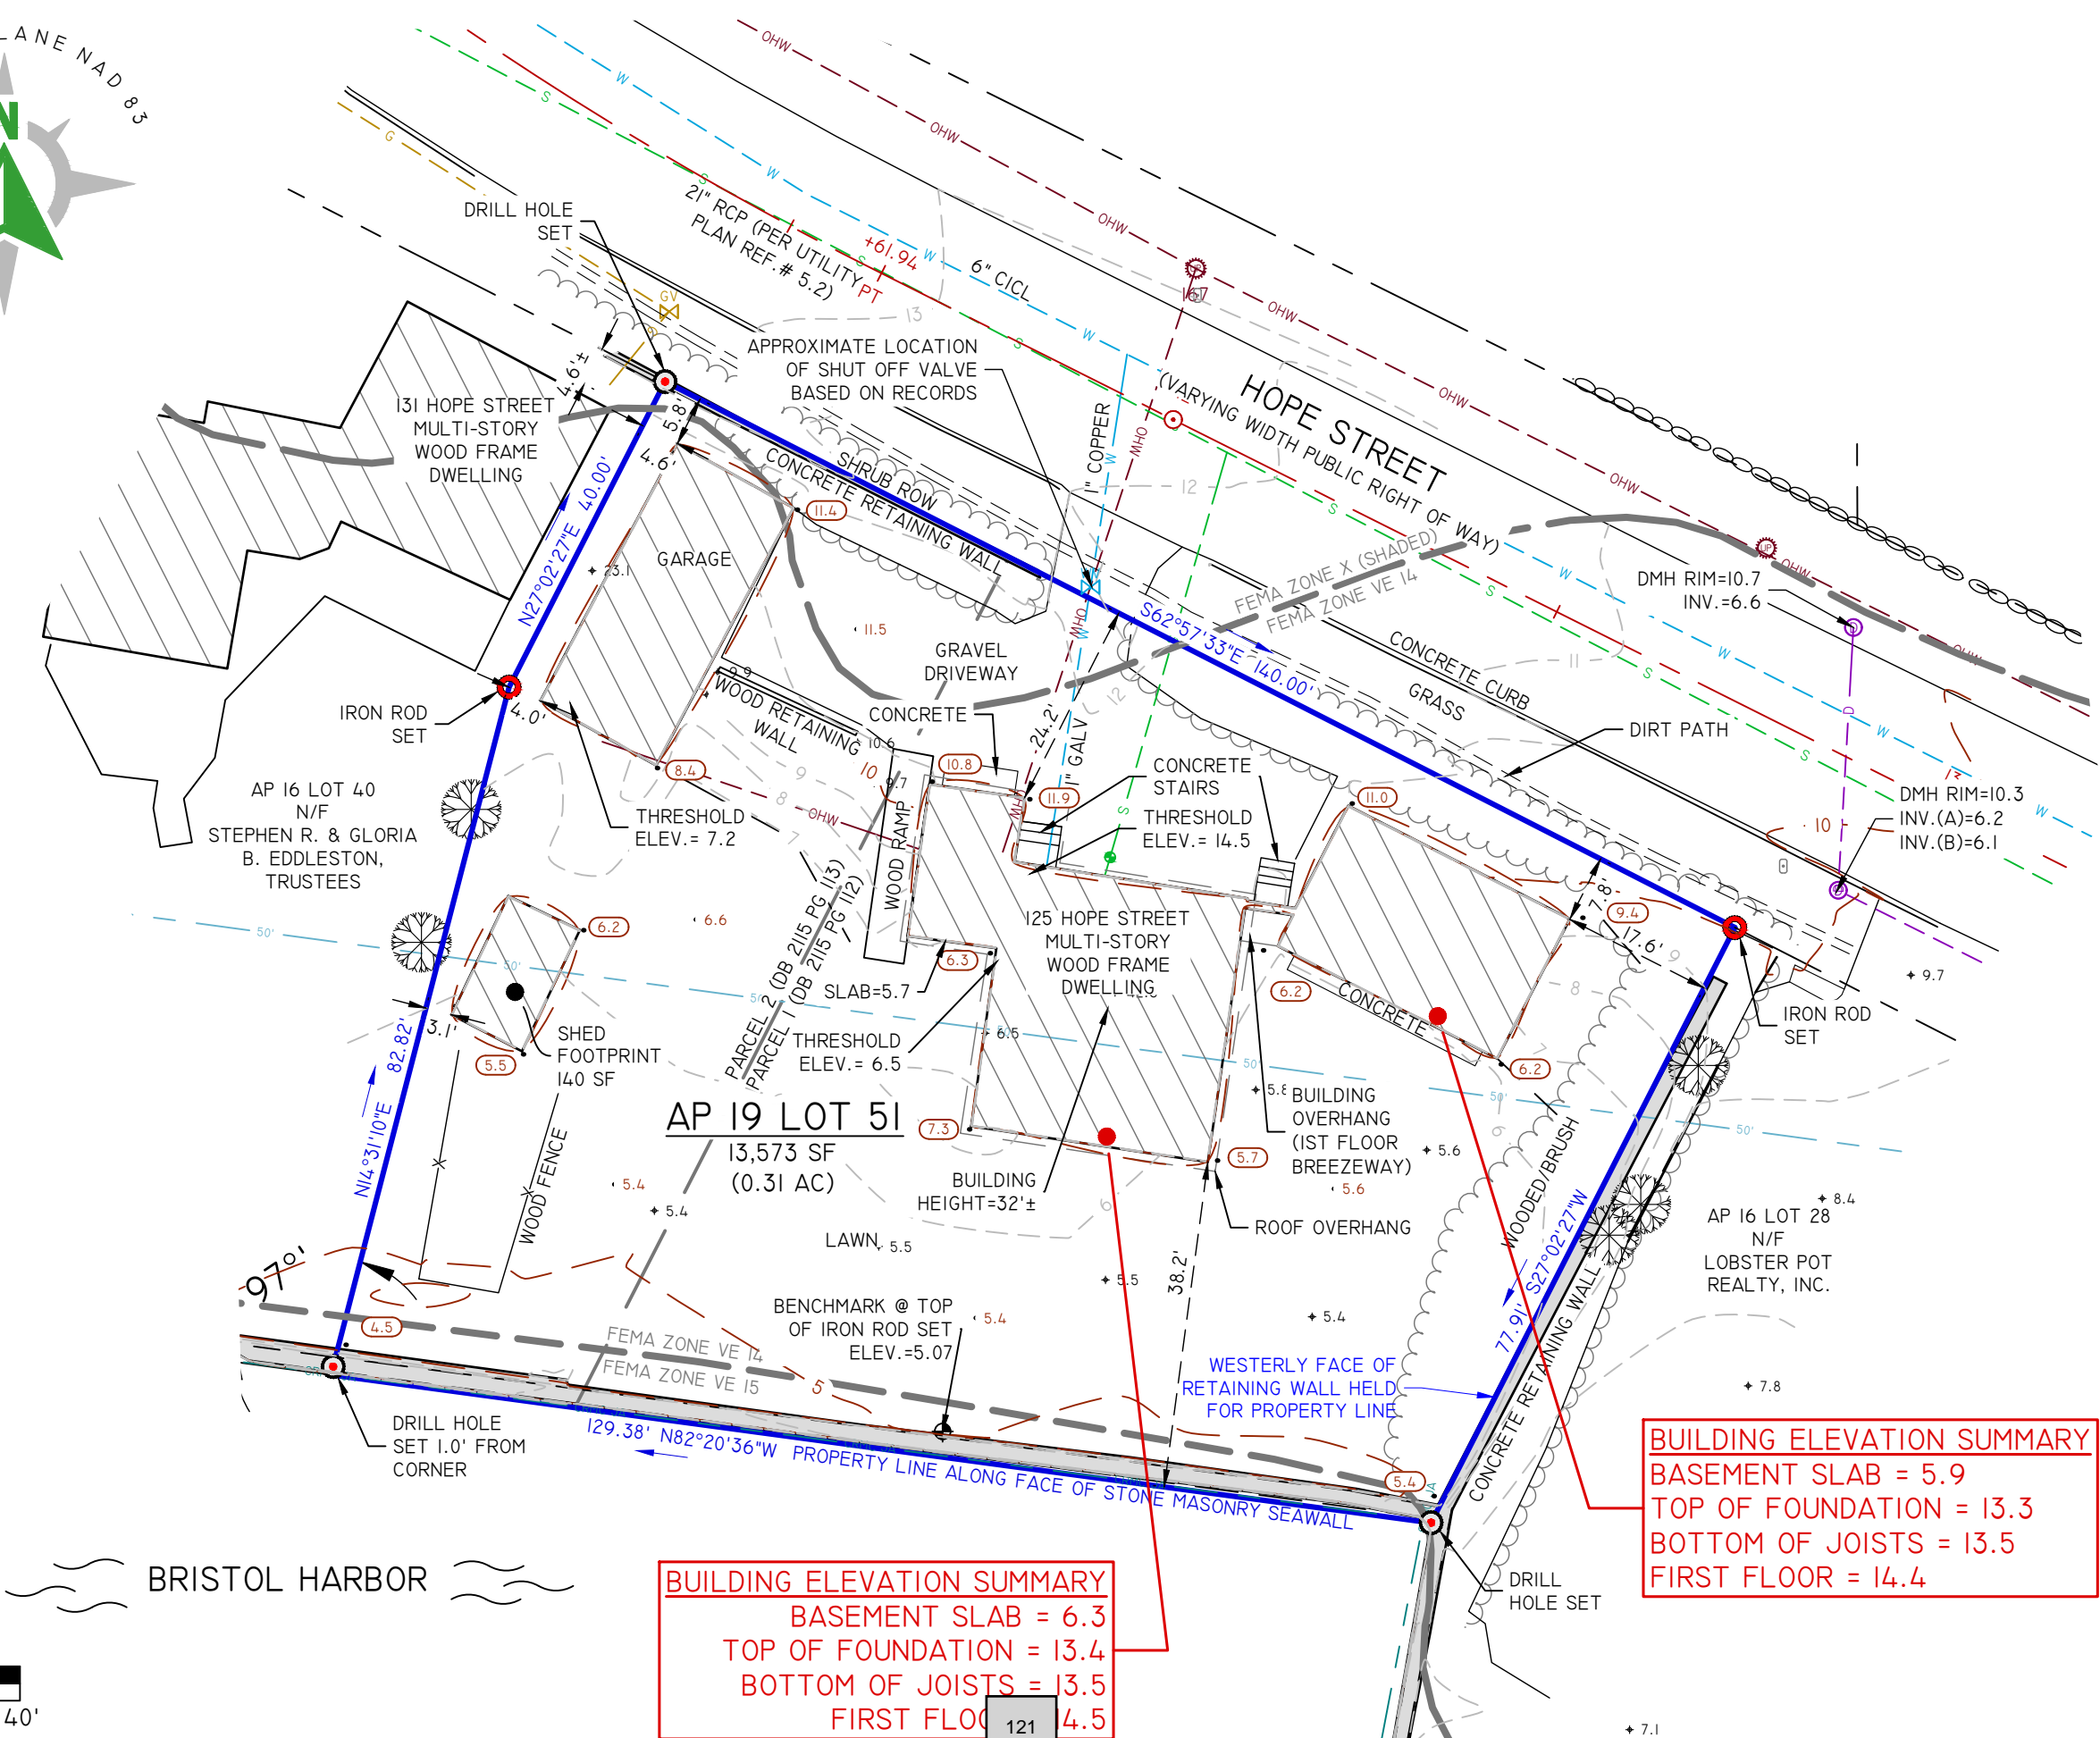
**BUILDING ELEVATION SUMMARY**  
 BASEMENT SLAB = 6.3  
 TOP OF FOUNDATION = 13.4  
 BOTTOM OF JOISTS = 13.5  
 FIRST FLOOR = 14.5

**BUILDING ELEVATION SUMMARY**  
 BASEMENT SLAB = 5.9  
 TOP OF FOUNDATION = 13.3  
 BOTTOM OF JOISTS = 13.5  
 FIRST FLOOR = 14.4
