BHDC

Review of Proposed Work 50 Thames St.

Summary:

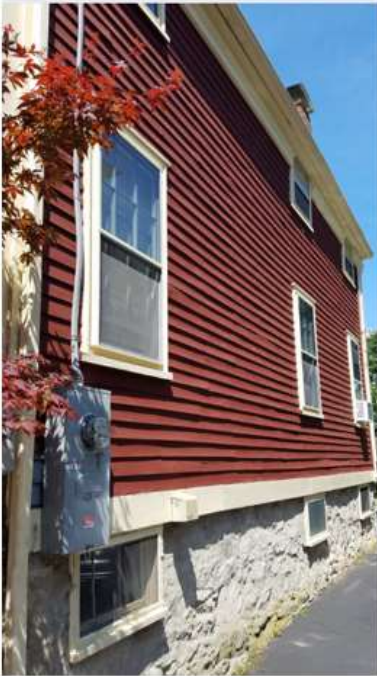
Existing

4. Replacement of storm/screen installations on a few windows to match existing or replacement of all depending on condition of existing - aluminum product available and preferred
 - a. Preservation of sills, window glazing, benefits of storms windows and screen

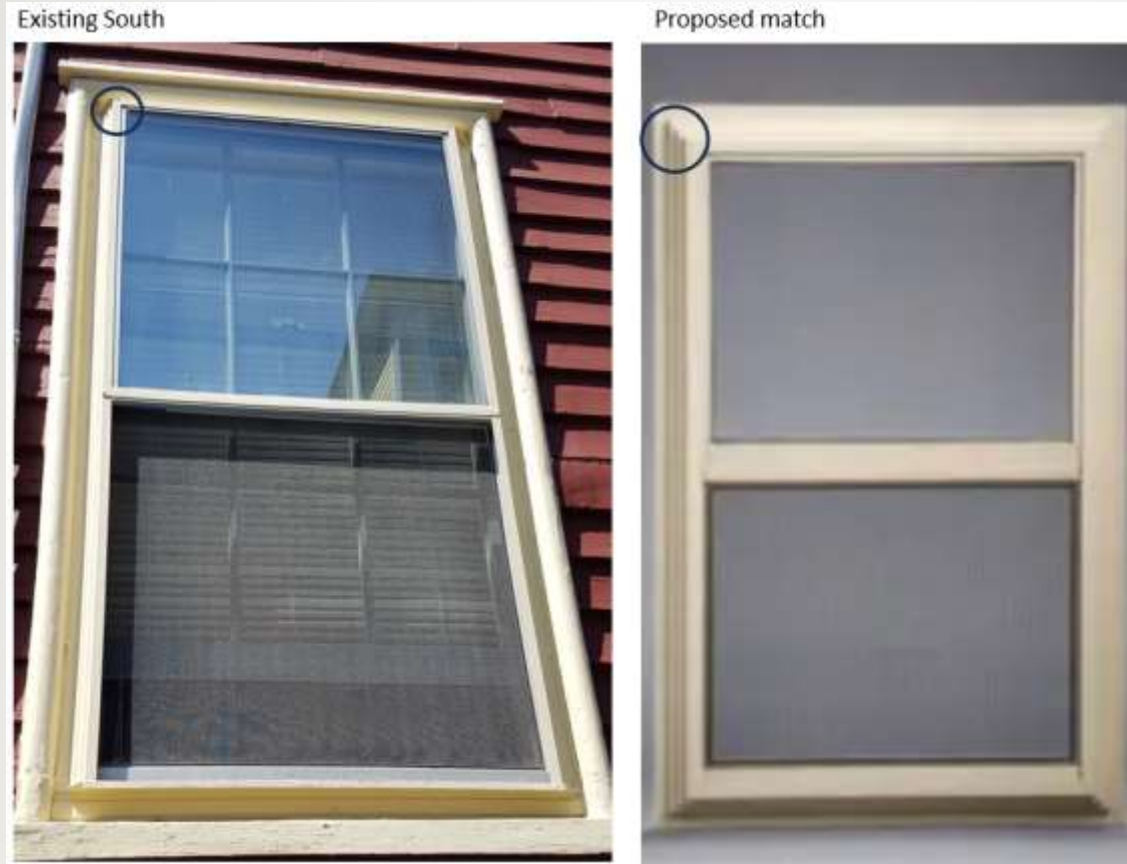
4. Replacement of storm/screen installations proposed
