## *HDC 186 Hope St Projects September 2025*

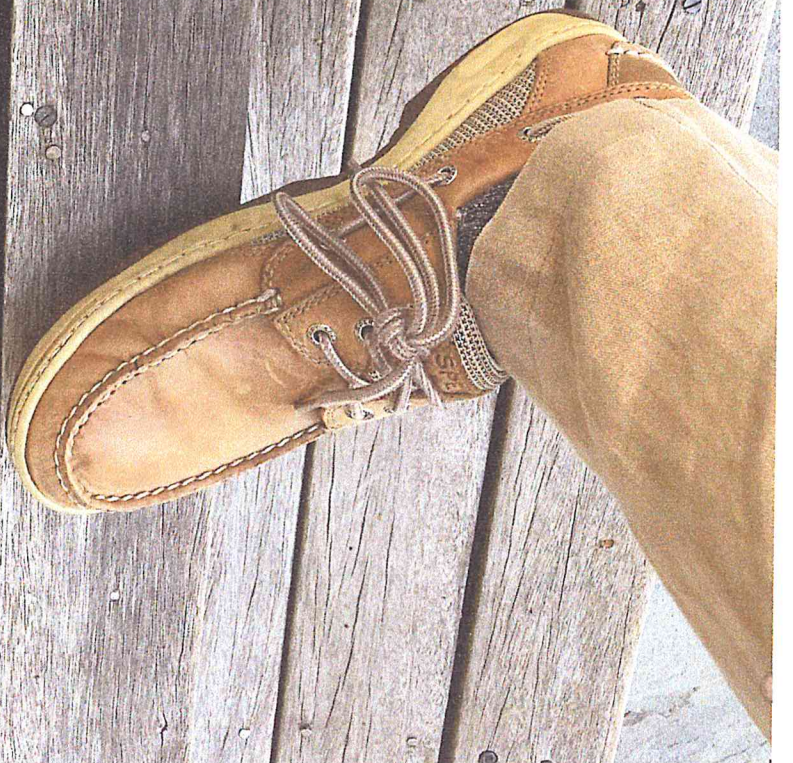
2005 SIDE ENTRANCE BURTON ST SIDE  
Porch Step Joists? Rot

- 2 Back porch stairs: replace decking and joists and posts in kind as necessary.
- 3 Front entry steps: (added in 2005) Install iron railing similar in material to pre 2005 railings but with straighter lines more in harmony with overall design of house and porch.

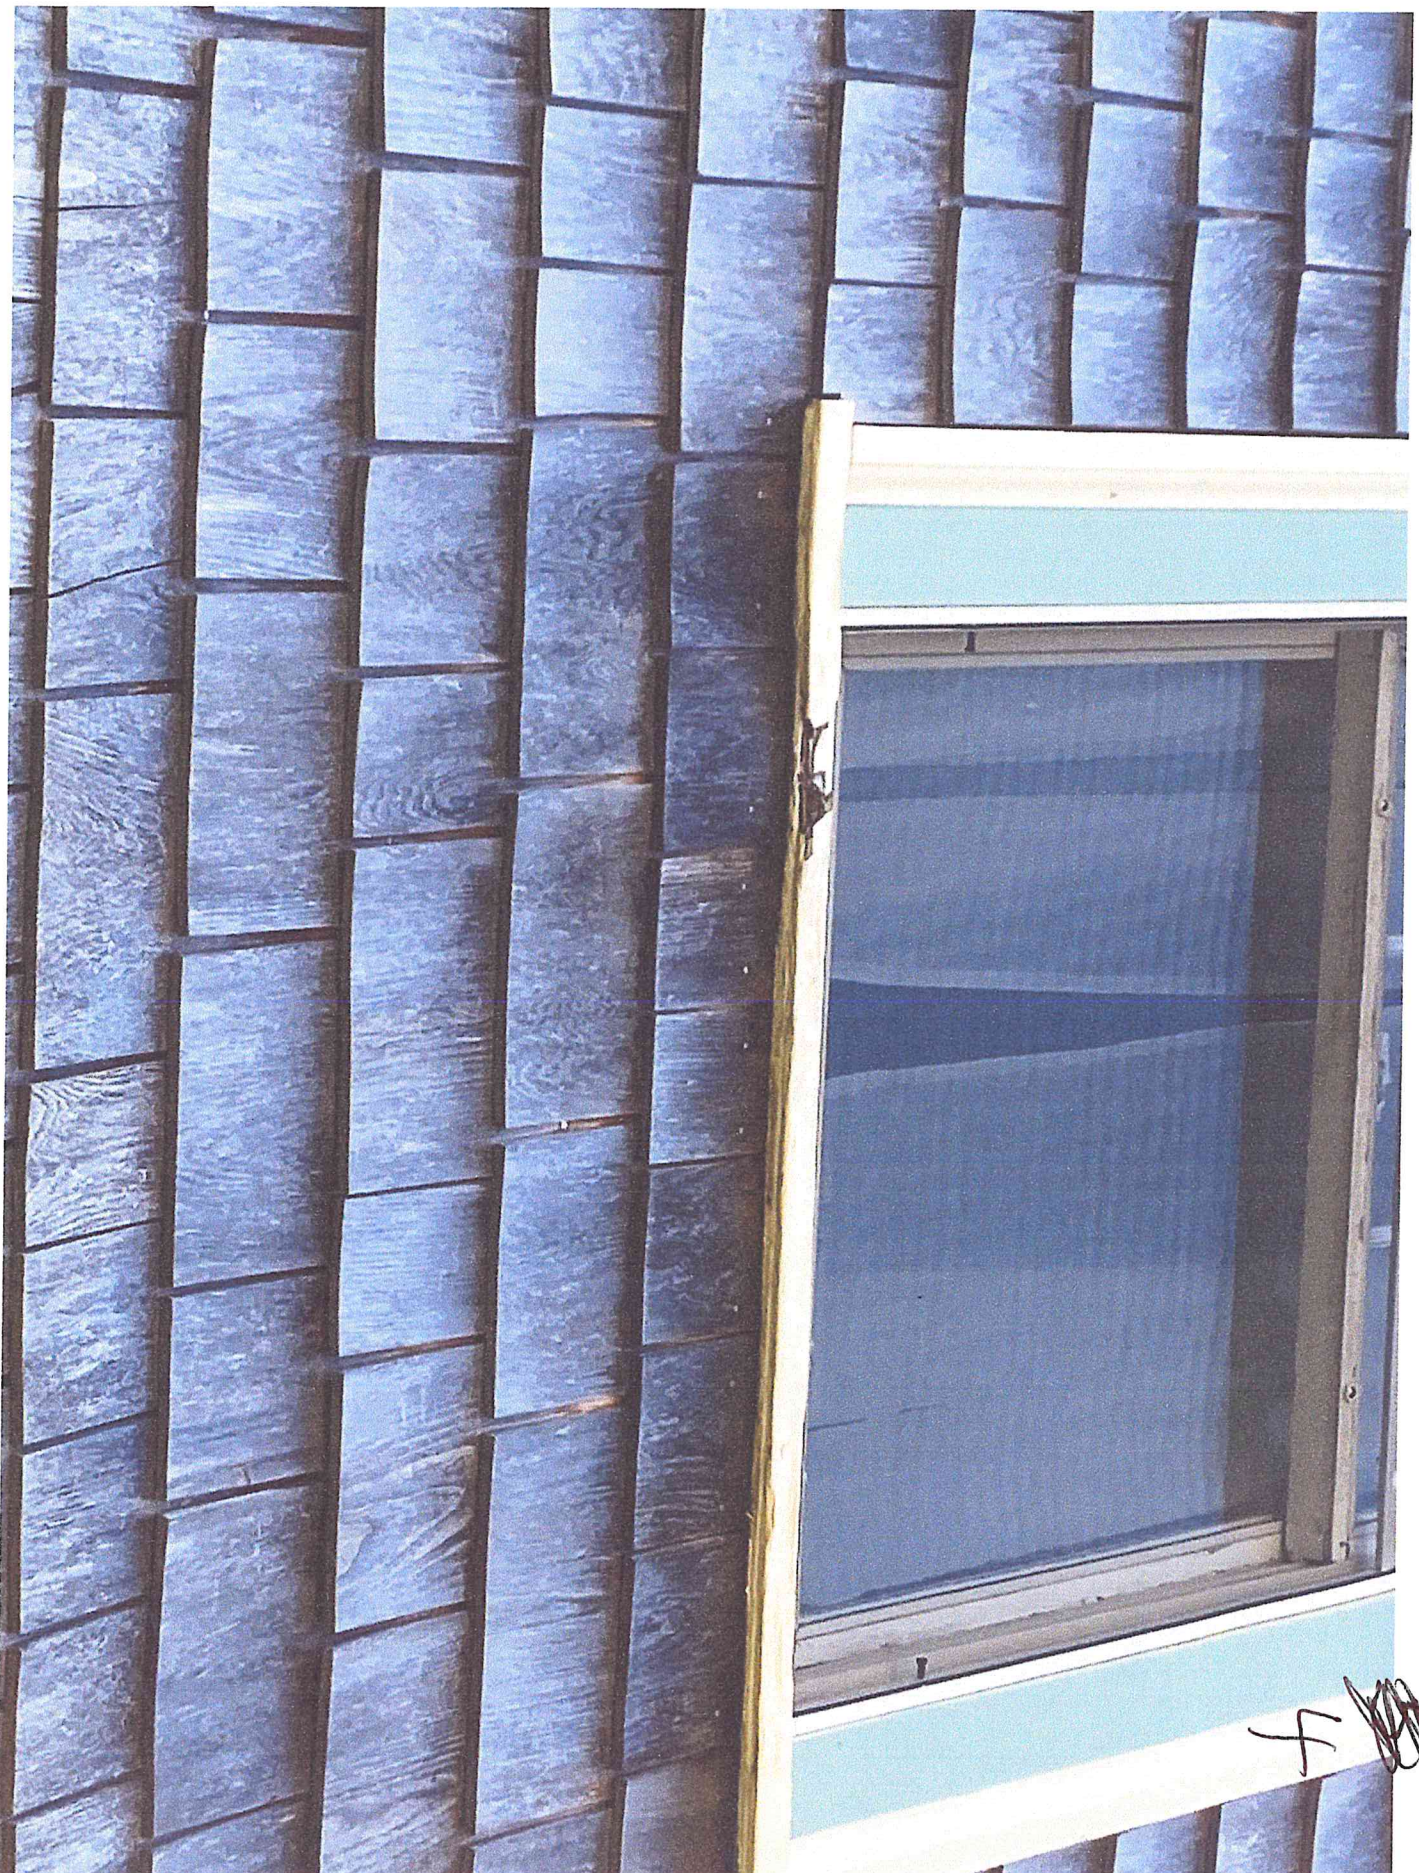
~~4~~  
4

2005 Addition 2nd Floor EAST WINDOW

FINGER JOINT SILL ROT

- 4 Window sill and trim, second floor East side (2005 Addition): replace rotted finger joint pine with mahogany.
- 5 Window, 2nd floor East bedroom, South face: replace in kind: sill, some trim pieces, parting beads and some internal frame pieces as needed, reglaze, saving original glass.

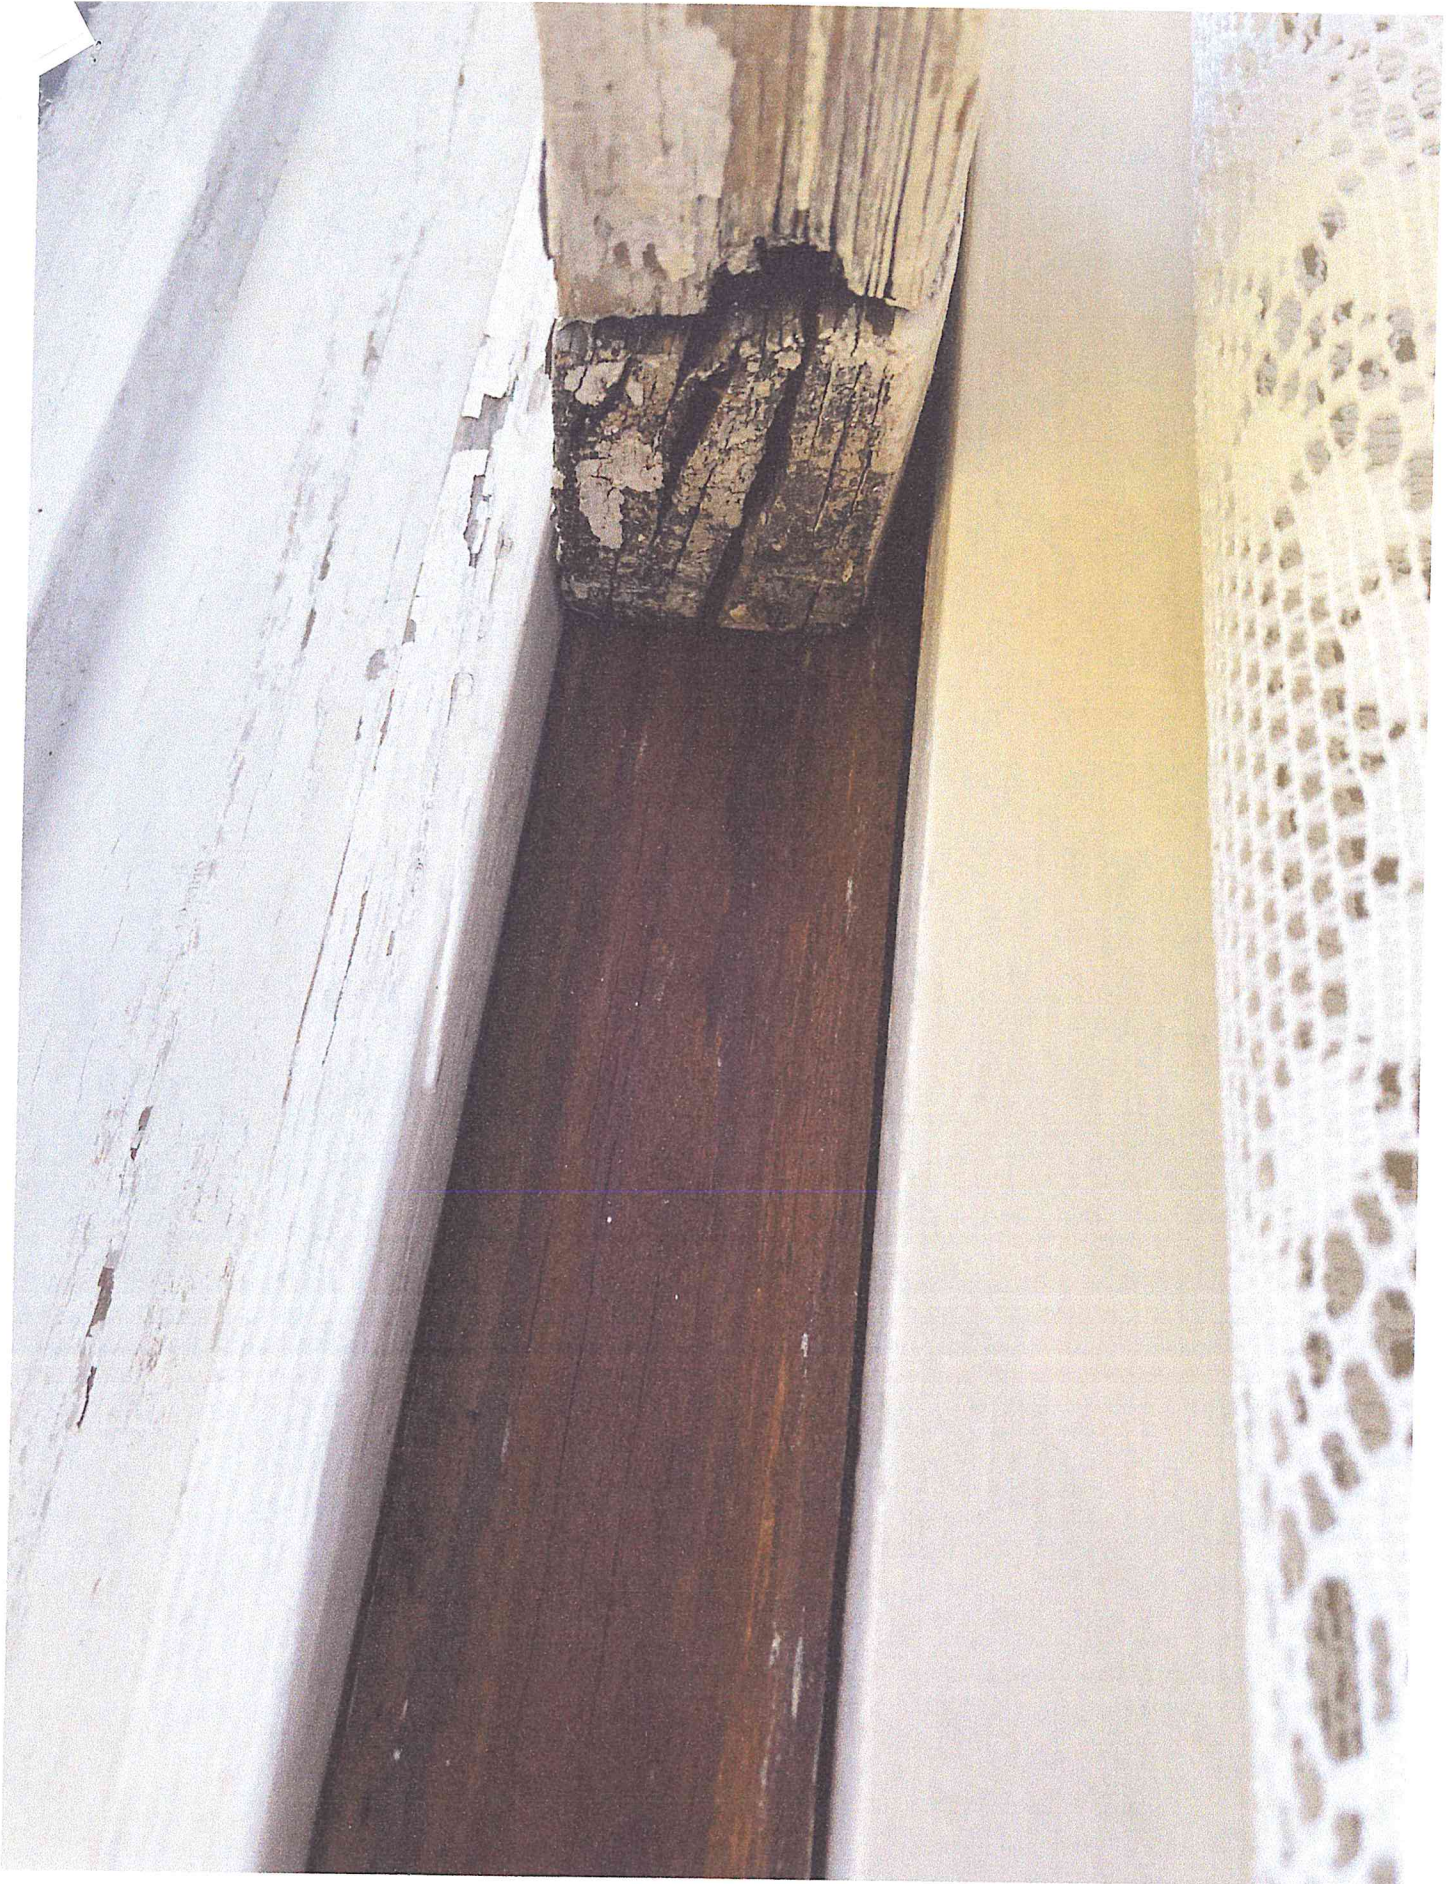
① DR LEFT OF 3 WINDOWS RIGHT SIDE OF LOWER SASH RAIL FROM BELOW: ROT

- 6 Windows South and West side, first and second floor: repair/replace in kind some sash pieces; some frame and trim pieces with in kind materials. Reglaze saving original glass.
