# Bristol Historic District Commission

## Application for Review of Proposed Work - Printable Application

| HDC-25-12 | Contributing | February 11, 2025 |

125 HOPE STREET, BRISTOL, RHODE ISLAND  
STRUCTURAL INSPECTION, JANUARY 16, 2025

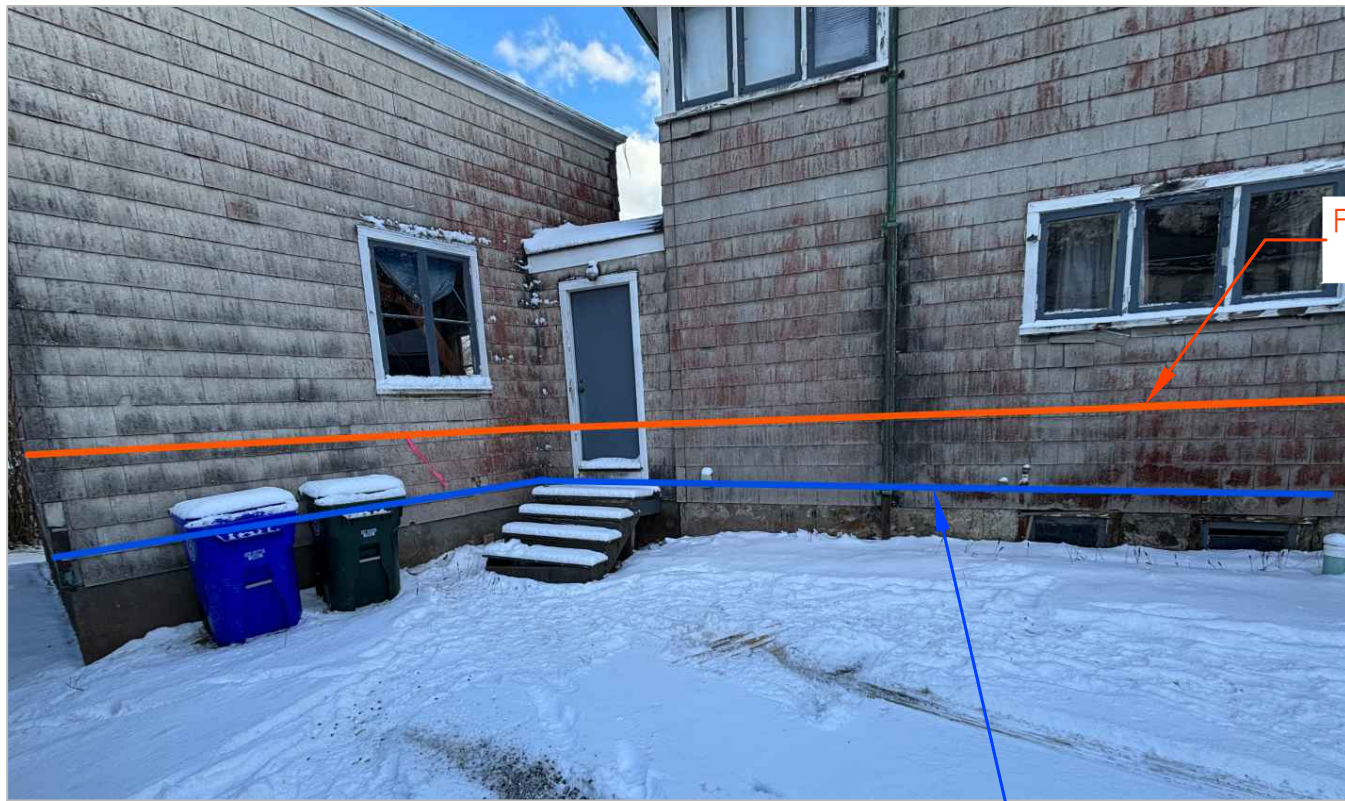
FUTURE FINISH FLOOR  
ELEVATION = 16.25

BASE FLOOD ELEVATION = 14.0

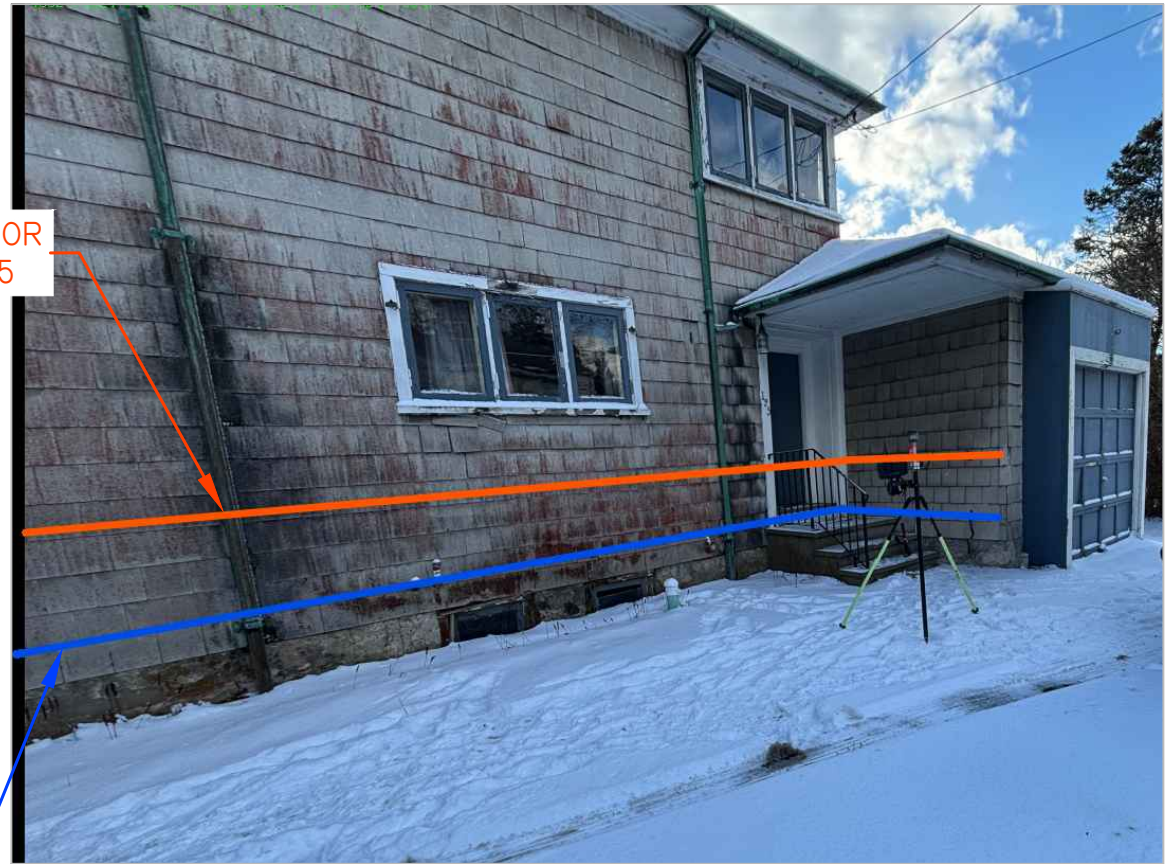
### FUTURE FINISH FLOOR CALCULATION

BFE + 1.0' TO LOWEST HORIZONTAL  
MEMBER + 15" (1.25') FUTURE JOISTS  
AND SUBFLOOR

$$= 14.0 + 1.0' + 1.25' = 16.25$$

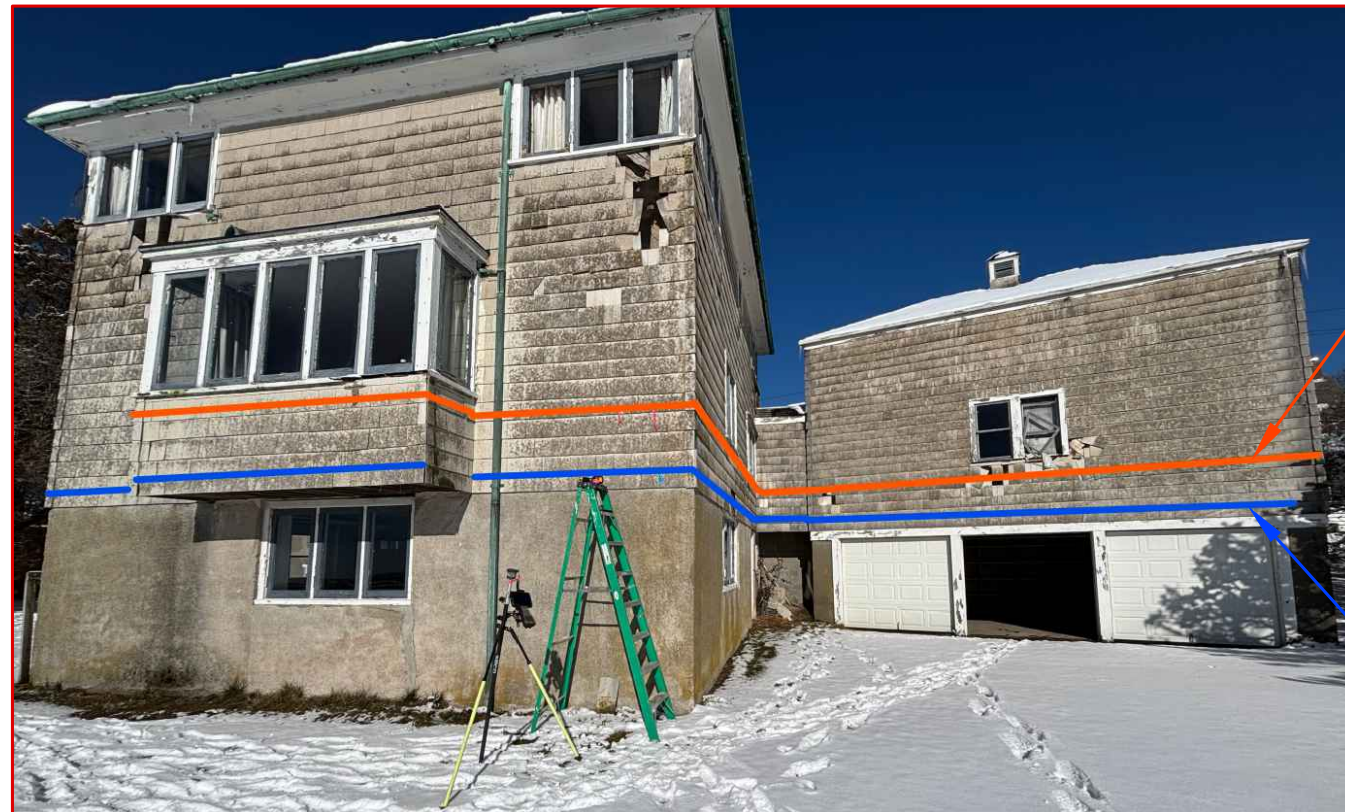
FUTURE FINISH FLOOR  
ELEVATION = 16.25

BASE FLOOD ELEVATION = 14.0

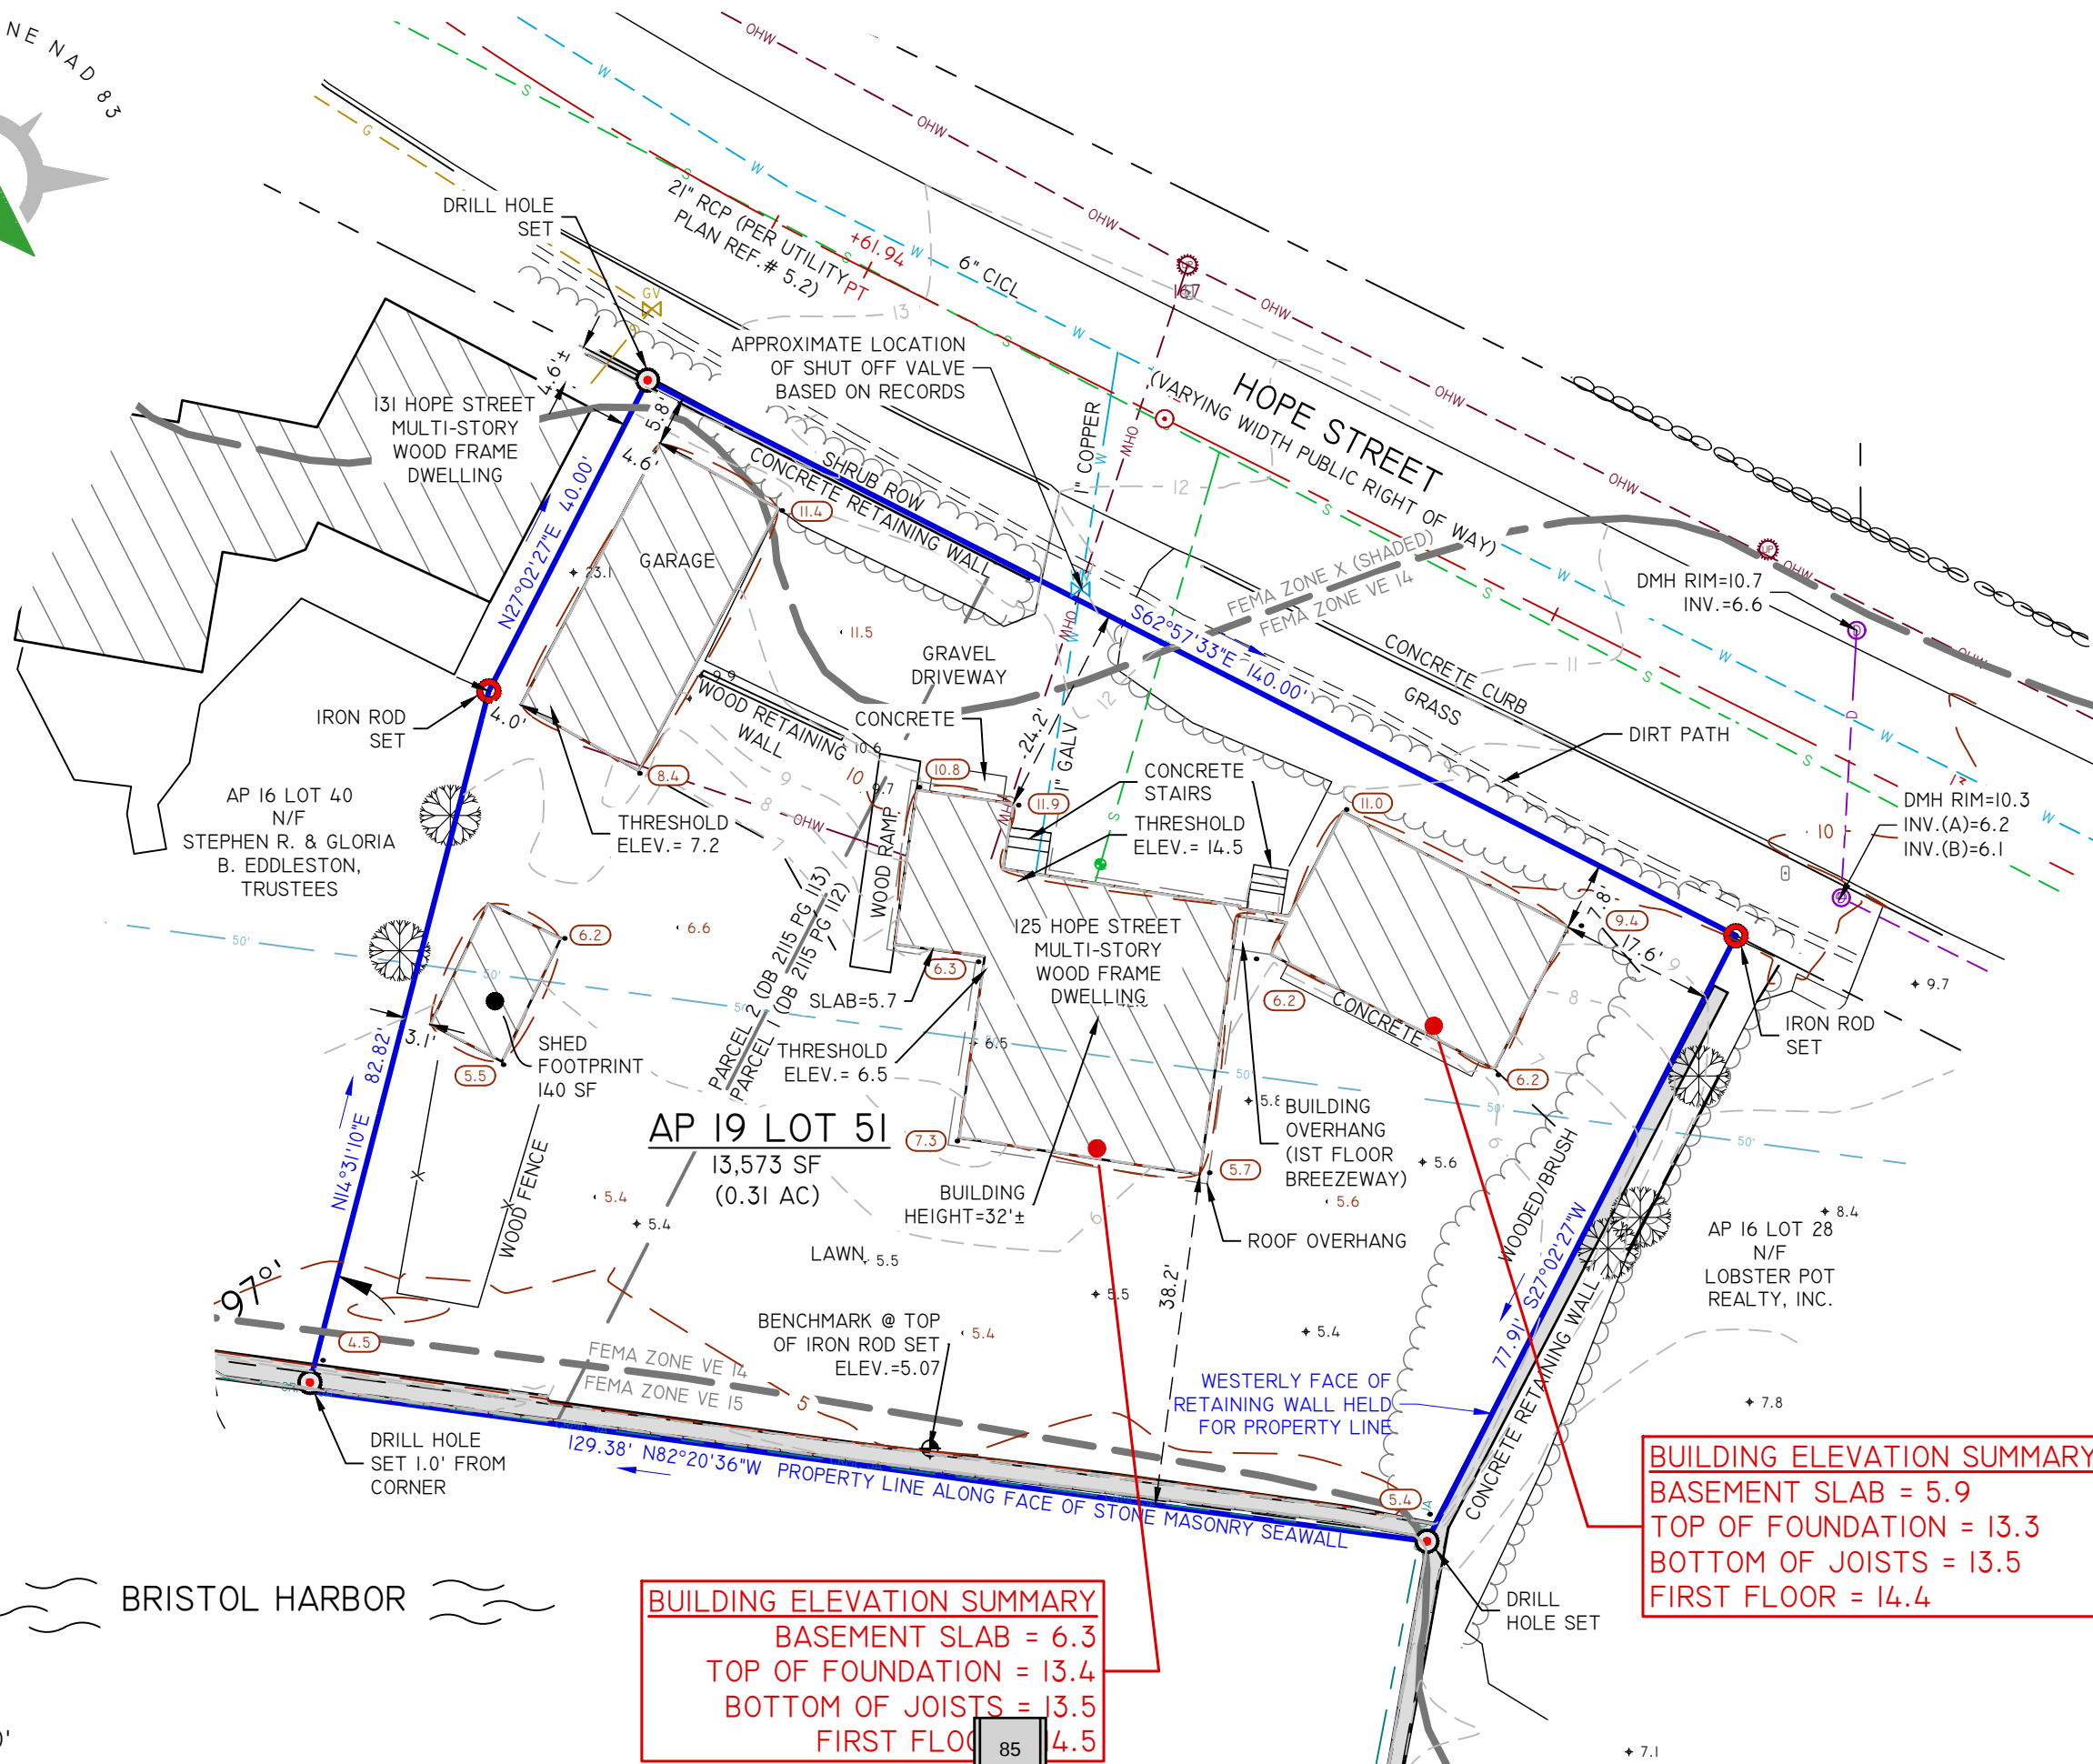
**BUILDING ELEVATION SUMMARY**  
BASEMENT SLAB = 6.3  
TOP OF FOUNDATION = 13.4  
BOTTOM OF JOISTS = 13.5  
FIRST FLOOR = 14.5

**BUILDING ELEVATION SUMMARY**  
BASEMENT SLAB = 5.9  
TOP OF FOUNDATION = 13.3  
BOTTOM OF JOISTS = 13.5  
FIRST FLOOR = 14.4
