# **165 High Street Carriage House**

## **Restoration-Rebuild Concept Review**

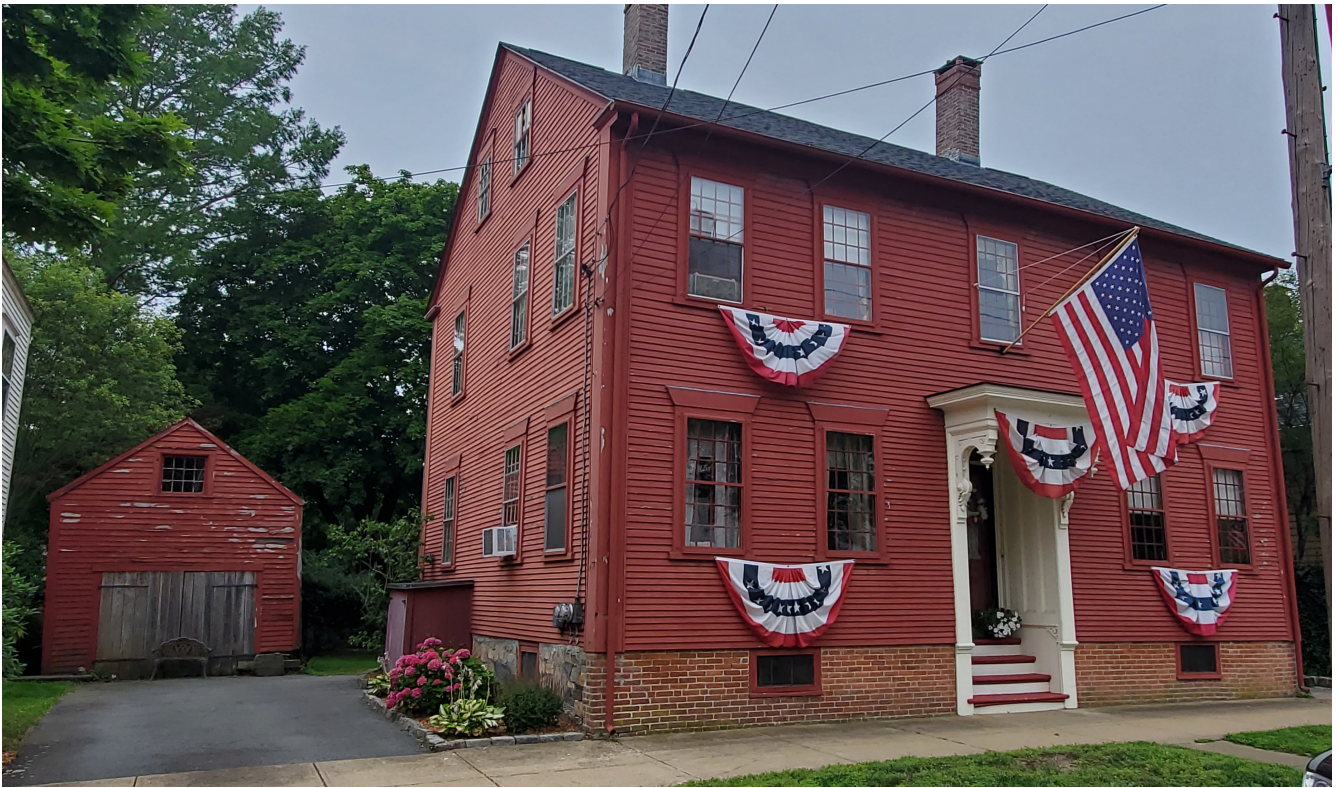
The main house (Figure 1) at 165 High Street was built (c1800) by John Smith (co-owner with James DeWolf of the brig the Yankee Privateer) and the Carriage House (Figure 2) built some time later. Both buildings are post and beam construction but differ in the method the timbers were made; the main house timbers are all (pre 1800) hand-hewn using broad axe and adze where as the Carriage house timbers are pit-sawn.

*Figure 1: The John Smith House (main house at 165 High St) showing Carriage House at the end of the driveway.*

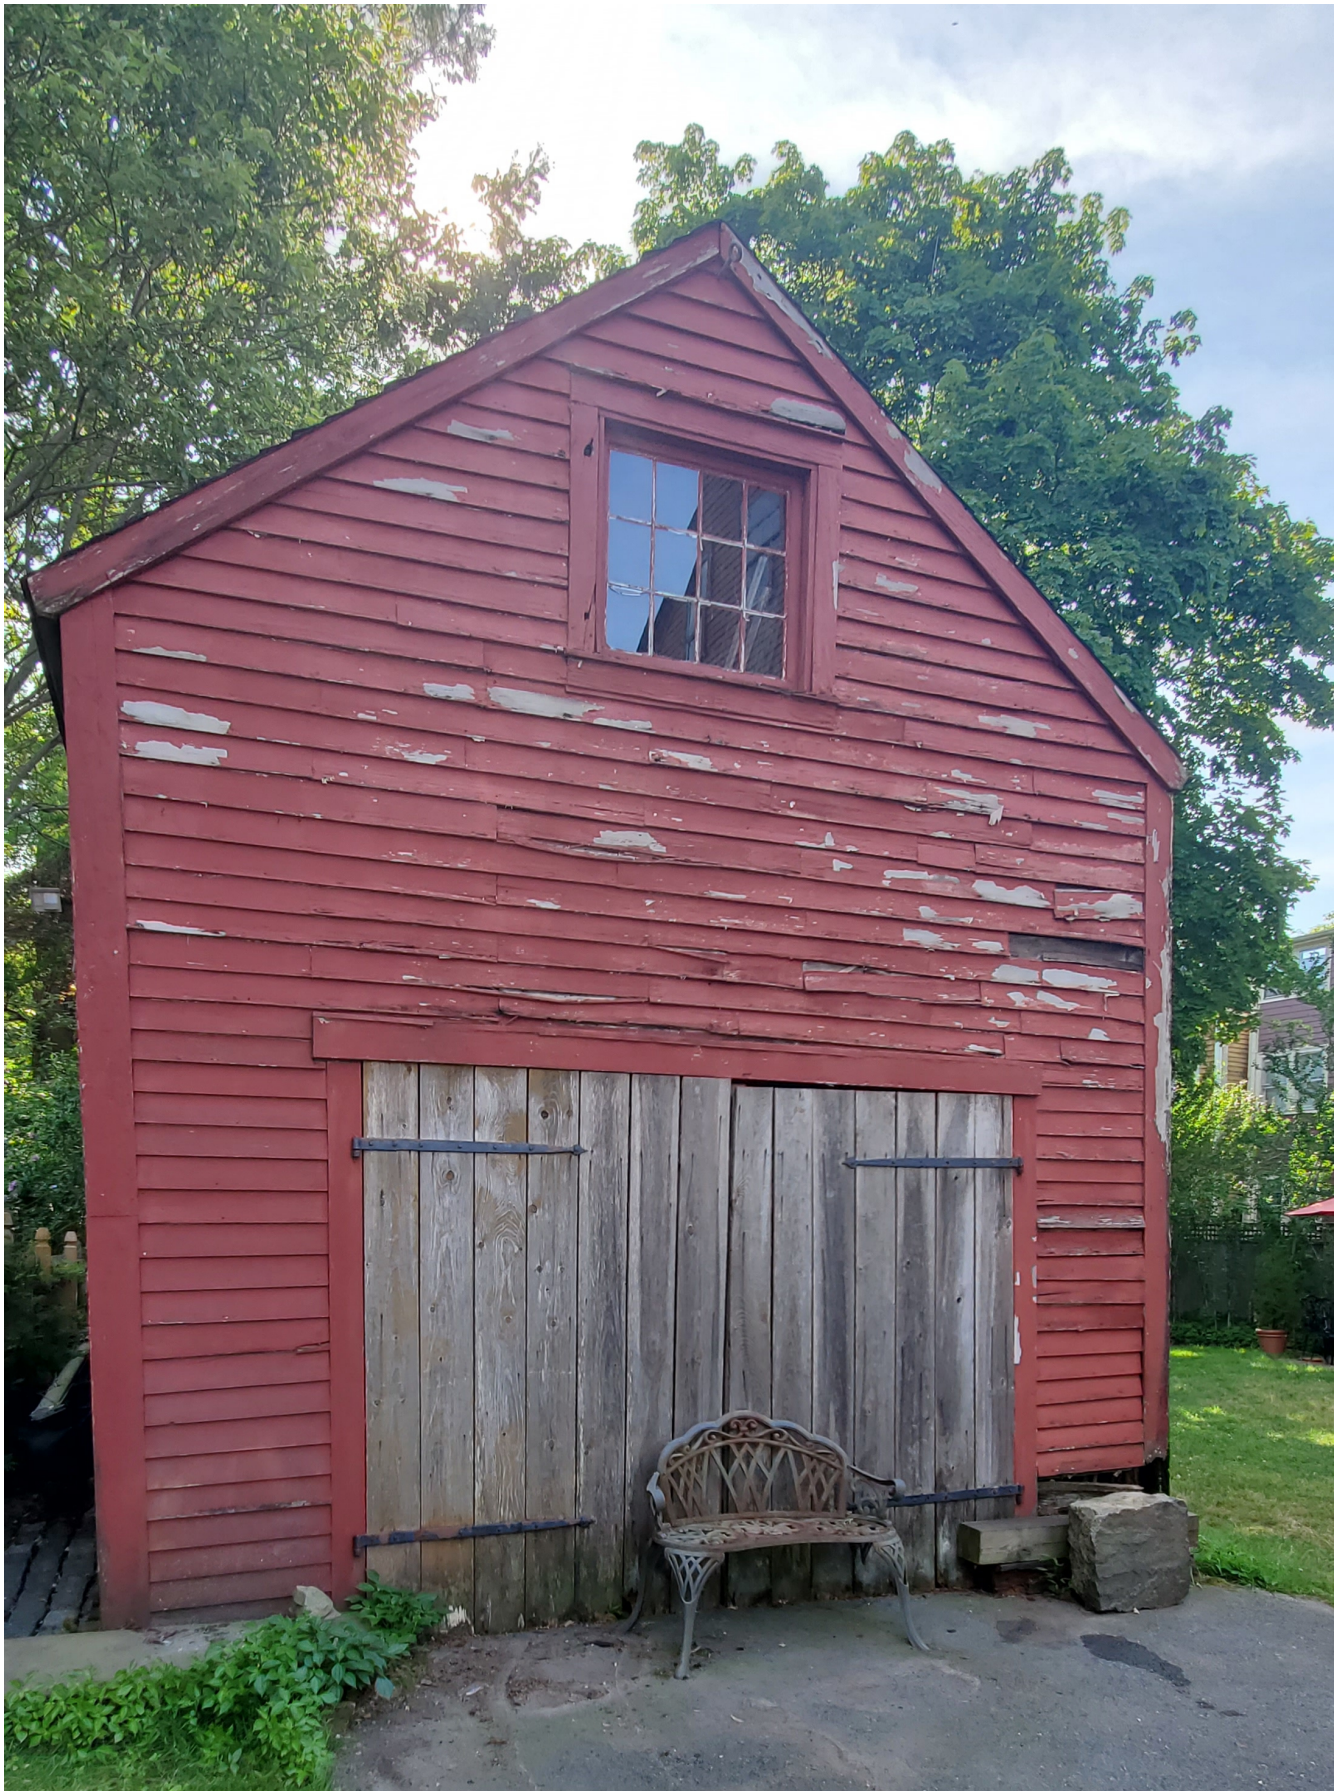
*Figure 2: Front of the John Smith Carriage House*

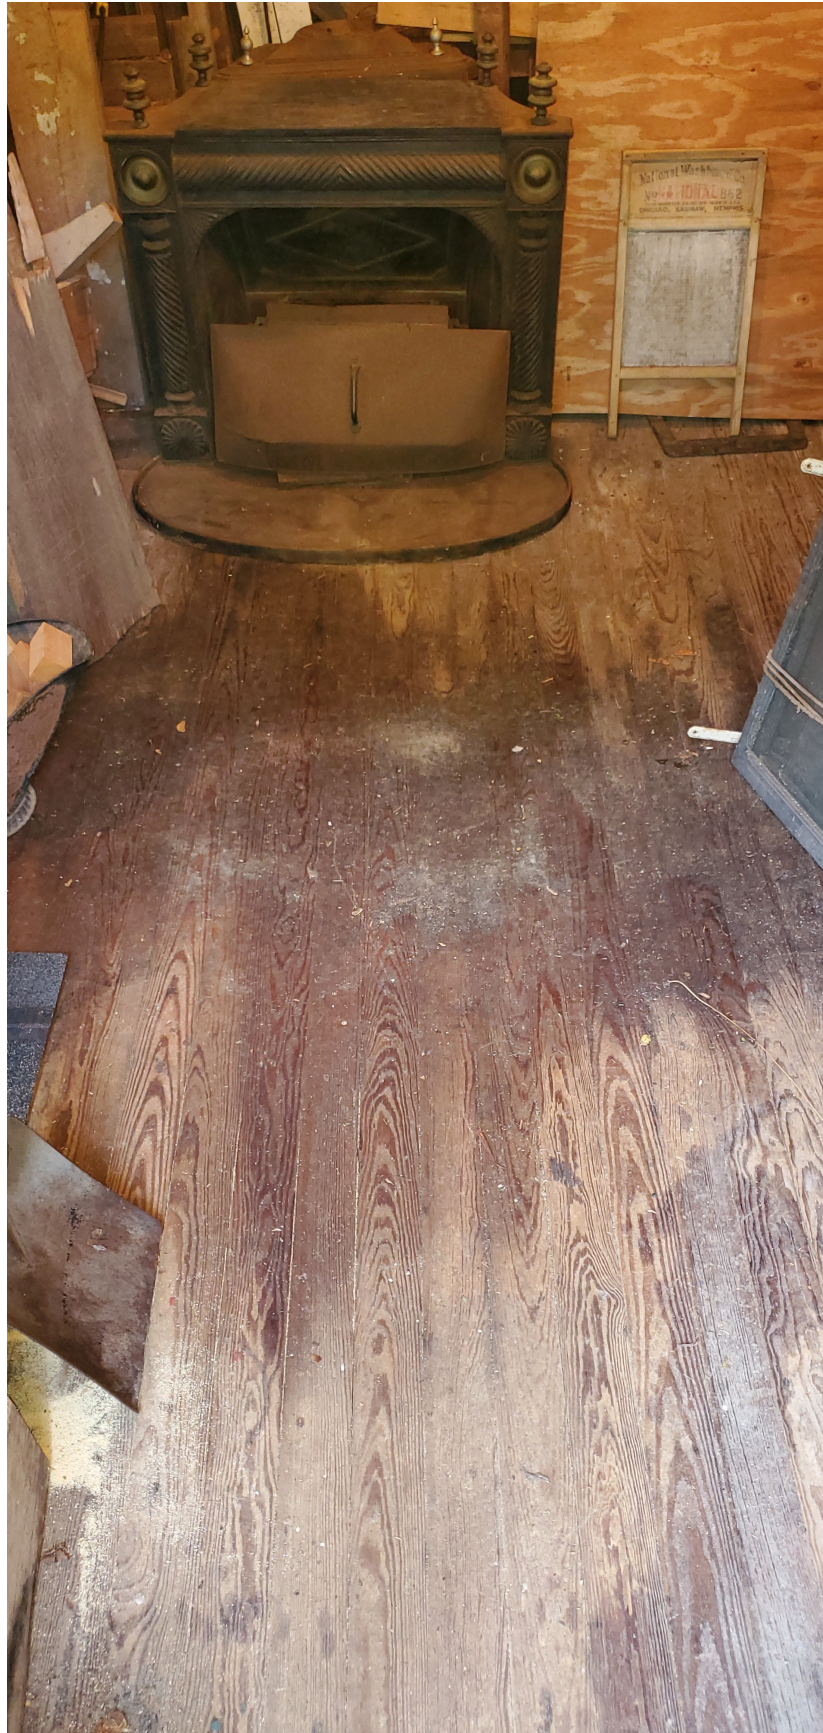
The post-and-beam barn was built on a field stone foundation. The main floor is constructed of multi layered narrow hard-wood boards (Figure 3). The loft floor, which doubles as the first floor ceiling, is double layered wide hard-wood planks.

*Figure 3: Carriage House first floor hard-wood floor boards*

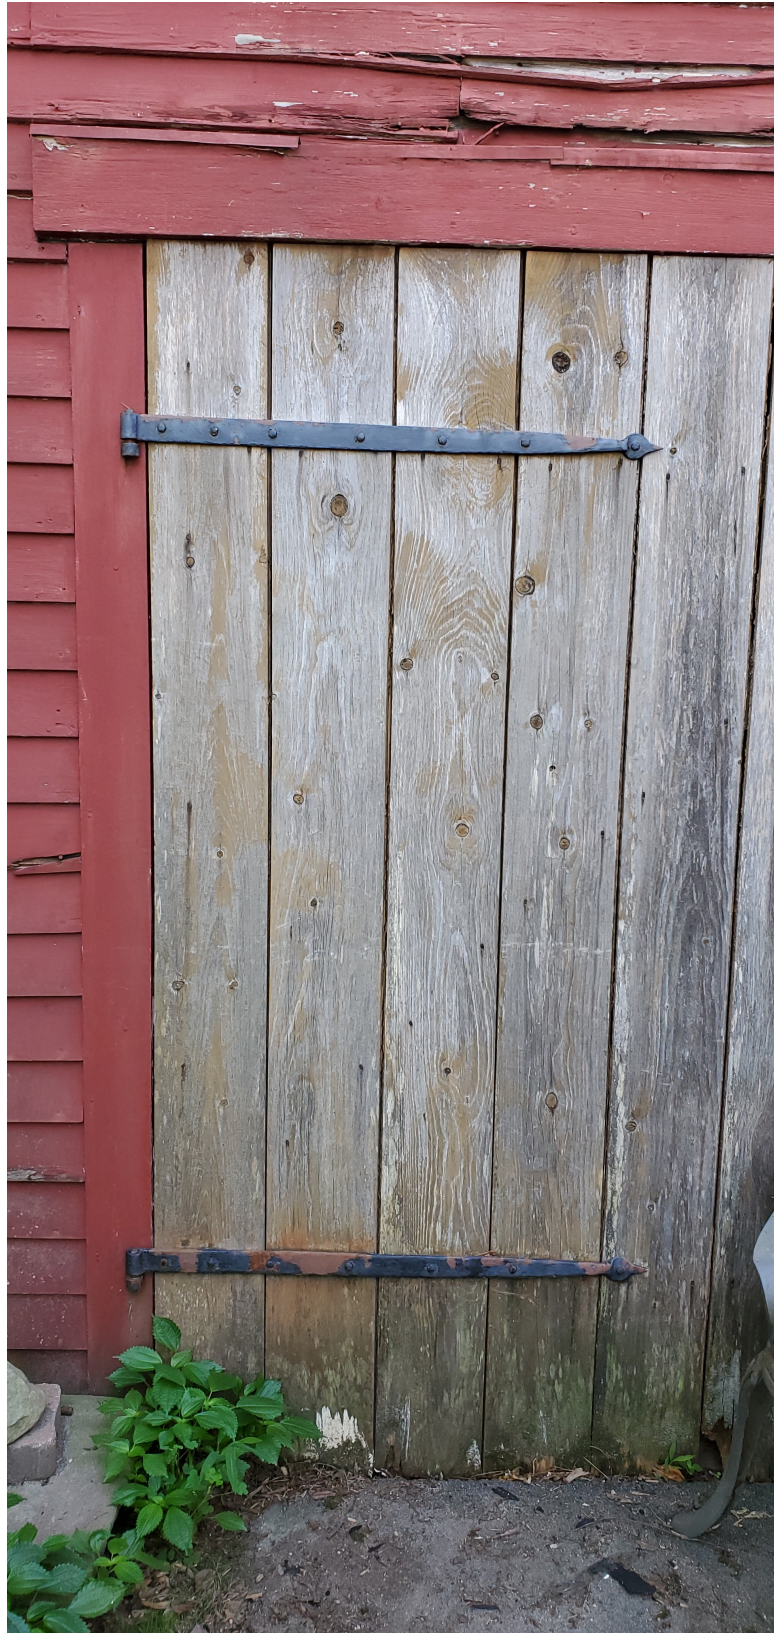
The current oak barn doors (Figure 5) replicate what was in place when the barn was used as a Carriage house including period iron strap hinges (built c1990 by the current owner to replace a 1960's overhead door).

*Figure 5: Carriage House barn doors with iron strap hinges*
