125 HOPE STREET, BRISTOL, RHODE ISLAND
STRUCTURAL INSPECTION, JANUARY 16, 2025

At your request, this office has conducted a structural inspection of the buildings located at 125 Hope Street in Bristol, Rhode Island. This inspection included a visual inspection of the accessible areas of the building's interior and exterior. The following is a report of our findings and recommendations.

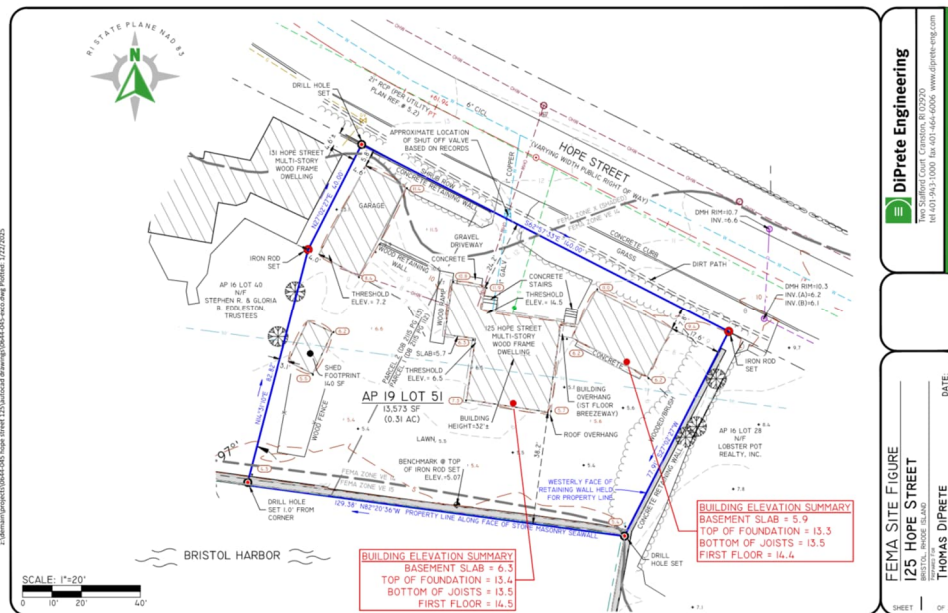
We are in receipt of survey results from DiPrete Engineering dated January 22, 2025 that indicate that “the site is located within a *Special Flood Hazard Area VE wave velocity zone*, Base Flood Elevation = 14.0”. According to this report, the bottom of the lowest horizontal structural members are located at elevation 13.5 at both buildings.
