Water and Wastewater Leak Detection Update

Infrastructure & Development Committee
February 4, 2026

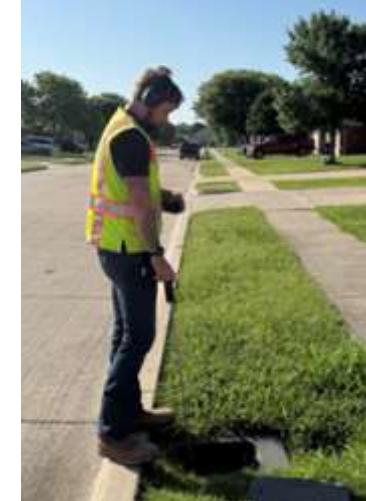
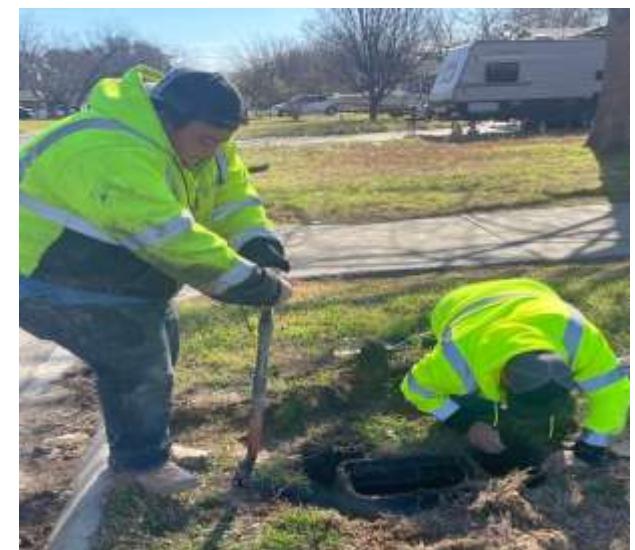
Satellite Water Leak Detection: Property Owner-side

#	Street	Est. Annual Loss (Gallons)
1	Pinnacle Cir	109,500
2	Pinnacle Cir	91,250
3	SW Wilshire Blvd	73,000
4	W Alsbury Blvd	102,200
5	SW Alsbury Blvd	80,300
6	Alsbury Blvd	94,900
7	Alsbury Blvd	87,600
8	Arnold Ave	76,650
9	Tarrant Ave	98,550
10	Oak St	83,950
11	Market St	91,250
12	Barkridge Ct	80,300
Total		~1,069,450

Two of fourteen property owners have provided documentation of repairs representing 90,000 gallons/year (\$711)

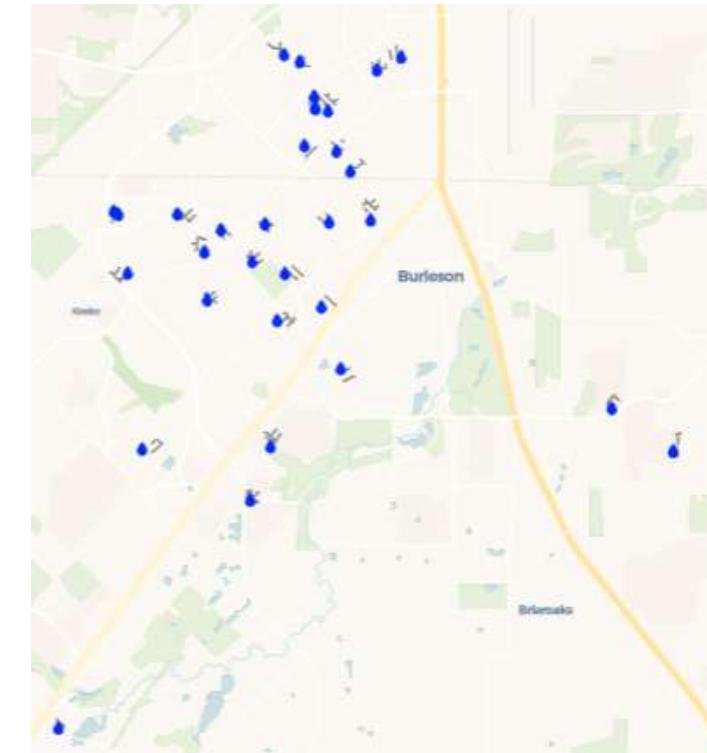
Satellite Water Leak Detection: Utility-side

Utility Leak Categories	Number of Leaks	Corrected
Service Pipe	7	Y
Service Connection	6	Y
Valve (shut off)	1	Y
Fire Hydrant	5	Y
Water Meter	7	Y
Water Meter Curb Stop	7	Y
Total	33
