Jerry Hofer

February 6, 2023

Tree Consultation Proposal For: McIntosh Property

Site Information: TaxParcel 127449000 3210 NW McIntosh Rd. Camas, WA 98607

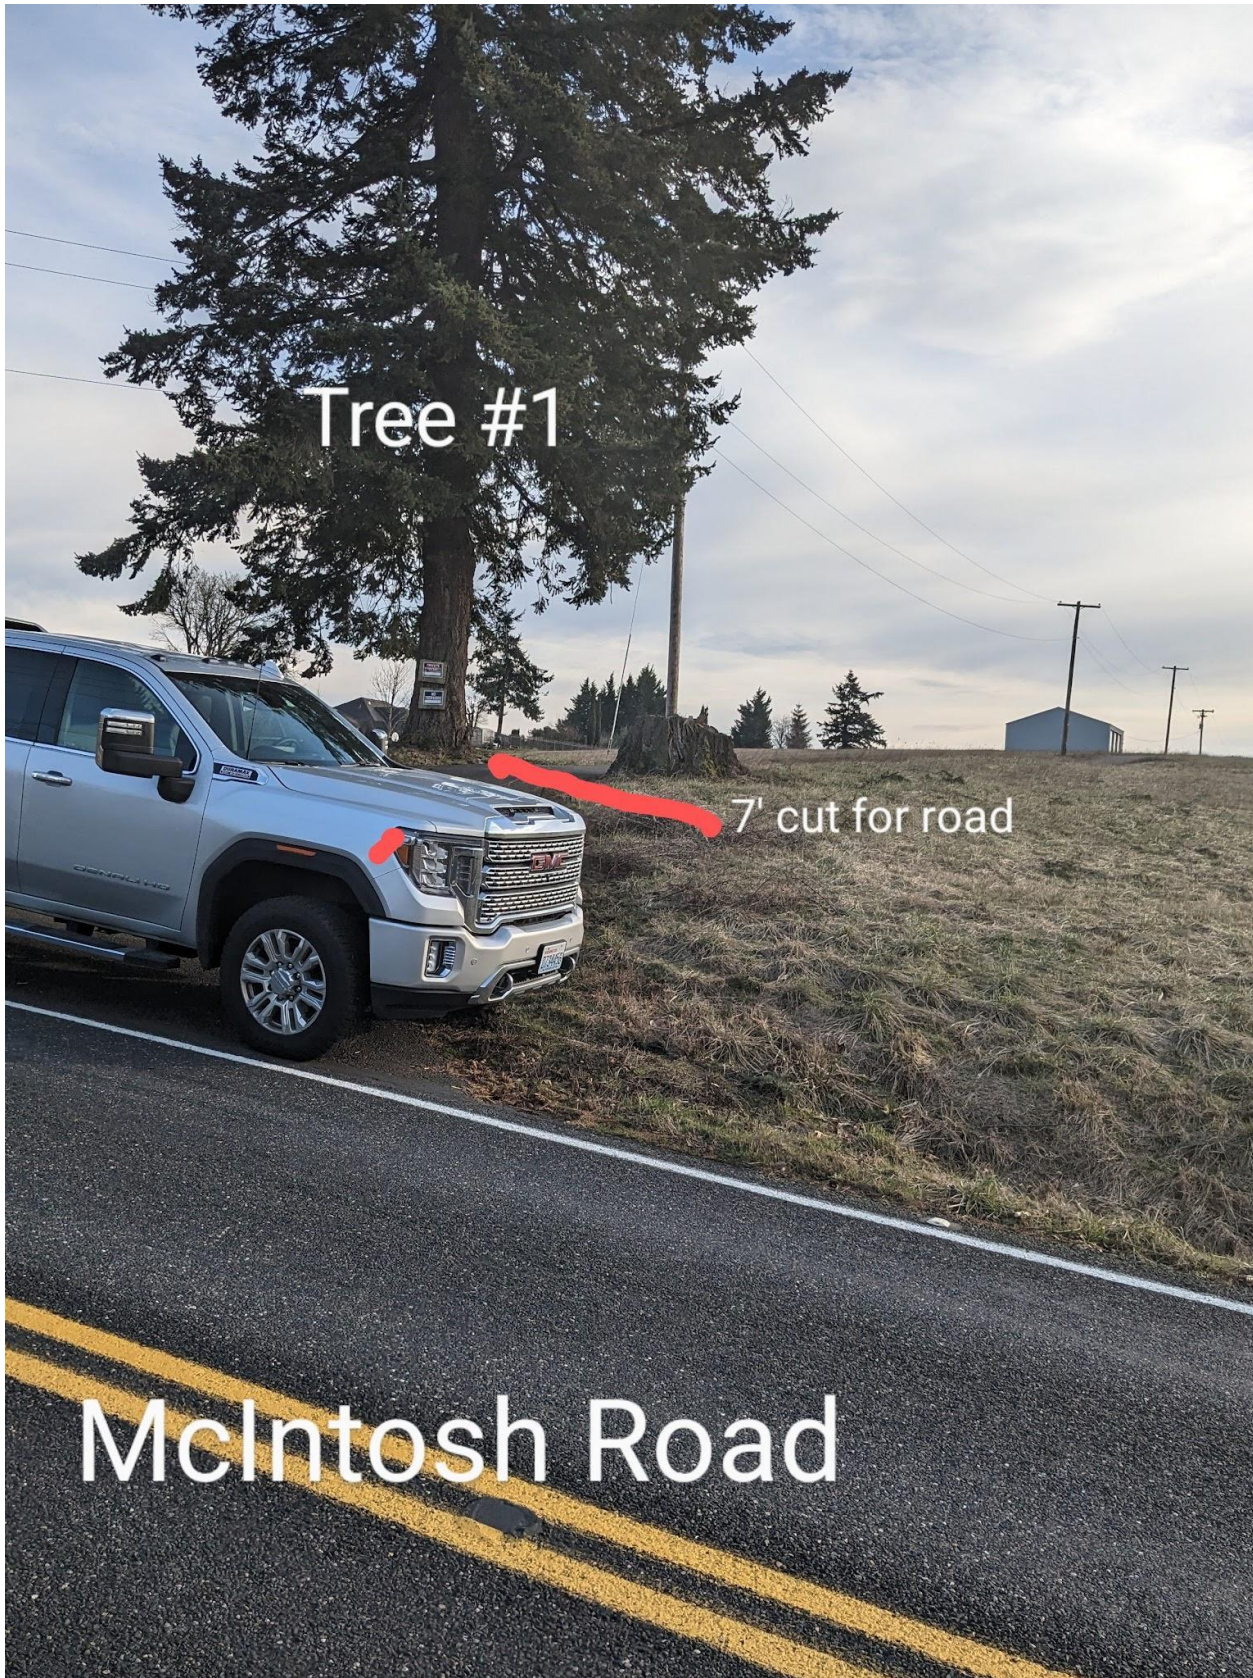
7' cut for road

Tree #1 is a 37" Douglas fir, 90' tall and located about 40' south of McIntosh Road where the entrance for this subdivision will be built. While the tree looks in good condition, it exhibits some past breakage about 15' from the top. This breakage resulted in several branches growing upward to become new tops. This creates a weak area subject to future breakage, especially from a freezing rain, ice/snow event.

would be hanging over the subdivision access road, it would be a potential hazardous situation for cars or pedestrians. Given both factors listed above, I recommend that tree #1 be removed. Additional trees will be planted along both sides of the access roads.
