# NW 18th Avenue Subdivision

## Tree Survey

### Camas, Washington

October 28, 2021

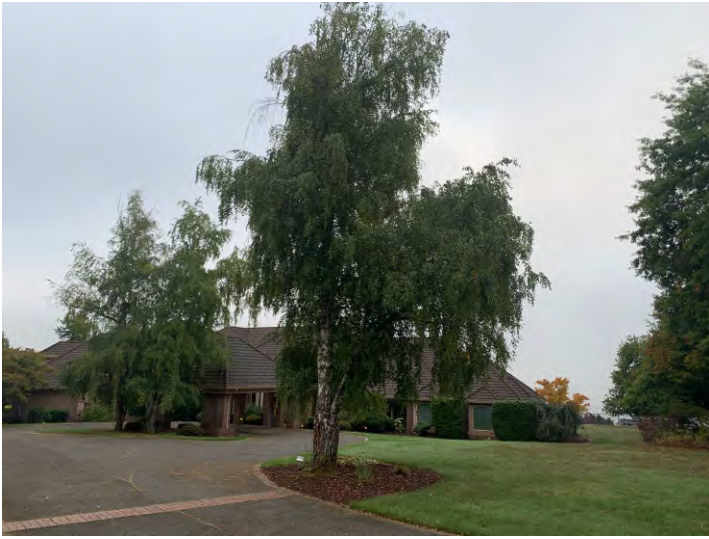
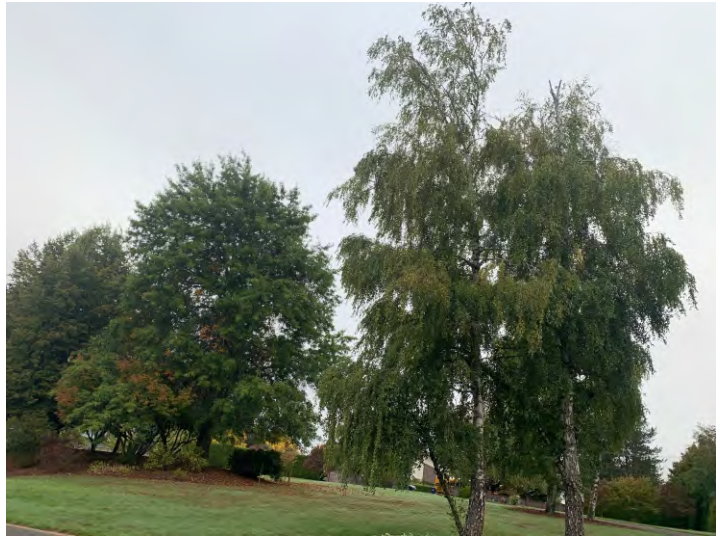
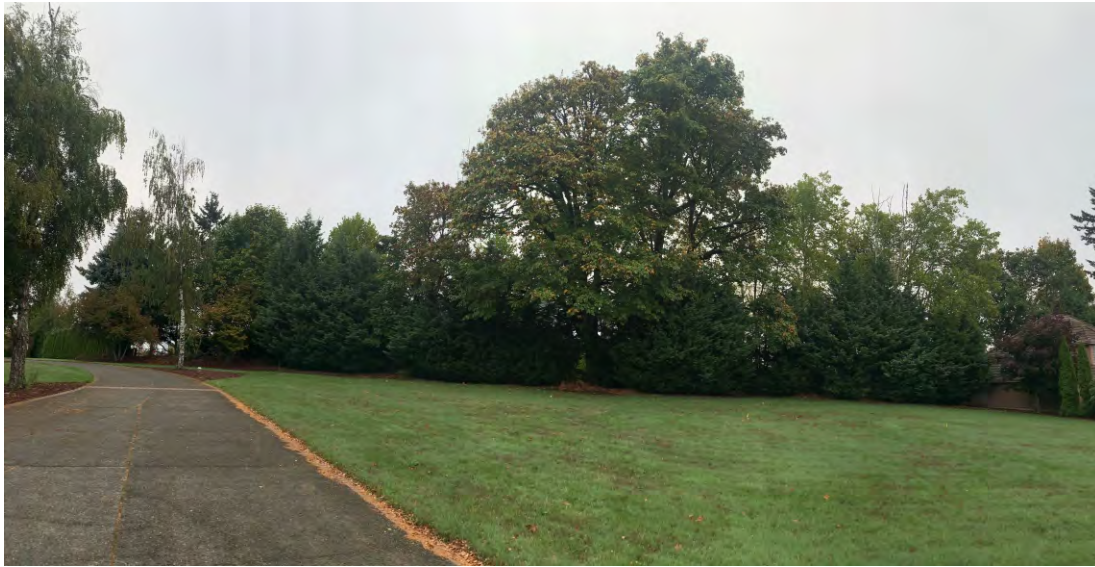
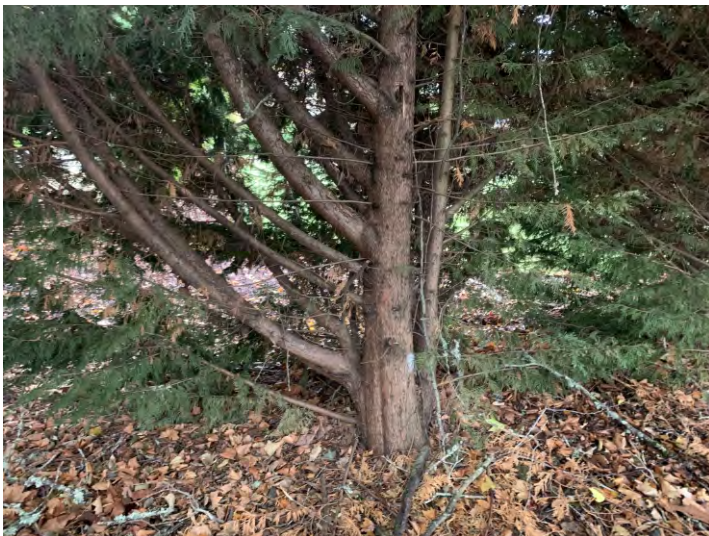
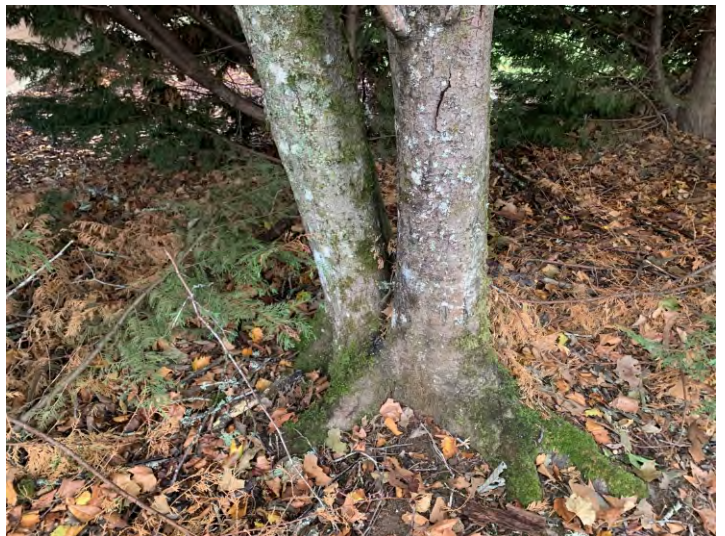
**Photo-Sheet 1**

Paper-birch (*Betula papyifera*) occurs in small groups along the driveway (Photo Sheets 1 and 2). Most of these trees are in fair condition with some dead wood and moderate vigor representative of the species. Just north of the main house there is a landscaped island -all of the tree roots in this location are severely exposed, with some root plates beginning to lift (Photo Sheets 3 and 4). One red oak (*Quercus rubra.*) tree#32) is marginally within strike distance of the house in the event of failure, and is considered a moderate to high risk. Targets for the

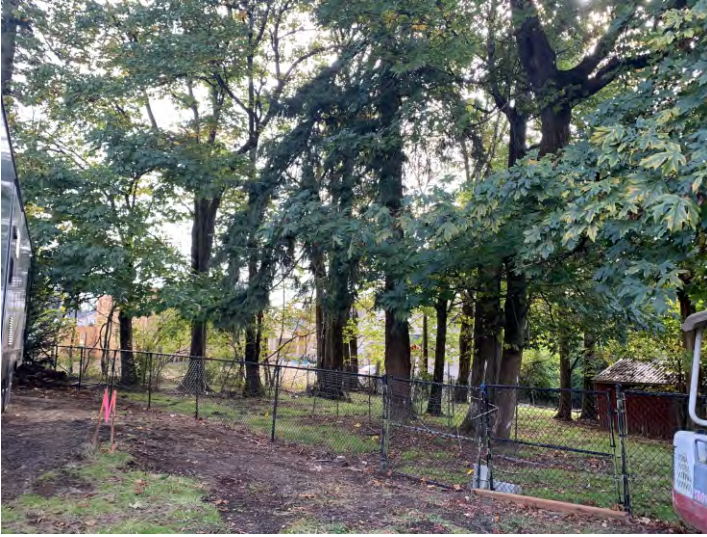
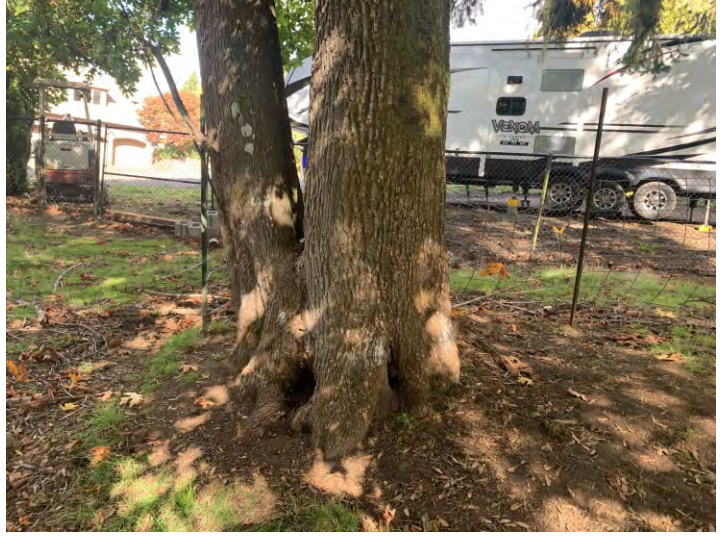
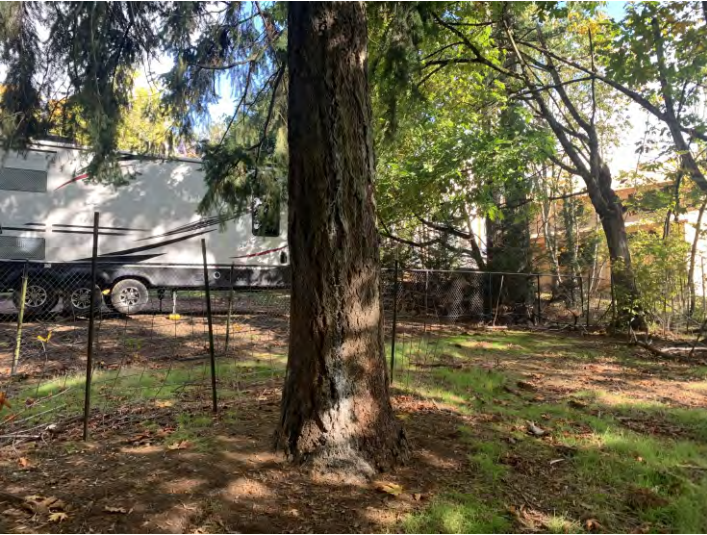
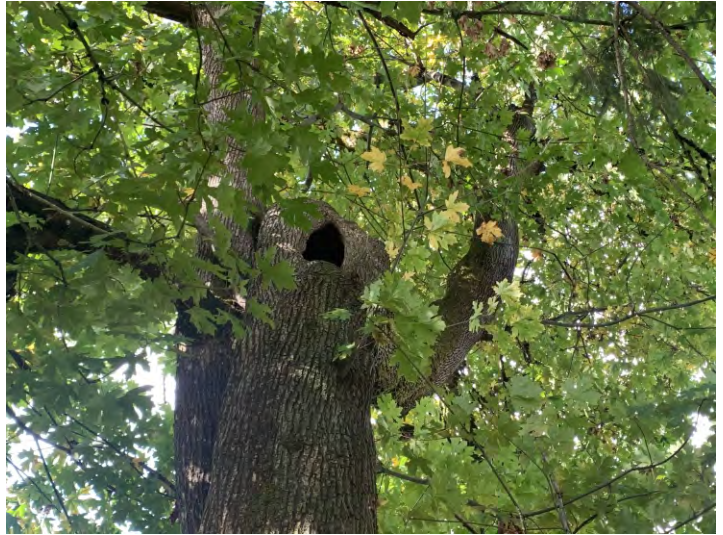
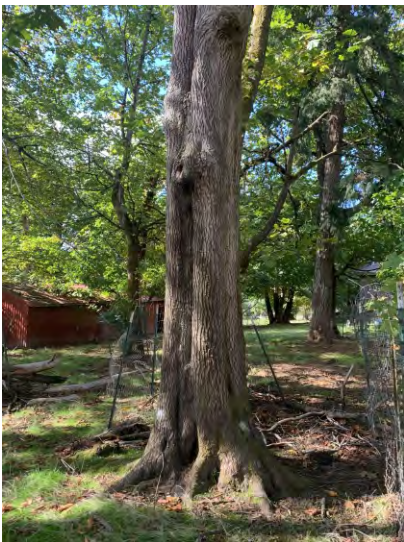
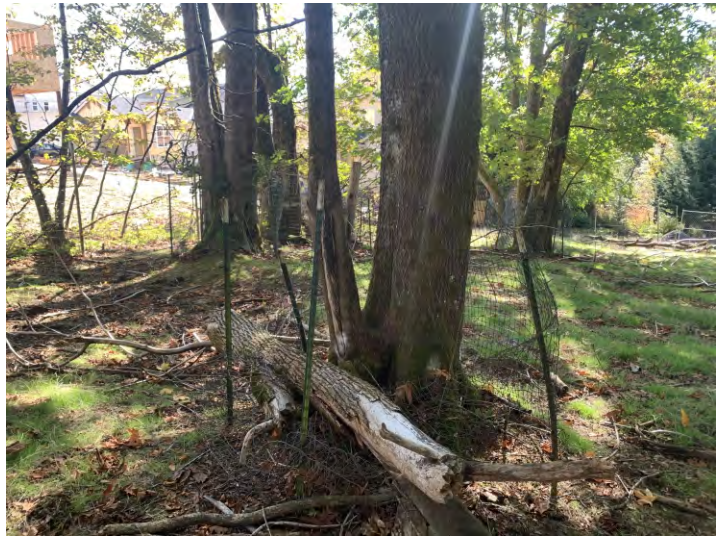
**PROPOSED ACTIVITIES IN:**  
 Lacamas Creek Watershed  
**LEGAL:** NE & NW 1/4 of S09, T1N, R3E  
 W. M.  
**NEAR:** Camas, Washington  
**COUNTY:** Clark County  
**DATE:** 10/28/2021  
**Photo-Sheet 7**

The eastern property boundary is composed primarily of a mix of arborvitae (*Thuja spp.*) and big-leaf maples, among a few other species from the garage north-ward (Photo Sheets 5-7). All of the large big-leaf maples in these areas are over-mature and displaying varying degrees of heartwood and sapwood decay, which is typical of this species given their age and size. Previous upper-canopy and main stem failures were also observed among some of these trees (especially tree#21, 22, 23, and 29). In addition, tree# 14 and 19 are currently dead. Targets for these trees in the event of failure are the lawn and the adjacent property. Due to the potential impacts to these targets (the adjacent property, in particular), they are considered to be high risk.
