# Stockton Avenue Bridge Structural Evaluation Findings

# Stockton Avenue Bridge at Soquel Creek

(Br. No. 36C0110)

## Structural Condition Evaluation

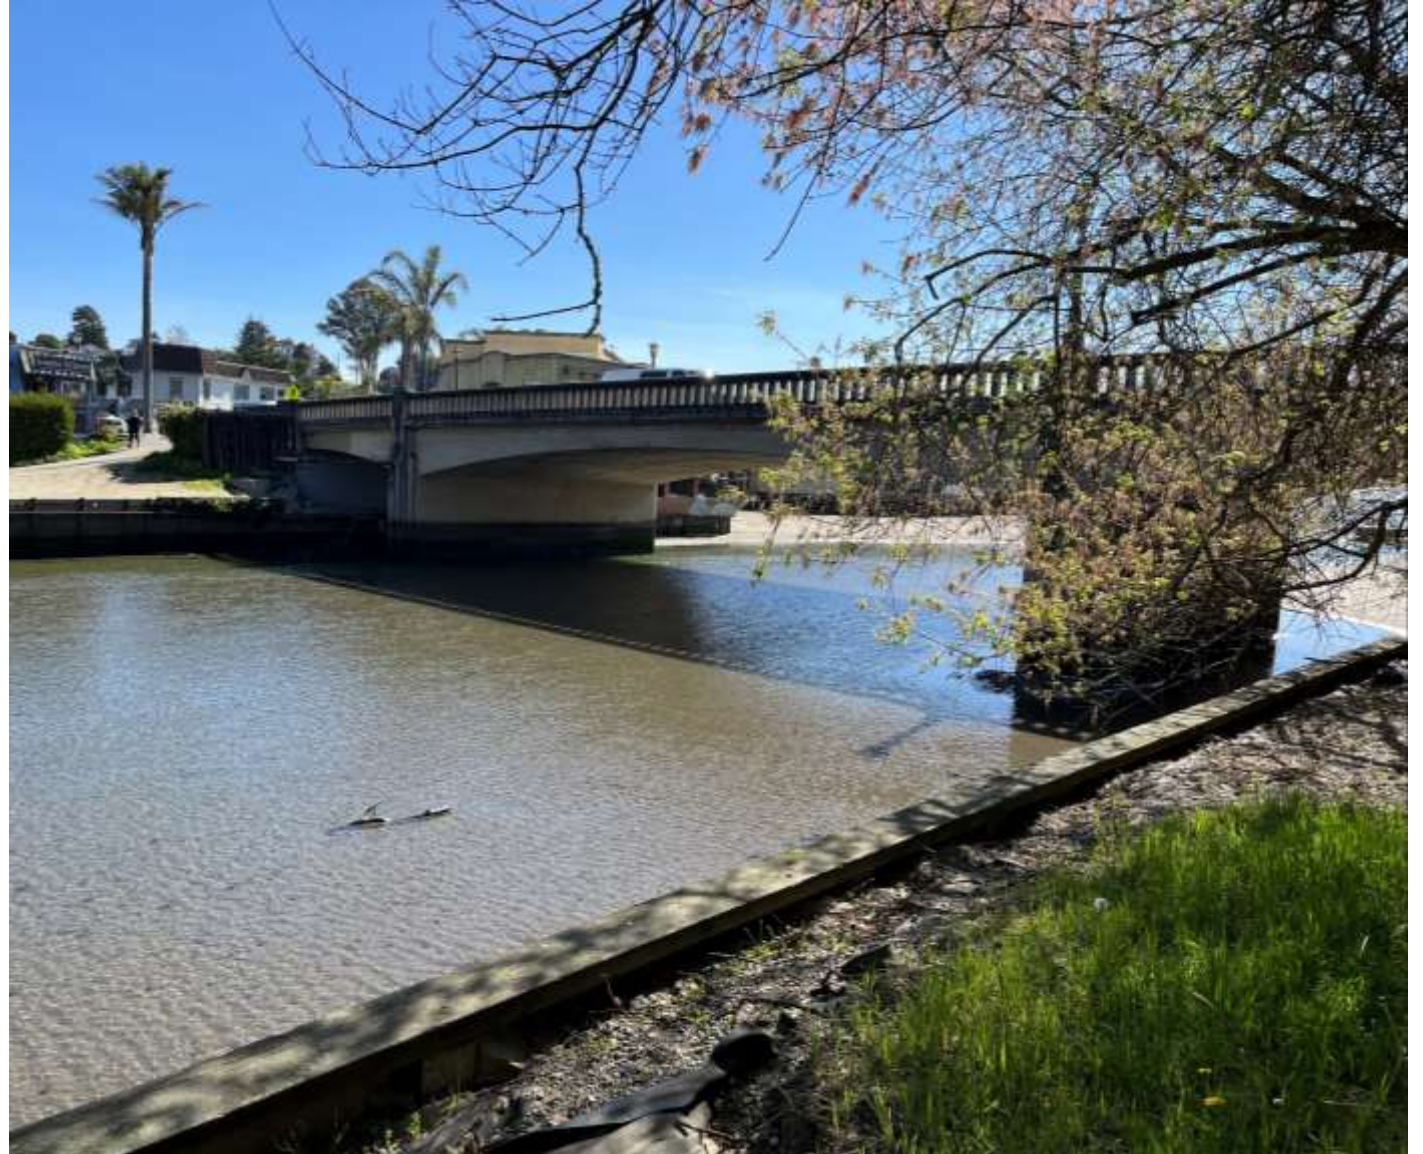
- 2023 Storms Caused Erosion at Abutments and Corrosion Repairs were implemented.
- CSWST2 determined bridge to be “Scour Critical” and developed several hydraulic mitigations in 2024
- Due to hydraulic mitigation complexity, the last alternative proposed to replace bridge entirely.

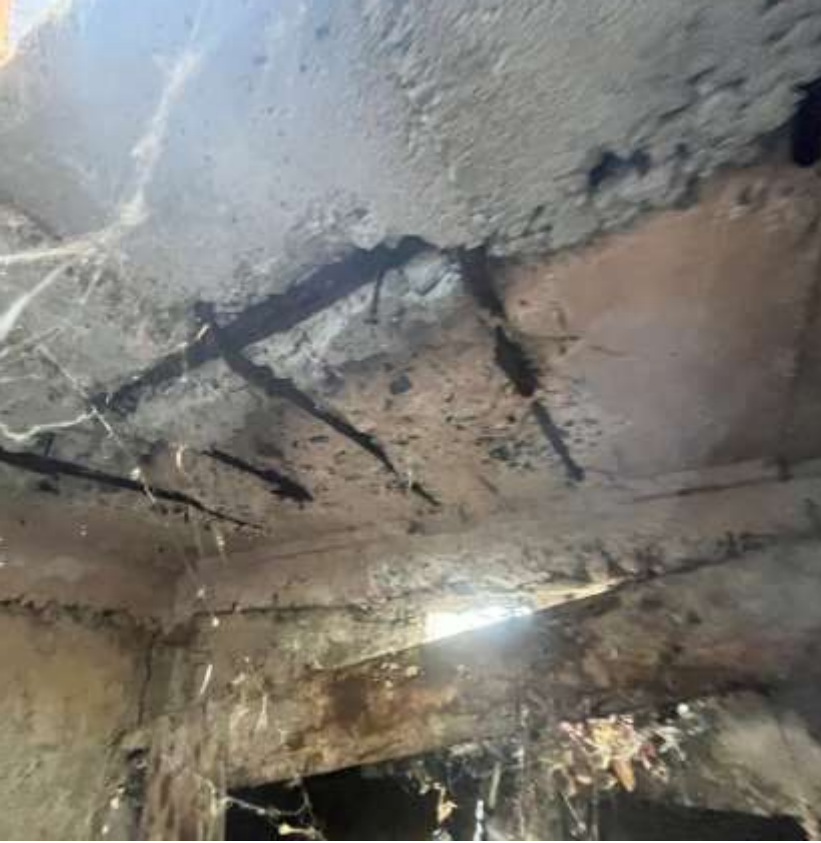
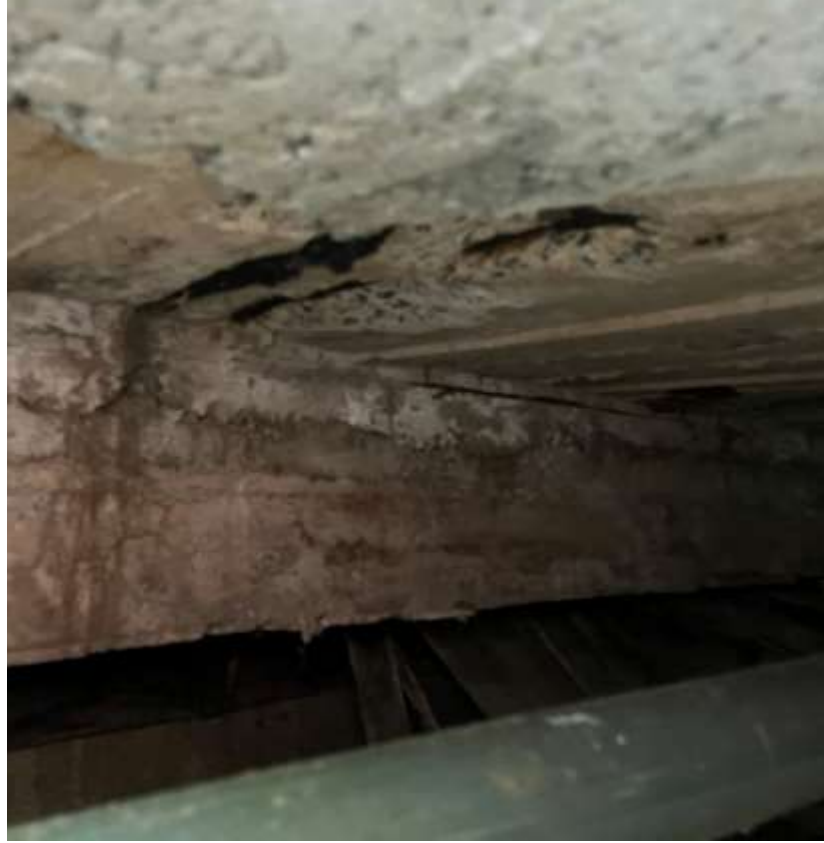
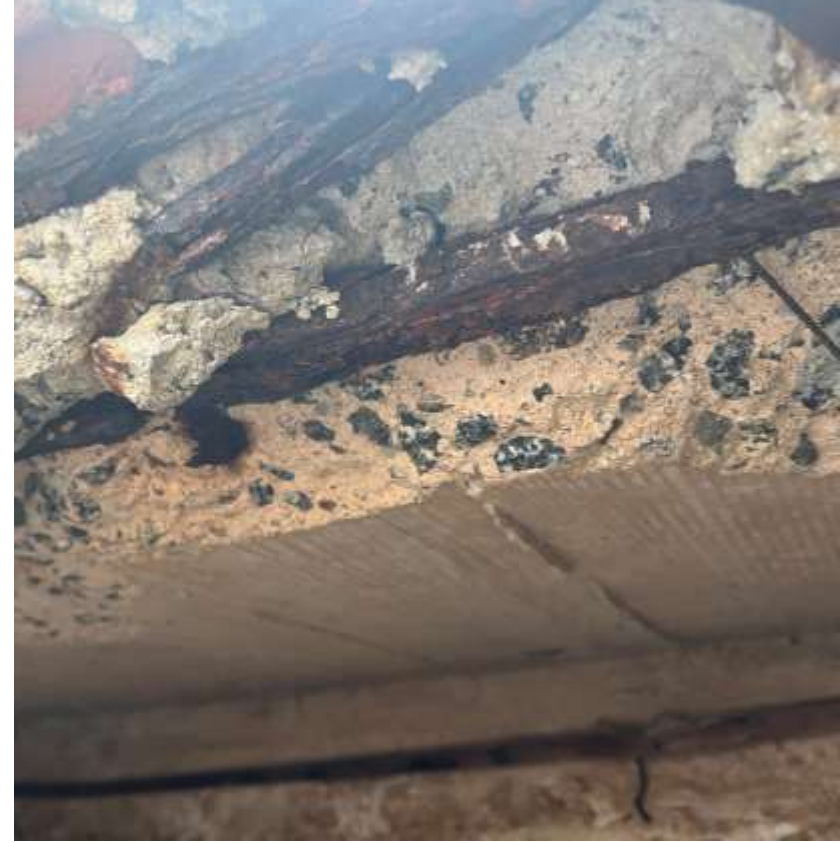
## EXISTING SIDEWALK CONDITIONS

July 2025 Site visit  
(manhole access only)

- Corroding reinforcement and spalling was observed in beneath the sidewalk. Underside of the bridge deck at roadway manholes not visible due to formwork.
- Chain-drag evaluation of the deck located several areas that indicated delaminations of the concrete
- Additional deck openings were recommended
