AN ASSESSMENT OF THE TREES WITHIN THE PROXIMITY OF PROPOSED IMPROVEMENTS ON THE LANDS  
OF SAMUEL ABBEY – 106 CLIFF AVENUE – CAPITOLA, CA - (APN 045-123-25)

Site visit by:  
Nigel Belton – ISA Certified Arborist WE-0410A  
July 17, 2021

Job – Sam Abbey – 8.10.20

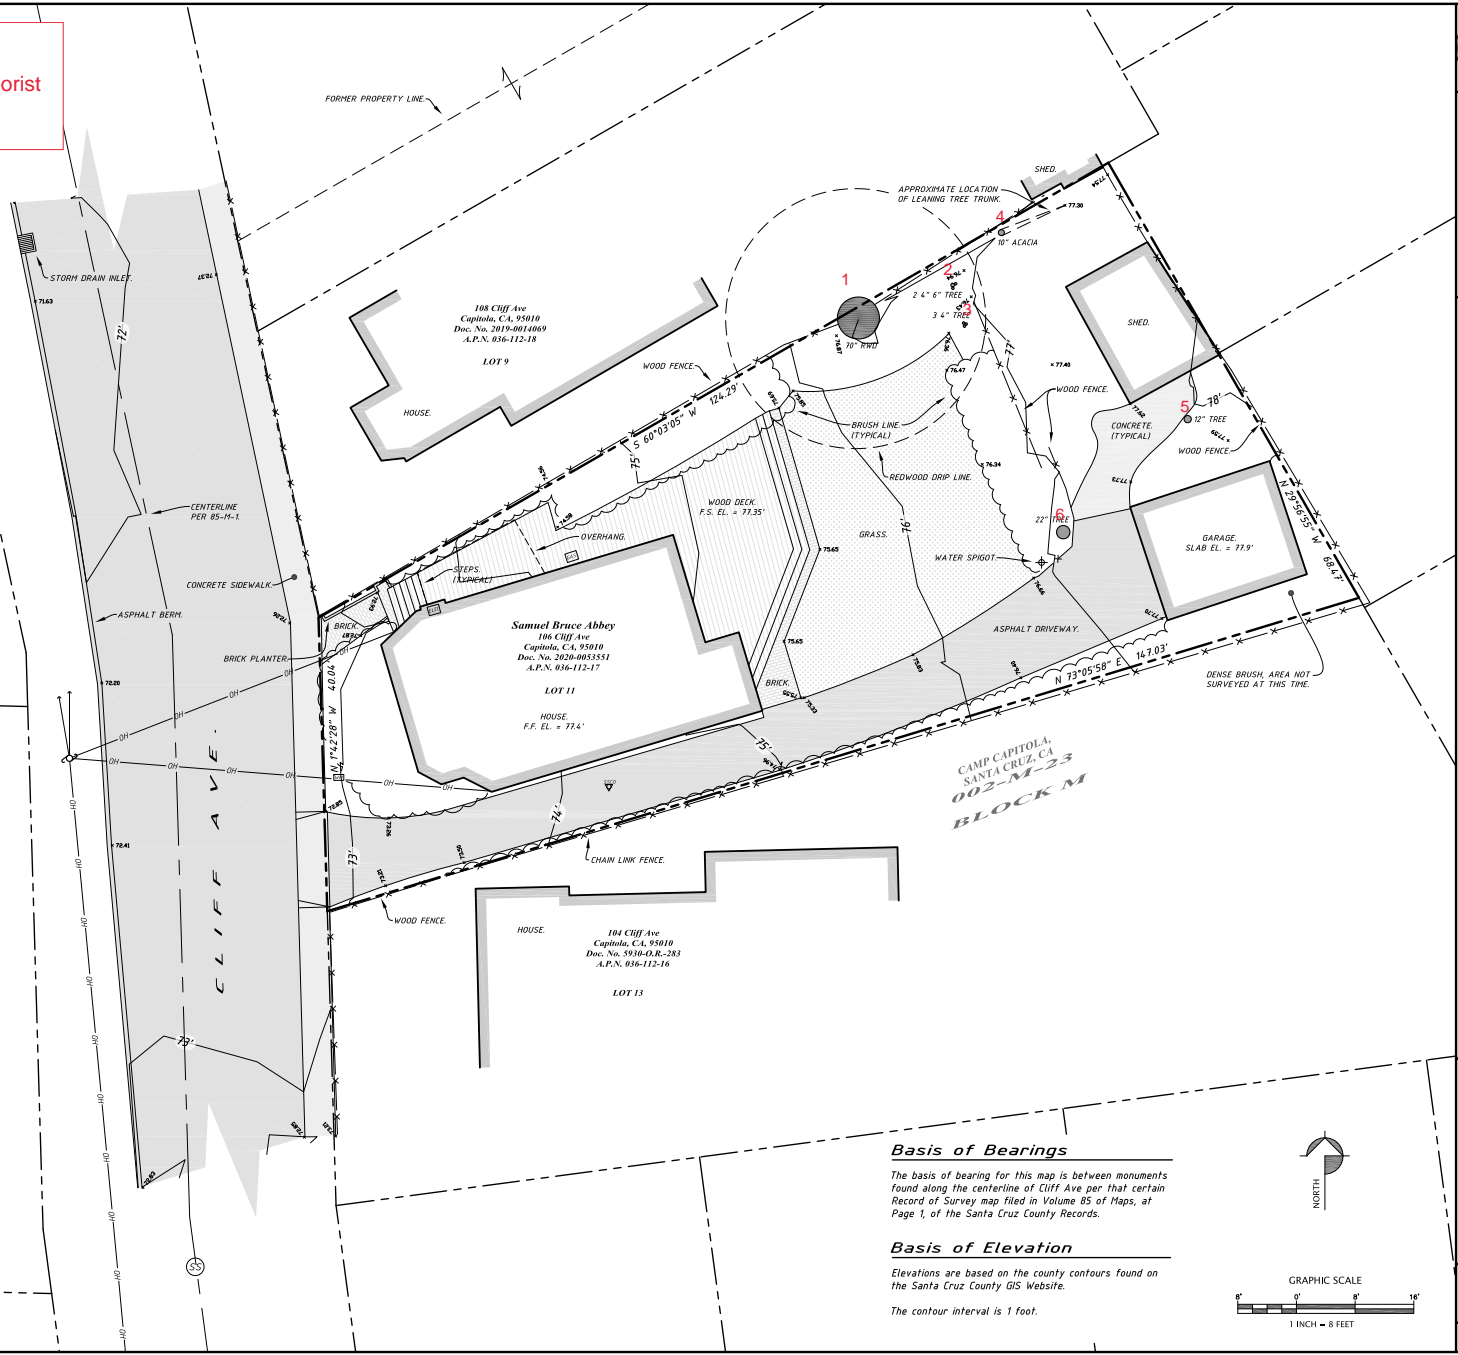
**TREE LOCATION MAP:**  
 Prepared by Nigel Belton - Consulting Arborist  
 August 10, 2021

The project site comprises of a narrow residential property with an existing house. I surveyed six trees, four of which were determined to be unsuitable for preservation because of their poor overall health and structural condition ratings. The largest and most significant tree on the property is the Coast redwood located on the north property boundary. This tree exhibits good health and it has a good structural condition.

This tree is suitable for preservation, based upon its good condition ratings and because of its location at the edge of the construction footprints. The trunk transects the north property boundary.

The large Coast Redwood located on the north property boundary must be preserved and protected during the construction period. The project arborist must provide oversight during the construction period.
