Building Assessment Report

07/02/2025 “FINAL Submittal”
Old Chipley City Hall

Old Chipley City Hall

Final Submittal – July 2, 2025

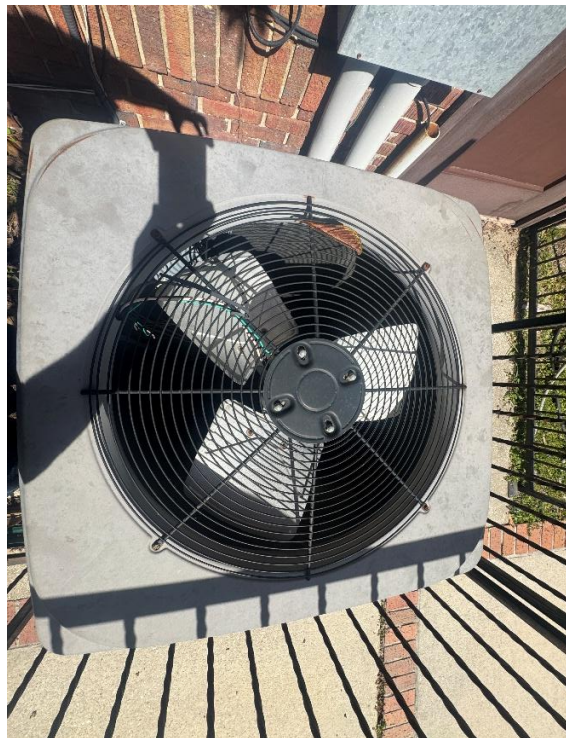
Figure 1 – Air Handling Unit (AHU-1)

The air handler and heat pump serving the first floor are past its life expectancy and is showing signs of major wear and tear. The electrical wiring inside the heat pump is exposed and zip tied. See Figures 1 & 2.

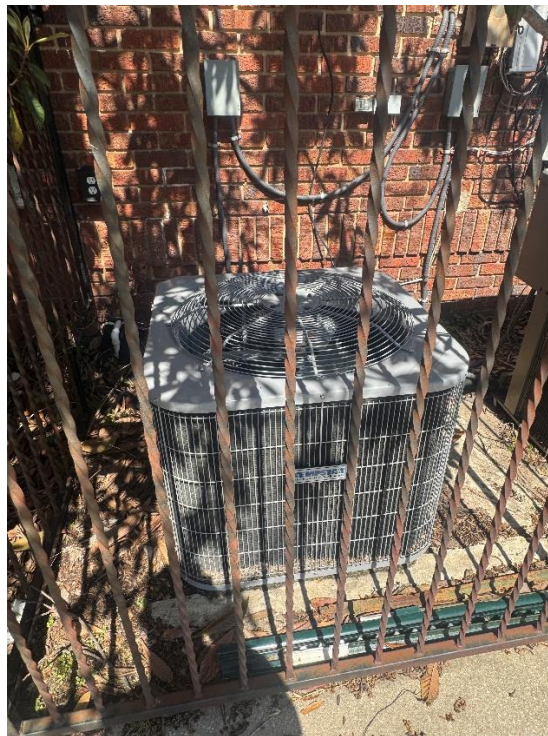
Figure 3 – Air Handling Unit (AHU-2)

The air handler and heat pump serving the second floor are approximately 5 years old. See Figures 3 & 4.

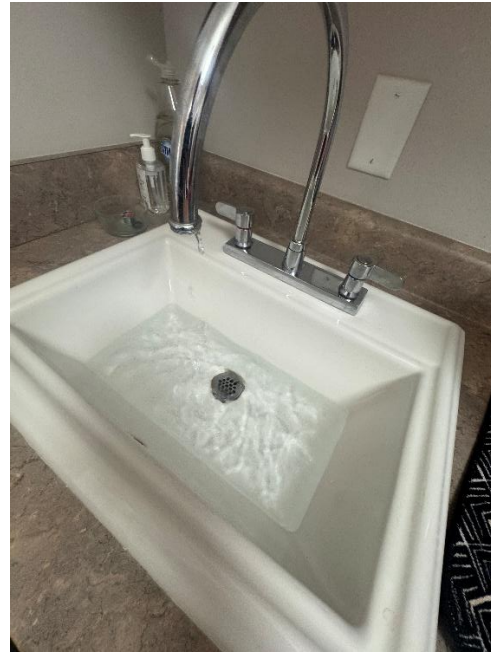
Figure 8 – Typical Restroom

The building currently has a total of four restrooms. Two restrooms are on the first floor and the other two restrooms are on the second floor. Each restroom consists of one water closet and one lavatory, see Figure 8. Plumbing fixtures were operational at the time of the site visit. Faucets were the two handle types and operational at the time of the site visit. Some of the sinks were missing P-trap covers. The water drainage in some of the sinks took a long time to drain. This could possibly be due to having a high flow faucet with a small bowl sink and possible small drain size, see Figure 9. This could also be due to clogs or undersized piping systems. A single water cooler was noted, see Figure 10. See Architectural report for ADA requirements.

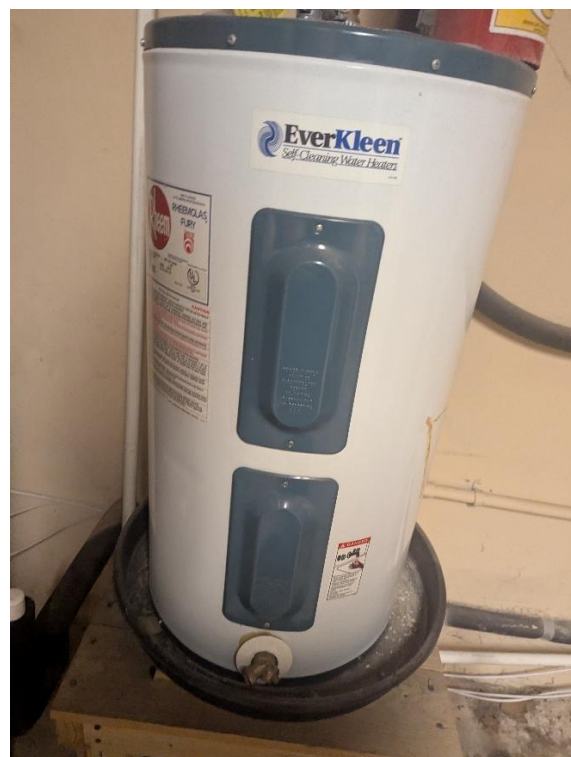
Figure 11 – Electric Tank Water Heater

There was an existing 20-gallon electric tank water heater. The water heater is approximately 18 years old and past its life expectancy, see Figure 11.

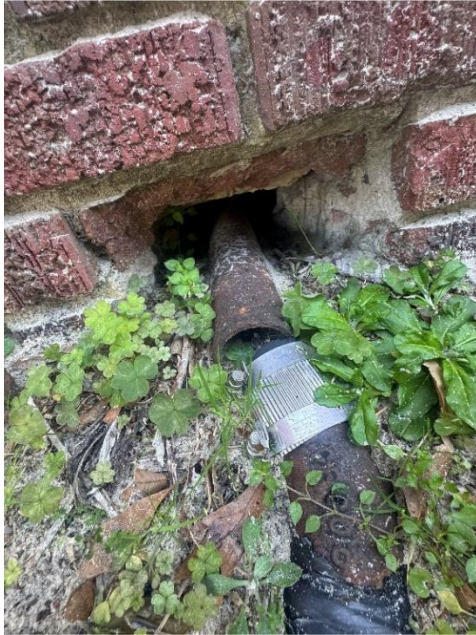
The domestic water system and sanitary systems were in normal operations at the time of the site visit. There was a disconnected and/or abandoned pipe noted at the exterior of the building, See Figure 12. There was also exposed PVC piping on the other side of the building which could suggest that some of the plumbing systems have been replaced at some point or re-routed. See Figure 13.

Figure 12 – Disconnected and/or Abandoned Pipe

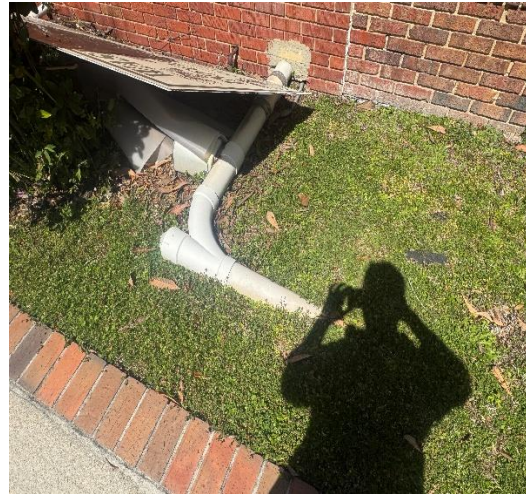
Figure 13 – Exposed Piping on Exterior of Building

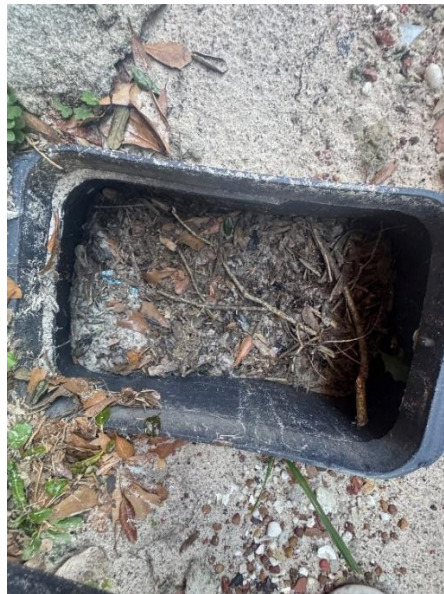
Figure 14 – Exterior Cover

The sanitary and domestic water systems and piping are expected to be past its life expectancy. Portions of the plumbing piping were not adequately supported or insulated. The water meter cover outside was empty and there was no shut off valve observed, See Figure 14.

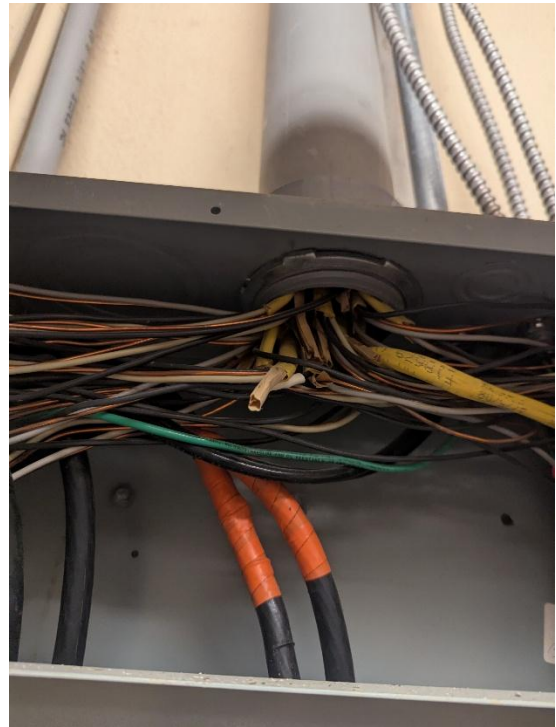
The existing building electrical service is provided by the local electrical utility that comes underground to the building. The service is being fed from an exterior junction box that feeds a single slot electrical meter as shown in (Figure 1). The electrical meter feeds an interior disconnect box that feeds an electrical panel in the electrical room, behind the electrical meter. The electrical panel 'A' is rated as 400Amps main circuit breaker, 240/120Volts, single phase as shown (Figure 2 and 3). Electrical panel 'A' feeds the whole building electrical load. The disconnect switch by the electrical panel 'A' acts as a junction box that feeds the electrical panel 'A' power. Electrical Panel 'A' had unlabeled circuits and missing conduit gaps as shown in (Figure 7). Electrical panel 'A' also had abandoned cables as shown in (Figure 5).

The building consists of general electrical outlets distributed throughout, of which some that were not operational. Above the ceiling there are multiple open junction boxes, abandoned wiring, and exposed wiring. Many of the circuits were unlabeled or unknown of which branch circuit breaker they were fed from as shown on (Figure 4 and 5).

Figure 5: Abandoned cabling

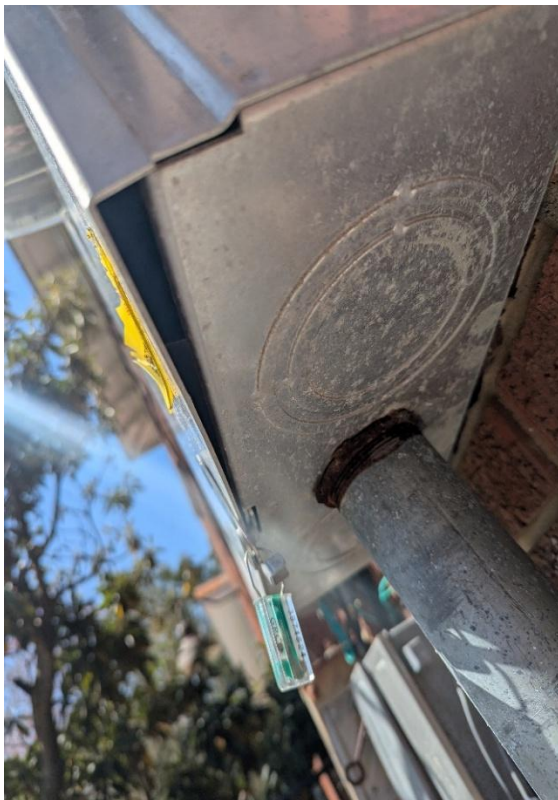
The electrical meter on the outside of the electrical room is not completely sealed, refer to (Figure 6). There is also no clearance in front of the electrical equipment outside as the A/C units sit in front of it as shown in (Figure 1).

Figure 6: Exposed Electrical Meter

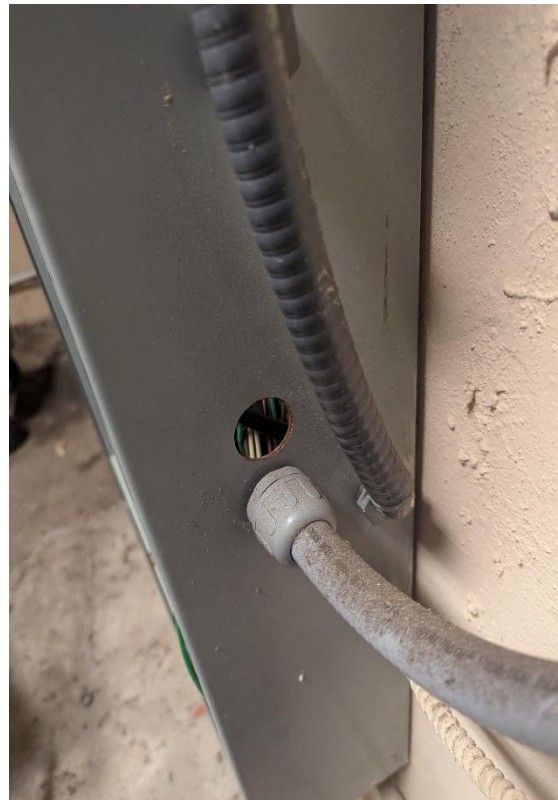
Figure 7: Exposed Electrical Gap

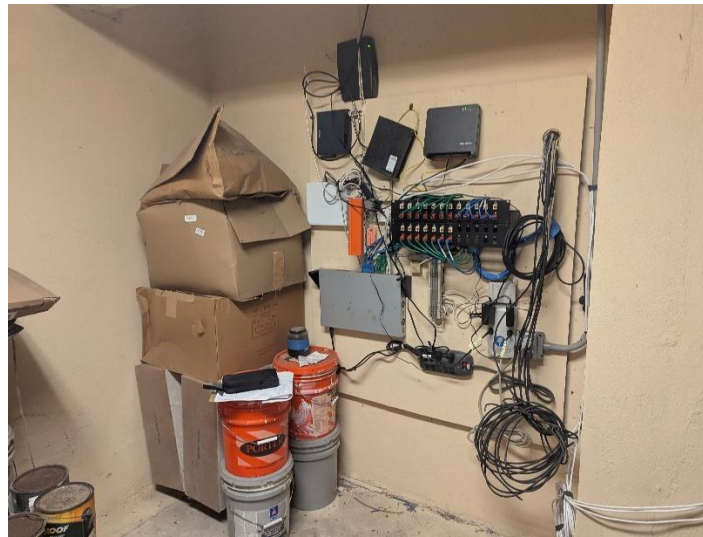
Figure 8 – Communication System

The main telecommunication components located in the electrical room as shown in (Figure 8). It is fed from the exterior telecommunication components as shown in (Figure 1). There are some telephone blocks that are abandoned. There are also unused and abandoned cabling that are not terminated.

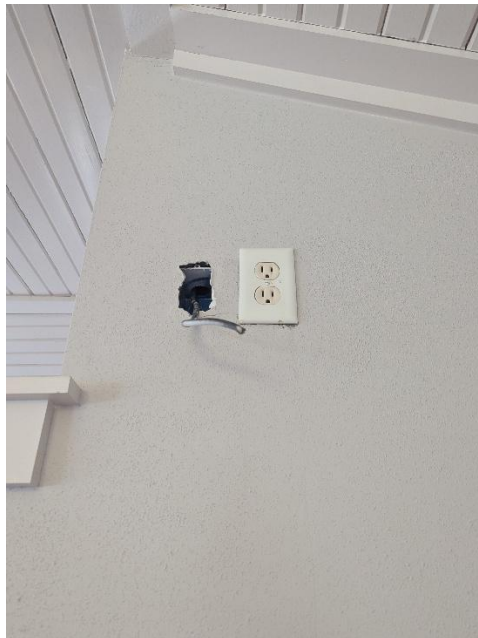
The facility consisted of data/telephone outlets and TV type coaxial cables. A few of the communication outlet locations were abandoned and non-terminated as shown in (Figure 9).

Figure 9 – Abandoned Telecommunication/TV Outlet

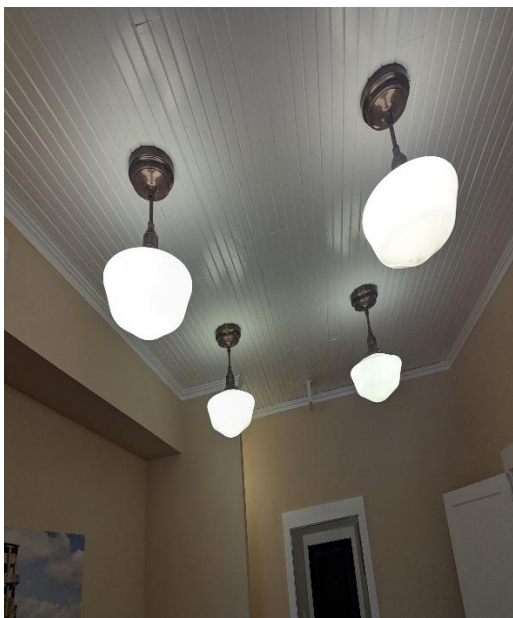
Figure 10 – Light Fixture (Down-Light)

Office, conference and restroom spaces consisted of surface mounted type down-light fixture as shown in (Figure 10). Some of those lights had battery as an emergency backup. A few of the lights were not operating as shown in (Figure 11). The building consisted of light fixtures with single pole switches control and no motion sensors. The building also consisted of exit signs for egress locations.

- Replace all the lighting with new LED lighting.
- Provide motion sensor and low voltage light switching controls.
- Provide emergency battery backup wall pack for egress pathway locations where required.
- Test all exit signs for battery operation. Replace with new if battery fails.

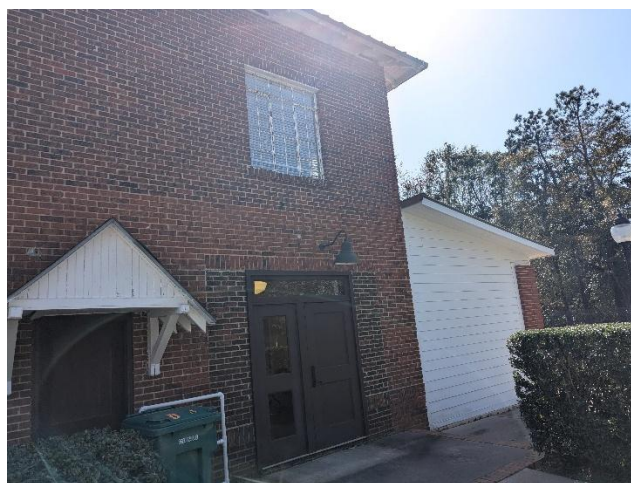
Figure 12 – Exterior Light Fixture (Wall Mounted)

Building exterior lights consisted of wall mounted type fixtures and decorative entrance lighting. Refer to (Figure 12).
