September 8, 2022

Coburg 500K Gallon Steel Reservoir Seismic Evaluation

Seismic Evaluation

PSE Project Number: 2101-0181

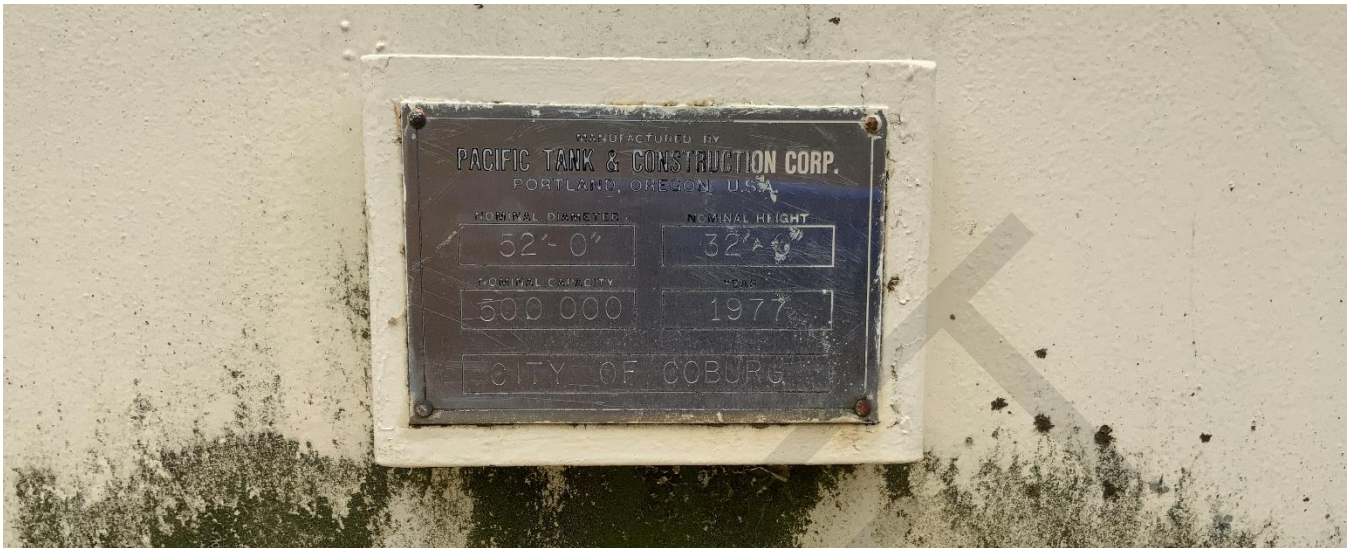
Photo 1 – Tank Plate

According to the plates present on each tank, the south tank was completed in 1975 and the north tank was completed in 1977, and both were manufactured by Pacific Tank and Construction Corporation of Portland Oregon. The tank plates did not indicate the design code used but based on the construction date both tanks were likely designed to the American Water Works Association (AWWA) D100-73 and the 1973 Uniform Building Code. No construction drawings were provided for review or verification of the design criteria or structural elements.

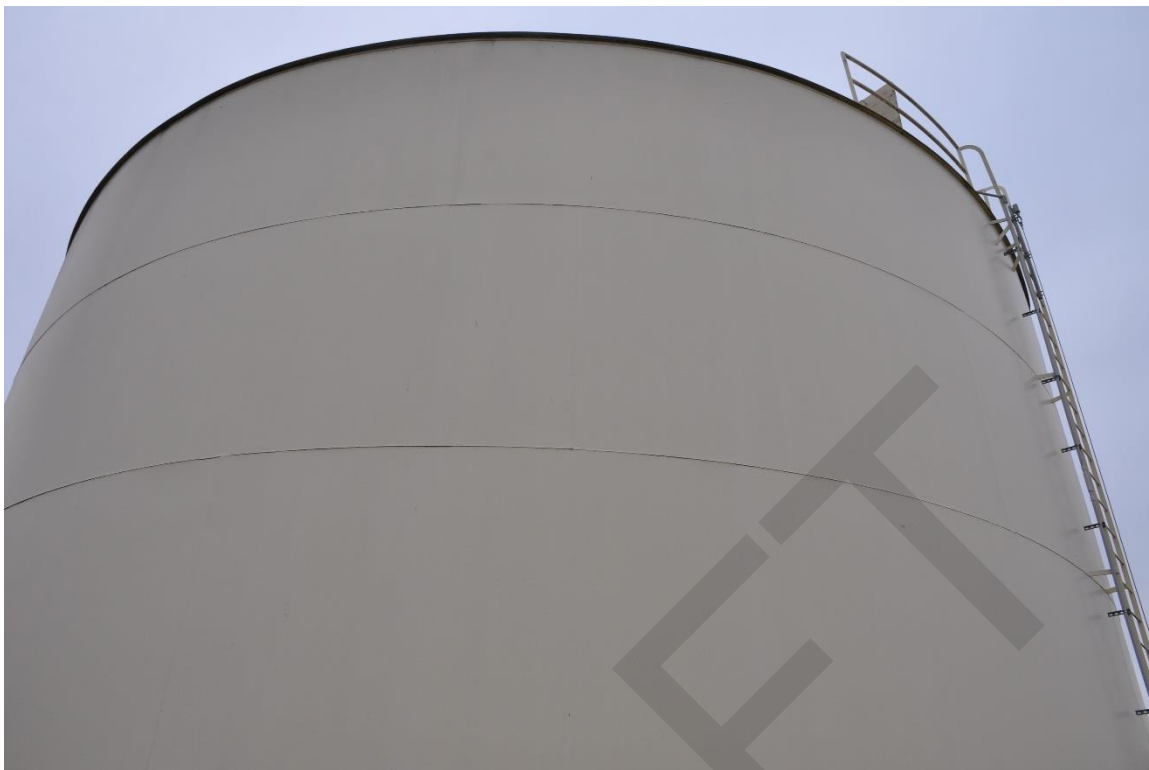
Photo 3 – Tank Exterior Upper

The general exterior condition of the north tank appeared to be in sound structural condition. No significant cracking or weathering of the ring footing concrete was observed. Some minor areas of corrosion were noted at the base of the shell, as well as some areas of flaking in the exterior coating but neither observation appears to present an immediate structural issue. The exterior surface of the roof was free of debris build up but appeared to have some minor areas of corrosion and flaking coating. The interior of the reservoir exhibited areas of corrosion staining at the typical operating level, roof plate seams, rafter flanges, and connection points but it is not a structural concern at this time.

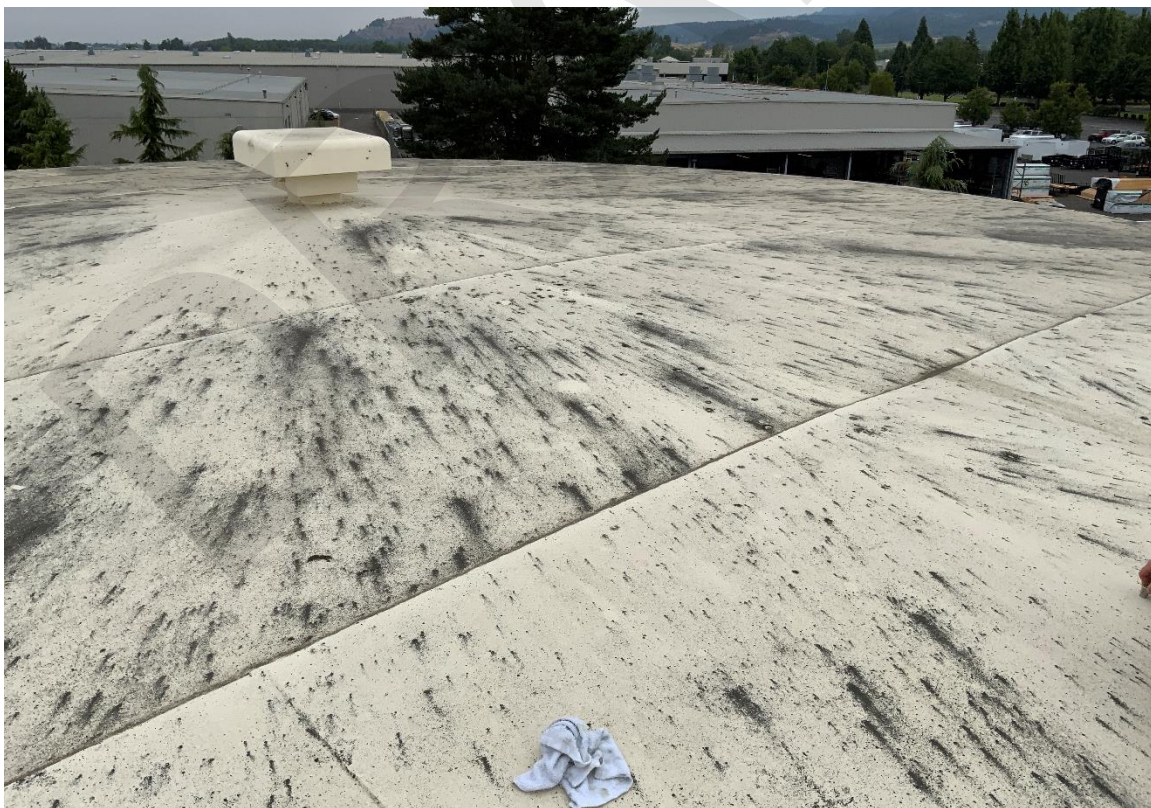
Photo 8 – Tank Exterior Roof

Using an ultrasonic thickness gauge, the roof plate thickness was measured to be 0.226-inches on the north tank and 0.212-inches on the south tank. The roofs consist of steel plates which are lapped together and welded on their external seams, with the roof plate overhanging the wall shell plate by 2.25-inches on both tanks. The foundation is cast-in-place concrete that is 12-inches thick and extends 4.0-inches beyond the exterior shell wall. The concrete is assumed to be at least minimally reinforced but no testing was performed to verify this.

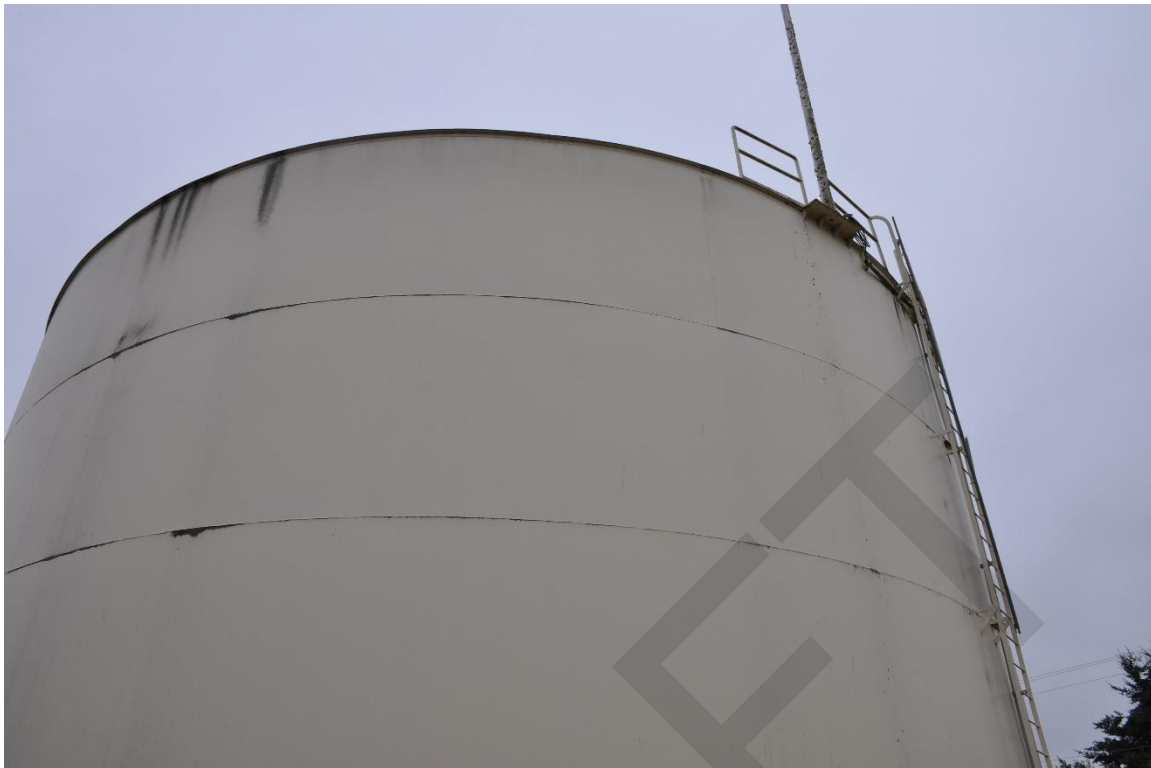
Photo 16 – Tank Exterior Upper

The exterior condition of the south tank generally matched that of the north tank. No notable structural concerns were observed with the visible portion of the footing or wall shell plates. Similar to the north tank, some minor areas of corrosion were noted in the bottom shell course, as well as some areas of flaking of the coating. The exterior surface of the roof was free of debris build up but appeared to have some minor areas of corrosion and flaking coating. The interior of the reservoir exhibited minor areas of corrosion staining, primarily occurring at the roof plate seams and bolted connections but it is not a structural concern at this time.
