## **Location Map | Garcia Creek**

#### **Scope Overview**

# **Existing Conditions | Garcia Creek**

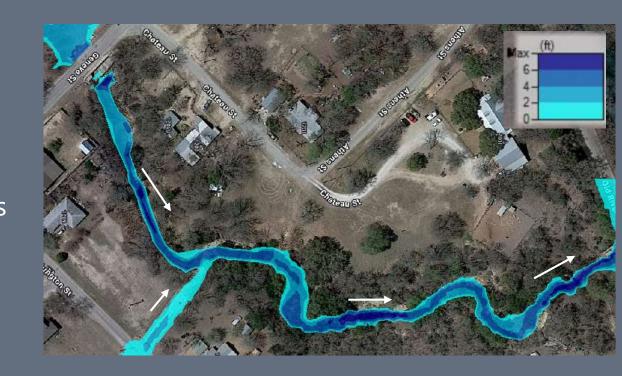
### **Defining the Problem Conveyance**

- Sufficient culvert & channel capacity
- 100-year flow contained within the channel banks
