Fire Facilities Inc. BCFD/Cartersville Joint Training Facility Cartersville, GA

Five Year Inspection - Structural Evaluation

RSE Project: 23906

Inspection Date: 28th April 2023

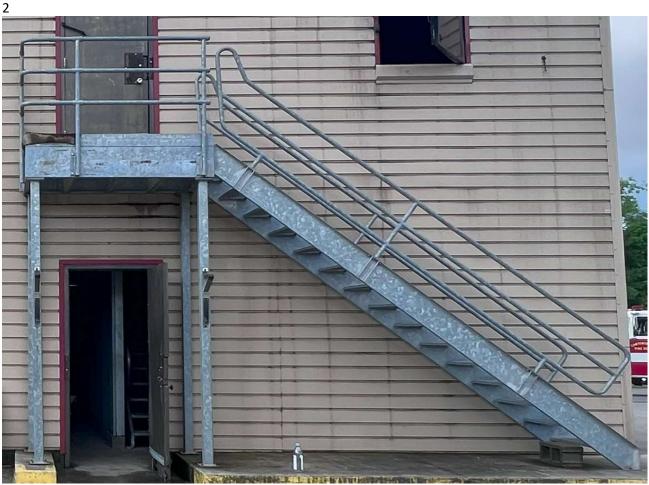
2. Clean surfaces as recommended in Appendix III (Paint Care and Maintenance Manual). 1*	
Condition of Exterior	Observations:	
Stairs and Landings	 Exterior stairs and landings showed minor wear. Minor corrosion at main exterior stair column base plates & stair bar grate treads. 	1. Low
	Recommendations:

Overall of Hot Dipped Galvanized Exterior Stair Structure

***	 Remove corrosion via sand blasting and/or power tools. Paint this area with a ZRC 221 Cold Galvanizing Compound by ZRC Corporation or comparable galvanizing paint (1.5 mils minimum. 2*/3*
