## DEADWOOD HISTORIC PRESERVATION COMMISSION

DEADWOOD NOT-FOR-PROFIT GRANT PROGRAM FOR  
SITES NOT ELIGIBLE FOR STATE PROPERTY TAX MORATORIUM

RE: Summary Report  
Extent of Damage to Wood Girder Truss  
Insured: Masonic Center Association, 715 – 717 Main St., Deadwood, SD  
Claim Number: PHNP20121407260  
KMS Engineering File Number: 20-023

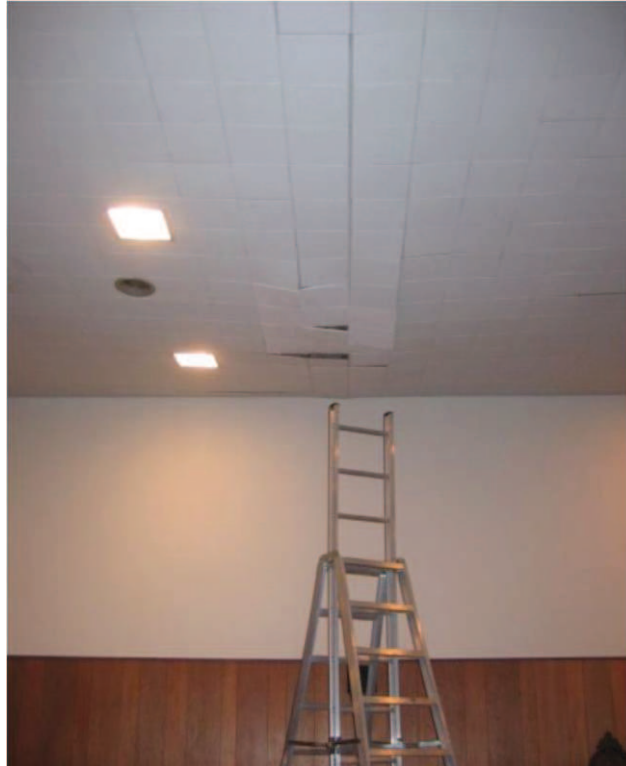
Observation was made at the auditorium for the condition of the ceiling tile and wall plaster. At the north end of the girder truss, the ceiling was significantly deflected downward. The ceiling tile joints were opened with the tile being displaced or missing. At the north and south walls, vertical crackage in the plaster was observed below each end of the girder truss.

Photo No. 1: Displaced ceiling tile in auditorium at north end of girder truss.

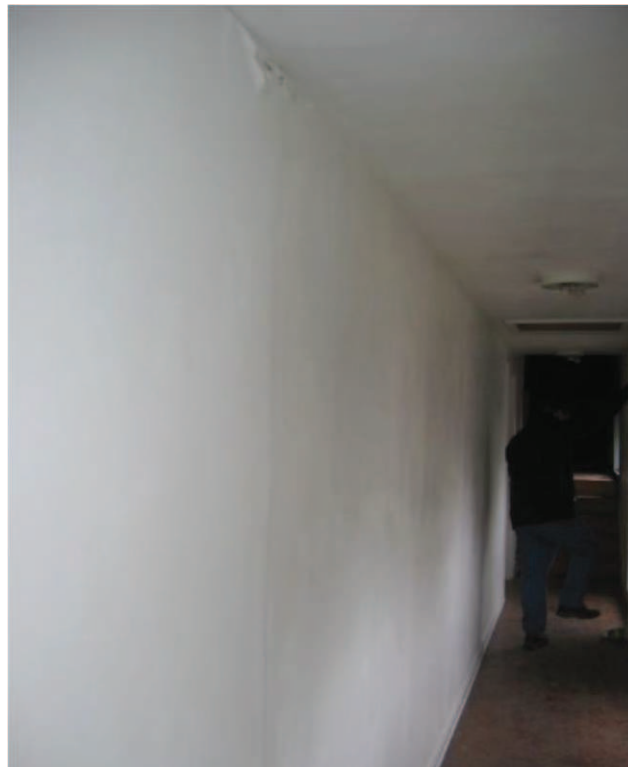
Photo No. 6: Corridor along south side of building at girder truss bearing.

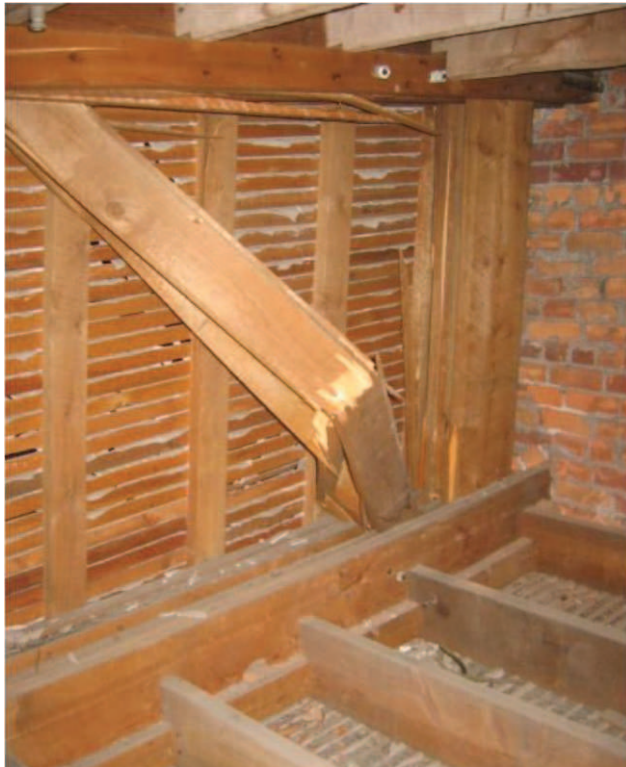
At the north end of the girder truss the first panel diagonal boards had buckled to the east and were broken. The end vertical boards were also broken. Both the top and bottom chords were broken at the second panel point. Deflection of the girder truss had occurred and was approximately 12-inches downward. Both the top and bottom chords had pulled out of the brick wall. At the south end, the diagonal boards of the first panel had buckled toward the east and had cracked. This same condition was observed on the outside board of the diagonal of the first panel at the north end of the girder truss to the east of the girder truss under investigation.

Photo No. 12: Breakage of diagonal chord member at north end of girder truss.

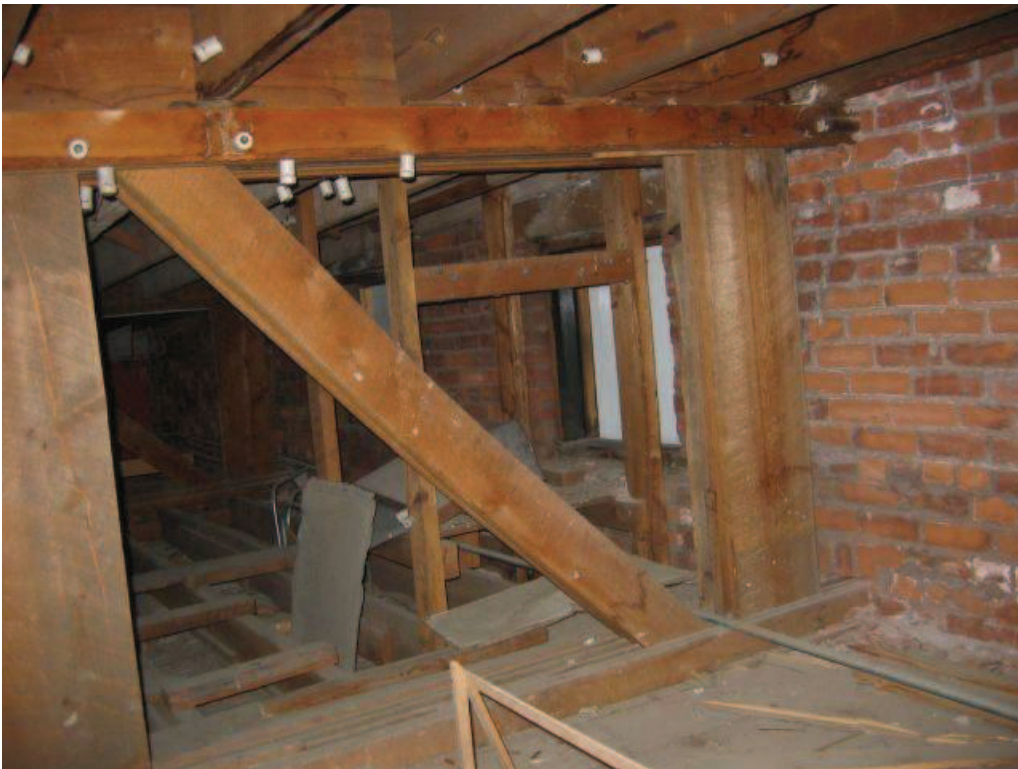
Photo No. 18: South end of girder truss, bearing point on brick wall.

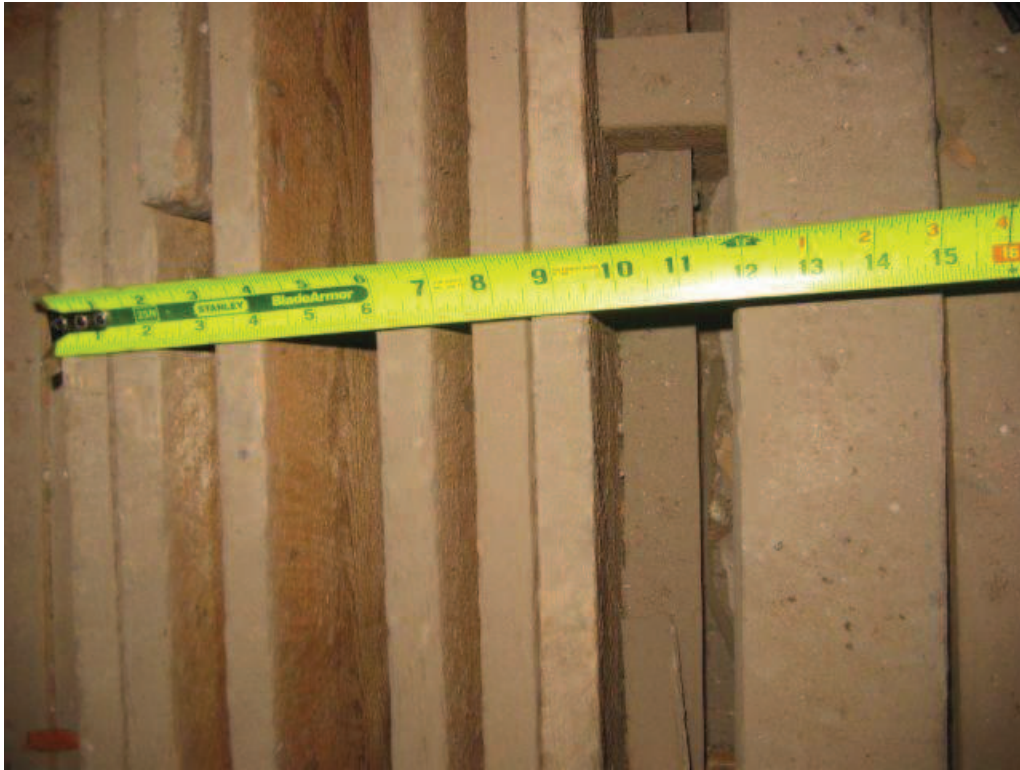
Photo No. 19: Spacing of bottom chord boards to allow for diagonal chord members.

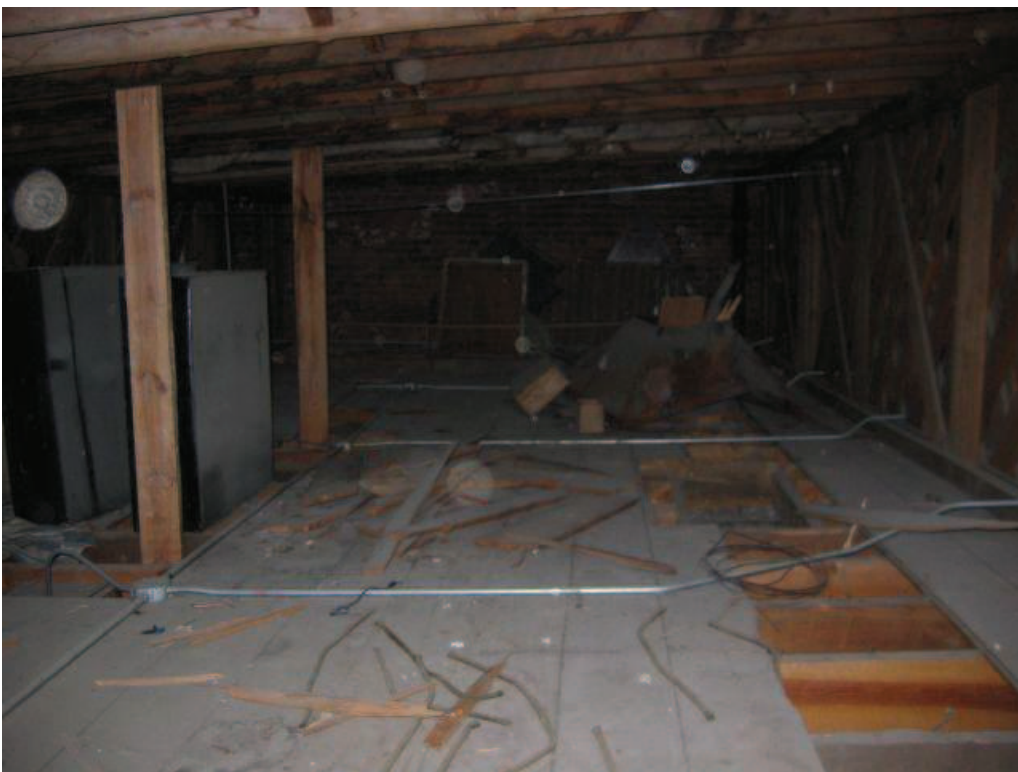
Photo No. 22: Typical ceiling and roof framing with floor planks on west side of subject girder truss.

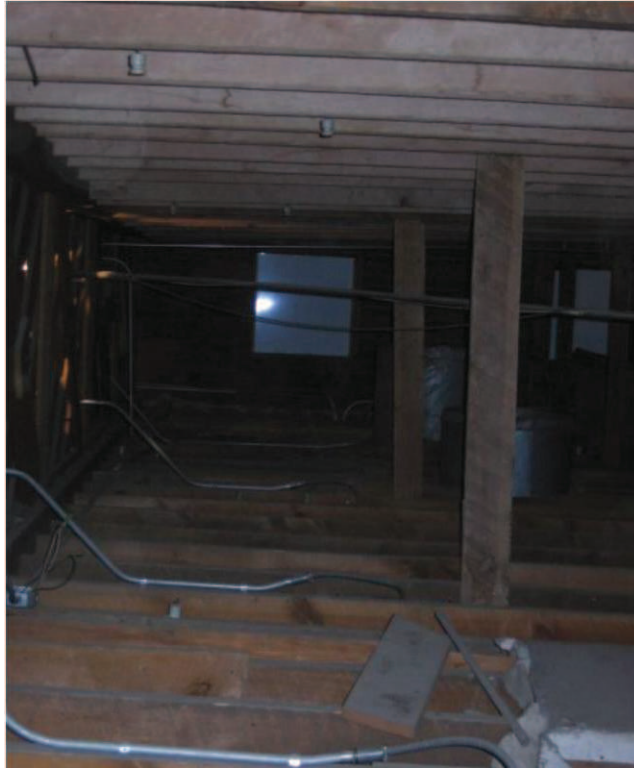
Photo No. 23: Typical ceiling and roof framing on east side of subject girder truss.

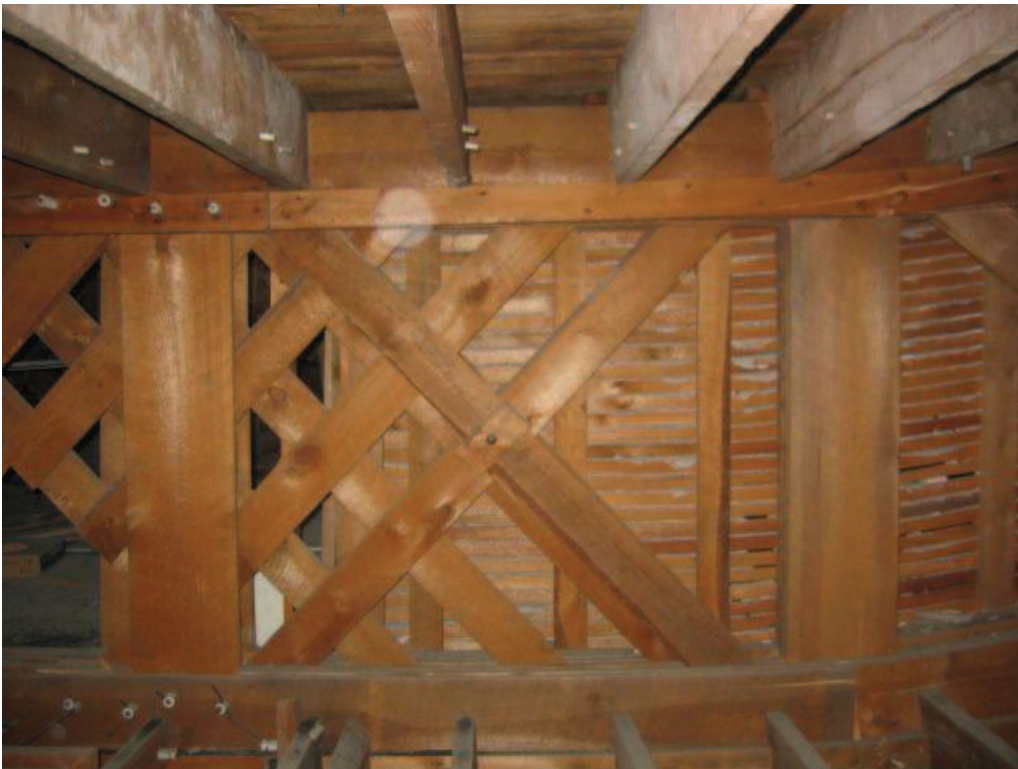
Photo No. 24: Interior panel of subject girder truss. View is at the north end, looking to the west.

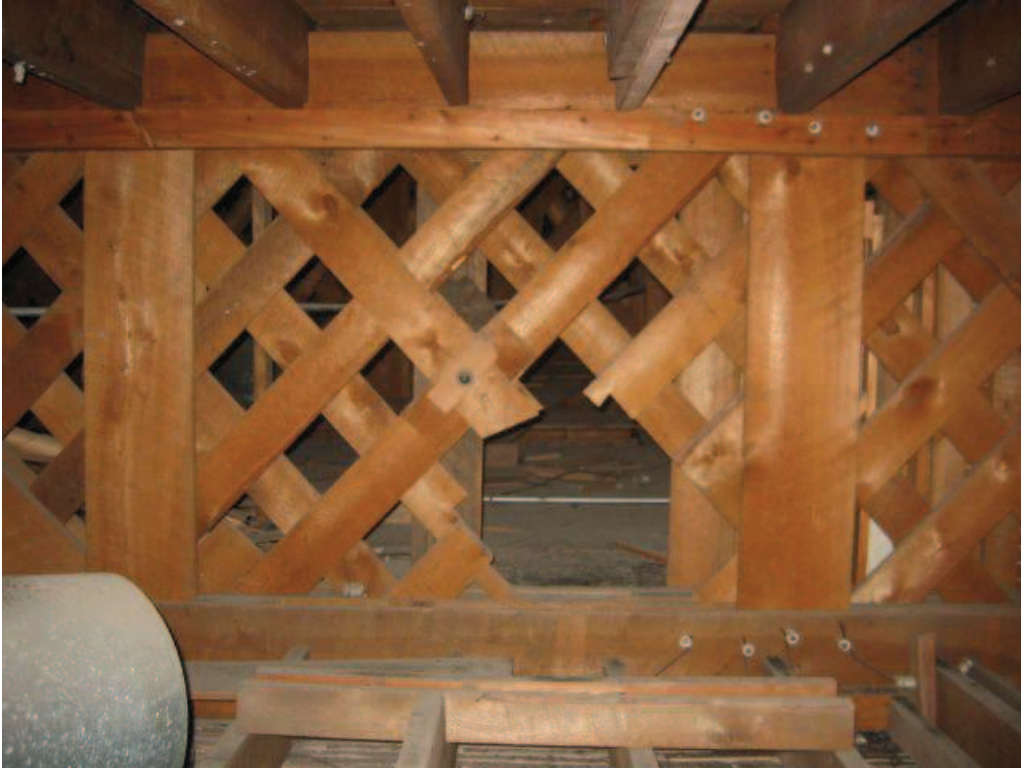
Photo No. 25: Interior panel of subject girder truss.

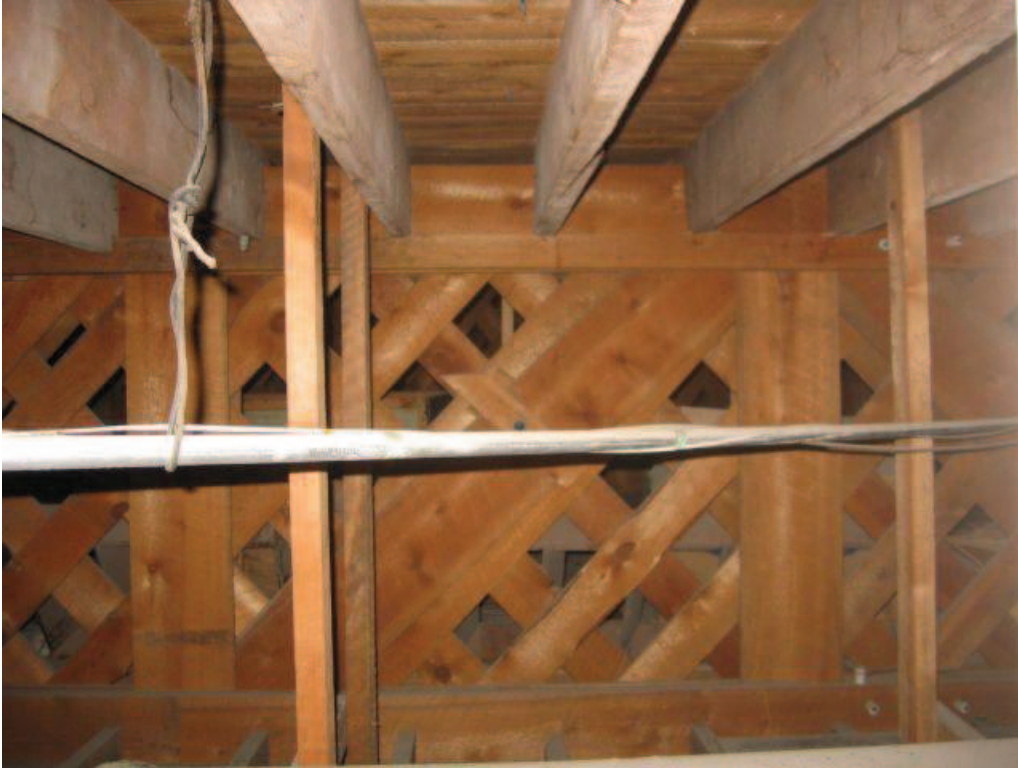
Photo No. 27: Interior panel of subject girder truss.

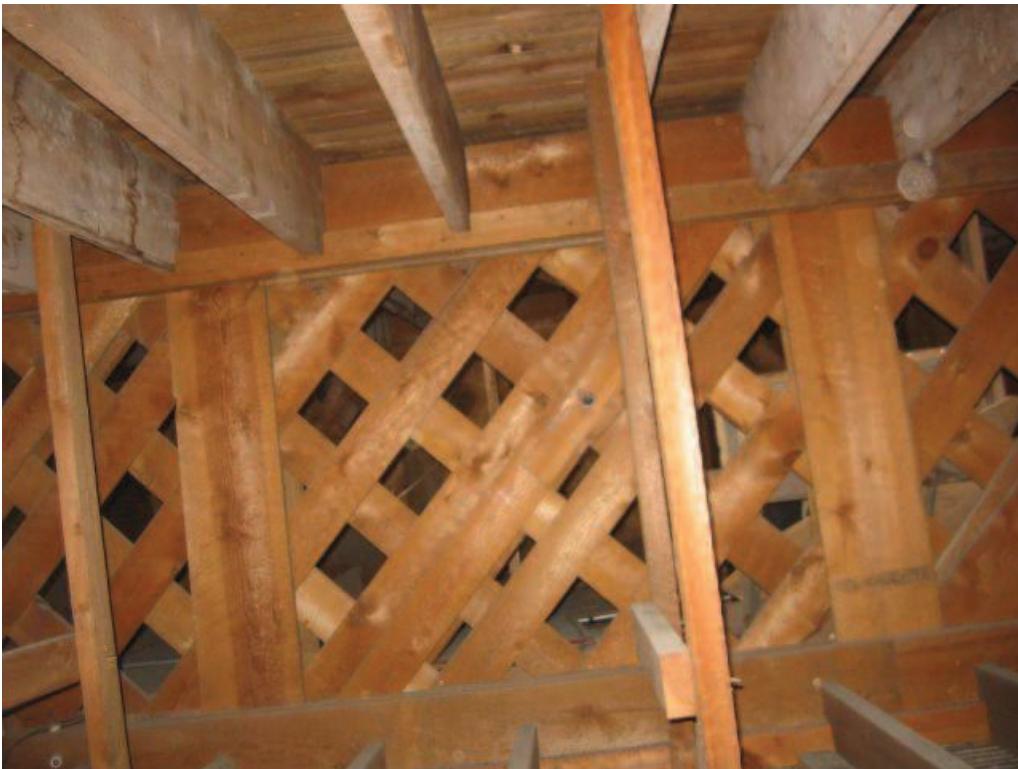
Photo No. 28: Interior panel of subject girder truss.

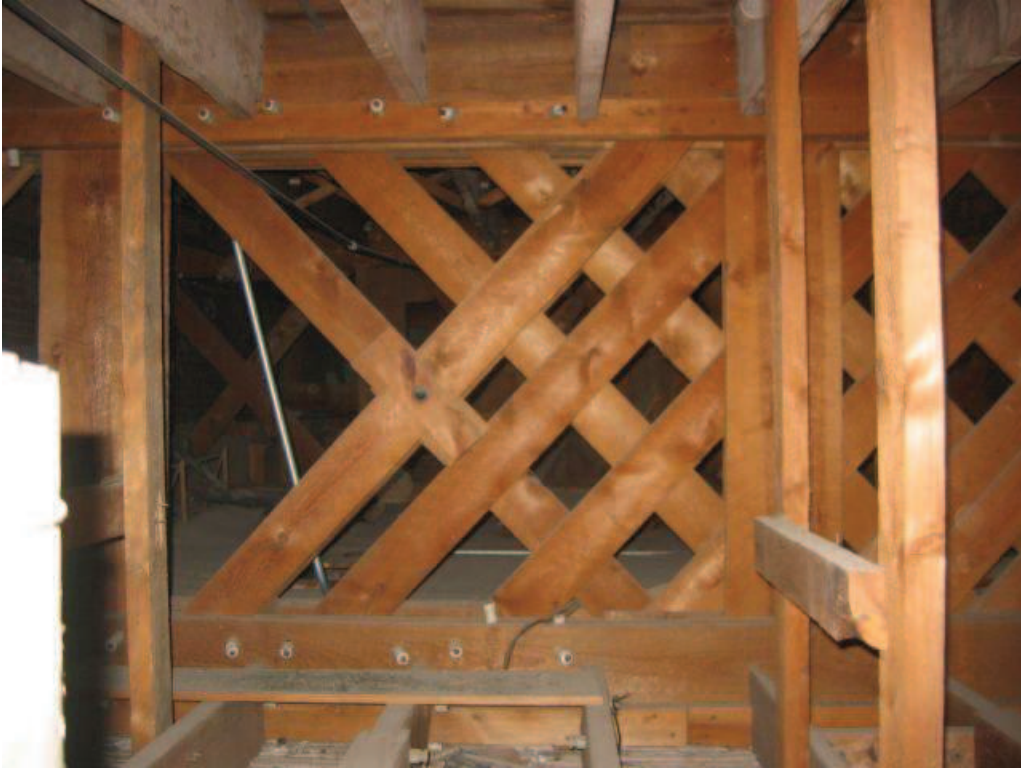
Photo No. 29: View of girder panel at south end of girder truss.

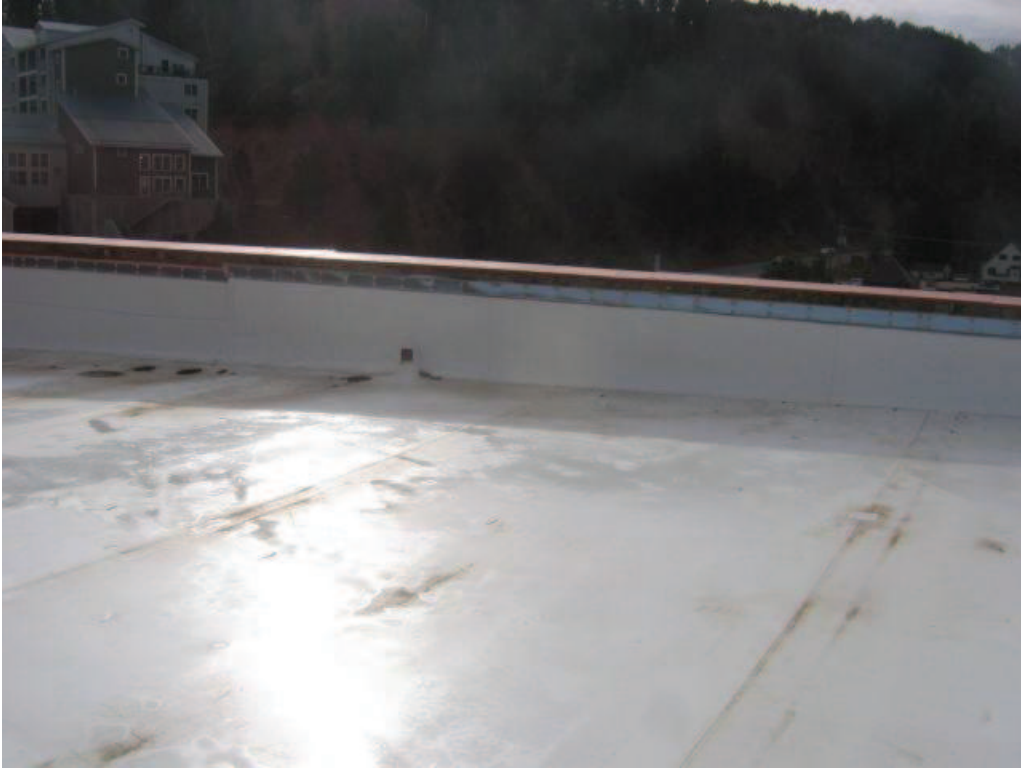
Photo No. 37: South parapet wall.

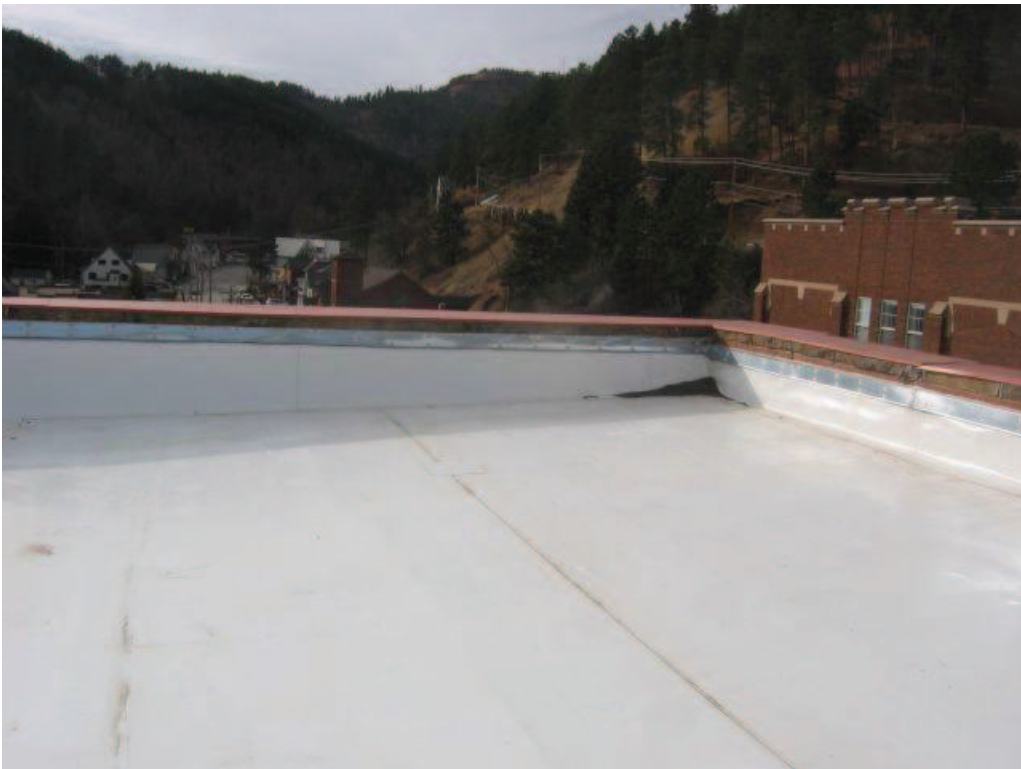
Photo No. 38: Southwest corner of roof and parapet.

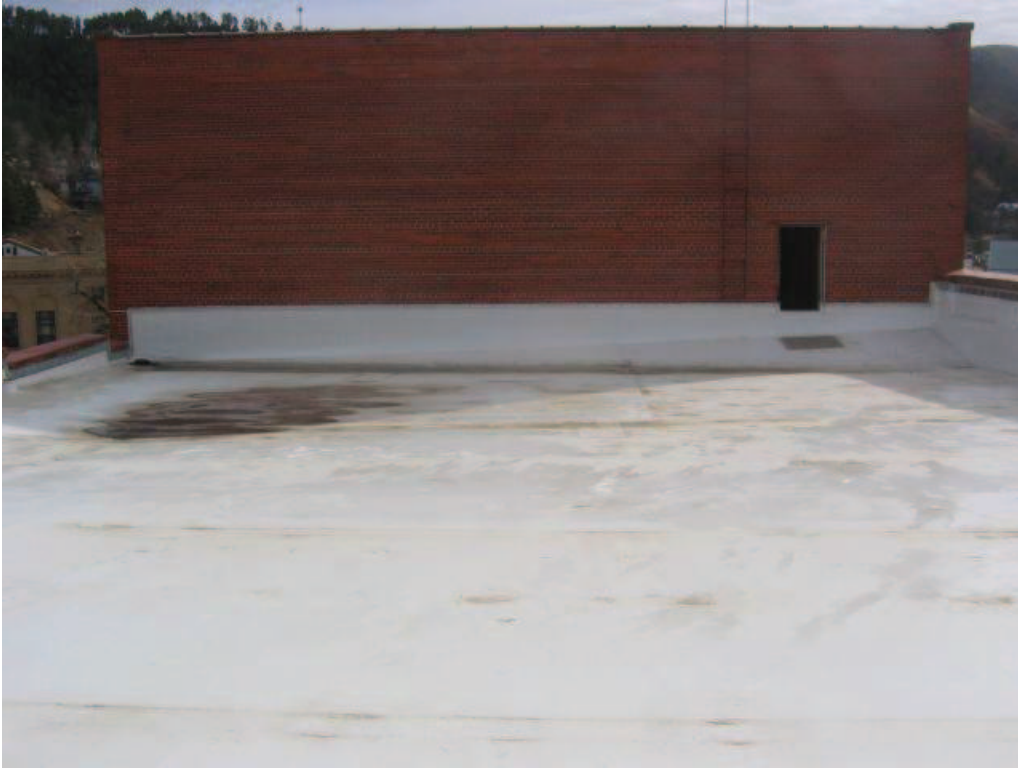
Photo No. 39: View of flyway wall at east end of lower roof.
